January 23, 2012 Federal Energy Regulatory Commission Clam River Project, No. 9185, Flambeau Hydro, LLC Article 401(b)(M), Purple Loosestrife Inventory

CC: FERC – CRO Clam River Project Purple Loosestrife Inventory July 22 & 23, 2011 FERC Project #9185 Article 401(b)(M)

## Purple Loosestrife

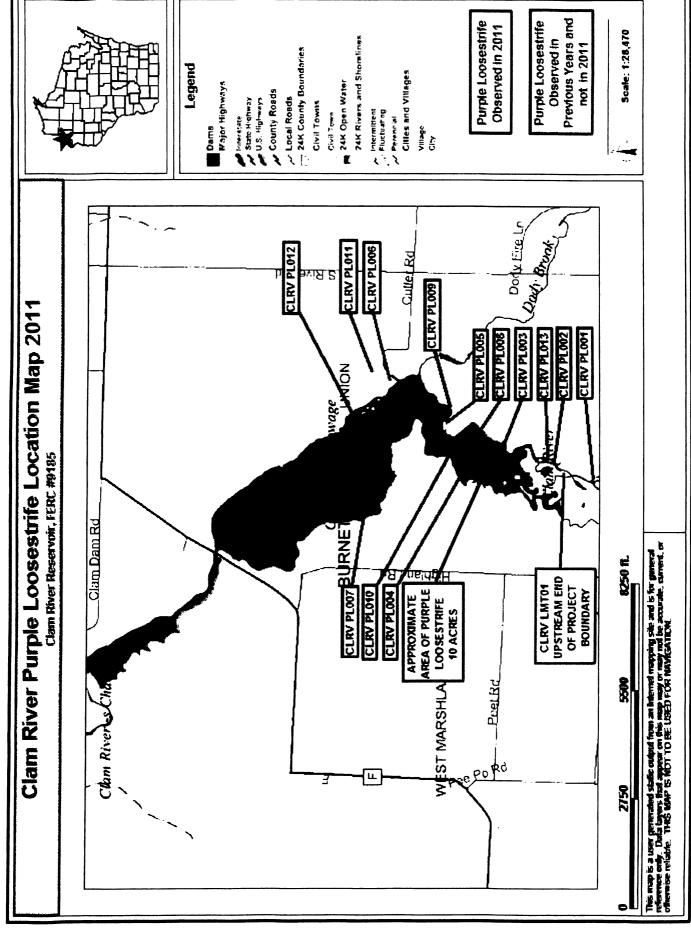
These purple loosestrife plants were inventoried and have been noted on the survey sheet(s) and map(s) at the end of this report. No other occurrences of purple loosestrife were observed.
