RE: Way Dam Hydroelectric Project, FERC No. 1759-036
Article 418-Low Dissolved Oxygen Mitigation- Progress Report

**Way Dam Hydroelectric Project, FERC No. 1759-036
Article 418
Low Dissolved Oxygen Mitigation Plan
Draft Progress Report (without Vertical Profile Tables).**

Way Dam, FERC Project No.1759-036
Article 418, Dissolved Oxygen Mitigation Plan
2004 Progress Report

Way Dam Hydroelectric Project, FERC No. 1759-036
Article 418
Low Dissolved Oxygen Mitigation Plan
Draft Progress Report

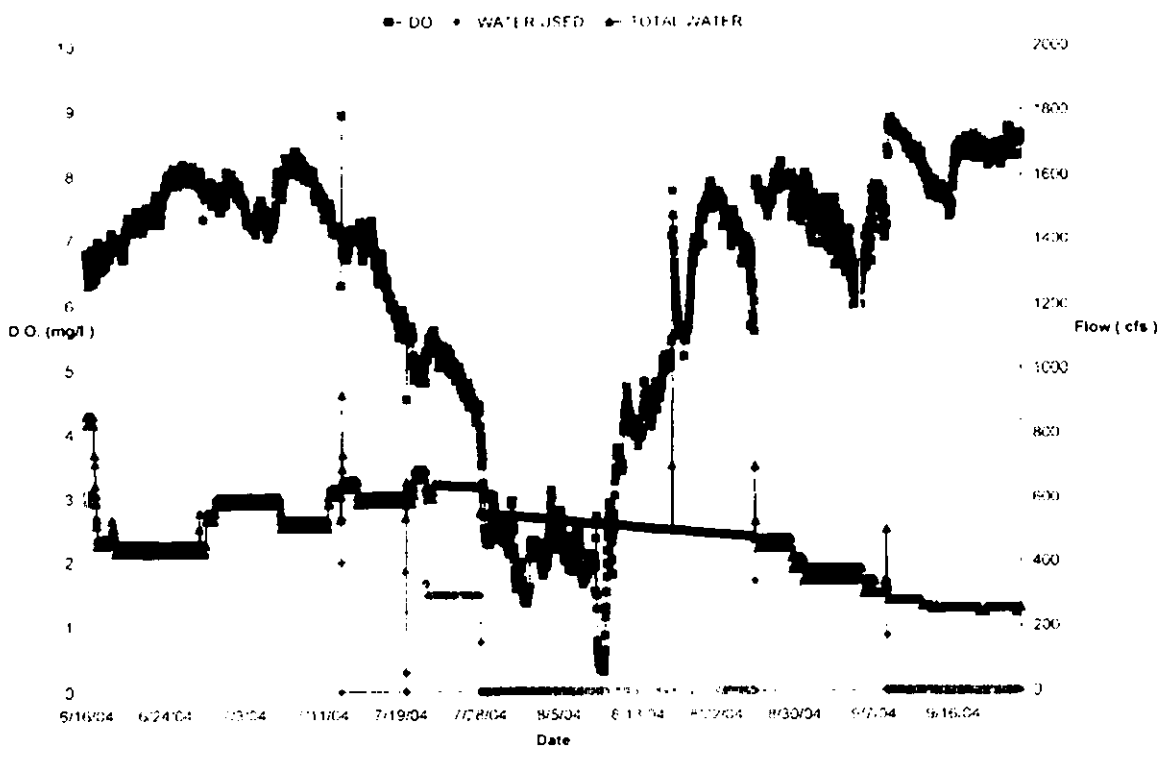
Figure 1 Way Dam 2004 Tailrace Data
Flow vs Dissolved oxygen June 15 - Sept 23 2004

Results of the entire continuous monitoring period as well as a more detailed examination of the period 22 July through 26 August are provided as Figures 1 and 2, respectively, to this report. The summary results for temperature and DO, based on the continuous monitoring program are provided in Table 1, while the results of the vertical profile measurements are provided in Appendix A.

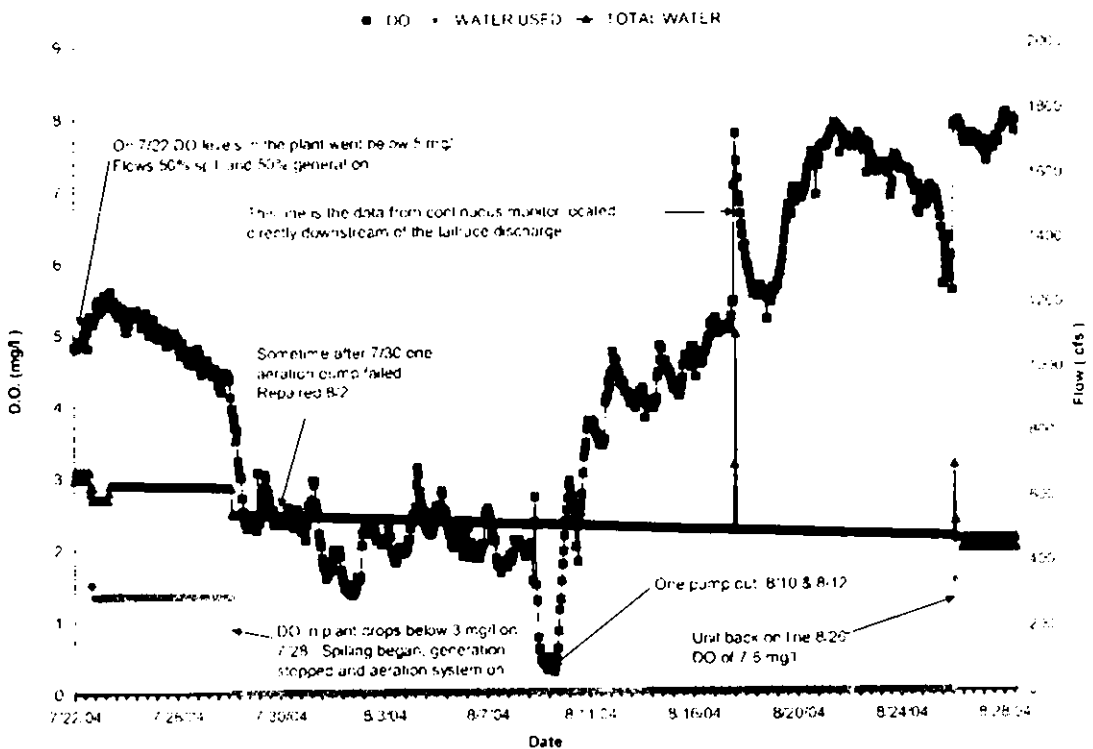
Figure 2 Way Dam 2004 Tailrace Data
Flow vs. Dissolved Oxygen 7/22 - 8/28, 2004

The unit was taken off line on July 28th. In response to this action, the DO dropped from 4.5 to 2.5 PPM, as measured by the downstream sonde, in approximately 12 hours. This may have been due to the discontinuation of aeration provided by the generator under low flows. At this time, the aeration system was activated.

From the time when the unit was taken off (July 28th) to when the head gate was closed (August 10th), the aeration system improved the DO in the tailrace, but did not increase the DO levels above 3.0 ppm. At this time, the company concluded that the actual leakage flow through the generator with the head gate open was likely greater than the 2 CFS assumed previously.

When the headgate was closed on August 10th, the DO as measured by the downstream sonde began a general increasing trend (ignoring for the moment the two pump failures experienced after 8/10). For example, on 8/11/04, the DO in the tailrace, as measured by the downstream sonde had increased above 3.0 ppm and did not go below this value for the rest of the summer. On 8/14/04, the DO in the tailrace, as measured by the downstream sonde had increased above 4.0 ppm and did not go below this value for the rest of the summer. On 8/17/04, the DO in the tailrace, as measured by the downstream sonde had increased above 5.0 ppm and did not go below this value for the rest of the summer.

The Gast pumps used to supply the air for the aeration system, experienced many failures (at least five during the testing performed in summer, 2004). The DO as measured by the downstream sonde showed declines in DO immediately following pump failure.

These failures was most likely due to the fact that these pumps have only been operated during the winter months when the ambient temperature is a lot less than during the summer months. A different air pump (Roots pump, specifications 30 ACFM @ 10 PS') has been purchased for use in 2005.

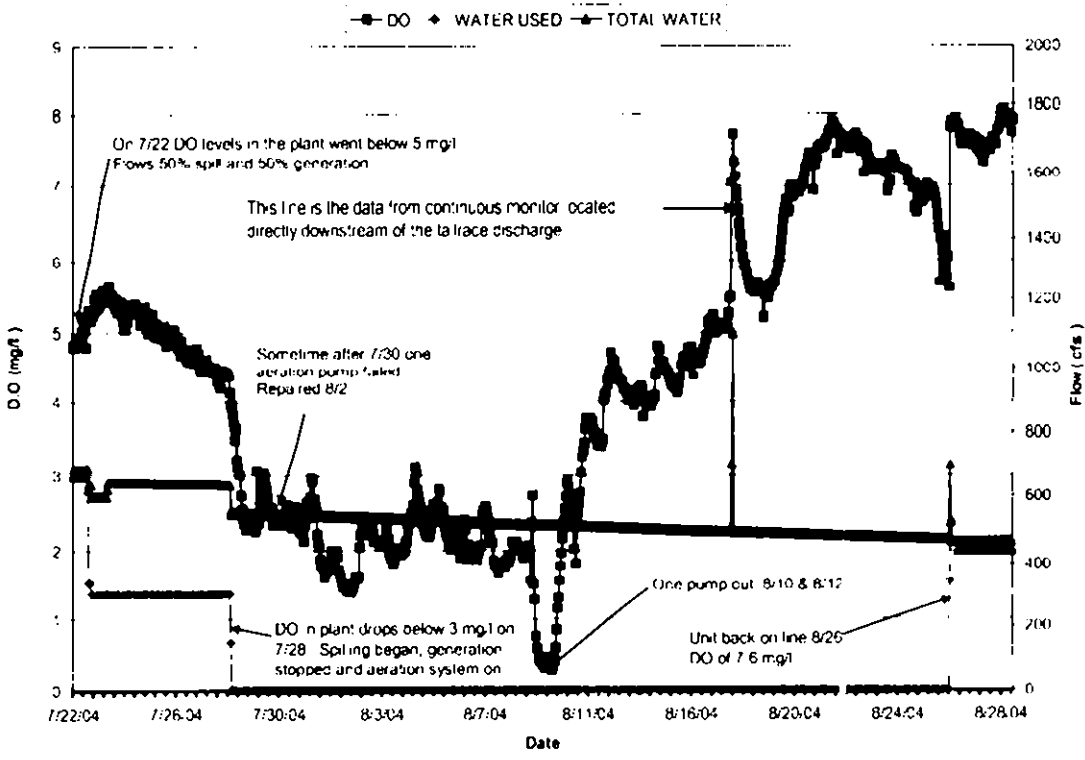
**Figure 2 Way Dam 2004 Tailrace Data
Flow vs. Dissolved Oxygen 7/22 - 8/28, 2004**

From the time when the unit was taken off (July 28th) to when the head gate was closed (August 10th), the aeration system improved the DO in the tailrace, but did not increase the DO levels above 3.0 ppm. At this time, the company concluded that the actual leakage flow through the generator with the head gate open was likely greater than the 2 CFS assumed previously.

When the headgate was closed on August 10th, the DO as measured by the downstream sonde began a general increasing trend (ignoring for the moment the two pump failures experienced after 8/10). For example, on 8/11/04, the DO in the tailrace, as measured by the downstream sonde had increased above 3.0 ppm and did not go below this value for the rest of the summer. On 8/14/04, the DO in the tailrace, as measured by the downstream sonde had increased above 4.0 ppm and did not go below this value for the rest of the summer. On 8/17/04, the DO in the tailrace, as measured by the downstream sonde had increased above 5.0 ppm and did not go below this value for the rest of the summer.

The Gast pumps used to supply the air for the aeration system, experienced many failures (at least five during the testing performed in summer, 2004). The DO as measured by the downstream sonde showed declines in DO immediately following pump failure.

These failures were most likely due to the fact that these pumps have only been operated during the winter months when the ambient temperature is a lot less than during the summer months. A different air pump (Roots pump,) has been purchased for use in 2005.
