Lake Grant Report: Identifying Restorable Wetlands in the Watersheds of Horicon Marsh & Lake Sinissippi

A project of the Rock River Coalition, Inc.

(Wisconsin Department of Natural Resources Lake Grant #SPL-322-14.1)

Submitted by:
Scott Taylor, Member
Patricia Cicero, President
Rock River Coalition, Inc.
April 2015

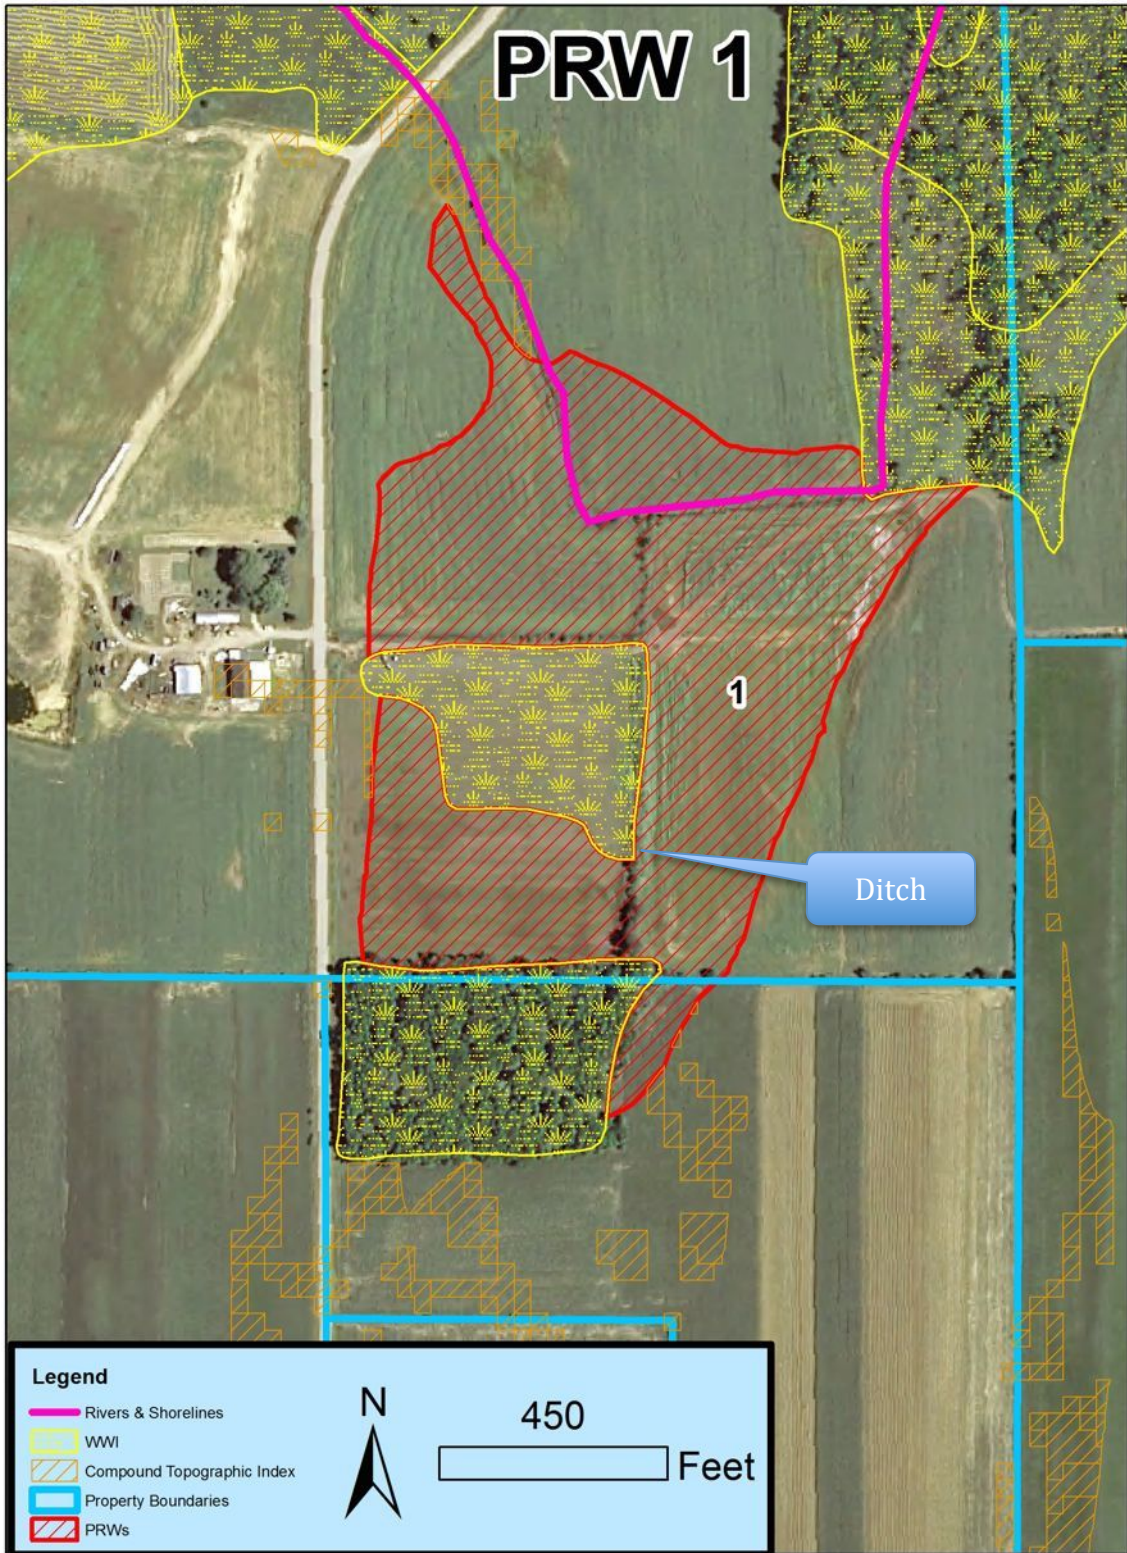
PRW 1

Flat area near woods shows signs of flooding, no crop survival, ruts in field, looks like muck. If tiles present and ditch can be filled, then decent restoration potential. A ditch along north edge of woods was recently cleaned. The woods are ash-dominated.

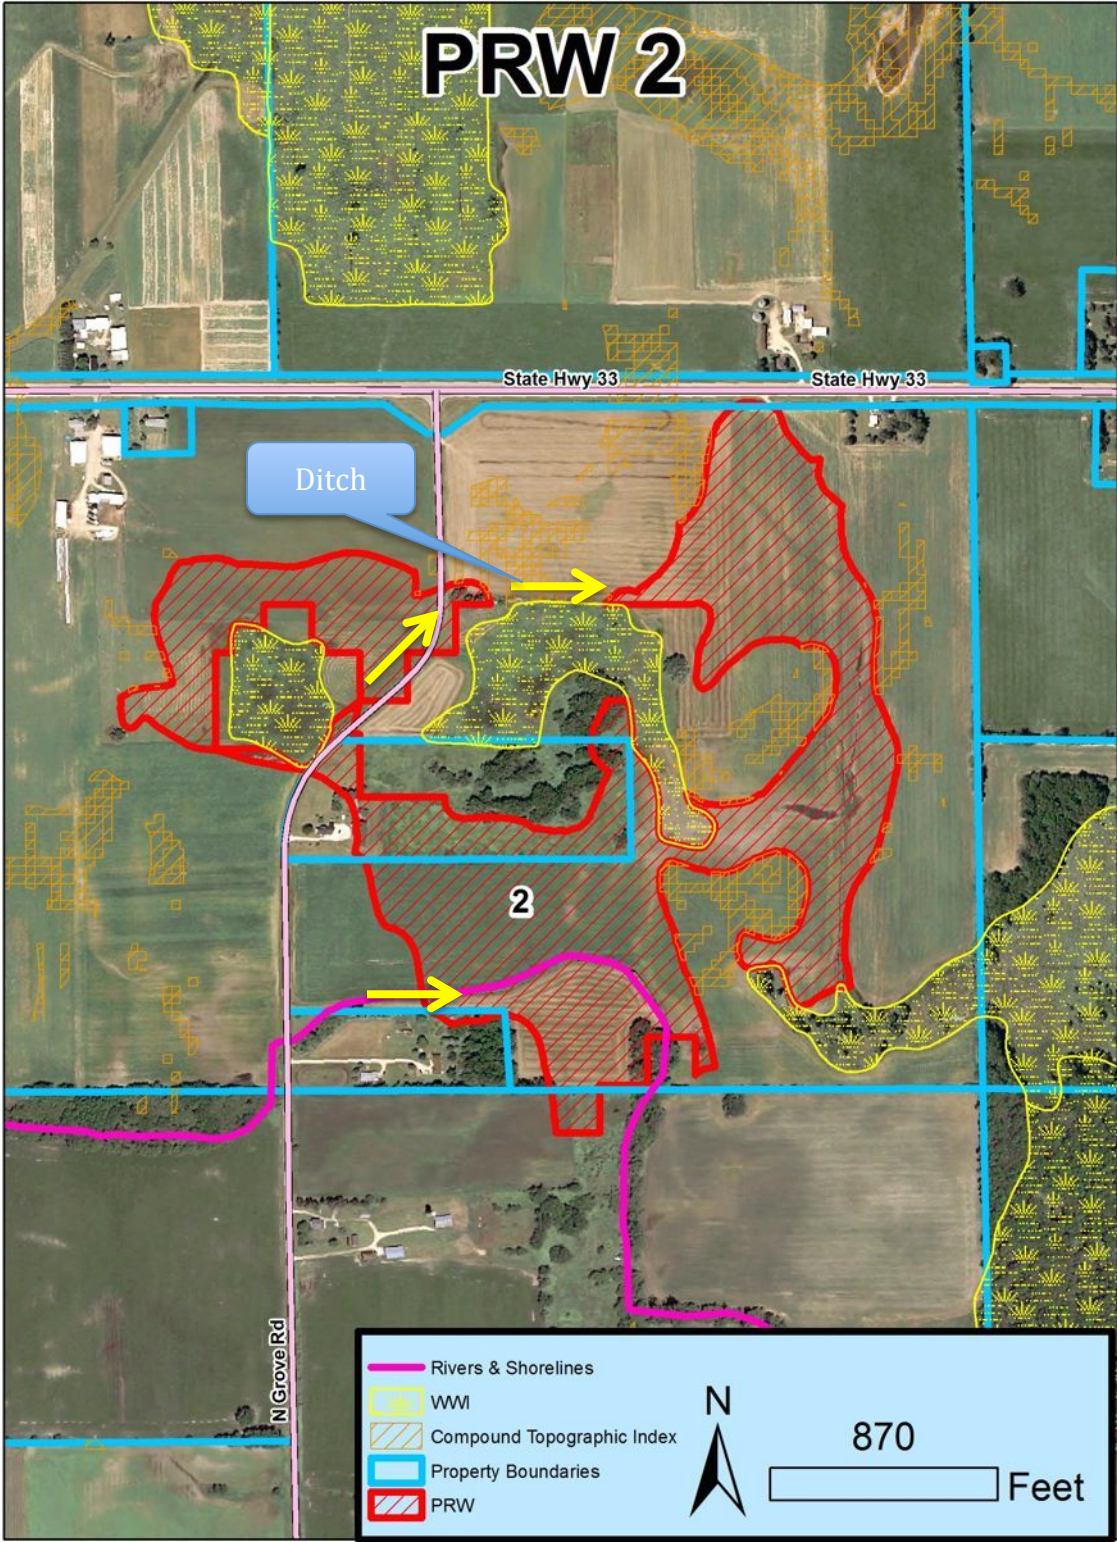
PRW 2

West Segment: Probable tile system, could be disabled. Can't manipulate main creek channel.

East Segment: Restorable by blocking ditch under N. Grove Rd.

South Segment: Same as 9a, possible tile system.

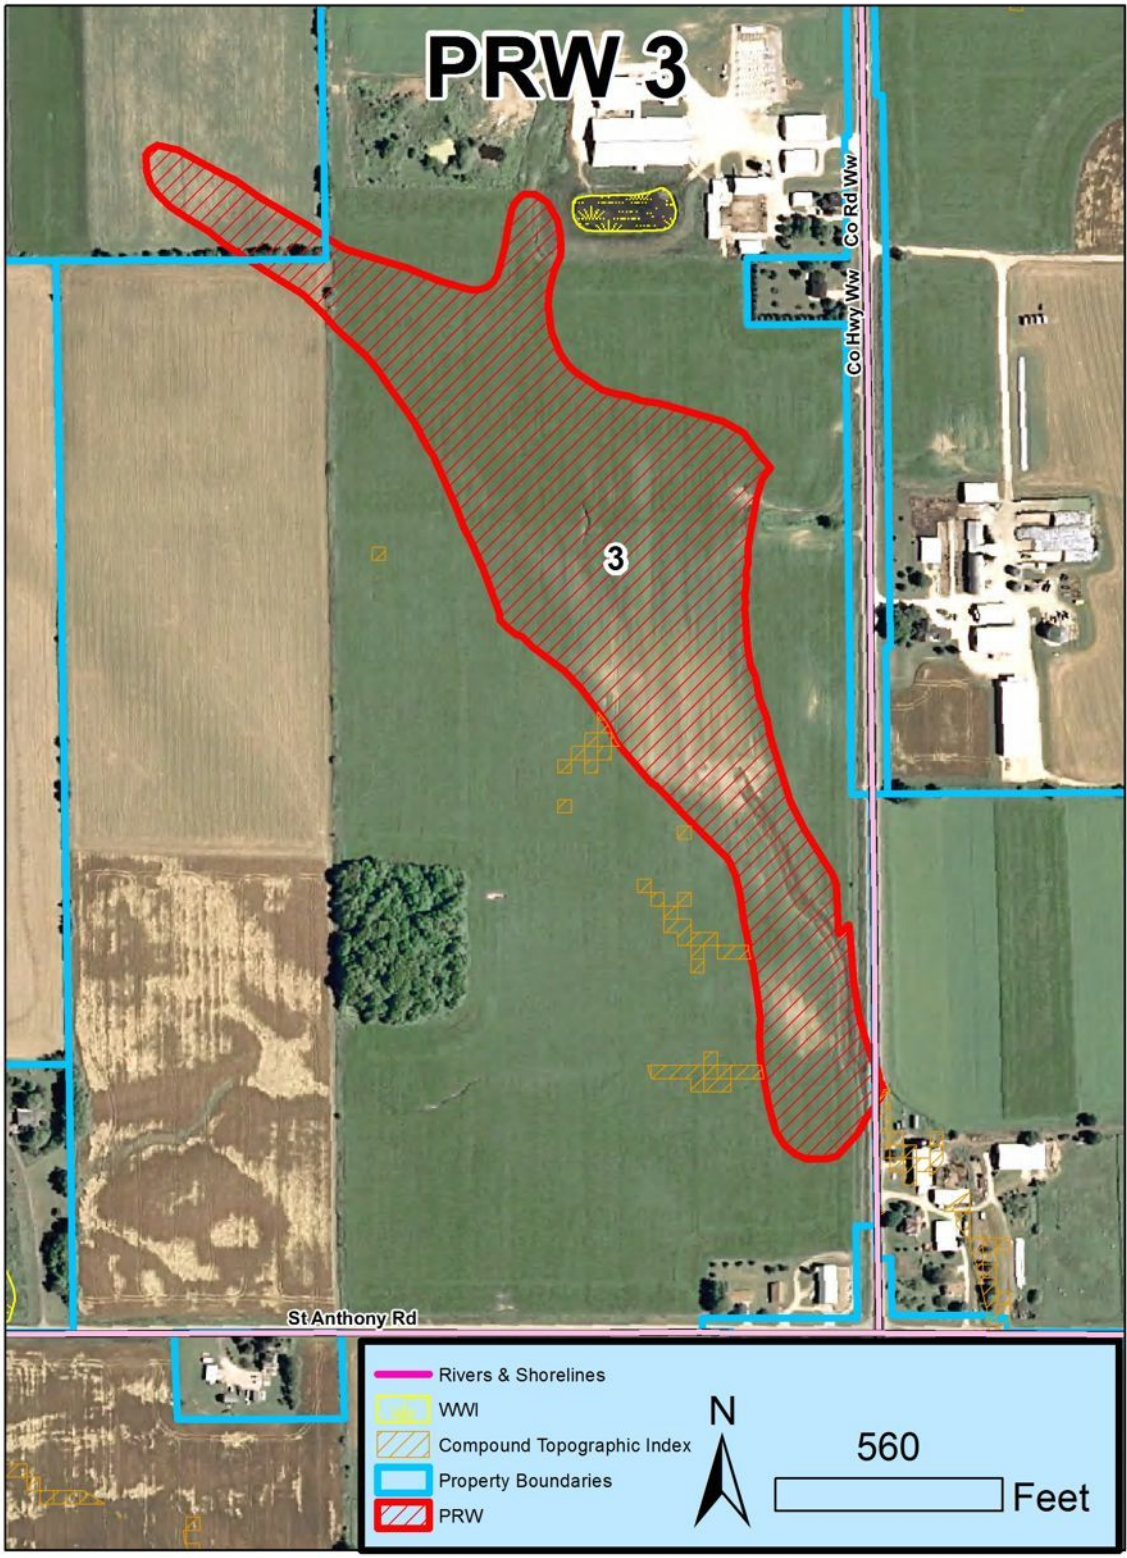
PRW-3

Waterway runs south. Tile riser in middle of field (tile lines present). Gently sloping south, no big flat area. Ditch runs east across road. Some potential for restoration.

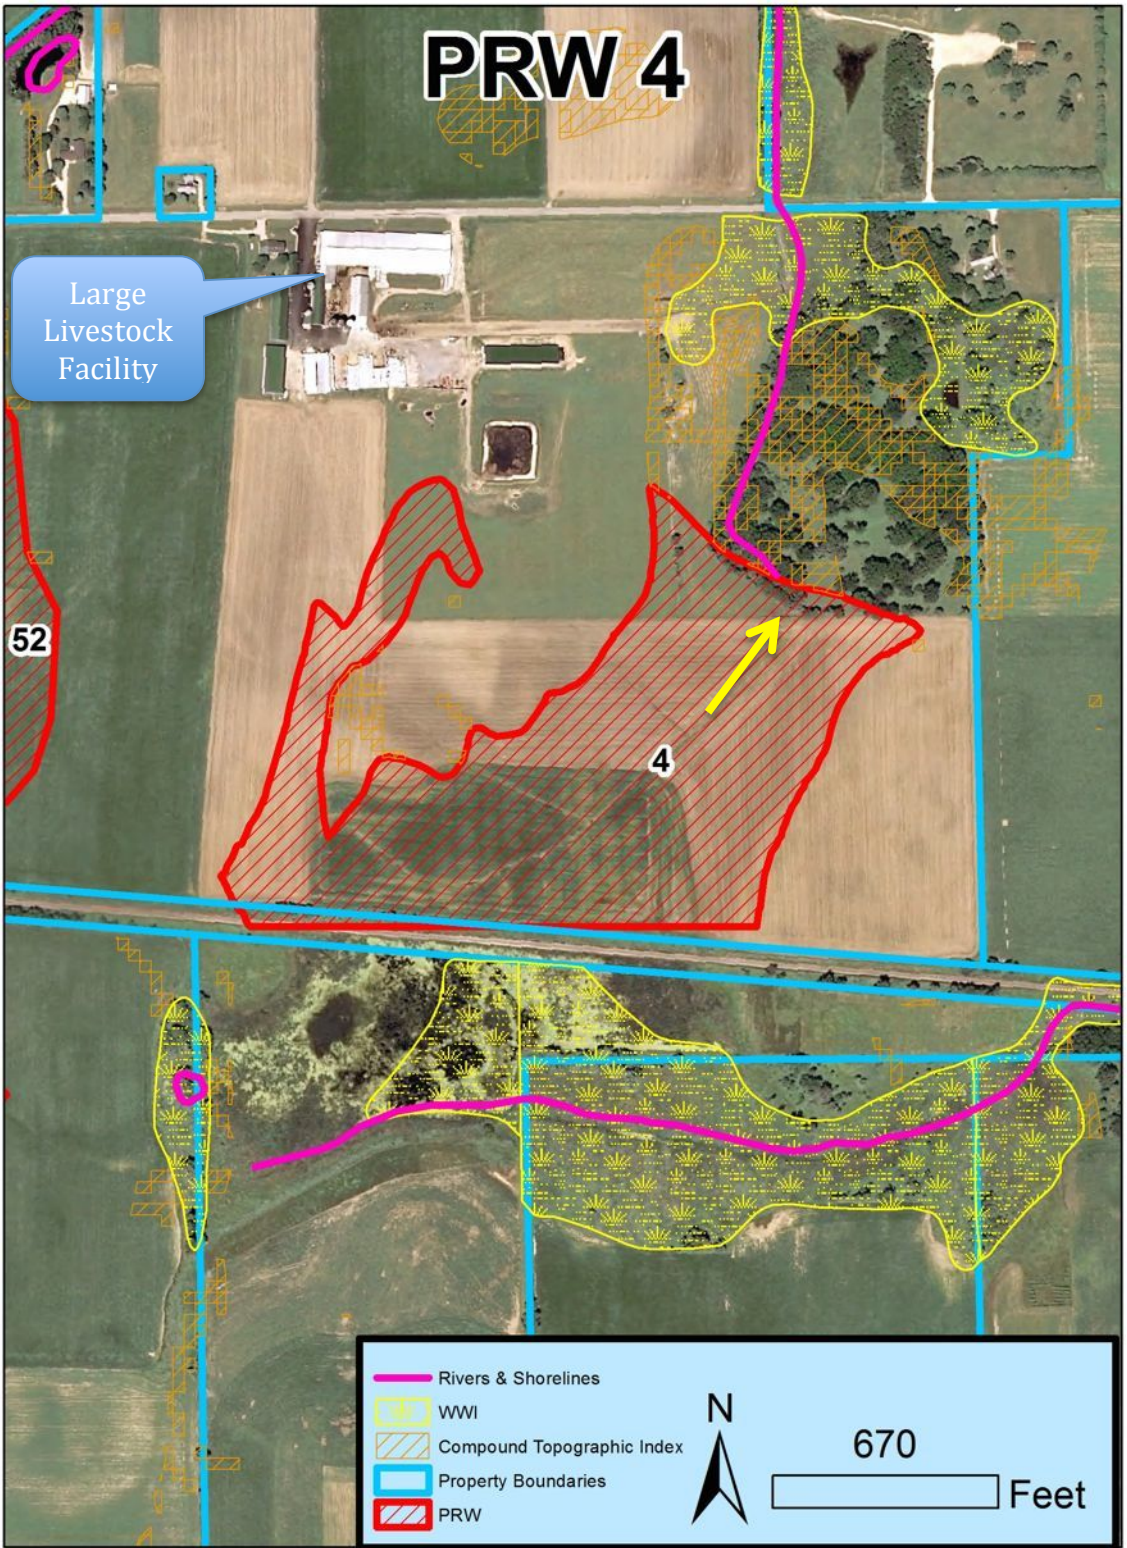
PRW 4

Could be restored by filling ditch. Large dairy operation, probably not interested.

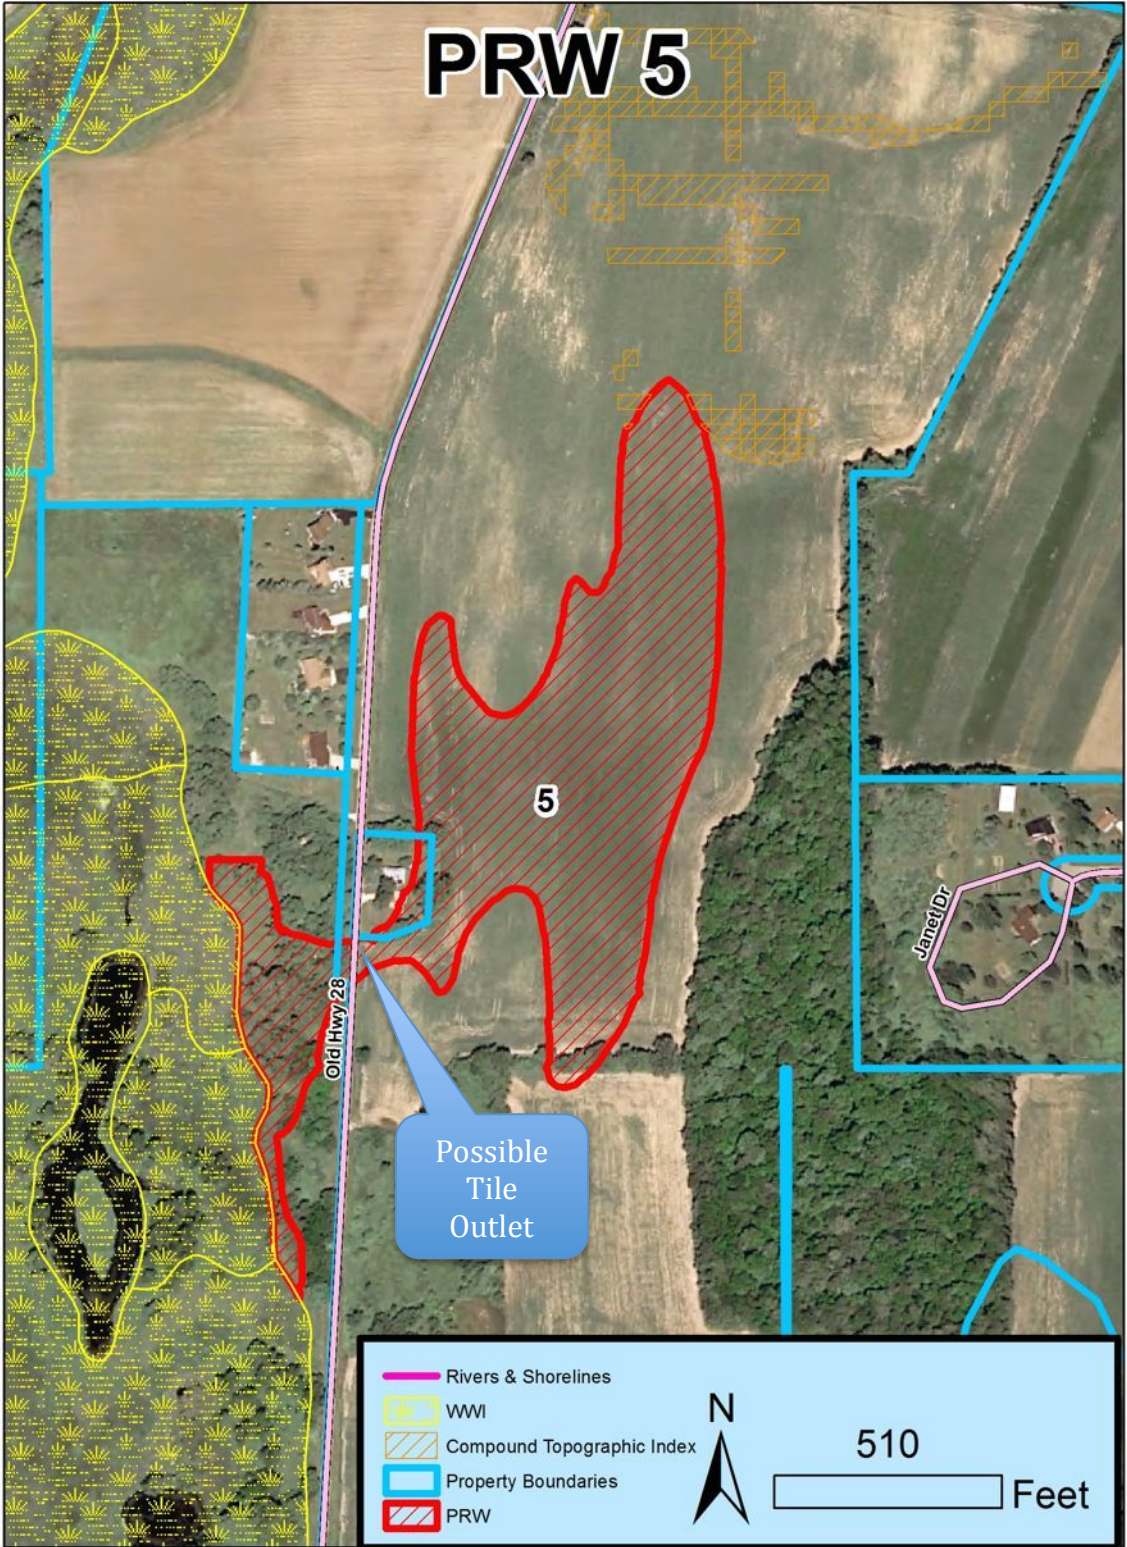
PRW 5

Possible tile outlet in southwest area by road. PRW supported corn in 2014 but pockets of crop stress. Neighbor to north just installed tile, likely connection to this site. Possible restoration if tiles exist.

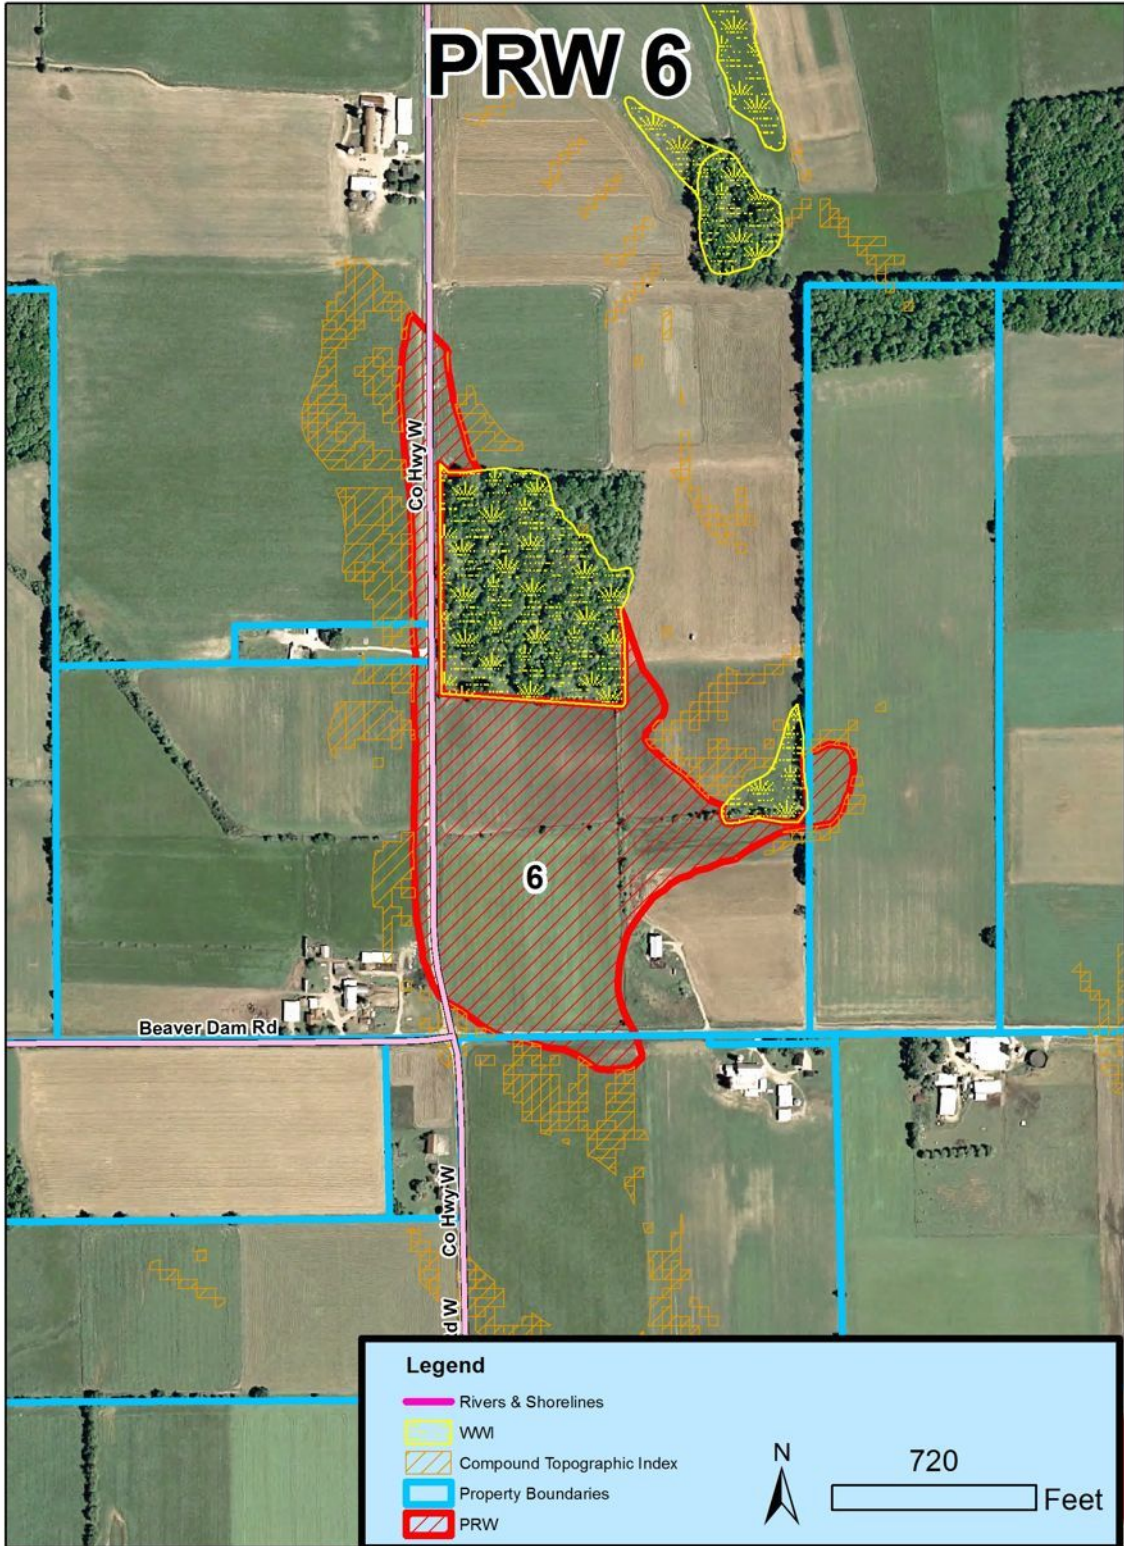
PRW 6

Isolated small ditches. No flow. Large flat landscape. No observable ditch outlet. Nearby woodlot dominated by ash trees. Low potential restoration but could be restored to hardwood swamp.

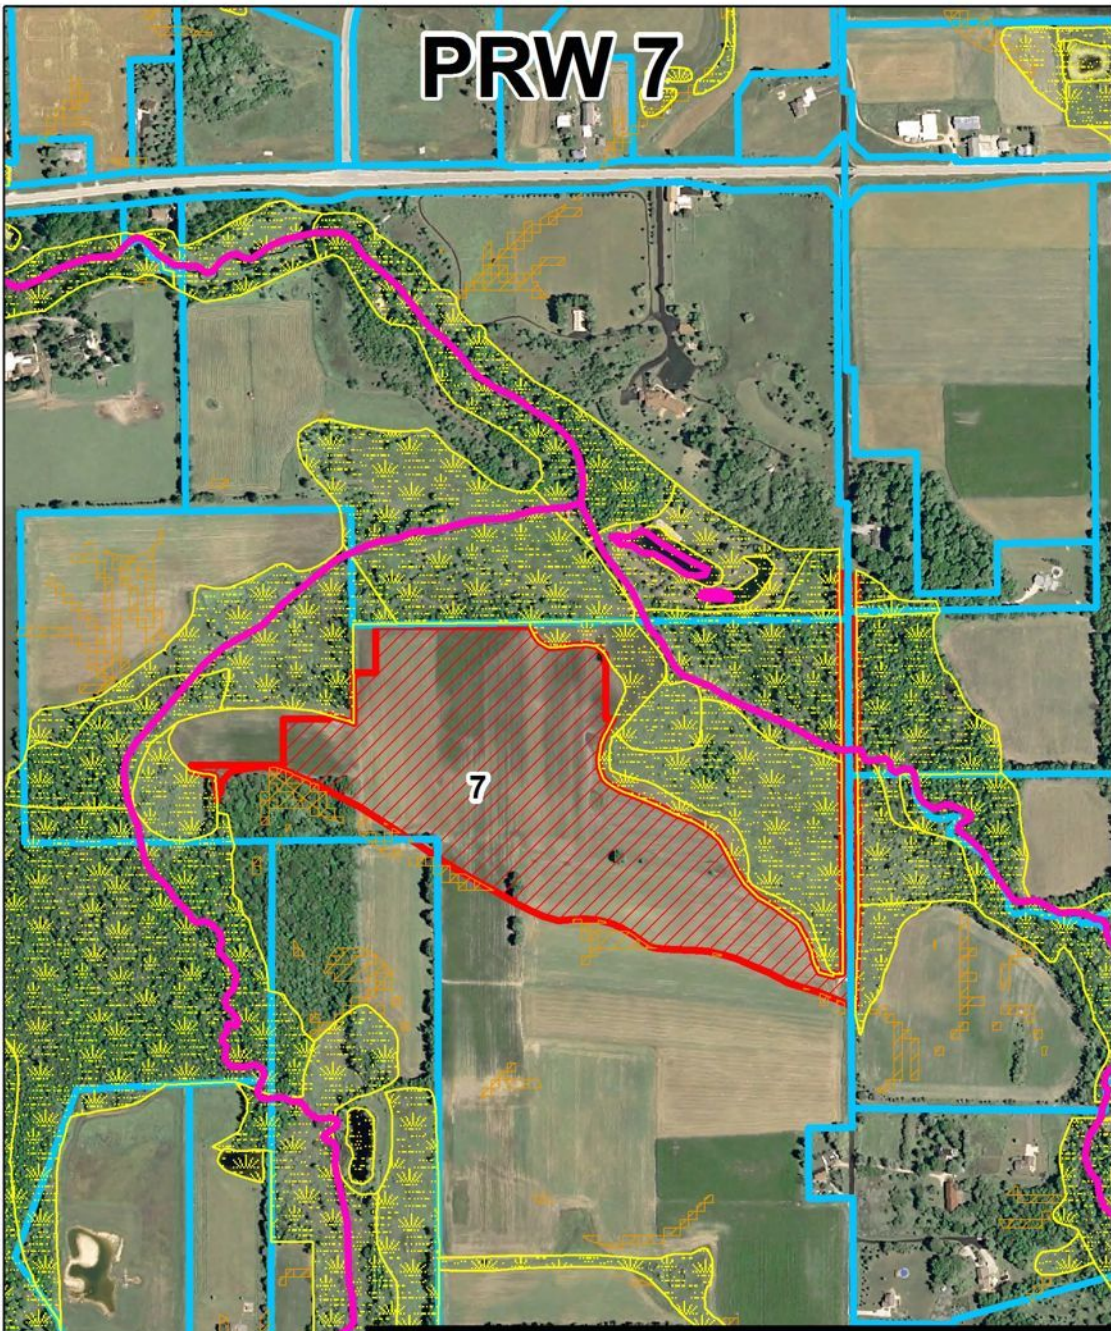
PRW 7

Big flat area, could be tiled to stream. Crops flooded out, reed canary amid stunted corn.
Restorability not clear.

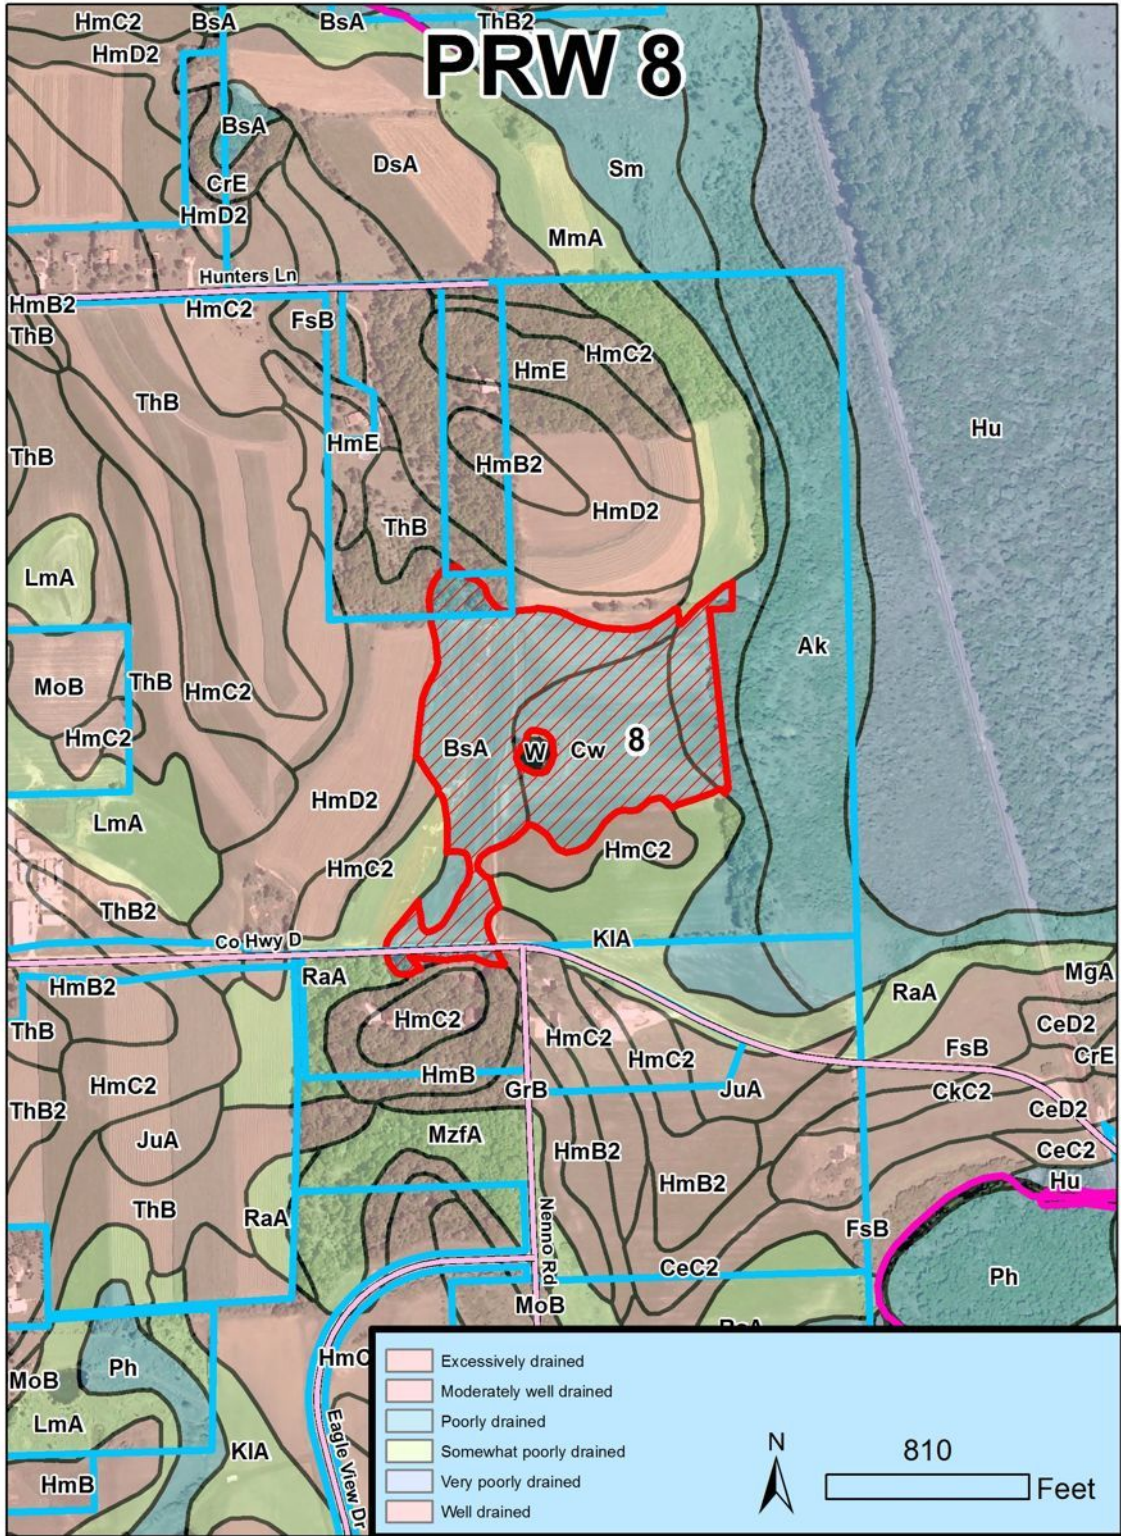
PRW 8

Pond in middle. Ditch (swales) along access road funneling water to pond area. Indications of tile present. Ditch or waterway in middle running east. Good restoration potential.

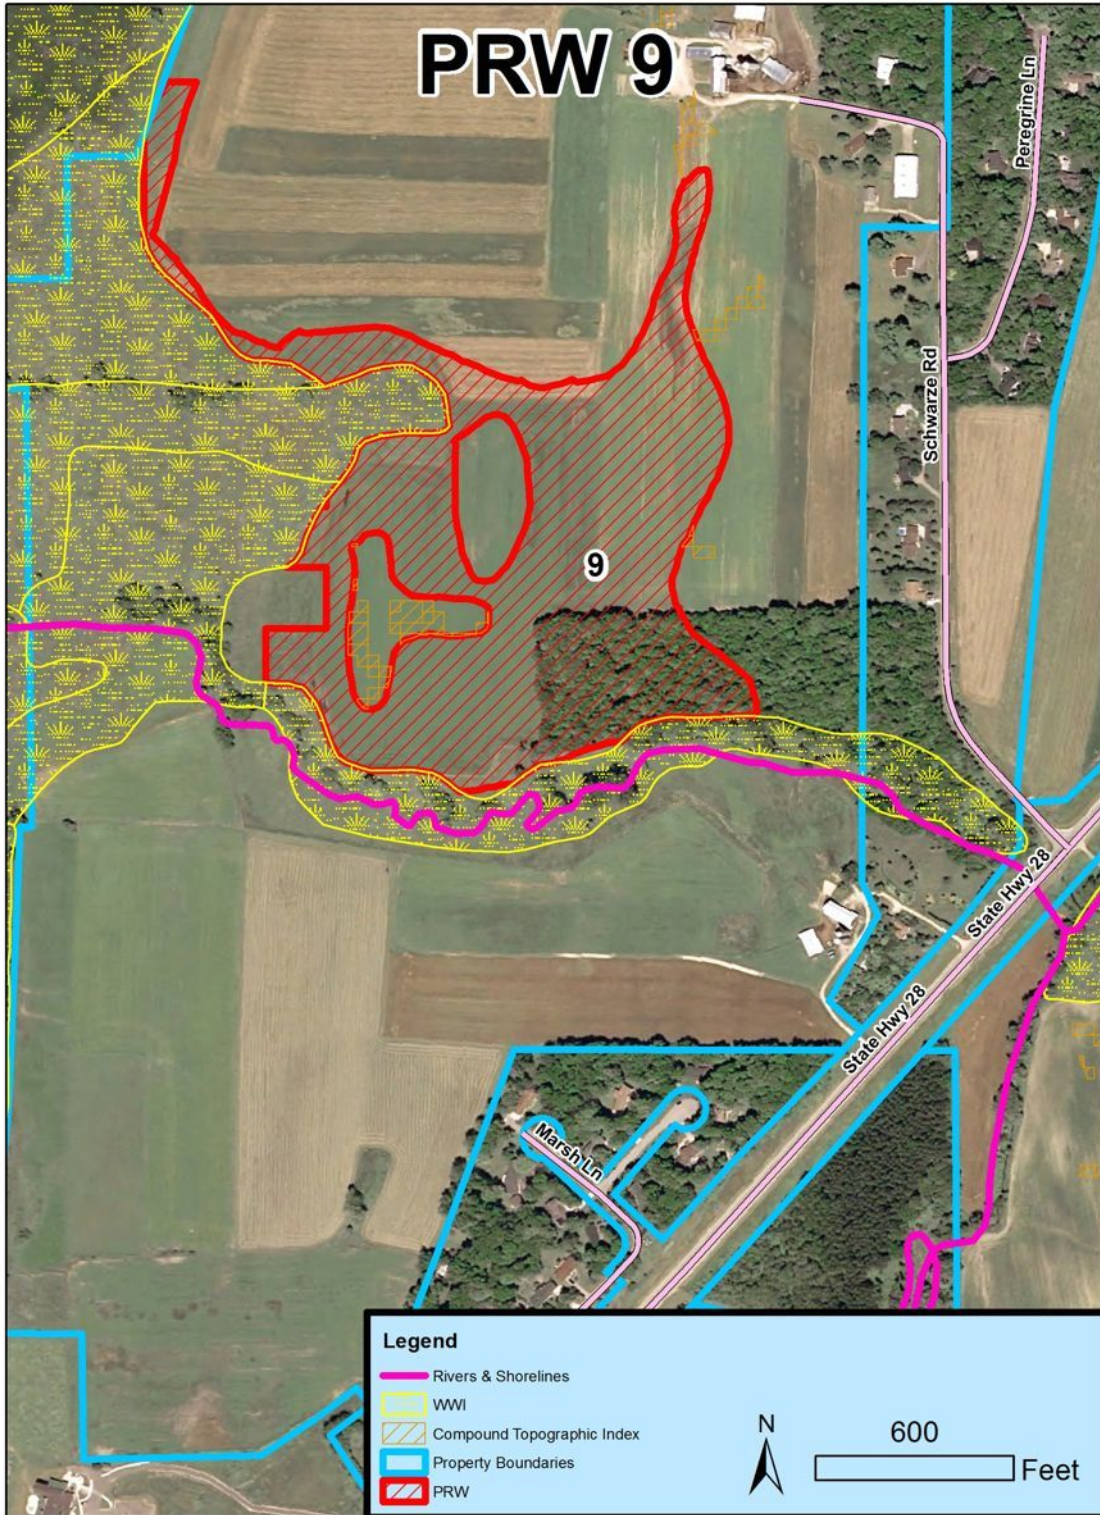
PRW 9

No ditch, grassed waterway on upper end, possible tile to stream. Flat grade adjacent to canary grass area, few small potential scrape areas. Site by Horicon Marsh. Stream small and not incised. Partially restorable.

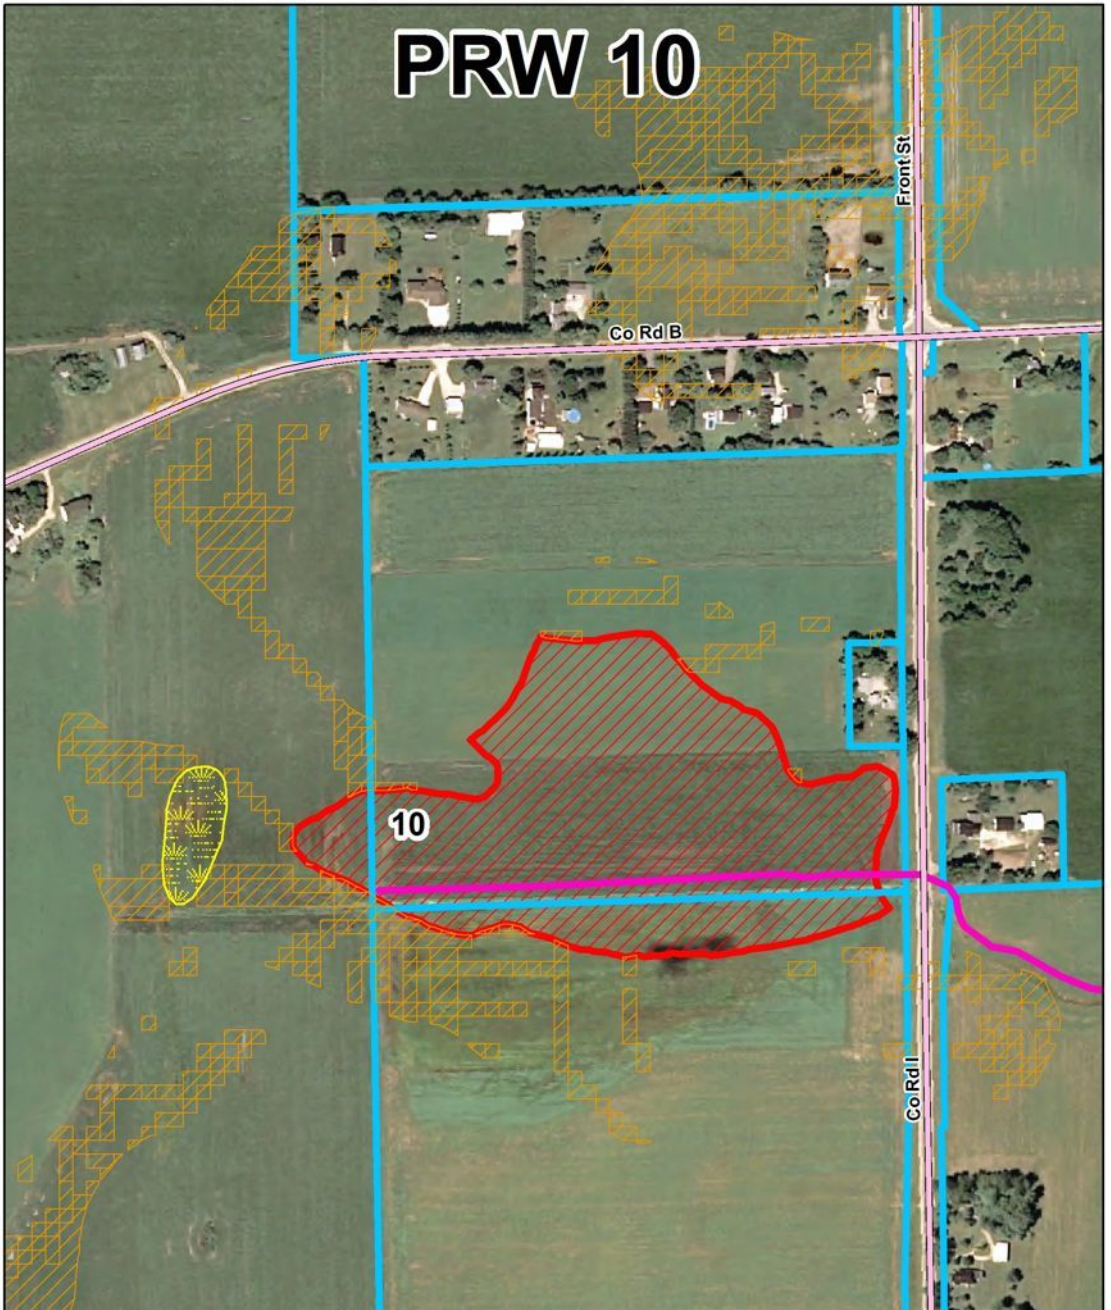
PRW 10

Restorable ditch, recently cleaned out. Not very likely they would have interest in restoration.

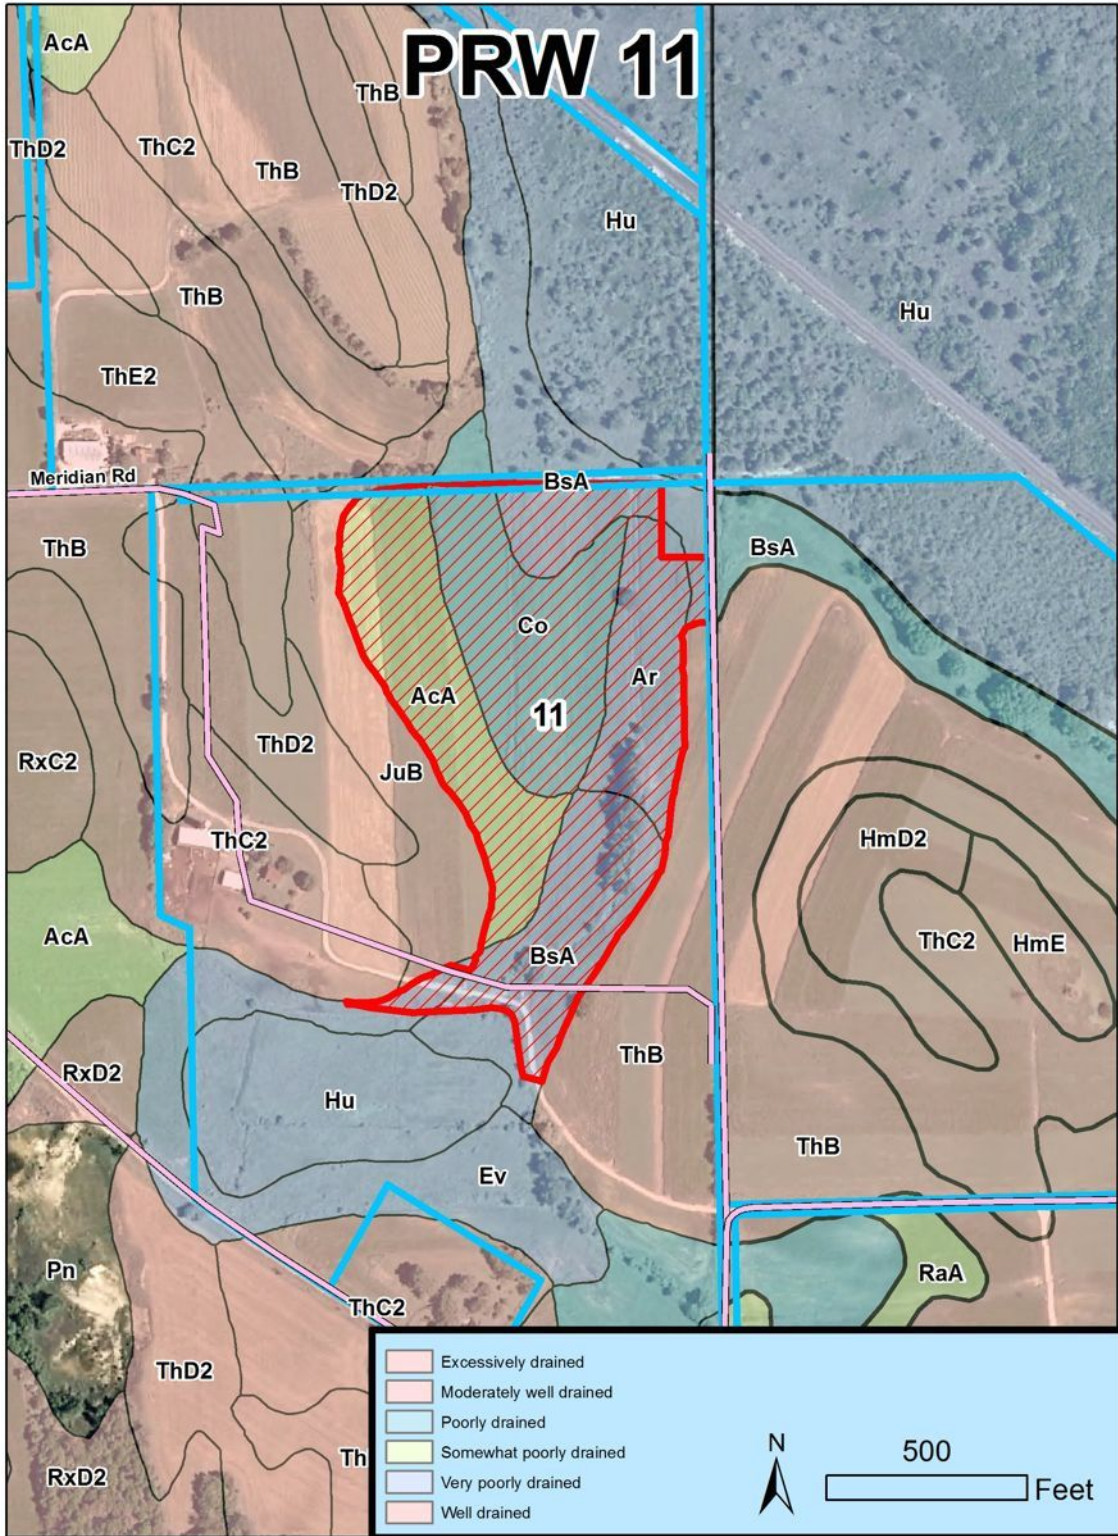
PRW 11

Cannot see clearly. Flowing water in ditch at road.

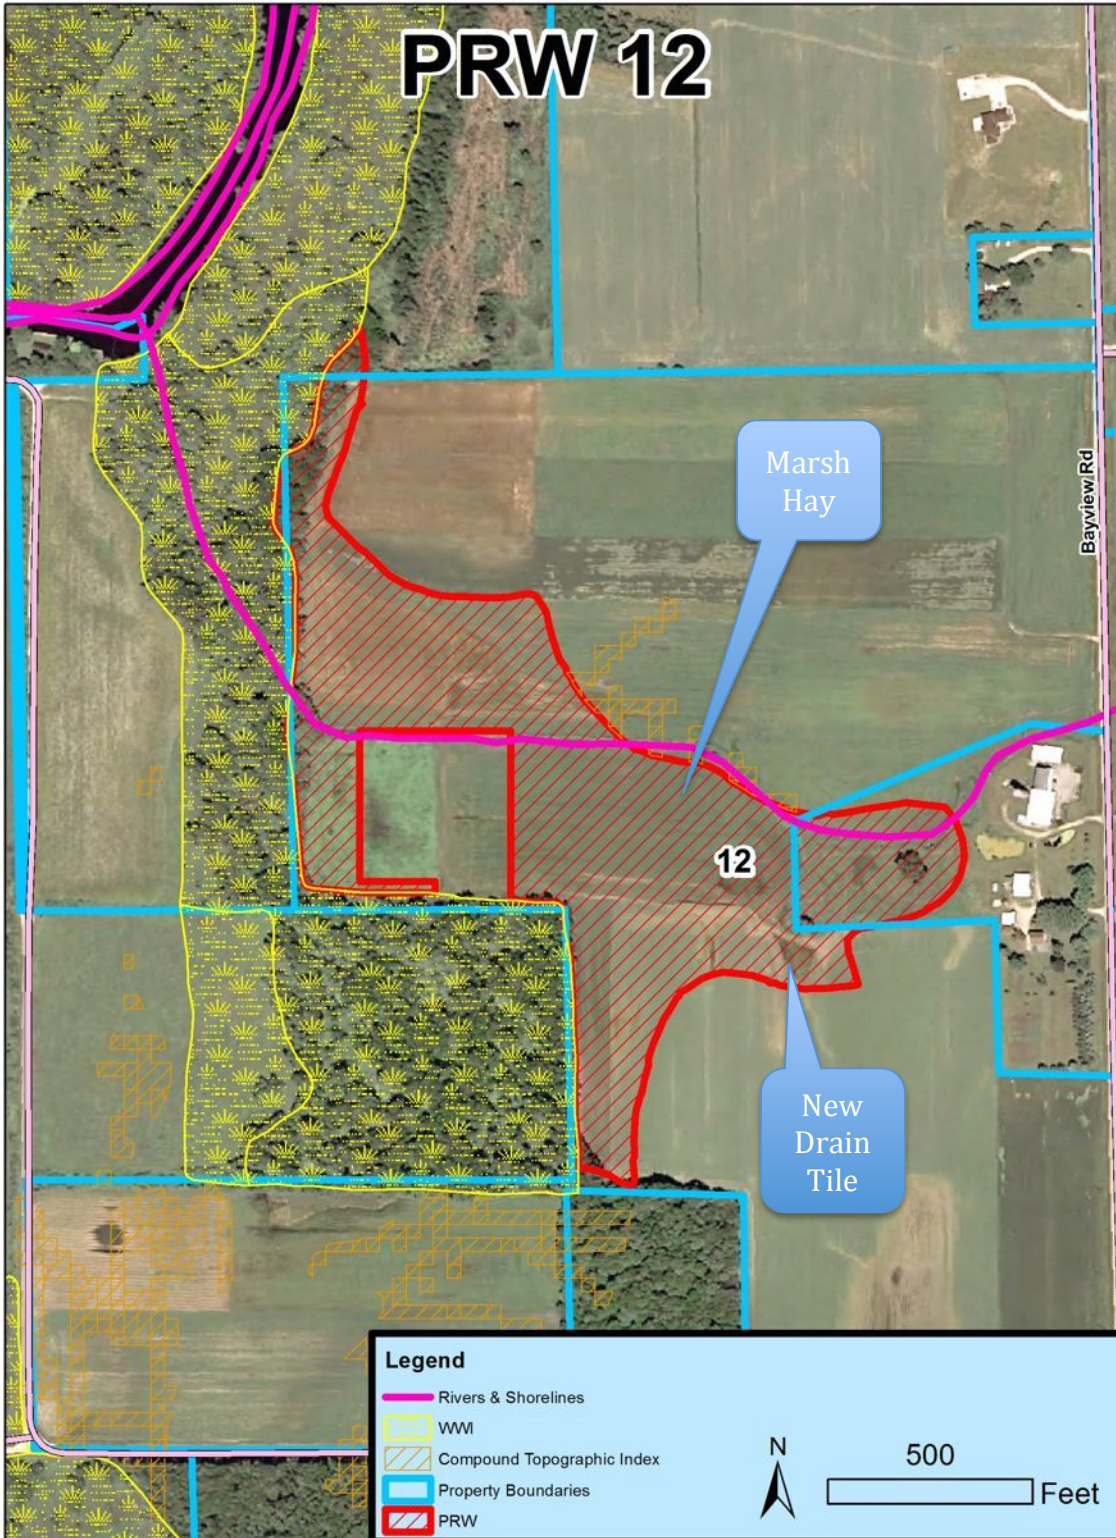
PRW 12

Ditch through center. Maybe stream history. Low area by ditch marsh hay or pasture.
Too wet to farm. Tile liines installed visible adjacent area, tile lines probably present in
PRW. Ditch small and has no water. Slope toe restorable.

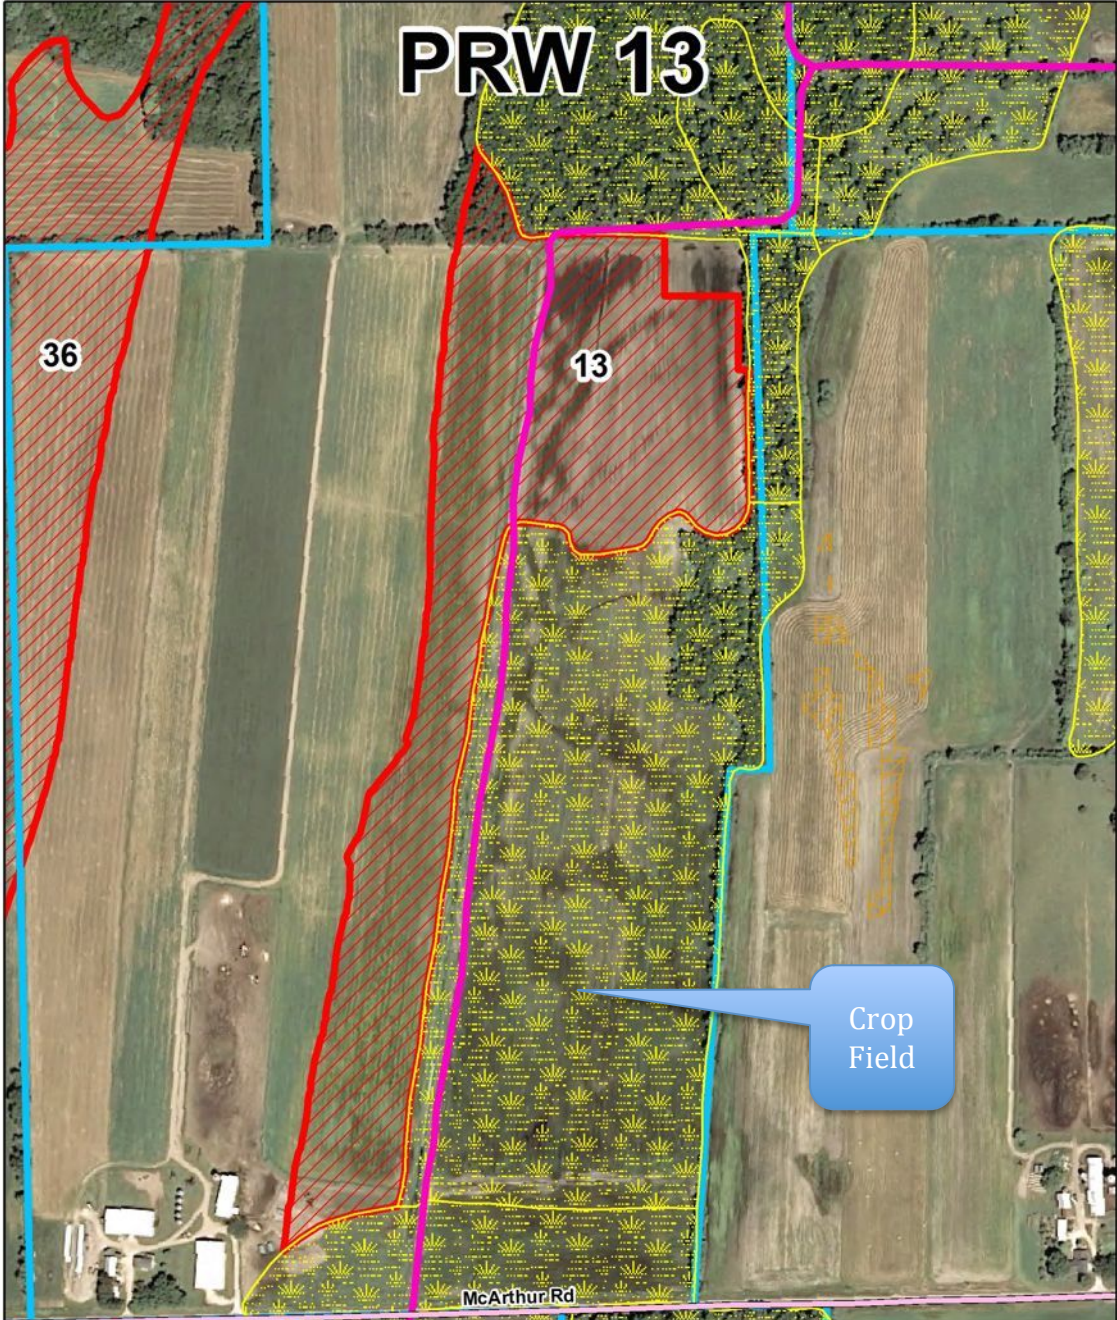
PRW 13

Ditch small but deep enough with water in it. Slope toe on west side of ditch, large flat on east side of ditch. Tile probably present on east side, signs of ponding. Possible impact to neighbor to east. Good restoration potential.
