Lake Grant Report: Identifying Restorable Wetlands in the Watersheds of Horicon Marsh & Lake Sinissippi

A project of the Rock River Coalition, Inc.

(Wisconsin Department of Natural Resources Lake Grant #SPL-322-14.1)

Submitted by:
Scott Taylor, Member
Patricia Cicero, President
Rock River Coalition, Inc.
April 2015

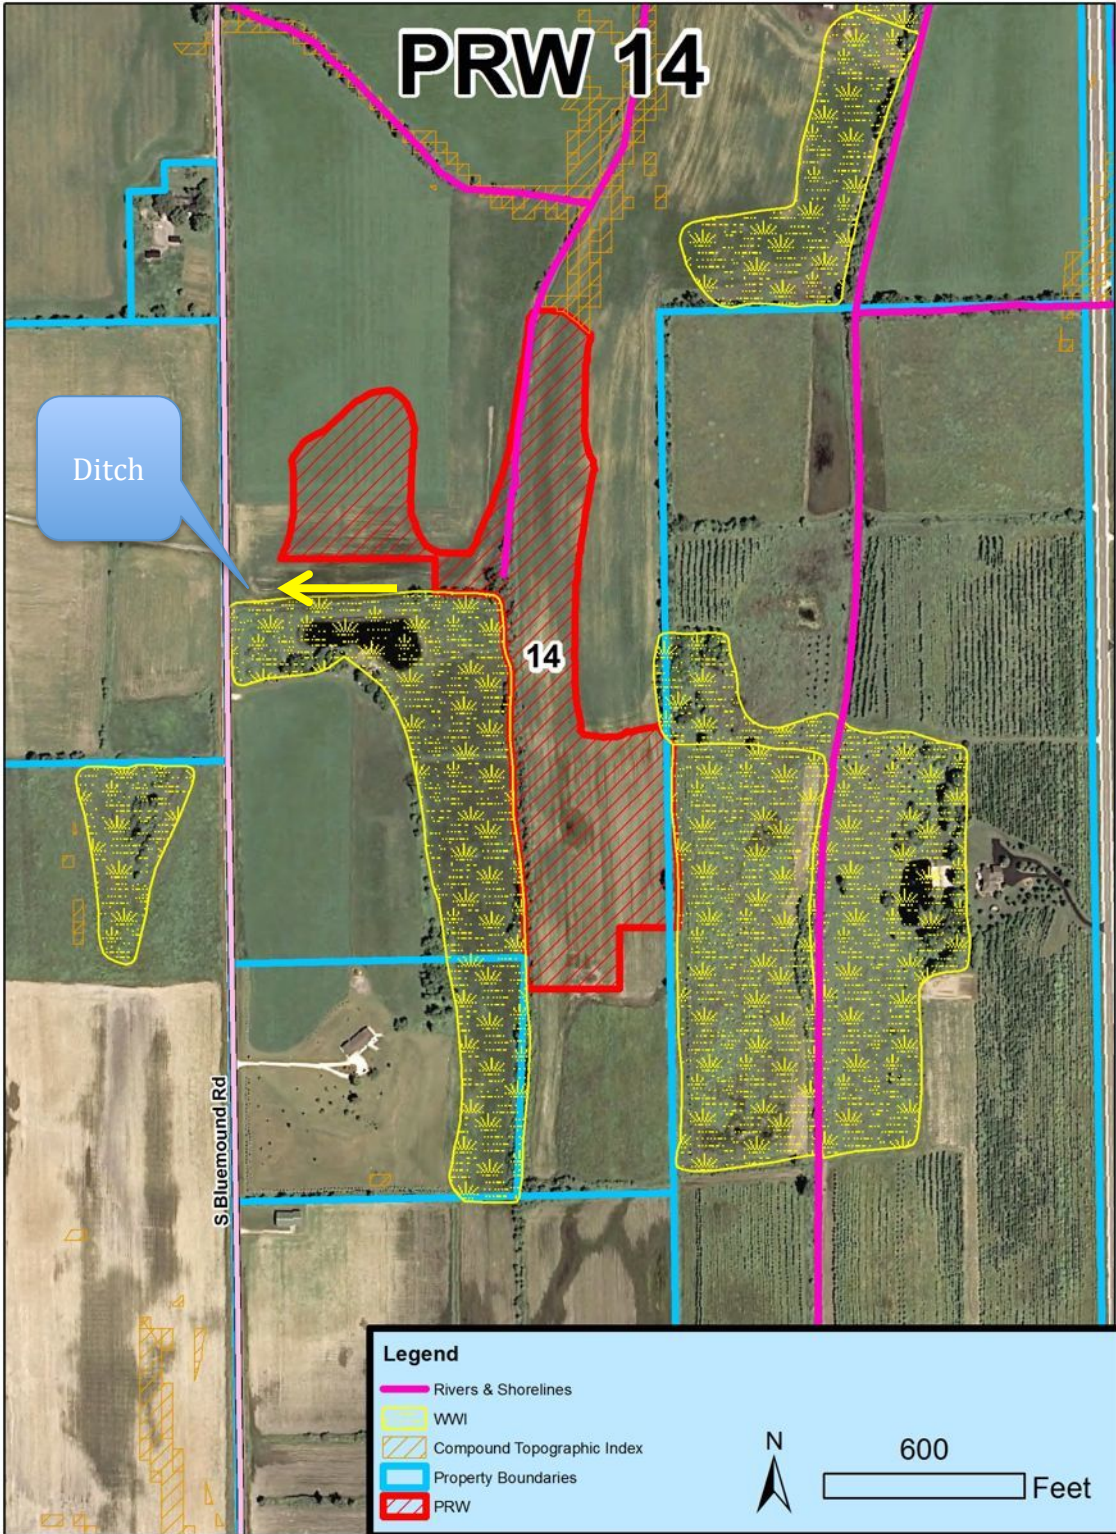
PRW 14

Ditch flows north, lateral flows west. Fill both to flood low, wet area of field. Decent potential.

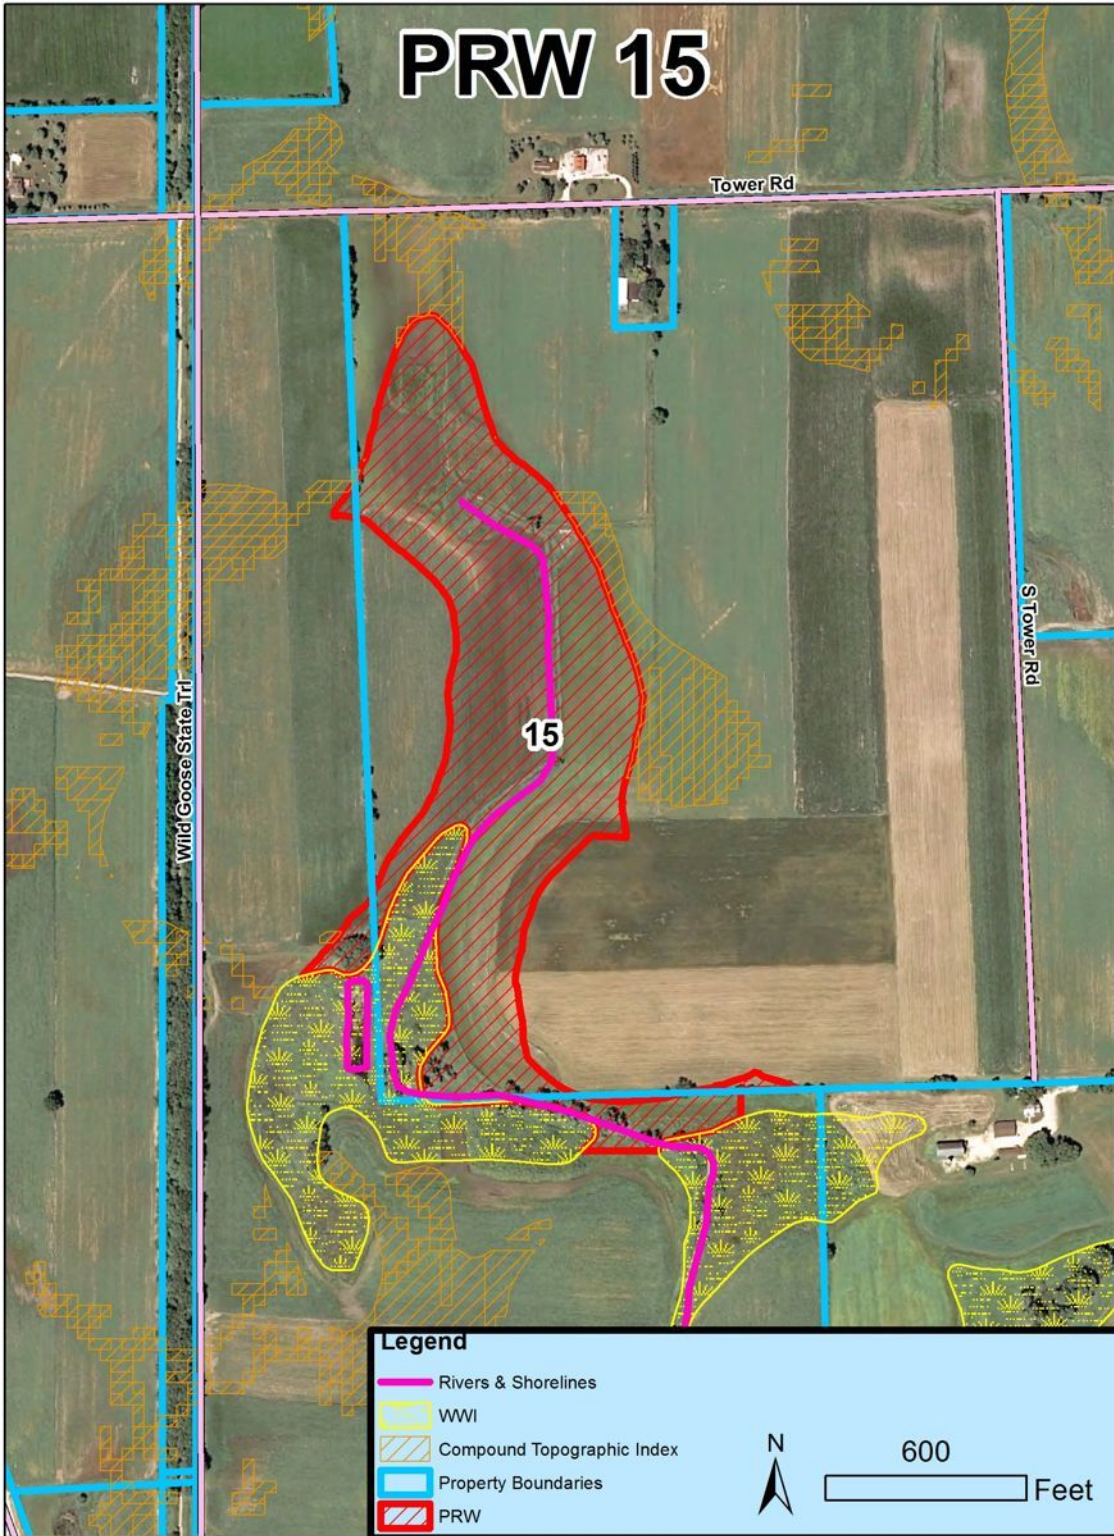
PRW 15

Restorable but ditch may be shallow, site was idle in 2014.

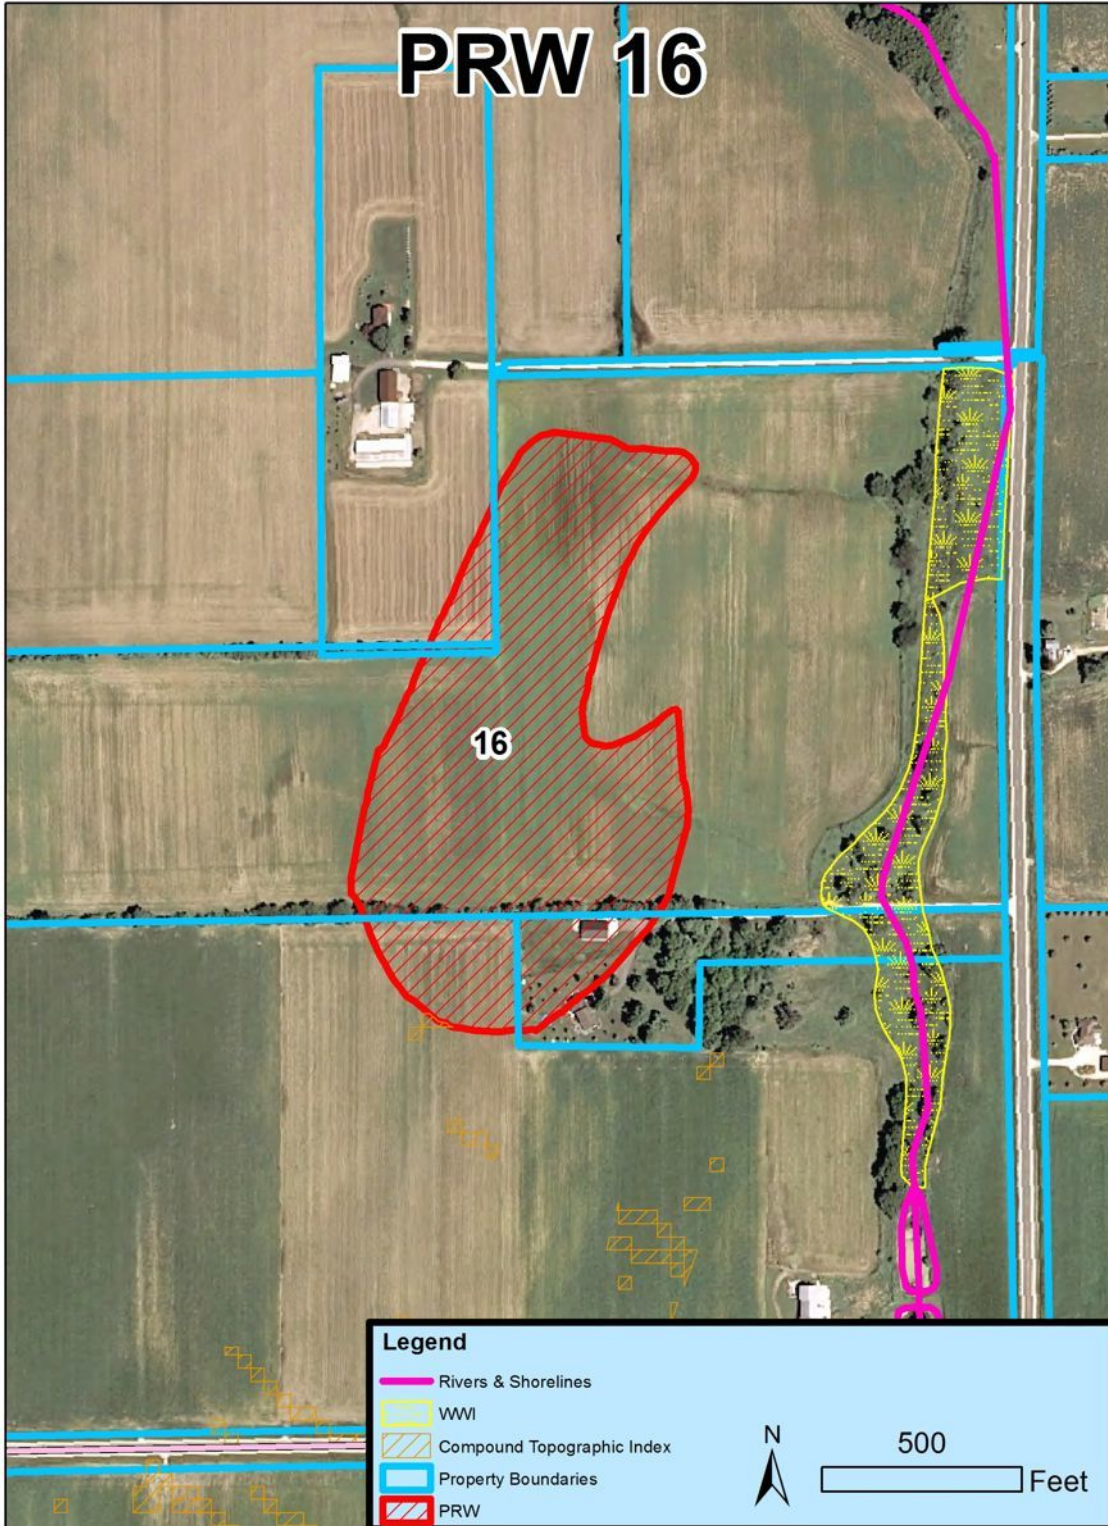
PRW 16

Two basins separated by high ground, each has outlet draining east that could be plugged. High on landscape, restoration would only produce saturated soil but should be easy restoration.

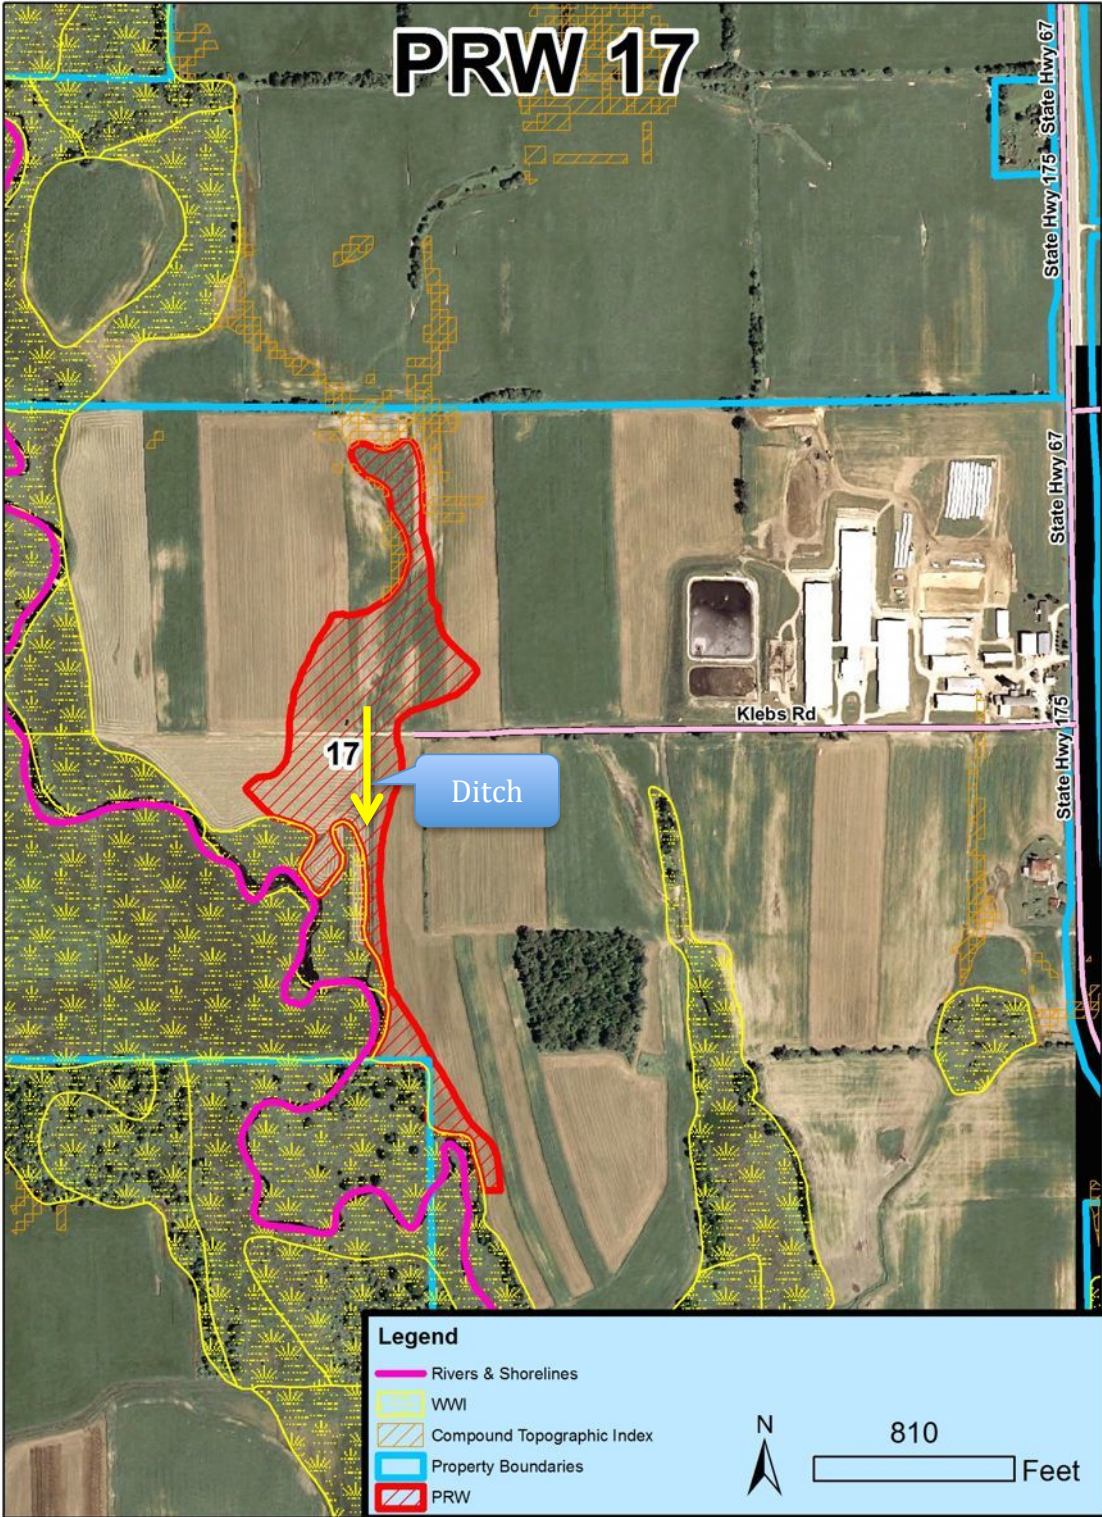
PRW 17

Main drain to river with lateral on lower end. Lower (south) end near river has potential. North of road is higher with little water input. Good restoration potential with water quality benefits.

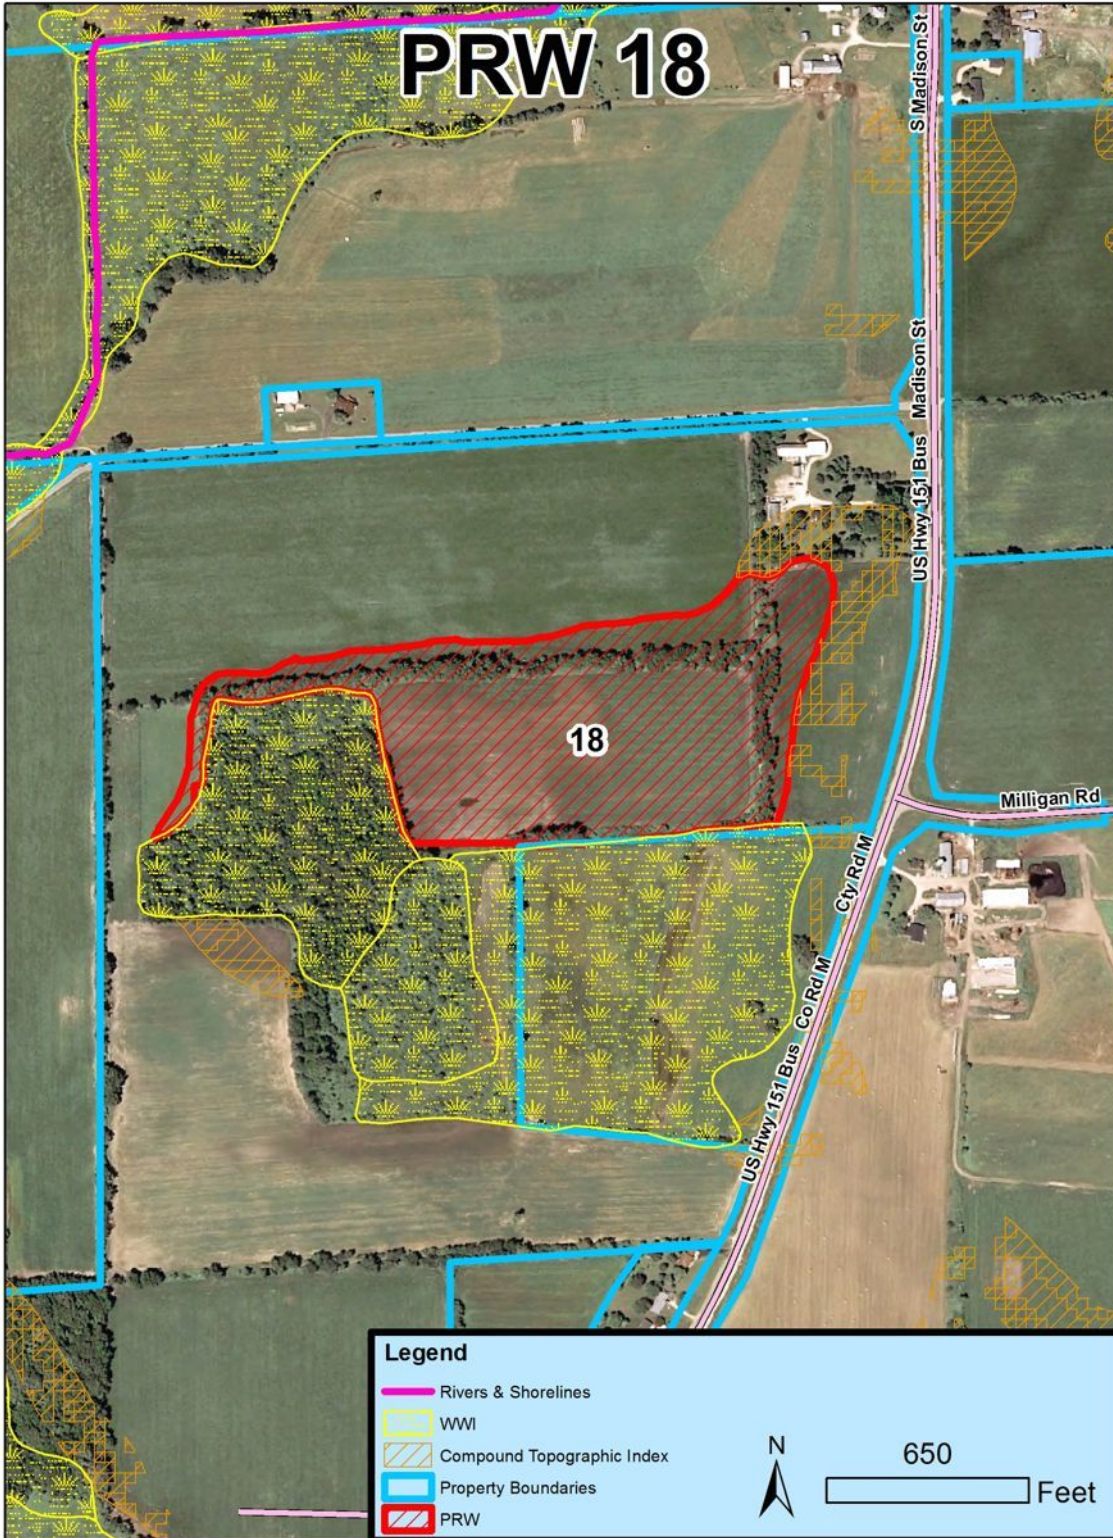
PRW 18

Not feasible without neighbor. Probable tile system in addition to ditches. Ditches do not look well-maintained. Gas pipeline sign in ROW. Also underground cable. Not sure which way they run.

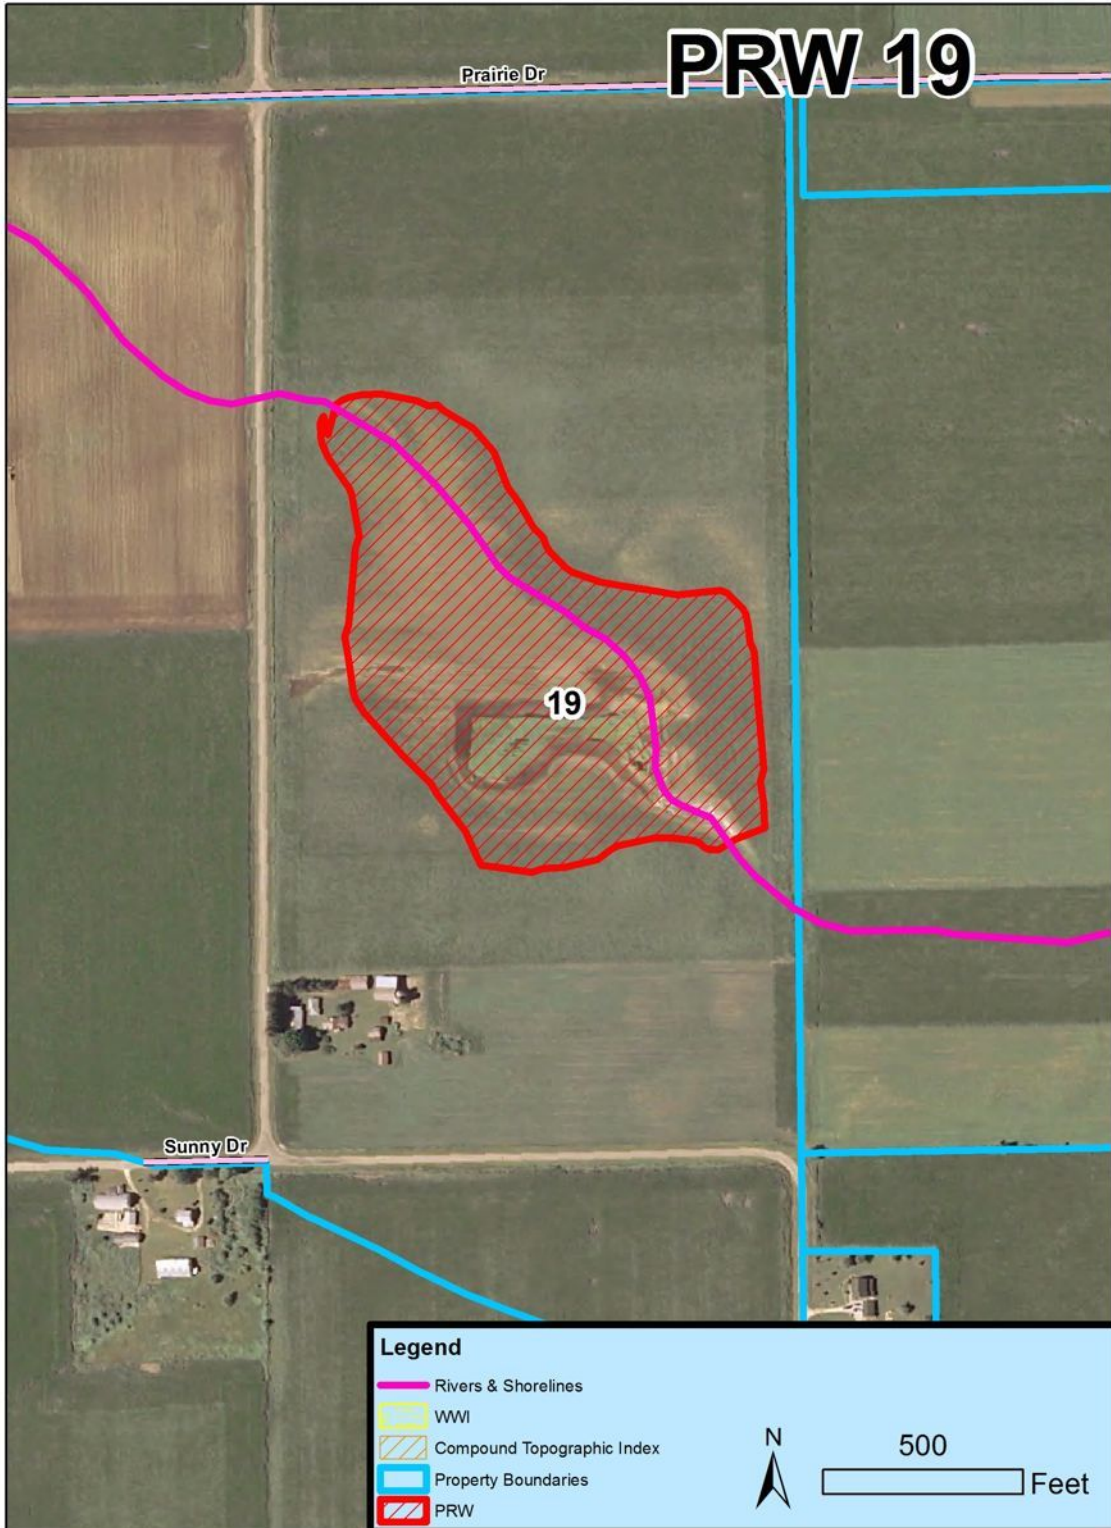
PRW 19

Probable tile system and ditch outlet. Very restorable.

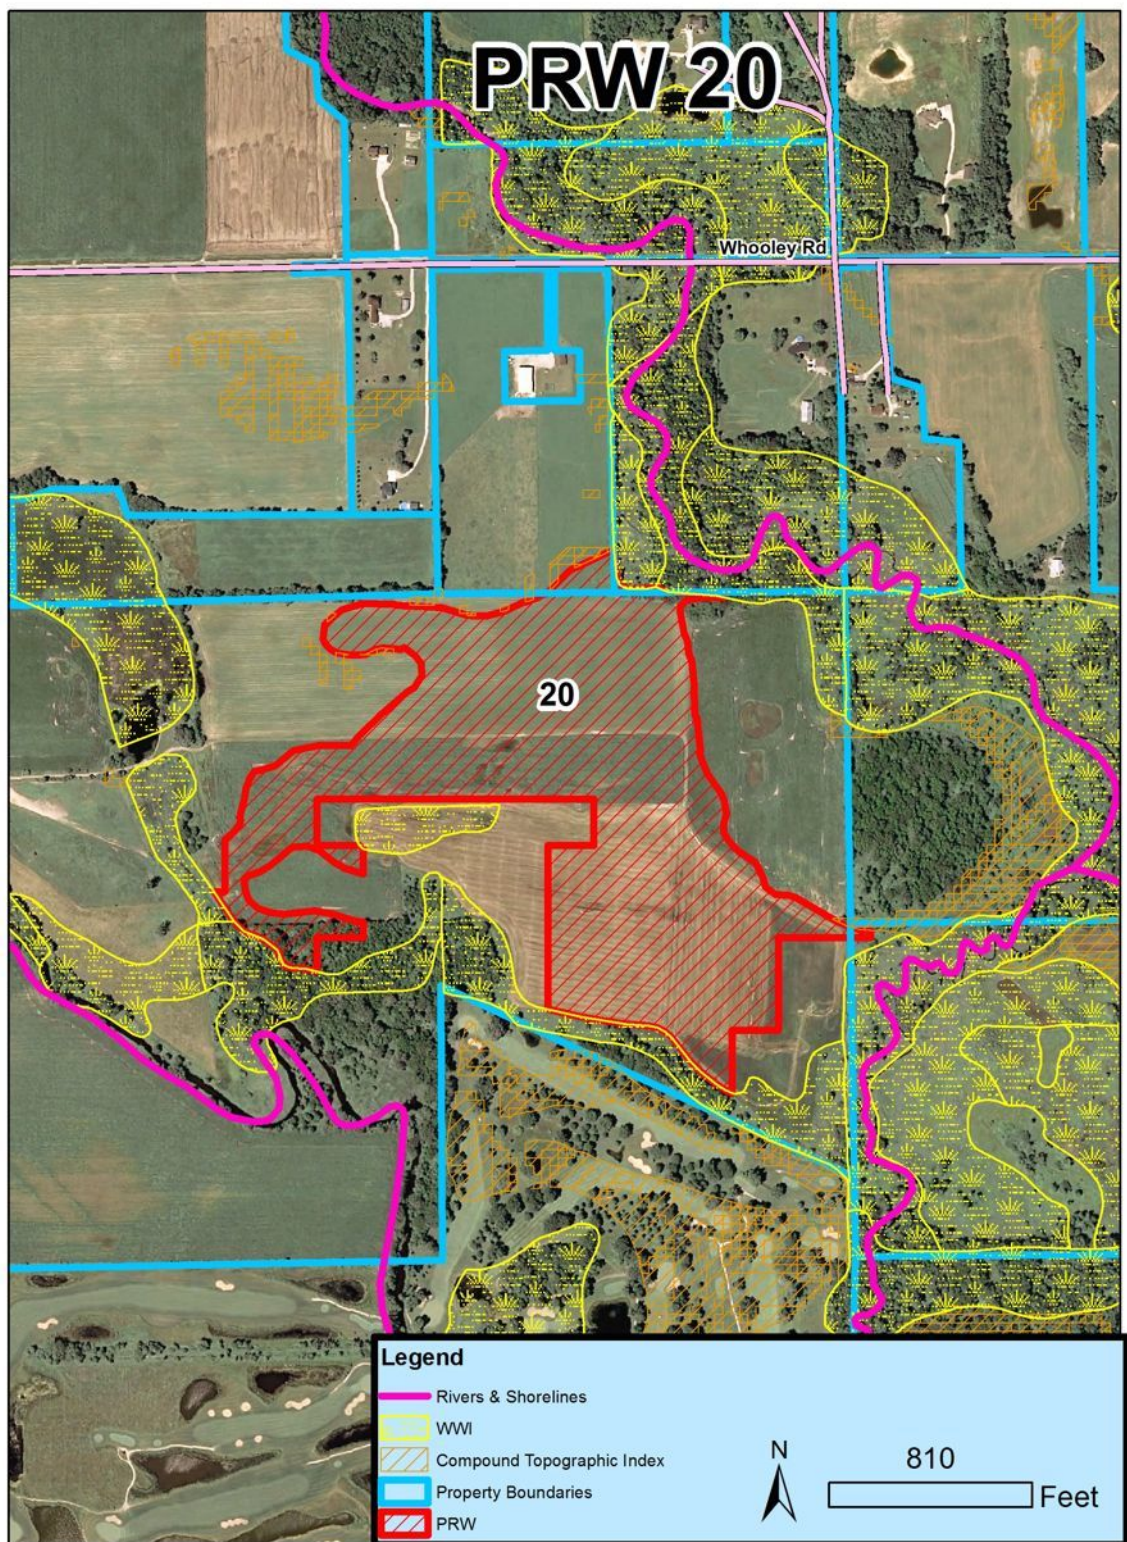
PRW 20

Large site, hard to see from road. Likely tiled, may have shallow ditches.

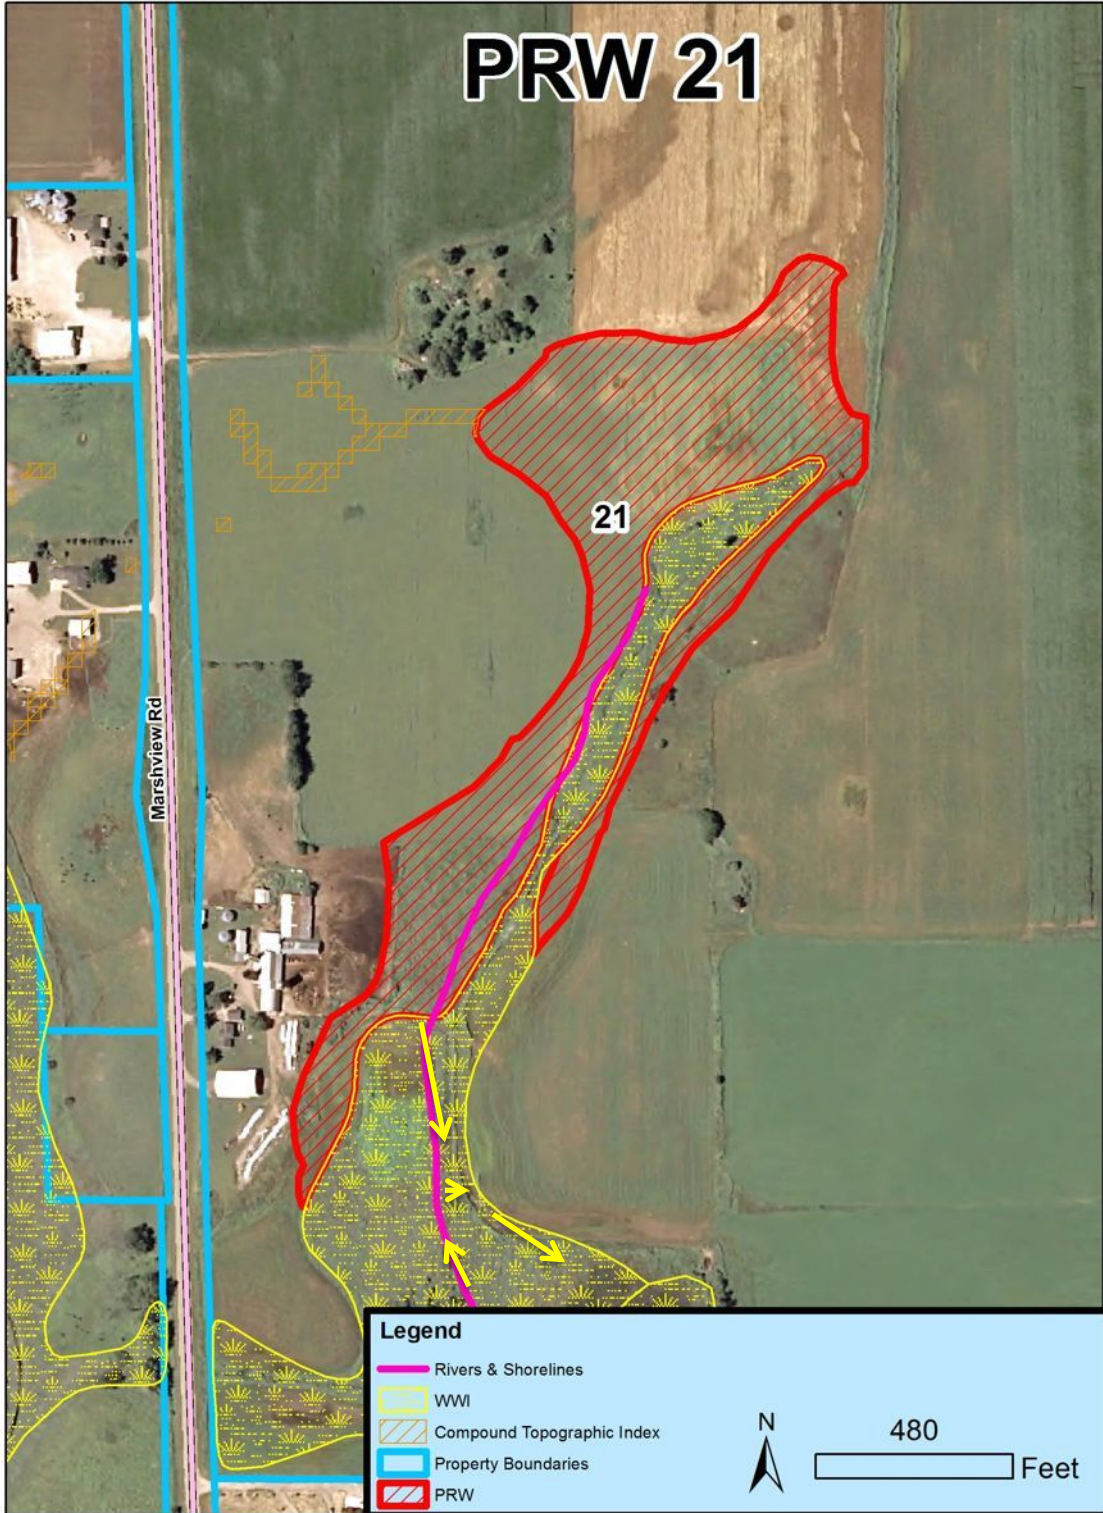
PRW 21

Possible restoration by ditch plug/fill.

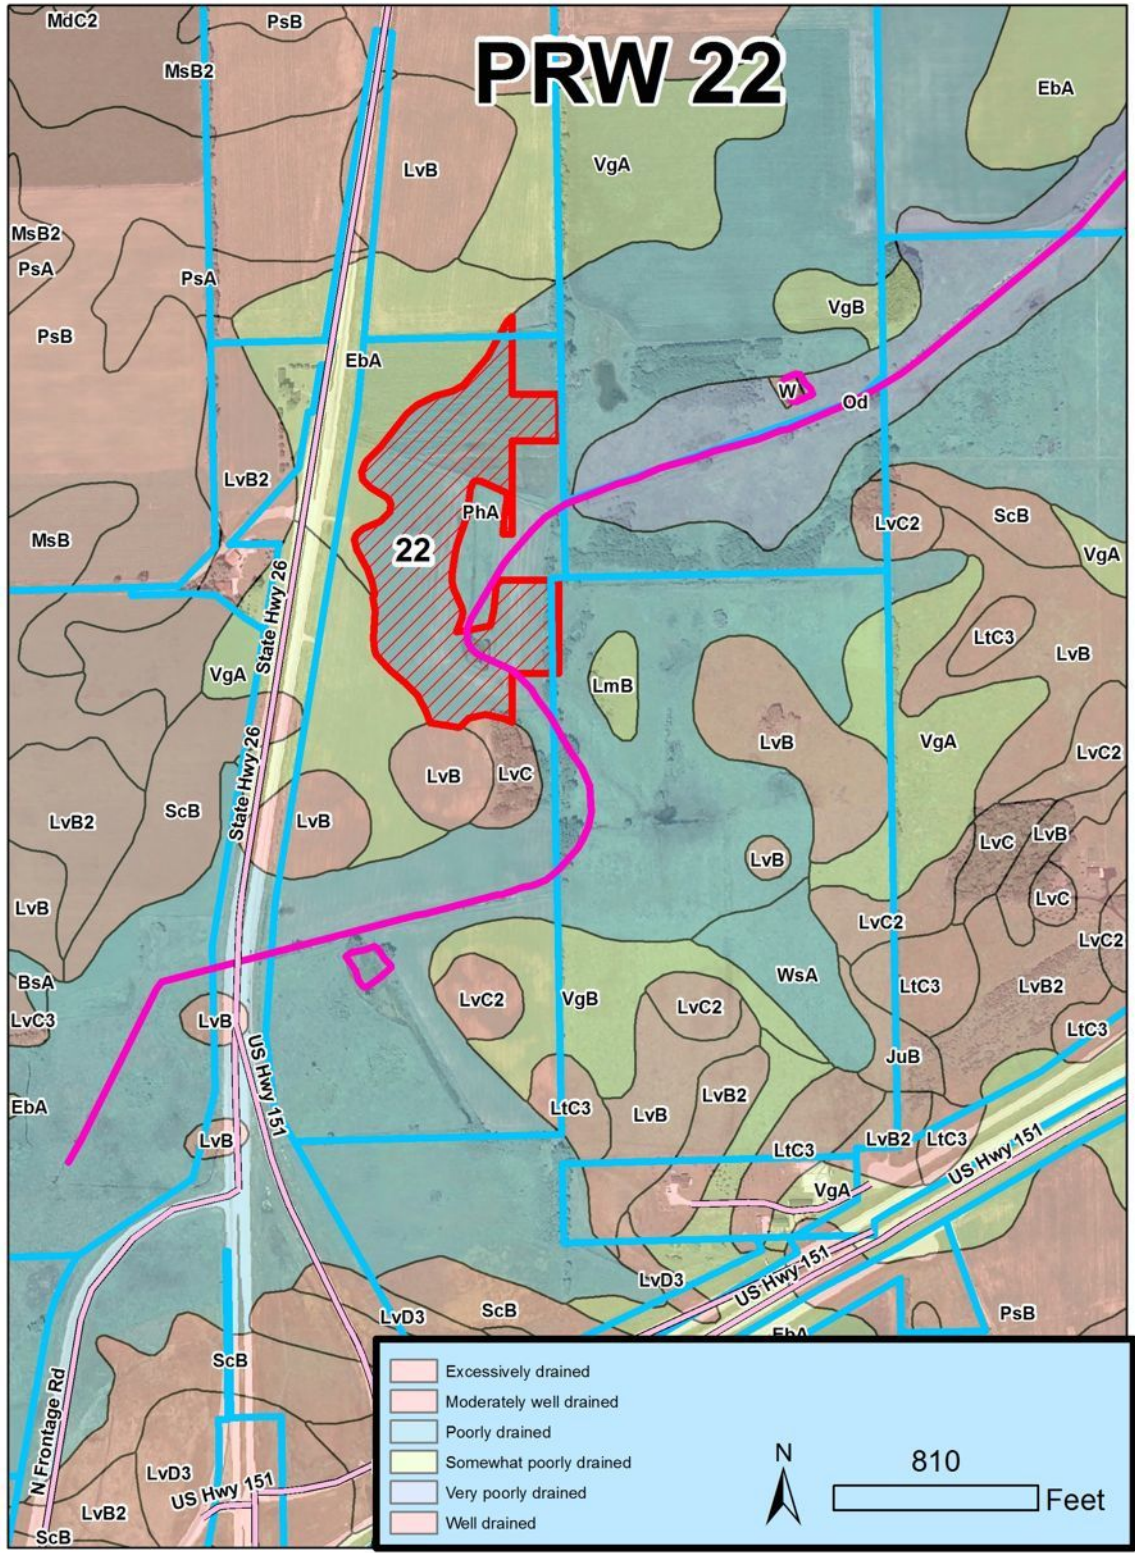
PRW 22

Good restoration potential, may be tiled, potential impact to Hwy. 26 ROW.

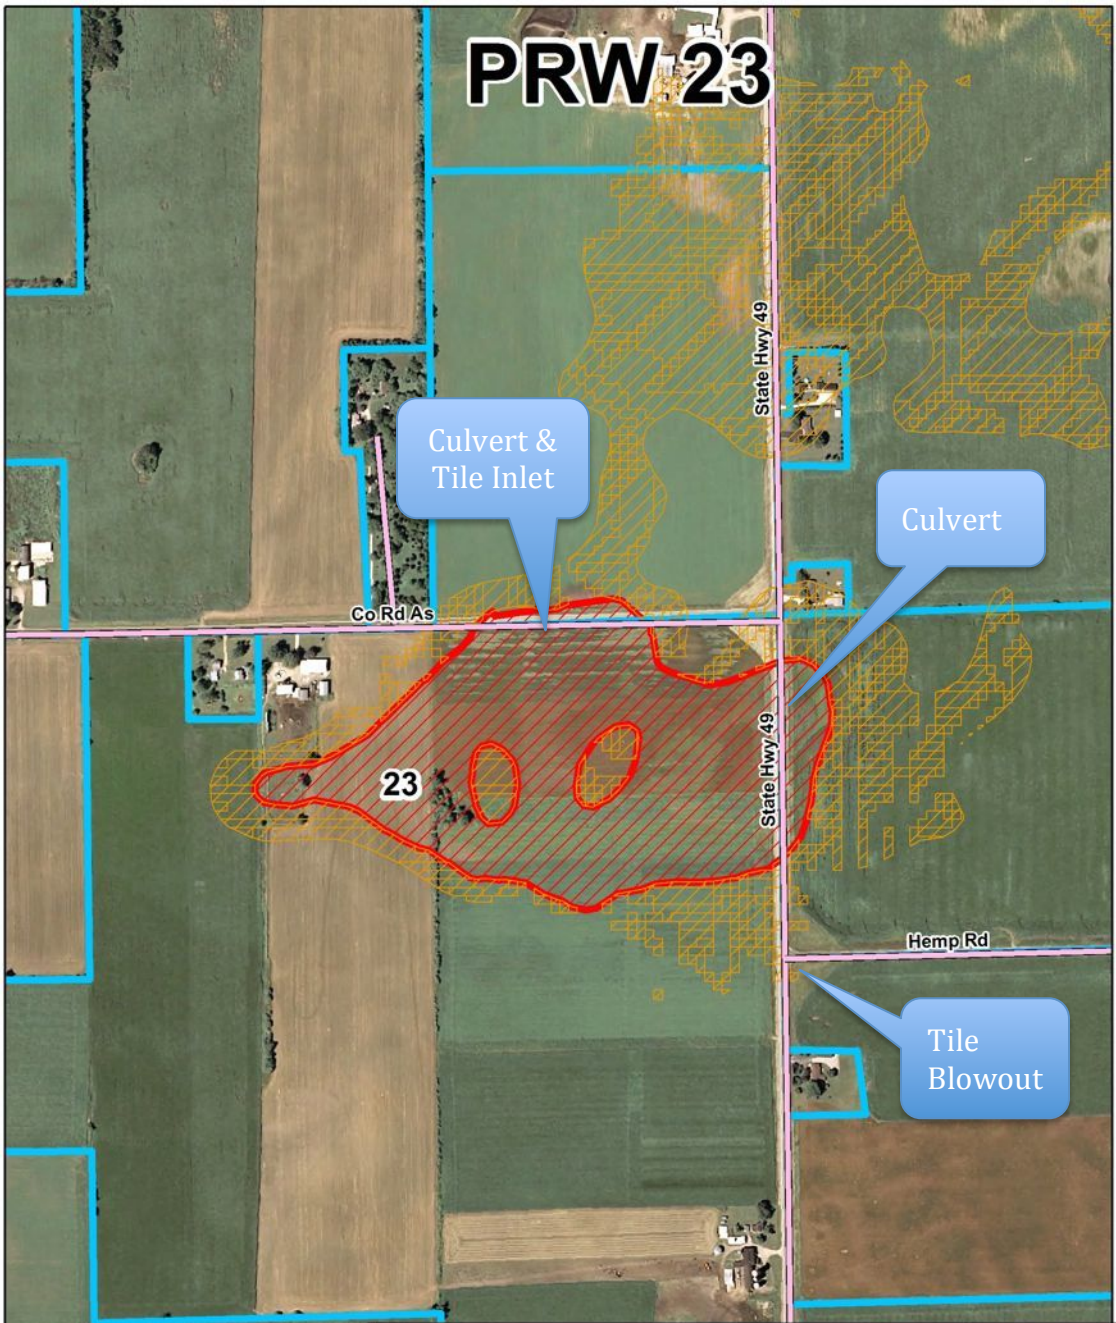
PRW 23

Tile system present (Breather/inlet on Hwy. AS, outlets southeast at Hemp Rd.)
Restoration would affect neighbor to the east and Hwy. 49 ROW.

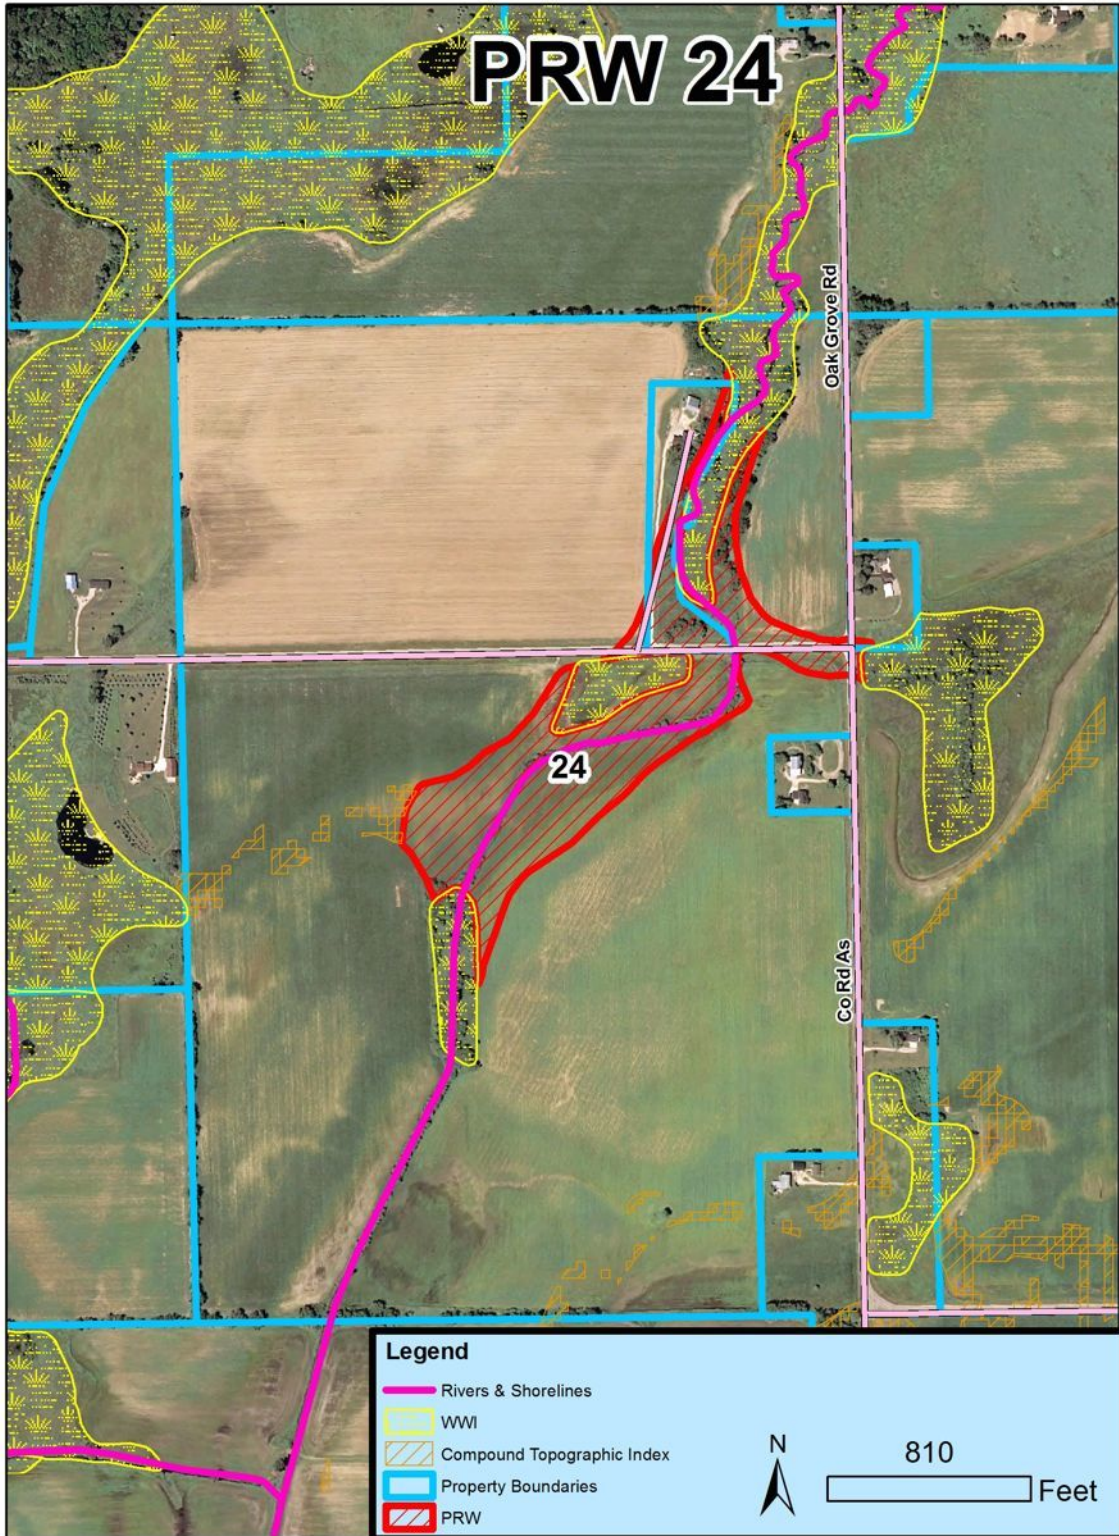
PRW 24

Possible tile system could be disabled. Ditch has probable stream history.

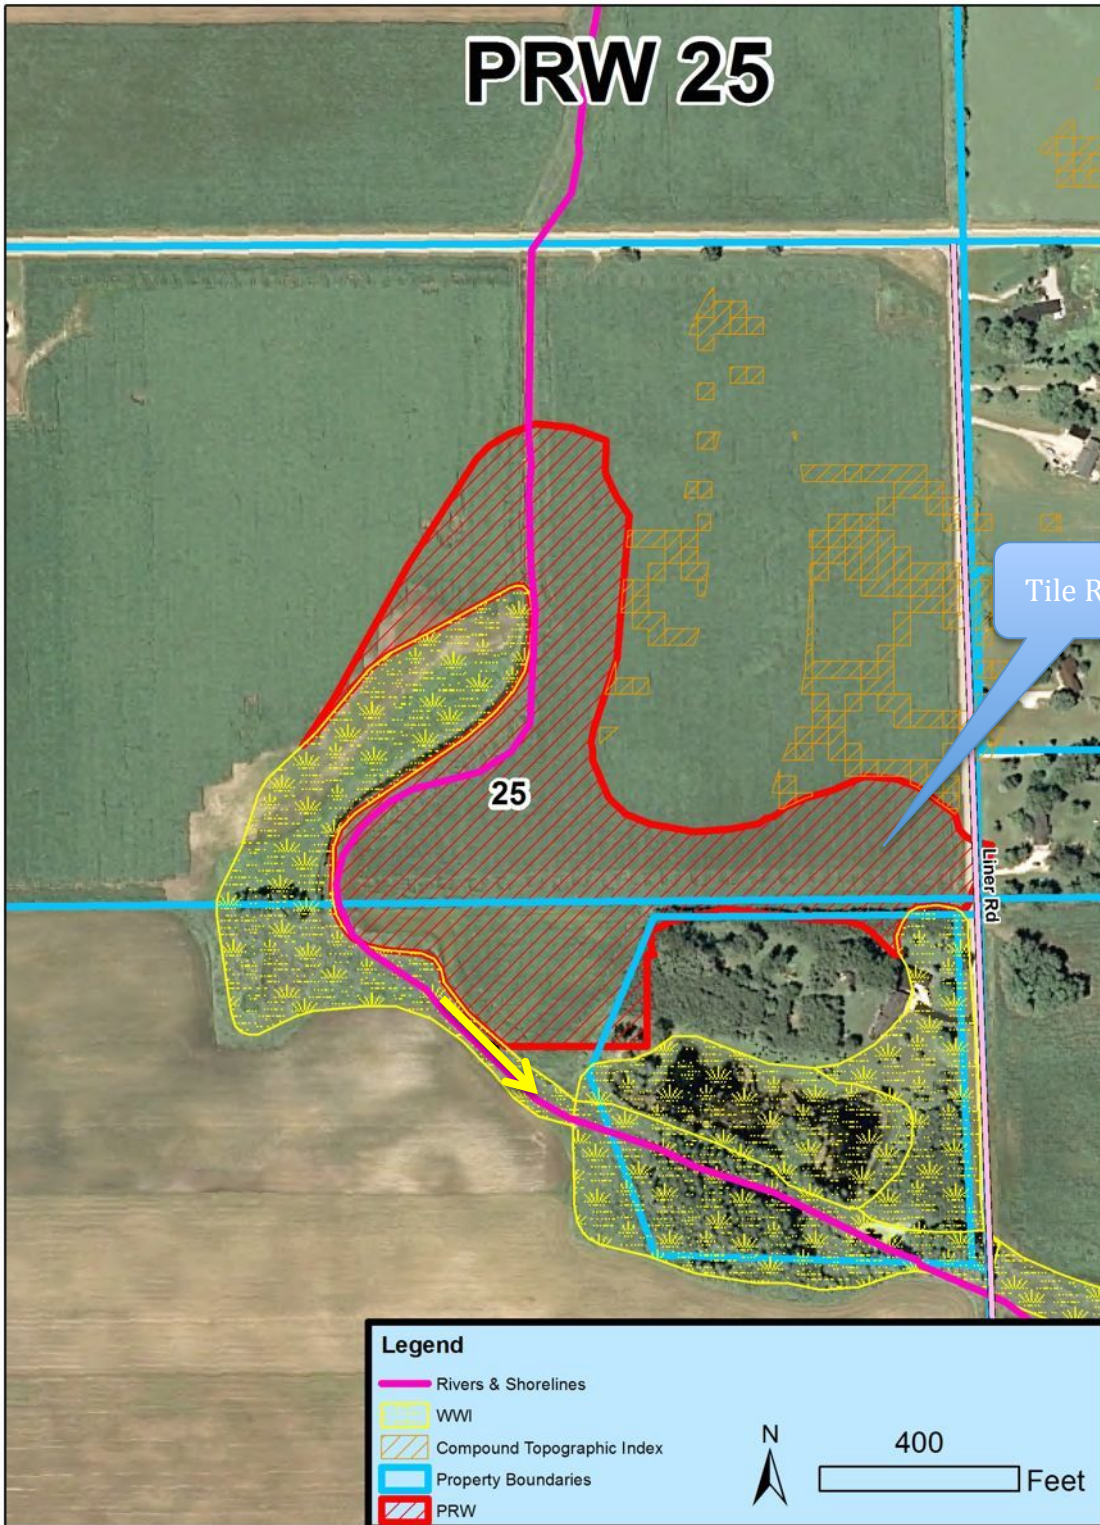
PRW 25

Potentially restorable. Would need to involve 2 landowner parcels.

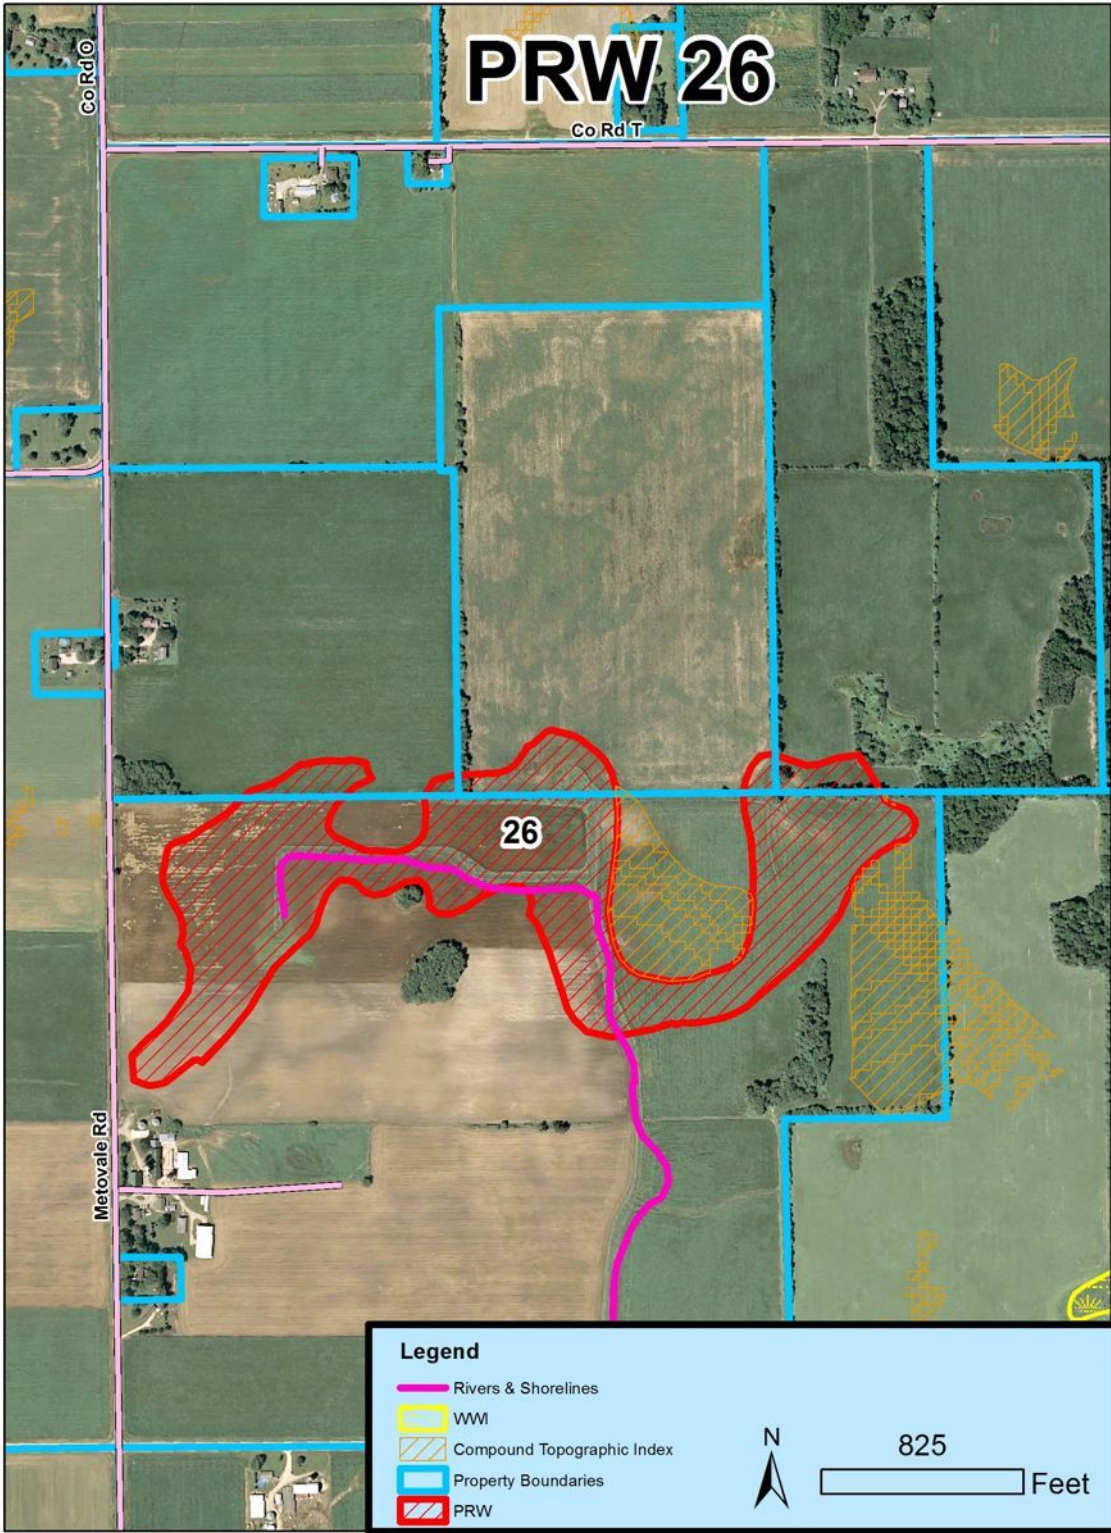
Potentially restorable, may affect neighbors on north property line.
