Lake Grant Report: Identifying Restorable Wetlands in the Watersheds of Horicon Marsh & Lake Sinissippi

A project of the Rock River Coalition, Inc.

(Wisconsin Department of Natural Resources Lake Grant #SPL-322-14.1)

Submitted by:
Scott Taylor, Member
Patricia Cicero, President
Rock River Coalition, Inc.
April 2015

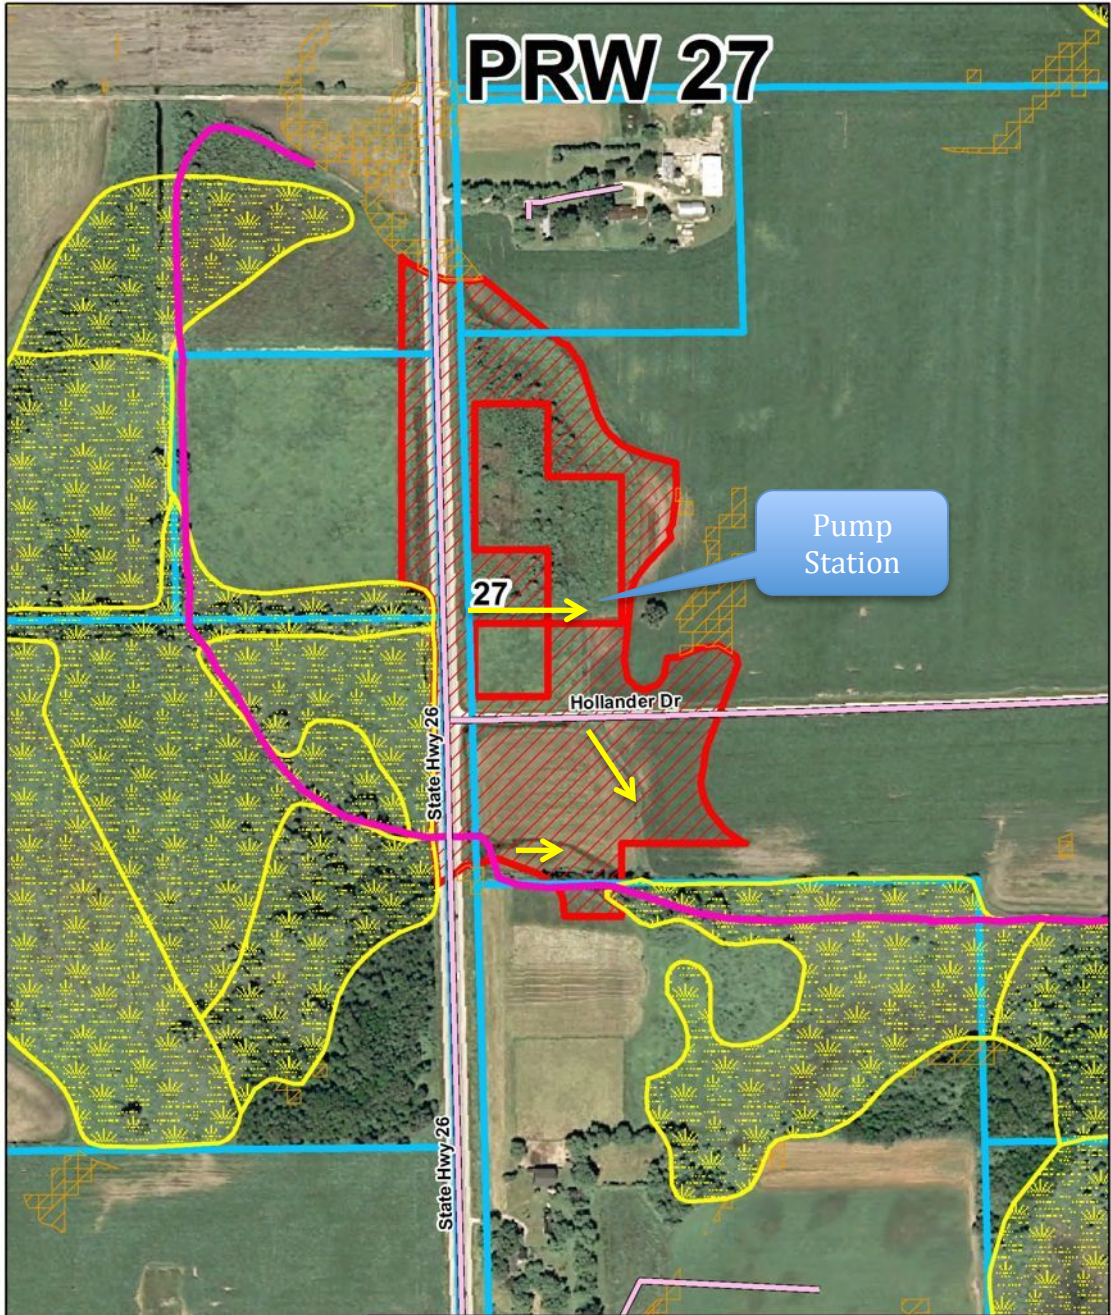
PRW 27

Ditch and tile with pump system. Possibly restorable be several conflicts: driveway, Hwy 26 ROW, culvert under highway drains west to east, south property line ditch drains under 26 west to east

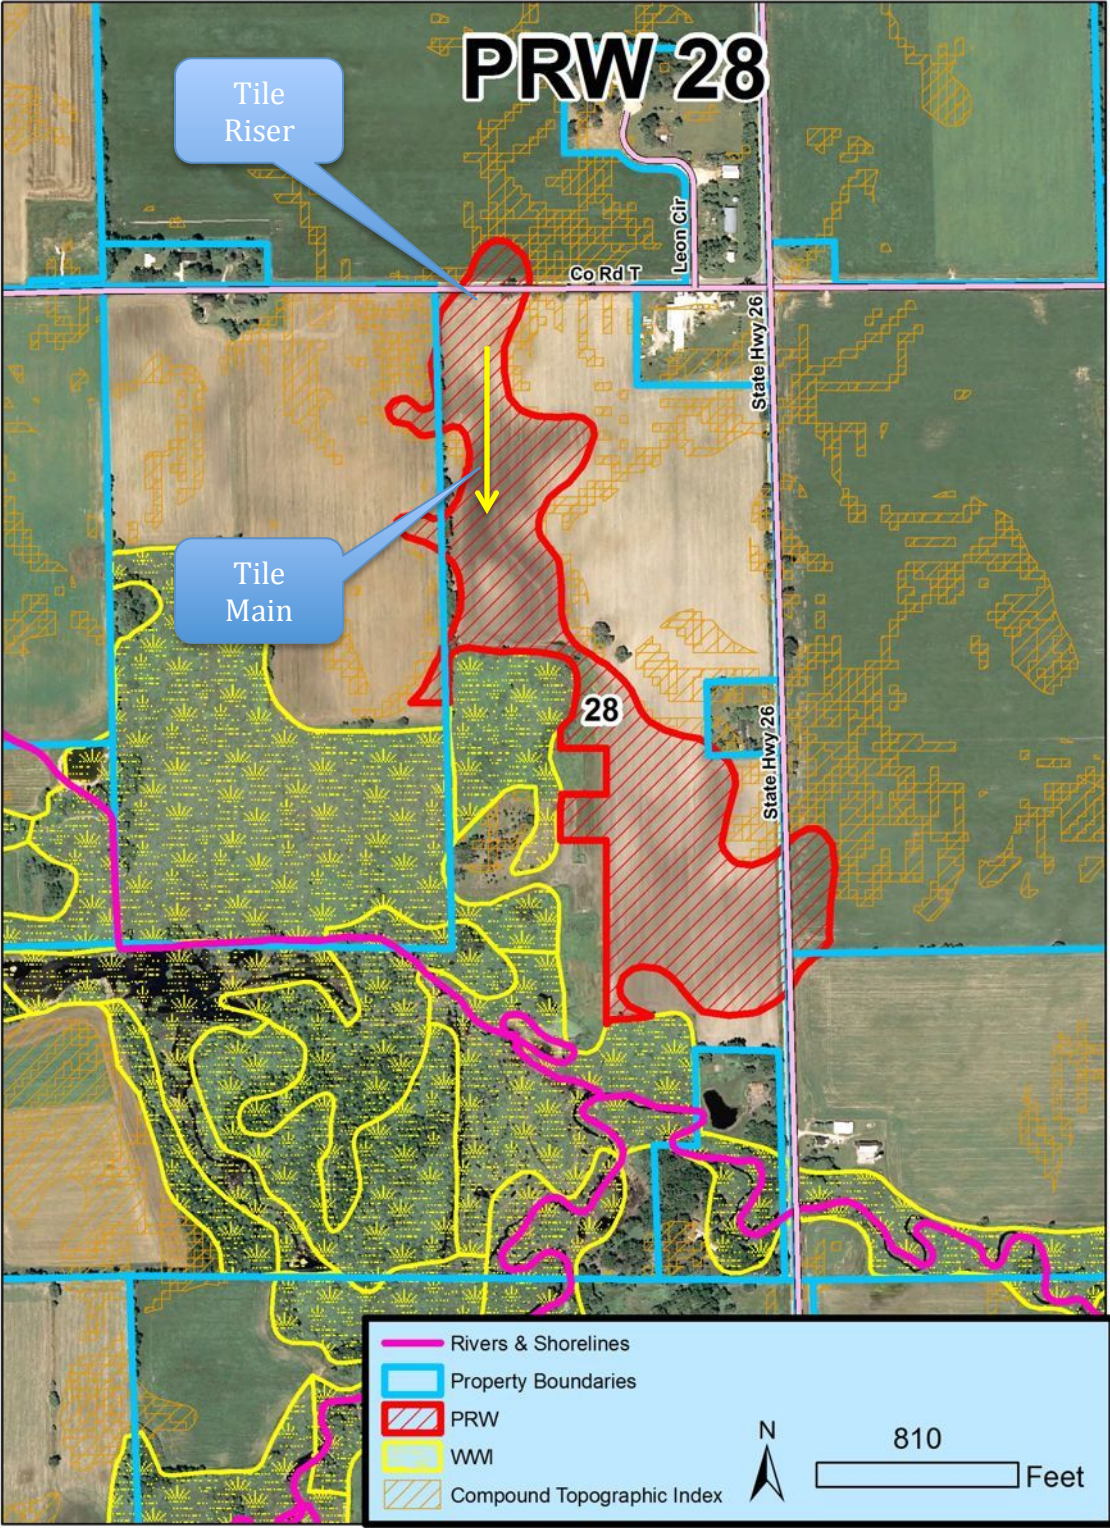
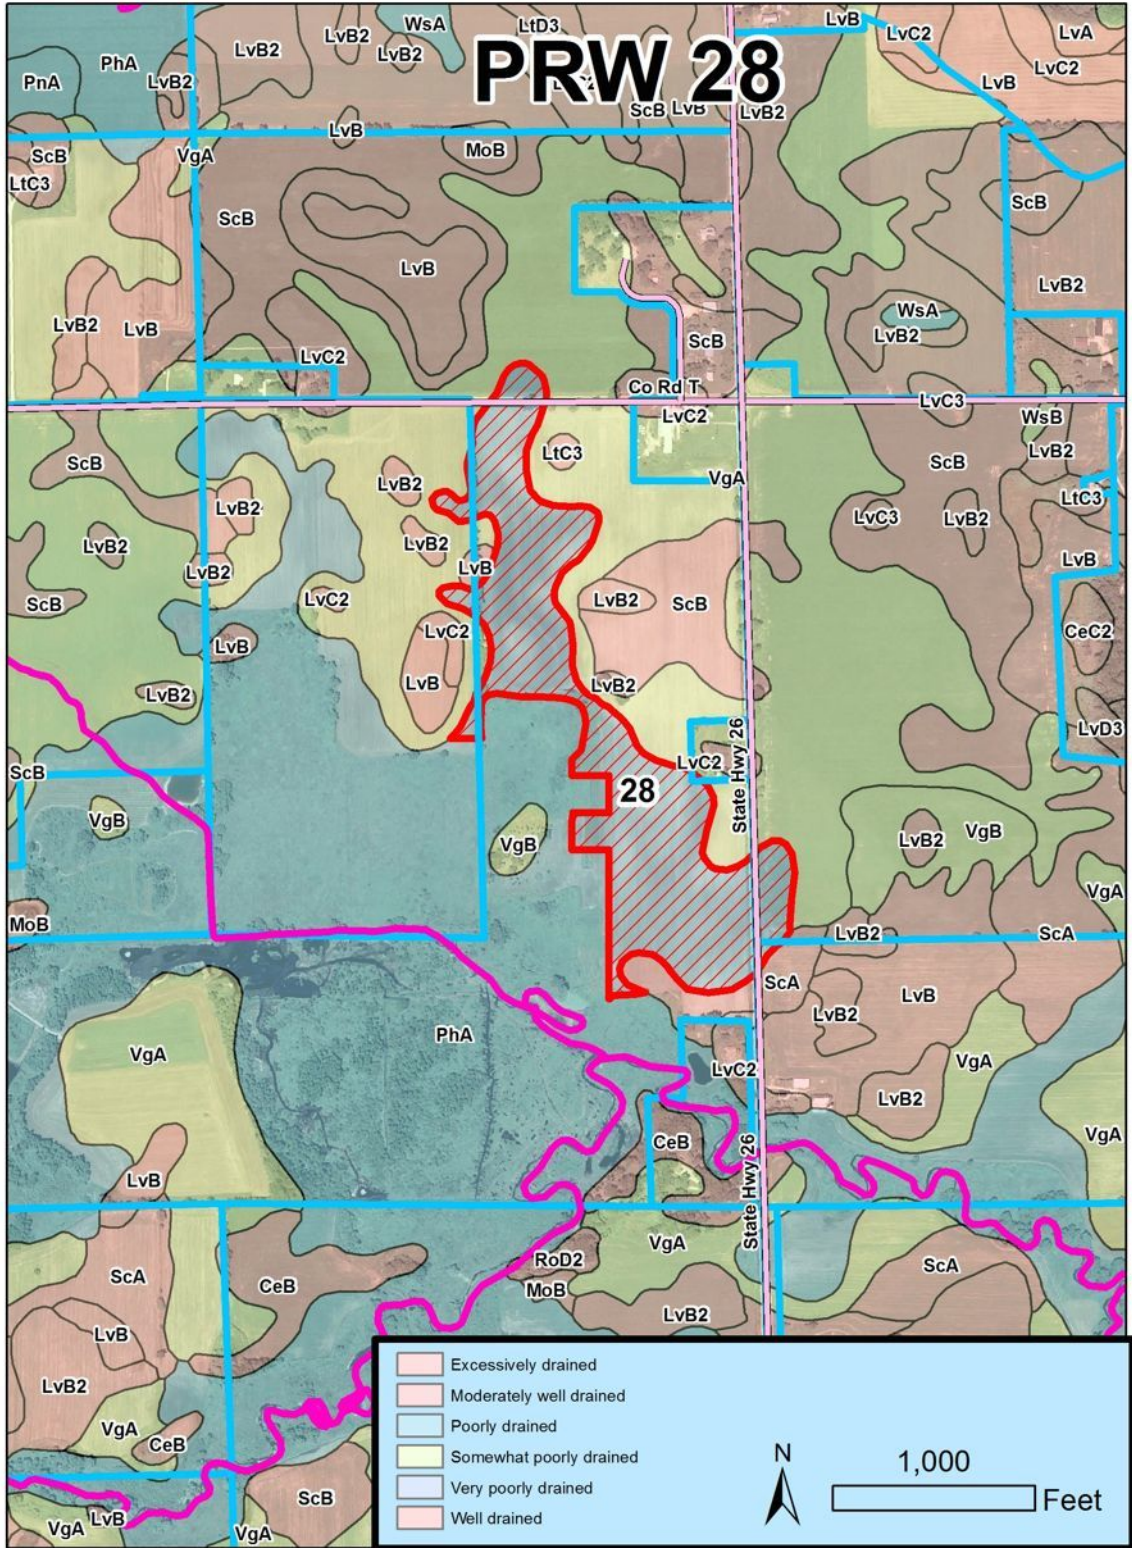
PRW 28

Tile system, potentially restorable. Conflicts: check drainage district status.

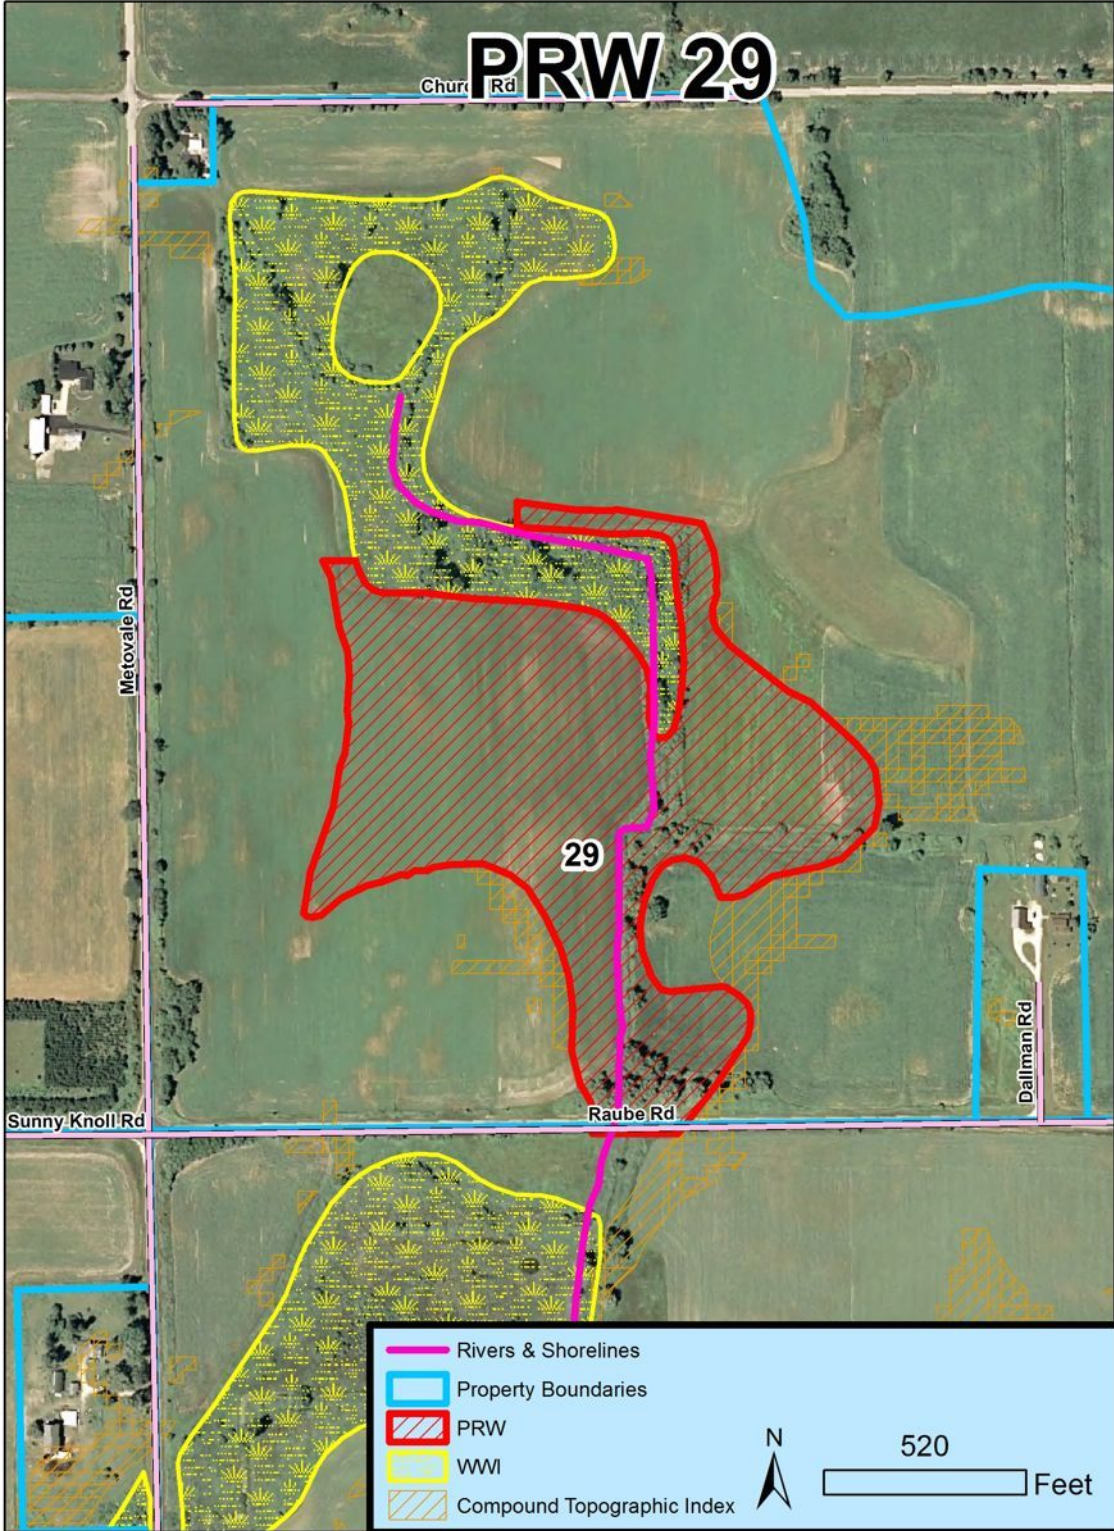
PRW 29

Restorable, old embankment with screwgate structure in main ditch. Need to check stream history but could be an easy restoration.

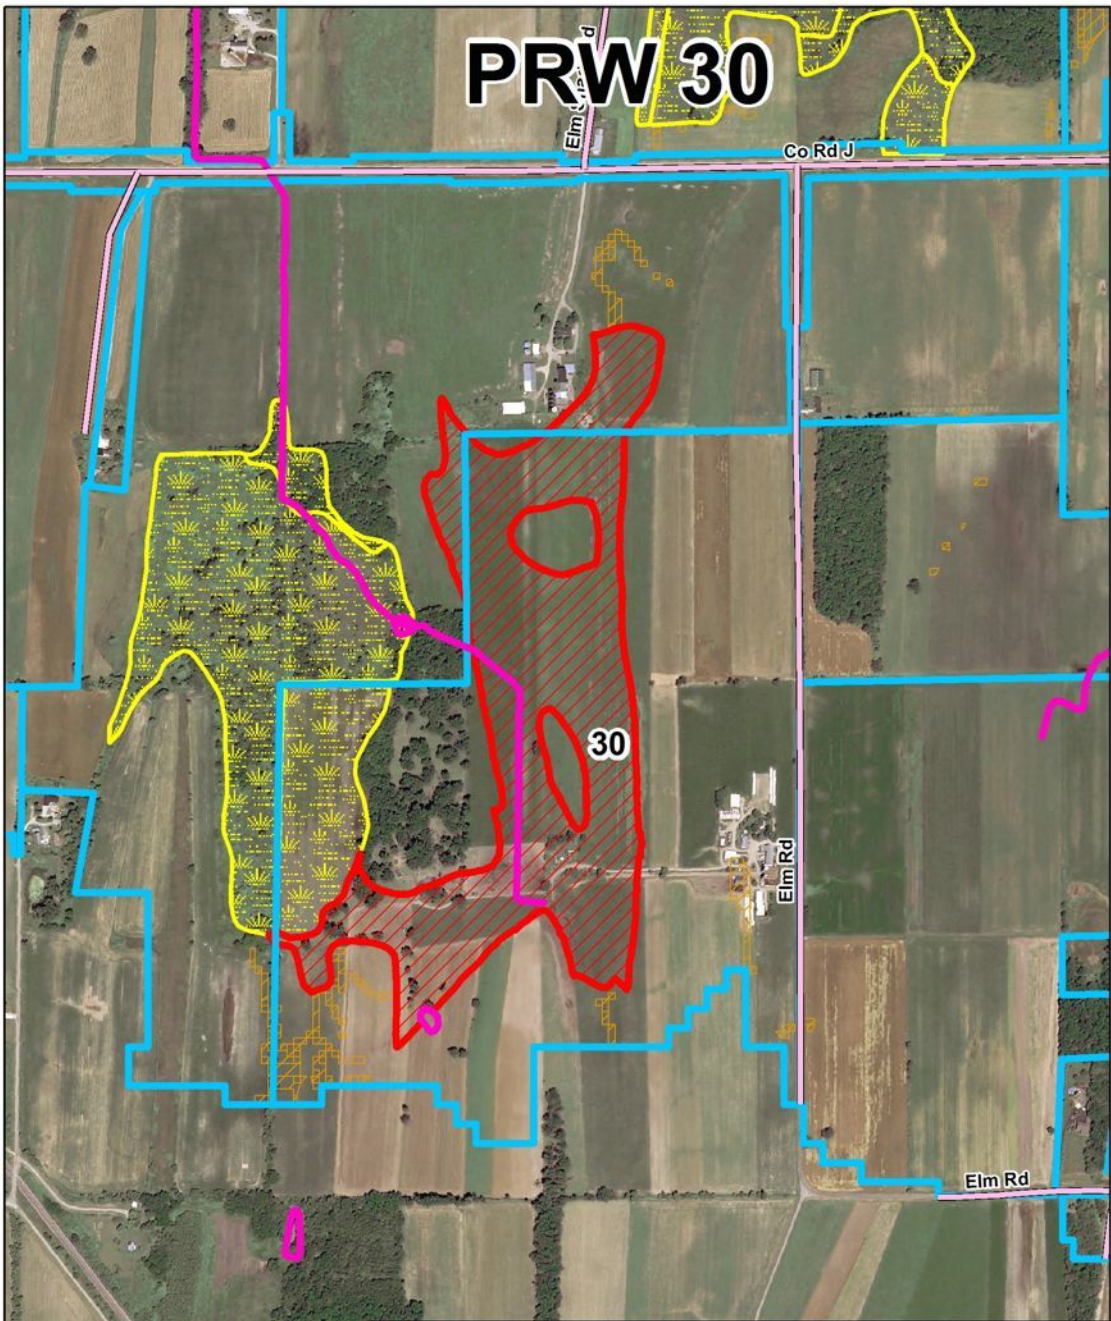
PRW 30

Could not see directly. Maps look like there may be ditch/creek that could be closed on south end of PRW.

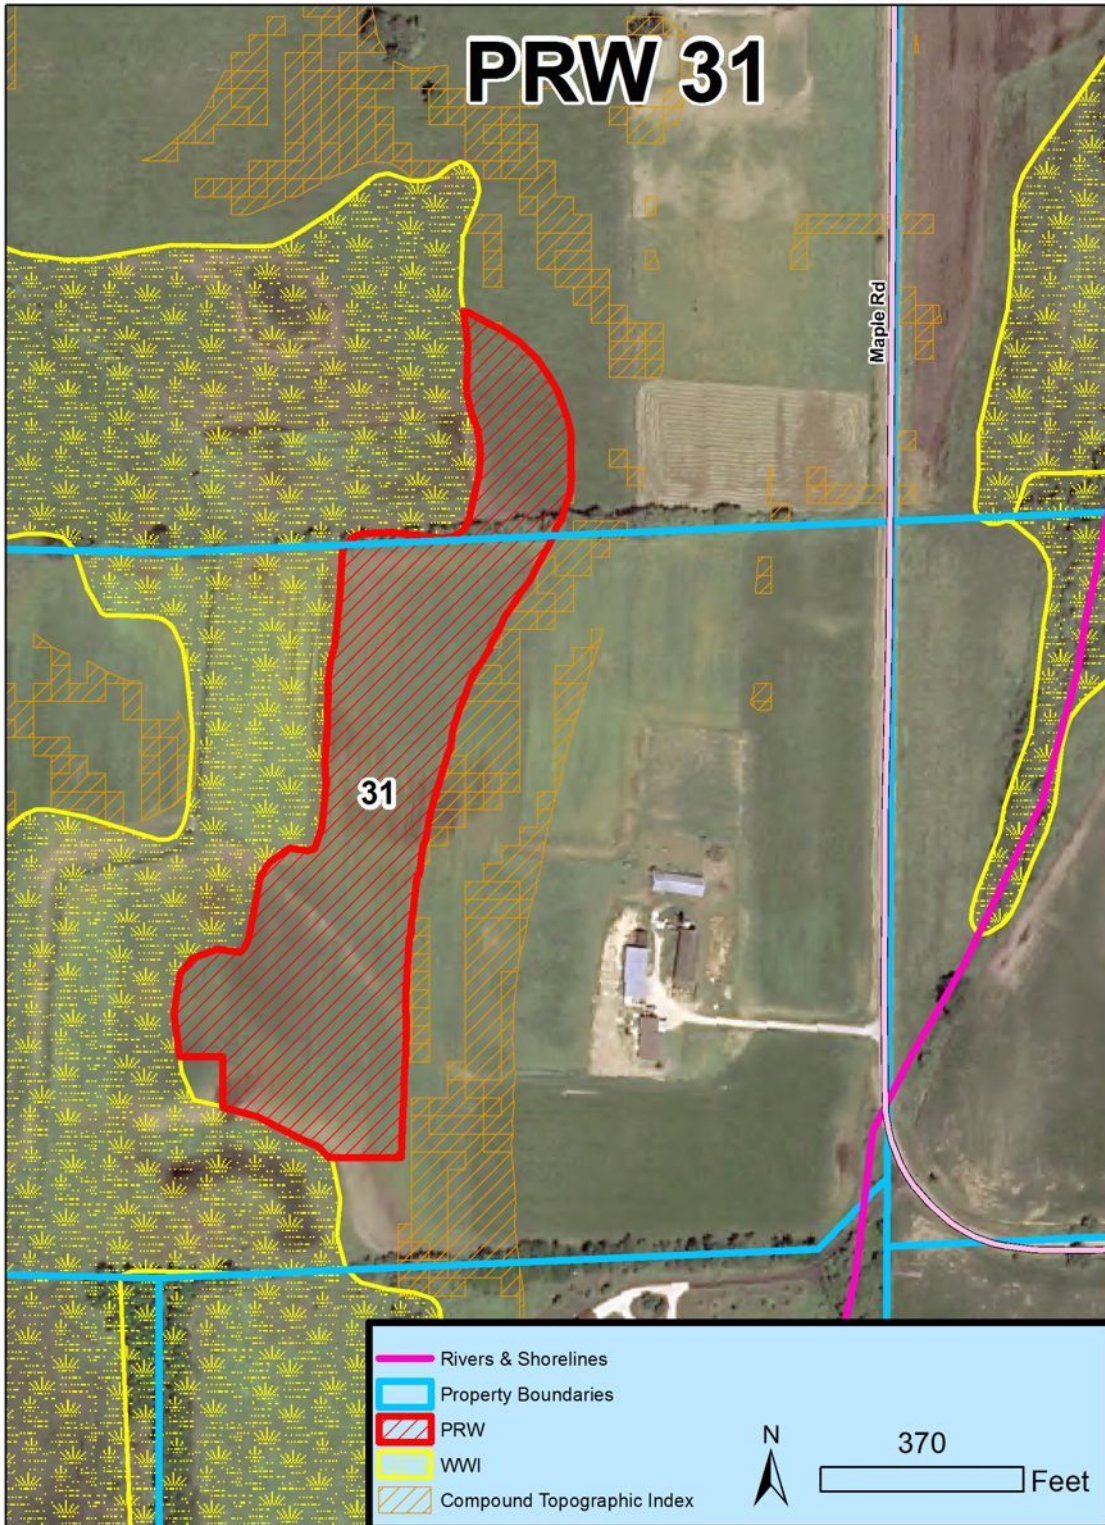
PRW 31

Can't see. No evidence of drainage in field.

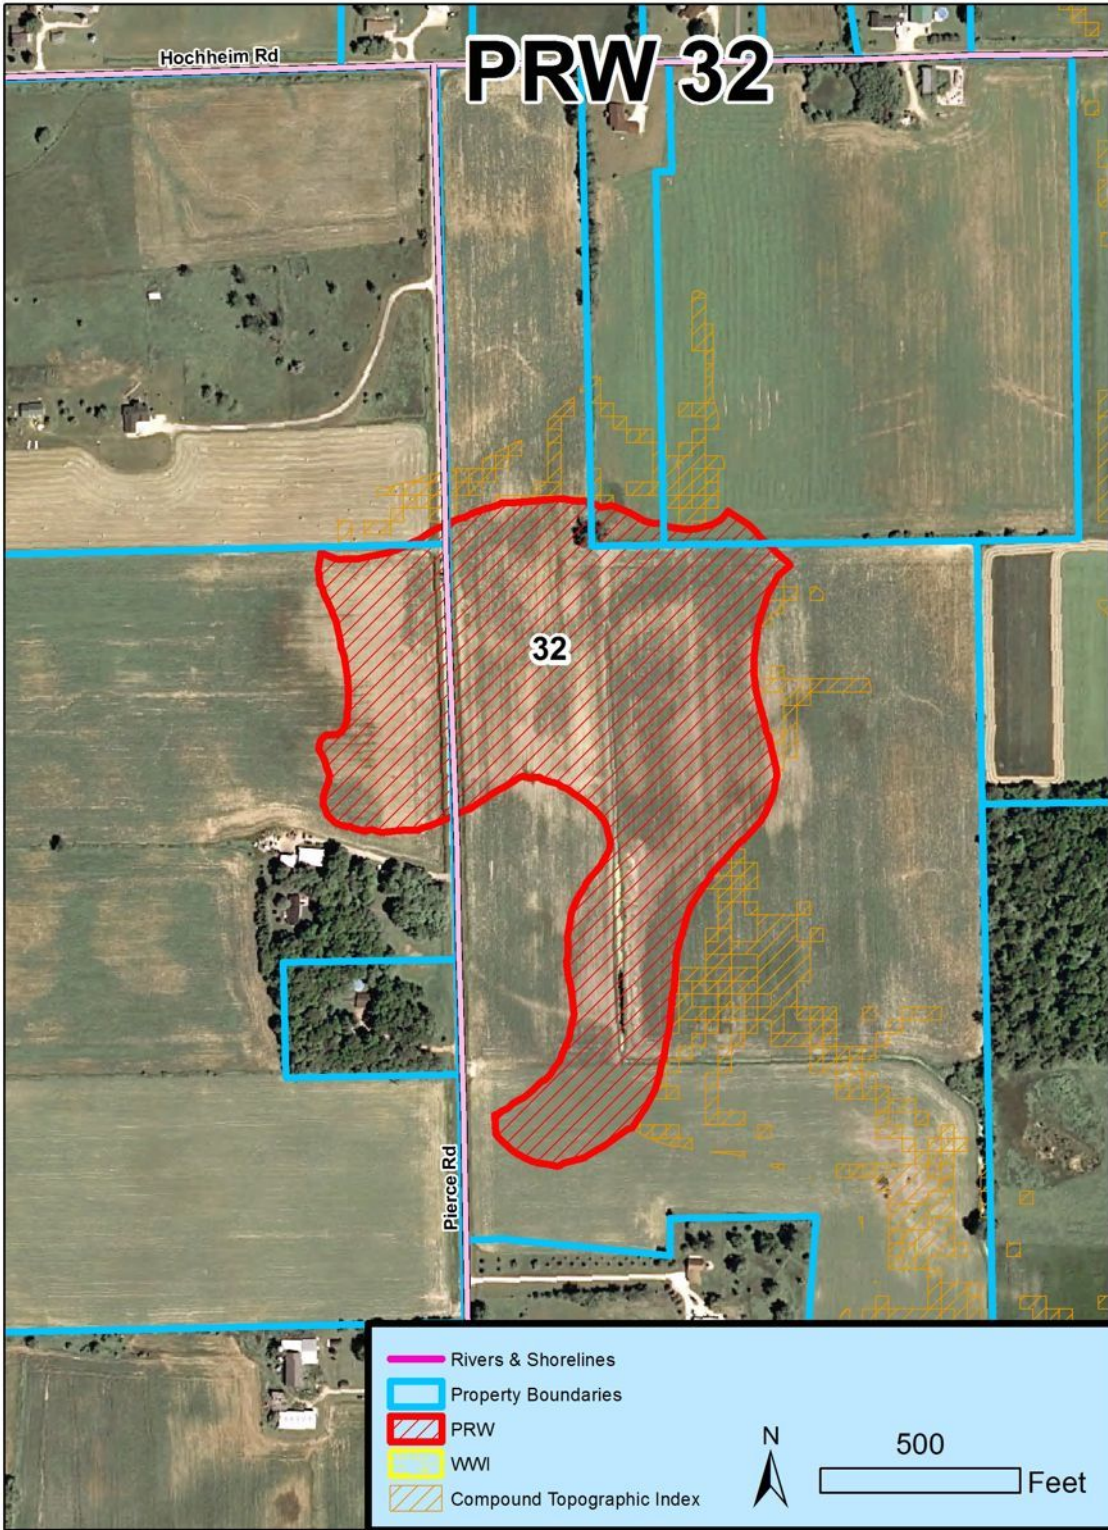
Ditch flows southeast. Good restoration potential.

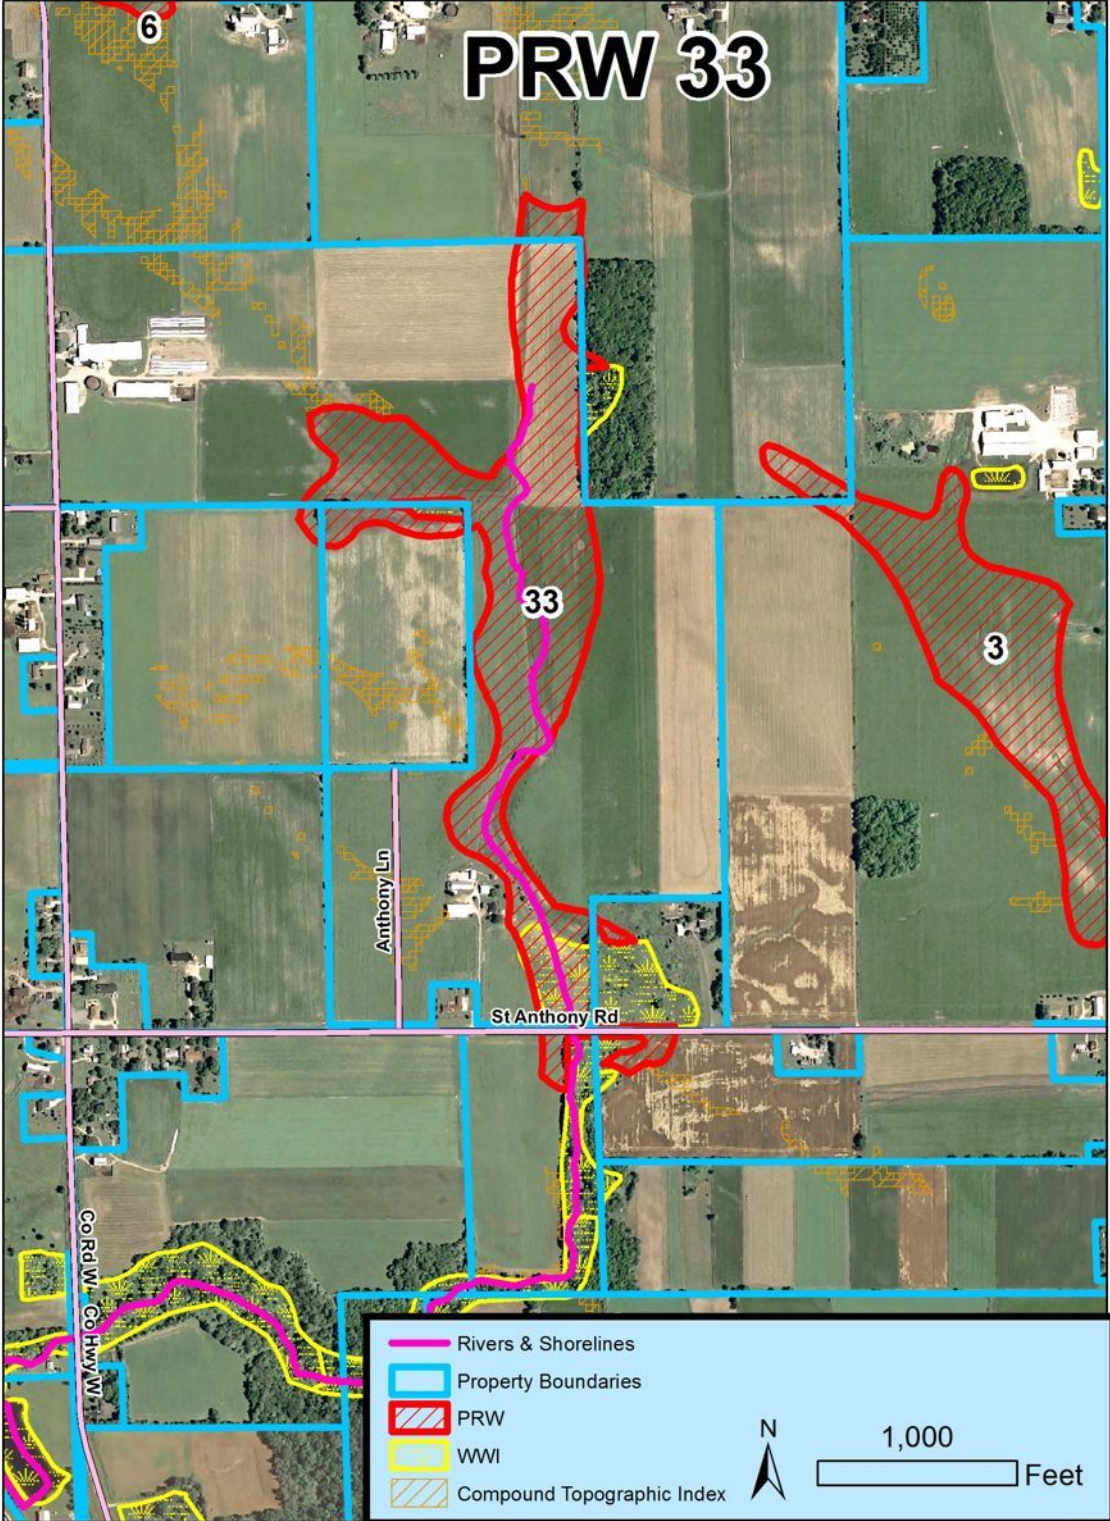
PRW 33

Could not see most of this PRW. Strong flow through 36 or 48" culverts under St. Anthony Rd. Much water for this time of year so there must be ground water or tile drainage. Good opportunity for a stream buffer.

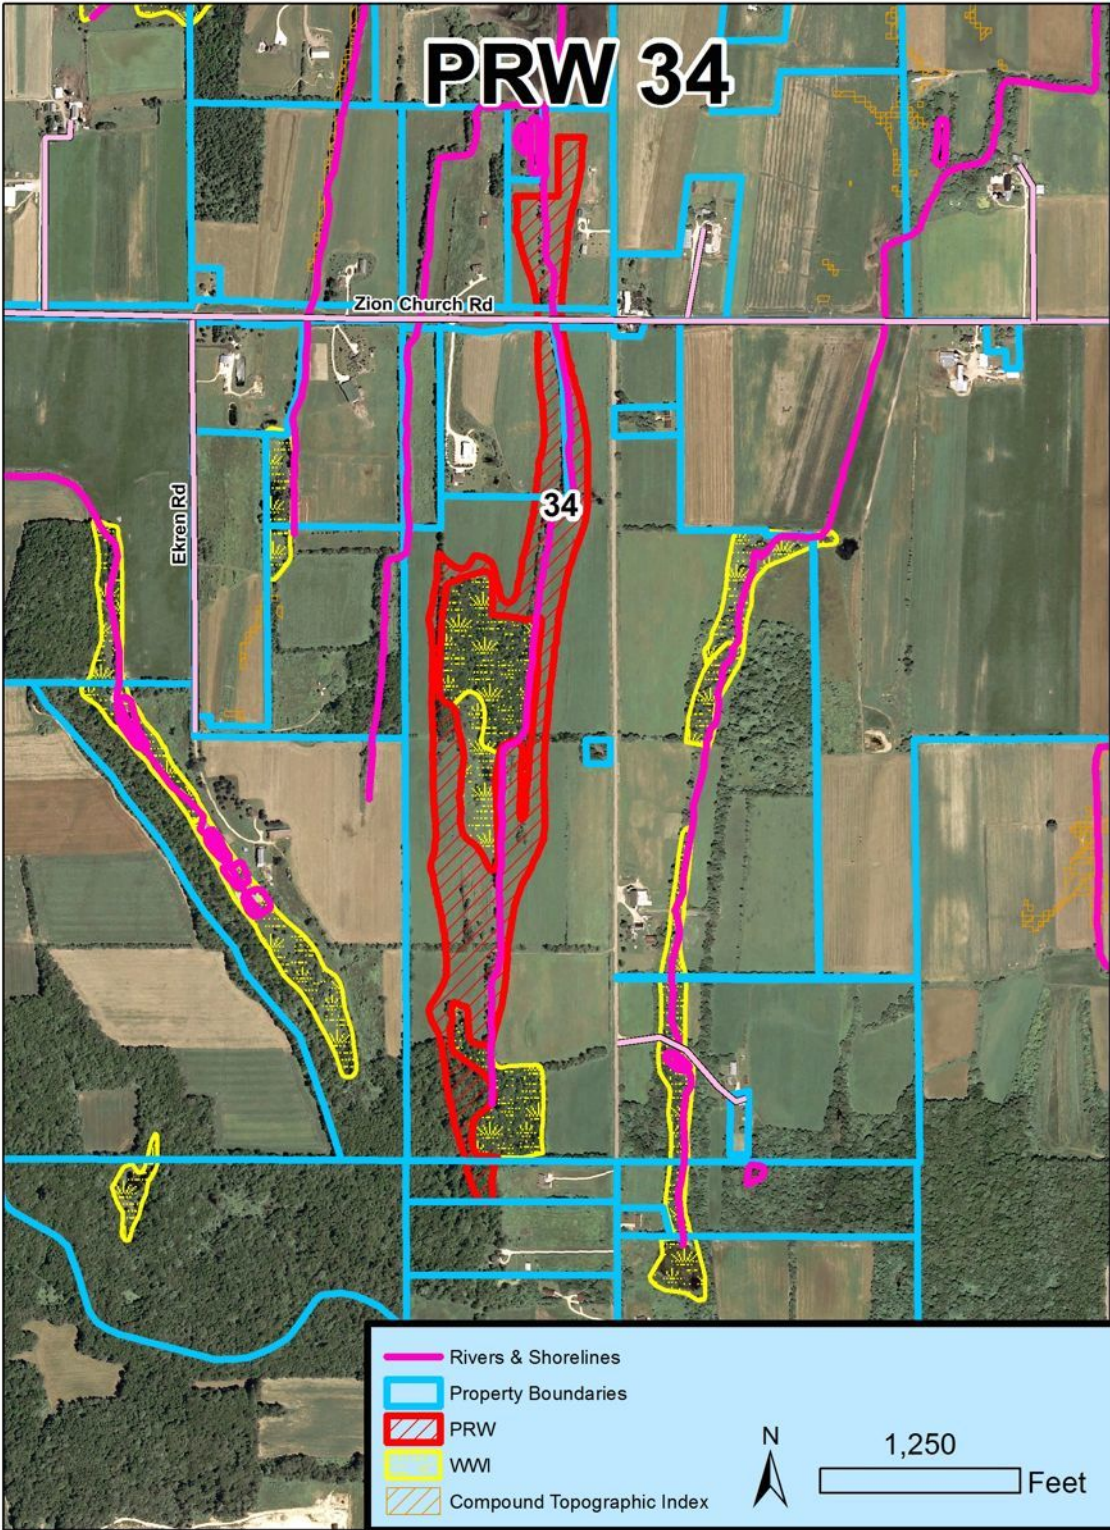
PRW 34

Can't see. Long linear ditch.

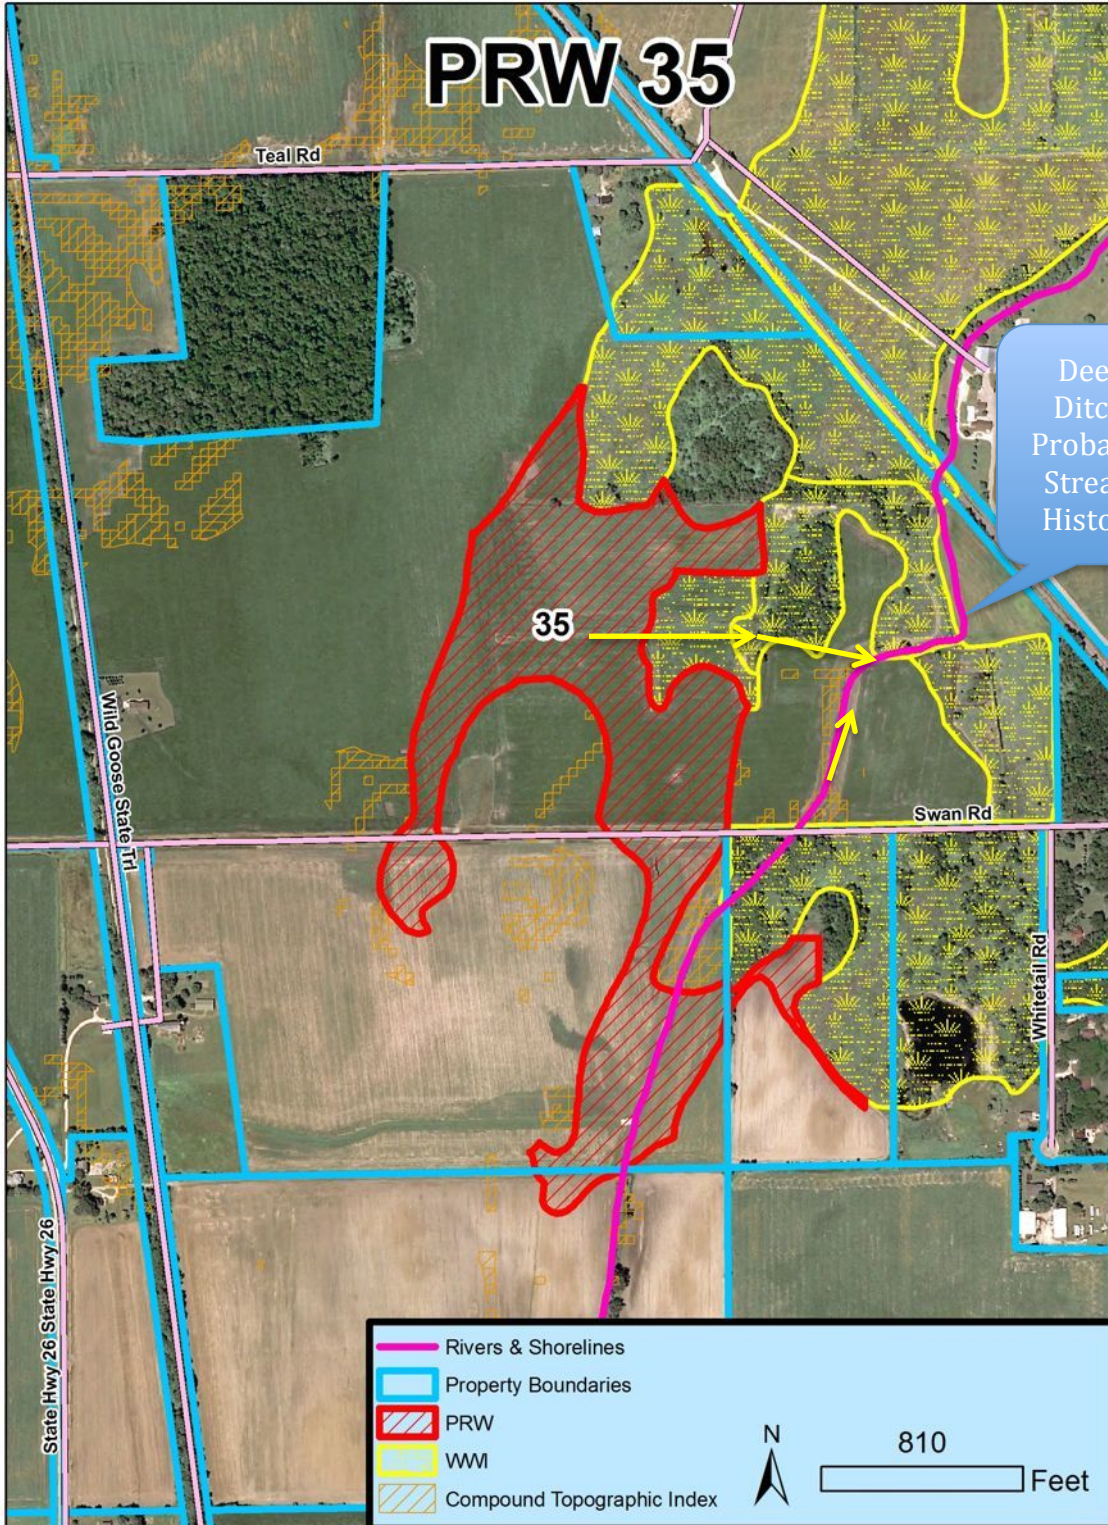
PRW 35

Good restoration north of Swam Rd. May have tile in addition to ditch.

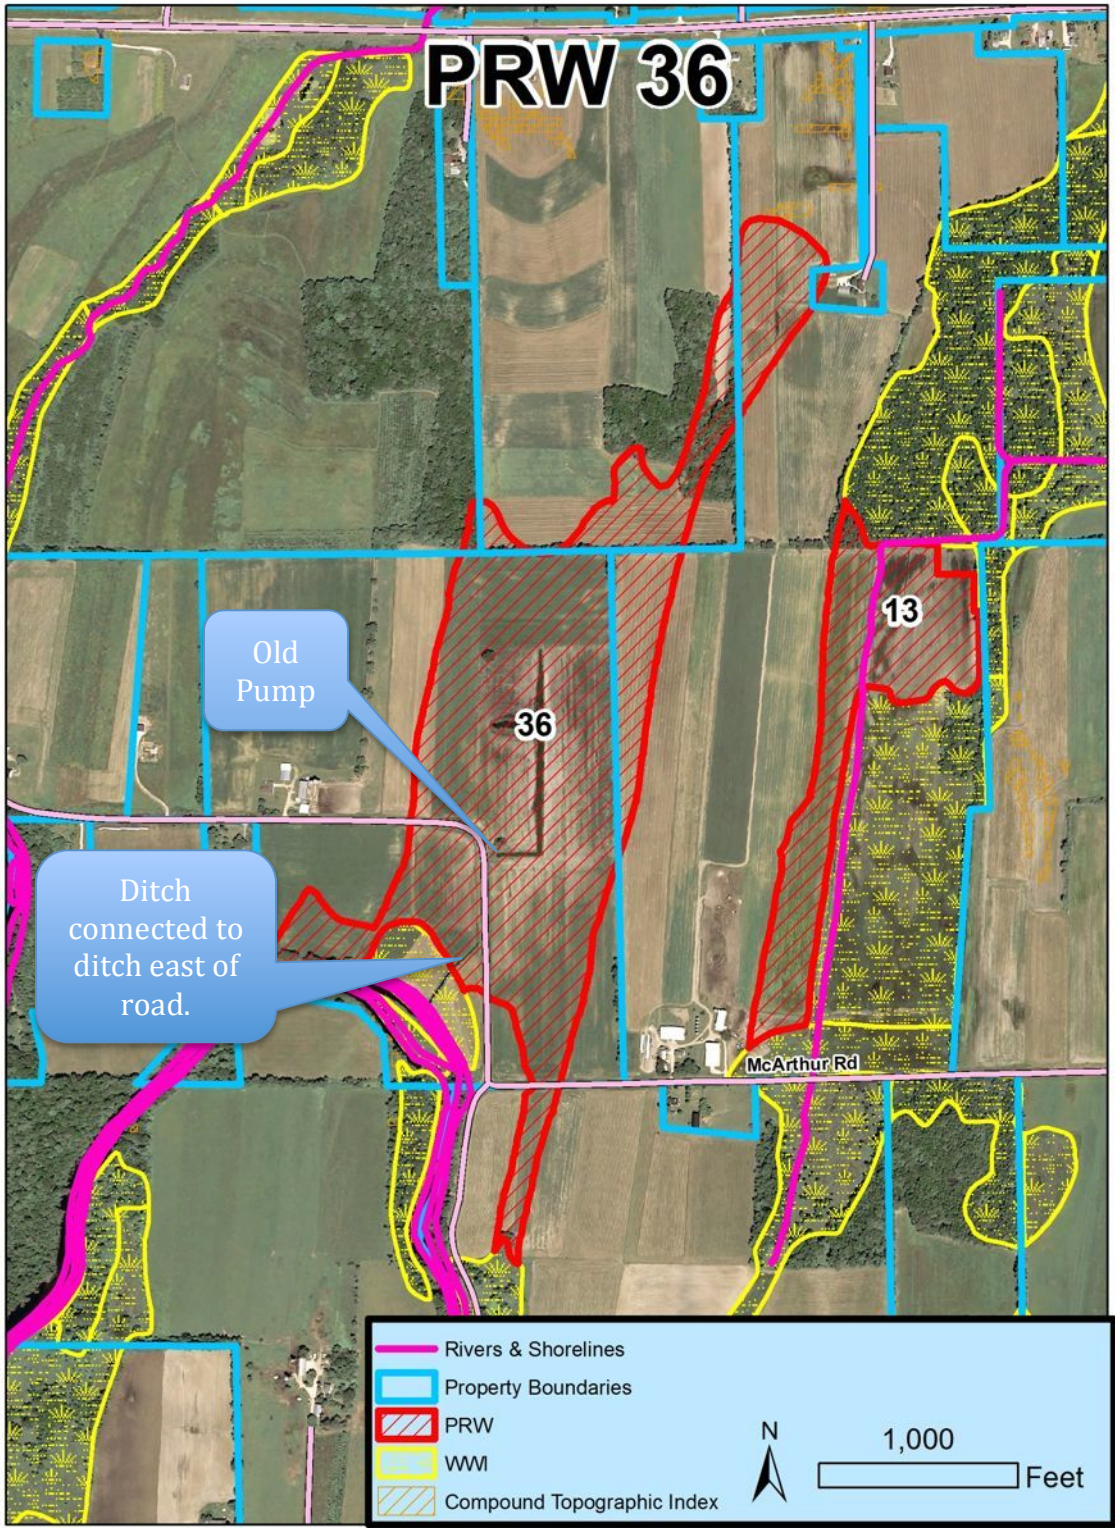
Ditch recently cleaned. Ditch connects to river. Shows flashiness from recent 5 inch rain. Hydrophytes persist in crop fields. Good restoration potential.

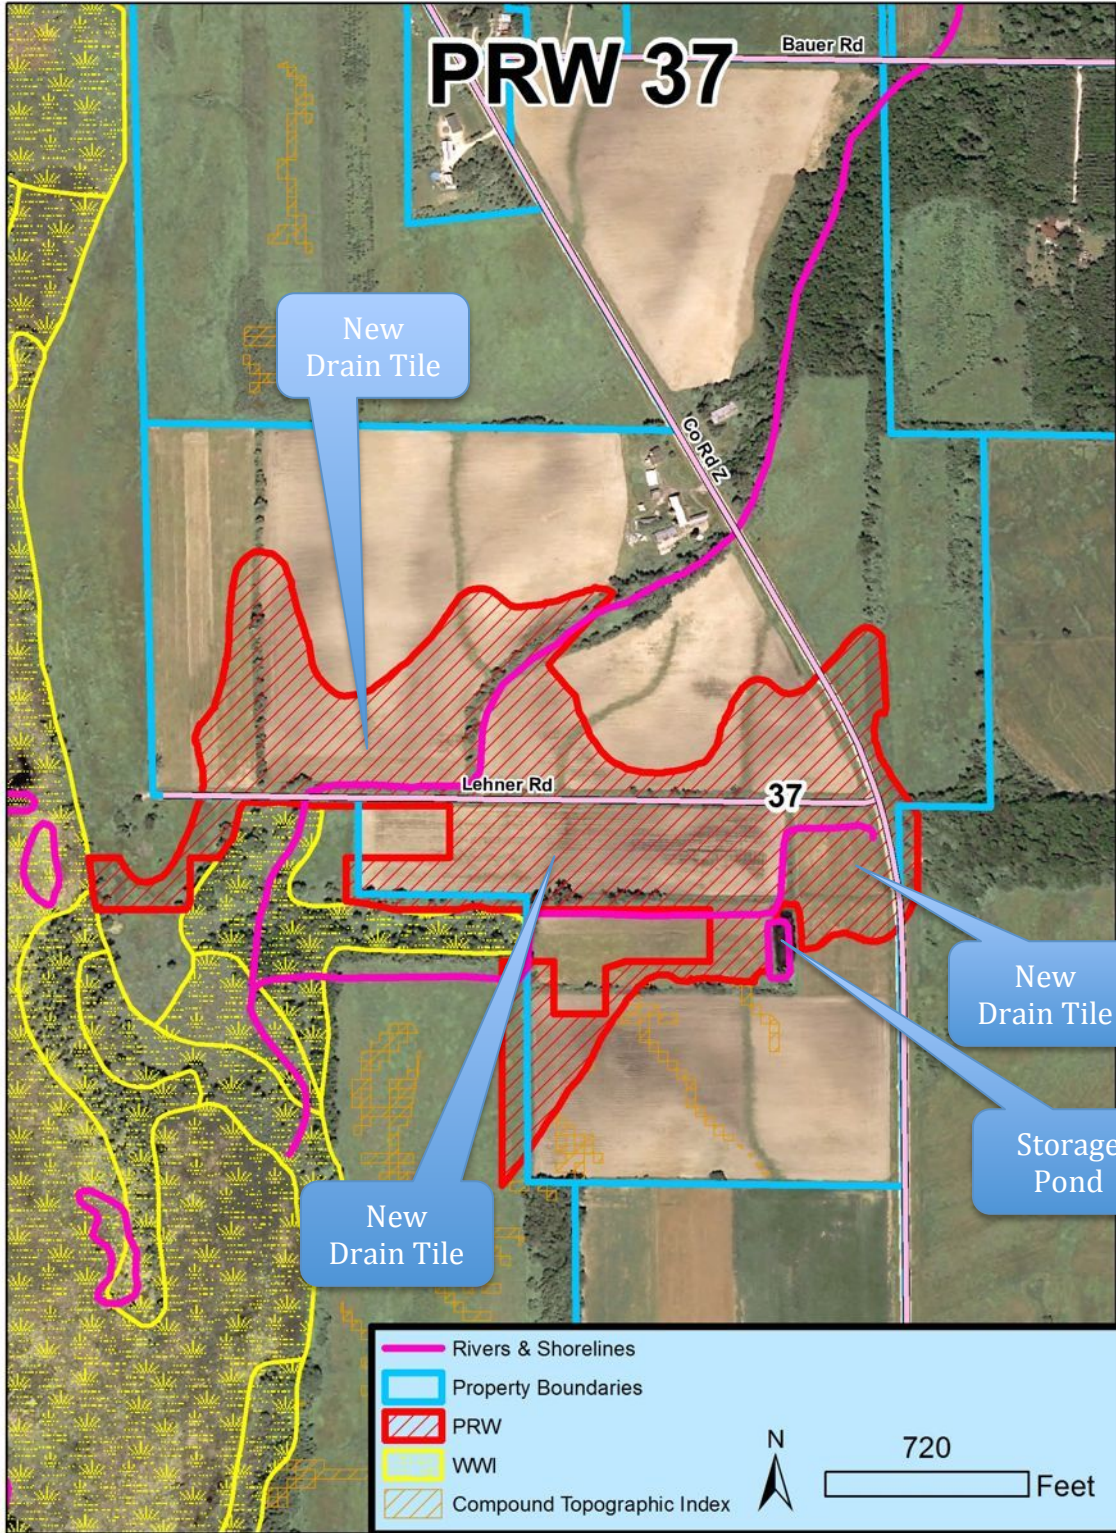
Flat area with ditches throughout. Large ditches on south side. New tile installed, appears connected to existing tile. Large canal for water storage on south side. South side ditches cleaned recently. Good potential.
