**RE: Winter Hydroelectric Project, FERC Project #2064
Flambeau Hydro LLC
Final Report 2017 Land & Wildlife Management Report**

2017 LAND & WILDLIFE MANAGEMENT FINAL REPORT

Winter Hydroelectric Project FERC Project #2064 Flambeau Hydro, LLC

Final Report – December 2017

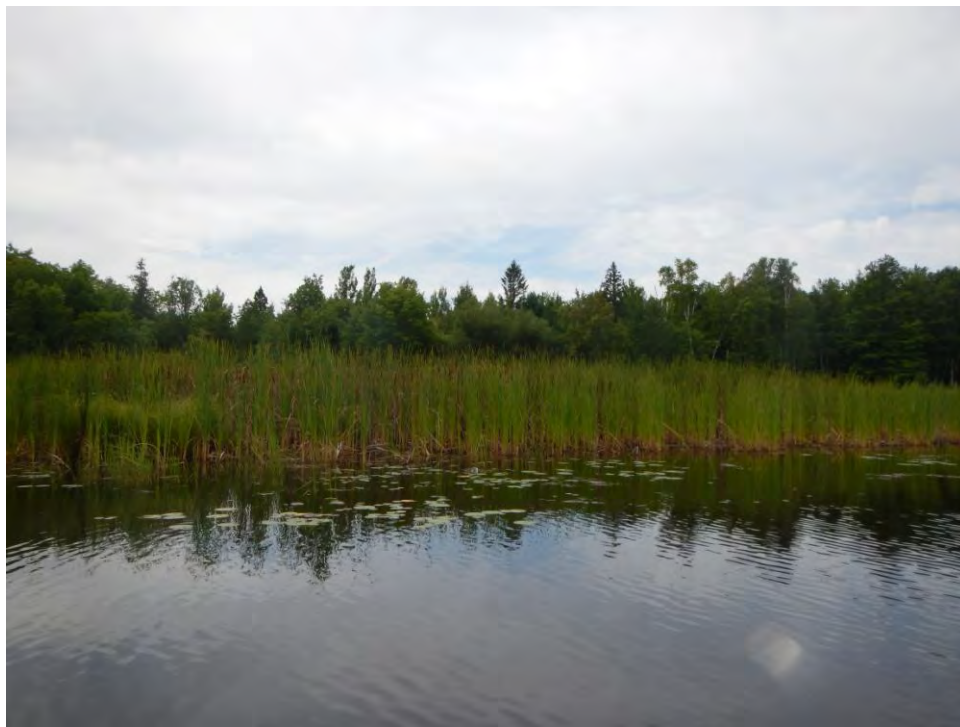
Figure 3. Narrow leaved cattail (Non-native cattail), Winter Project 2017.

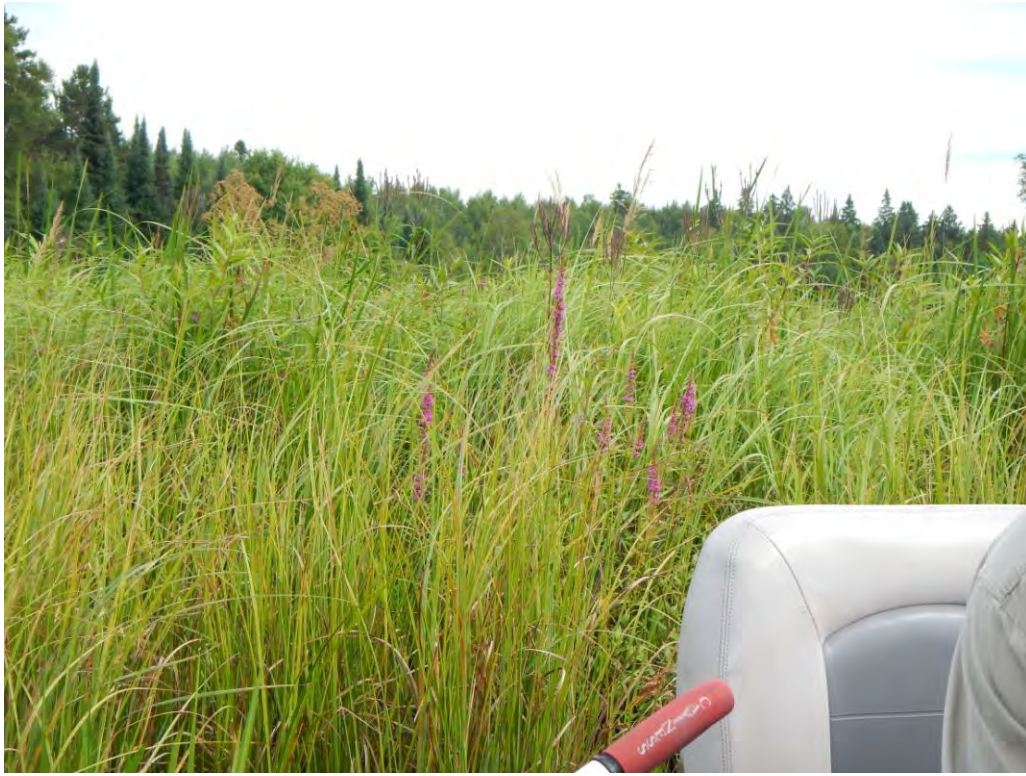
On August 9, 2017 White Water Associates, Inc. performed an inventory of purple loosestrife at the Winter Hydroelectric Project in conjunction with the Invasive Species Survey (Table 1). Three locations had purple loosestrife. Site WNTR PL003 (Figure 4 and 5) (45.93084, -90.94380) had approximately 20 plants which some were hand-pulled. Site WNTR PL005 (Figure 4 and 5) (45.93082, -90.94358) had approximately 8 plants and they were all hand-pulled (Figure 6). Site WNTR PL005a (same location as 005 but nearby) had approximately 25+ plants and there was no treatment. Both of these locations were located on land adjacent to the impoundment and had previous occurrences of the invasive plant. No purple loosestrife was observed on Flambeau Hydro LLC land, adjacent to the tailrace, or adjacent to the bypass channel.

Figure 6. Purple loosestrife in wetland area, Winter Project, 2017.

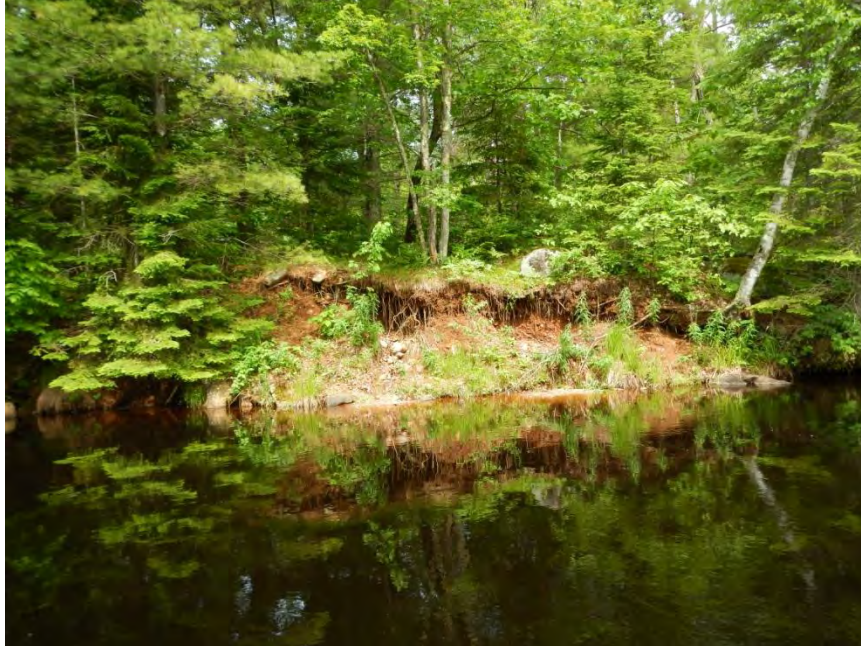
WNTR ER002 is located on the right side of the river near the spillway about 0.43 miles upstream from the powerhouse (Figure 24). This site is not located on FHLLC property. It is considered a Minor site due to the small size and stability of the toe (Figure 7). The entire toe is established with rock and gravel and has been growing more grasses during the last 4 years. No noticeable erosion has been evident during the monitoring period of 2011 through 2017. It is unlikely to contribute noticeable sediment to the river in its current condition. No other unusual erosion sites were observed in the impoundment.

Figure 7. WNTR ER002 (Photo ID 3852) 6/14/2017

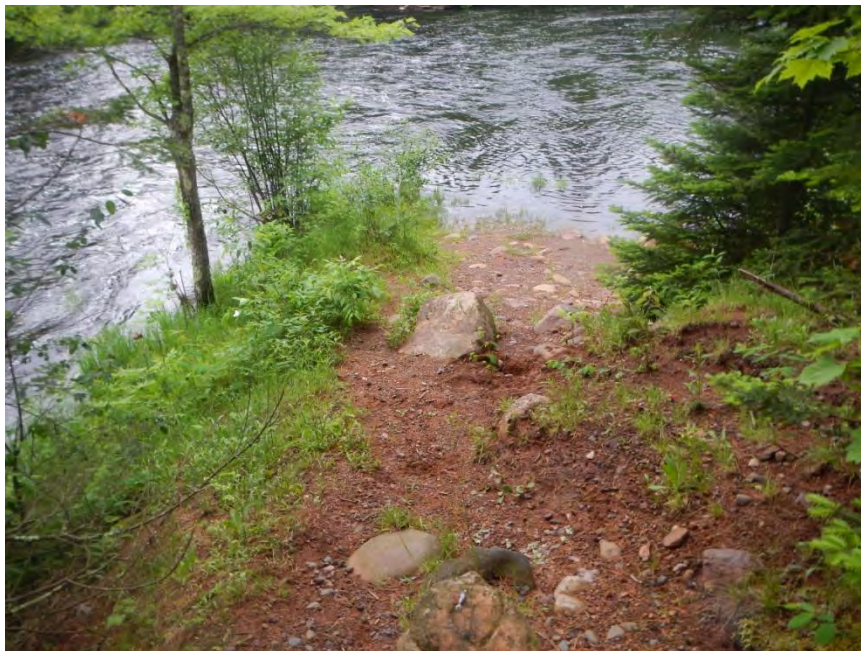
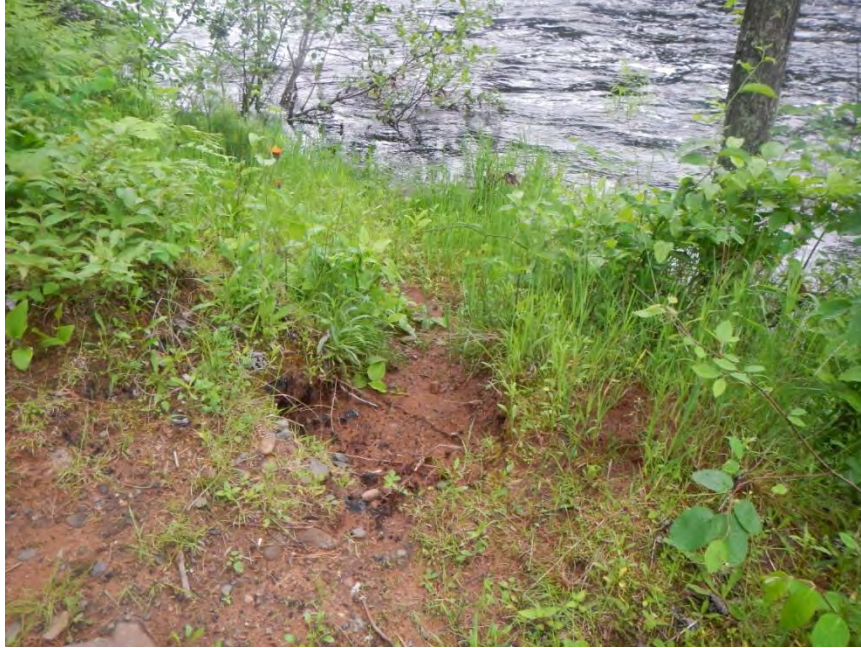
On June 14, 2017 White Water Associates, Inc. performed an erosion survey at the Winter Hydroelectric Project (Table 2). The tailrace reach was surveyed on foot and no unusual erosion sites were observed. The *FHLLC owned property within the project boundary* was surveyed on foot and one minor erosion site (WNTR ER003) was observed.

did in past surveys. Human activity at this site appears to be what has caused this to be classed as an erosion site. It is unlikely to contribute noticeable sediment discharge to the river in its current condition.

Figure 8. WNTR ER003 (Photo ID 3835) 6/14/2017

Figure 8a. WNTR ER003a (Photo ID 3834) 6/14/2017

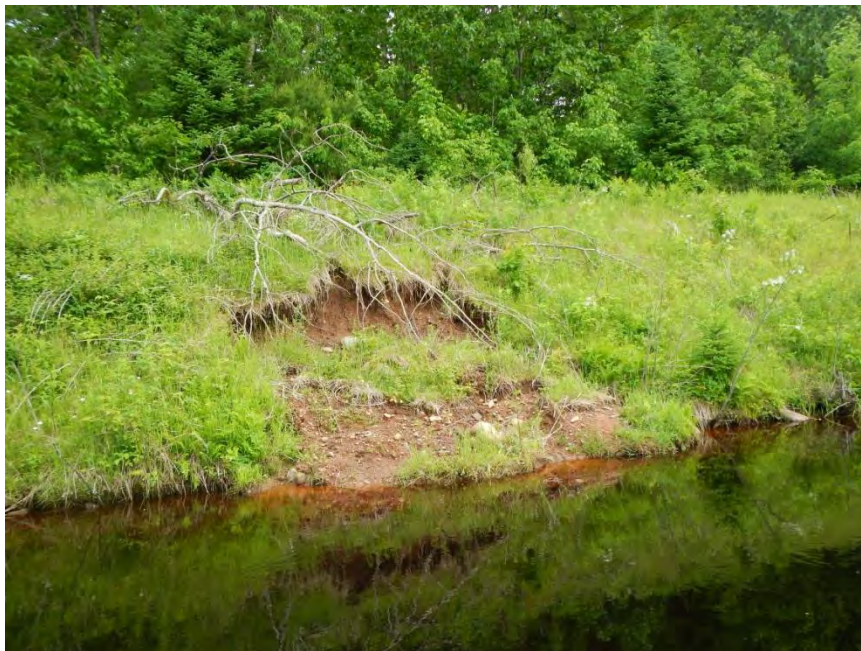
WNTR ER004 was first observed in 2017 along the left bank facing upstream (Figure 22). It is Moderate in condition. Slumping of the bank due to weathering was the cause of this erosion and grasses are present (Figure 9).

Figure 9. WNTR ER004 (Photo ID 3836) 6/14/2017

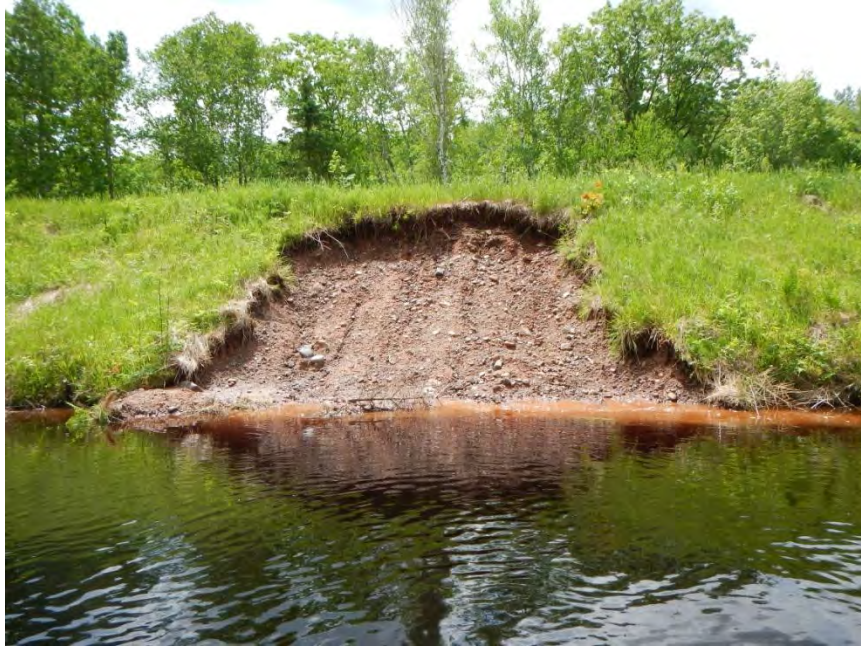
WNTR ER005 was first observed in 2017 along the left bank facing upstream (Figure 22). It is Severe in condition. Slumping of the bank due to weathering was the cause of this erosion (Figure 10). The entire site is bare soil.

Figure 10. WNTR ER005 (Photo ID 3868) 6/14/2017

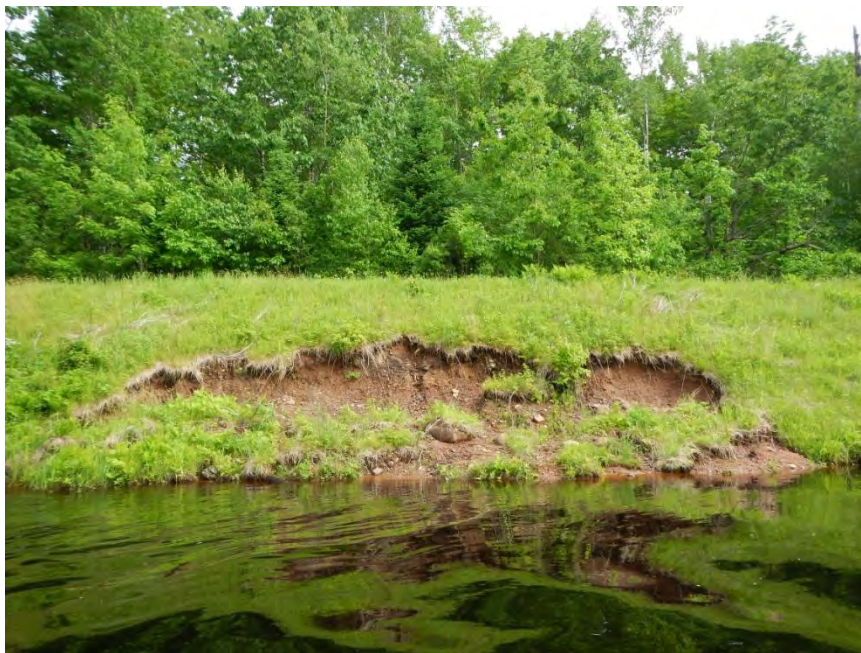
WNTR ER006 was first observed in 2017 along the left bank facing upstream (Figure 22). It is Moderate in condition. Slumping of the bank due to weathering was the cause of this erosion and grasses are present (Figure 11).

Figure 11. WNTR ER006 (Photo ID 3837) 6/14/2017

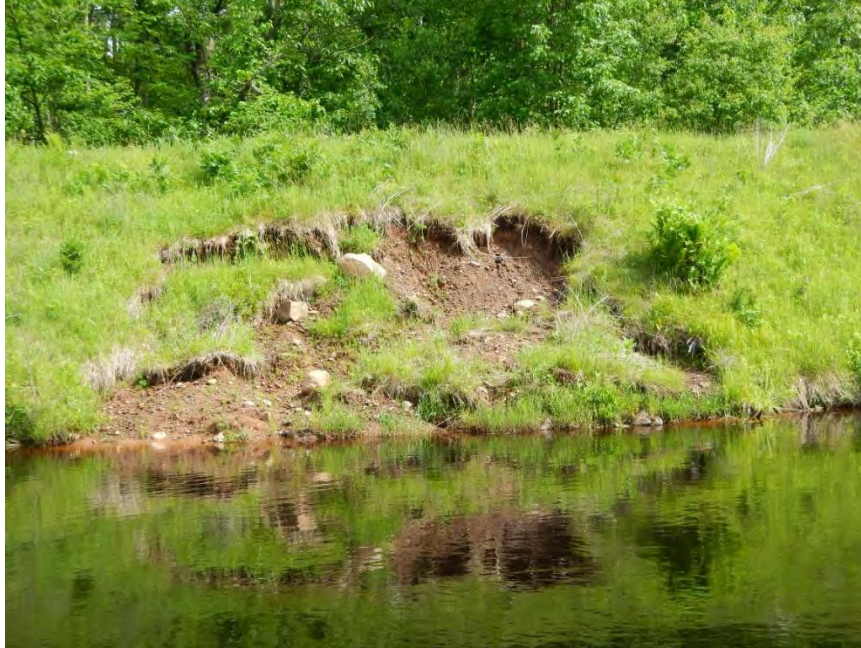
WNTR ER007 was first observed in 2017 along the left bank facing upstream (Figure 22). It is Moderate in condition. Slumping of the bank due to weathering was the cause of this erosion and grasses are present (Figure 12).

Figure 12. WNTR ER007 (Photo ID 3838) 6/14/2017

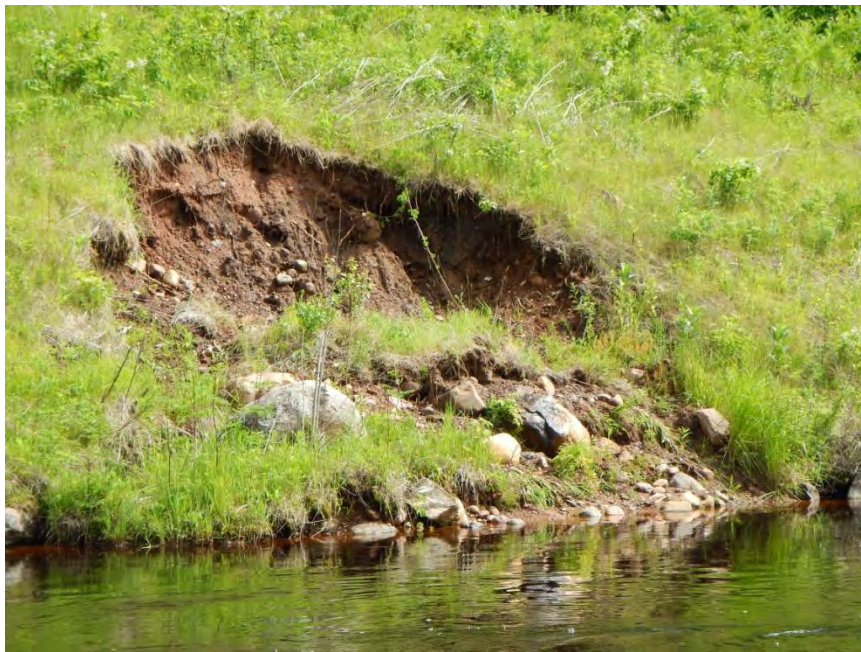
WNTR ER008 was first observed in 2017 along the left bank facing upstream (Figure 22). It is Moderate in condition. Slumping of the bank due to weathering was the cause of this erosion and grasses and many rocks are present (Figure 13).

Figure 13. WNTR ER008 (Photo ID 3839) 6/14/2017

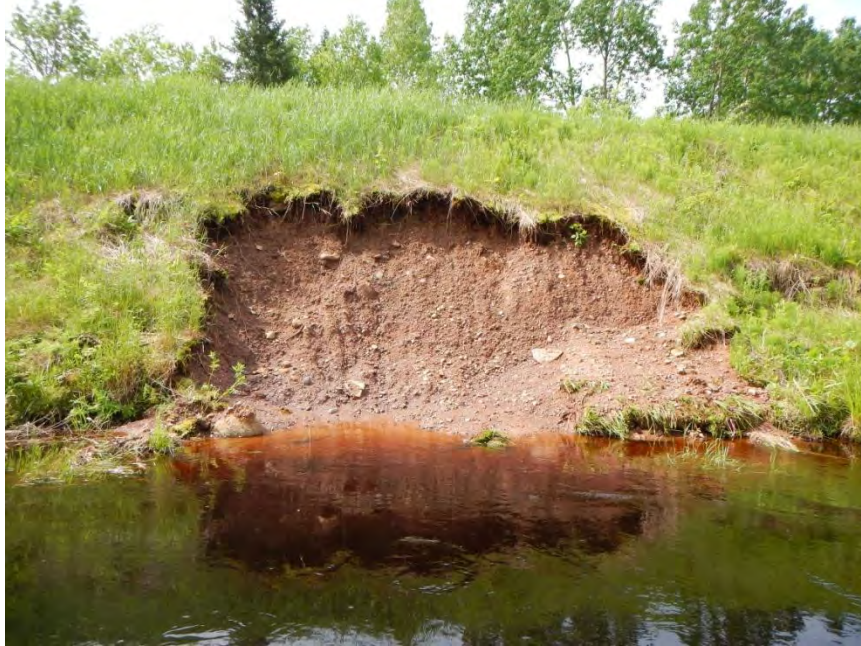
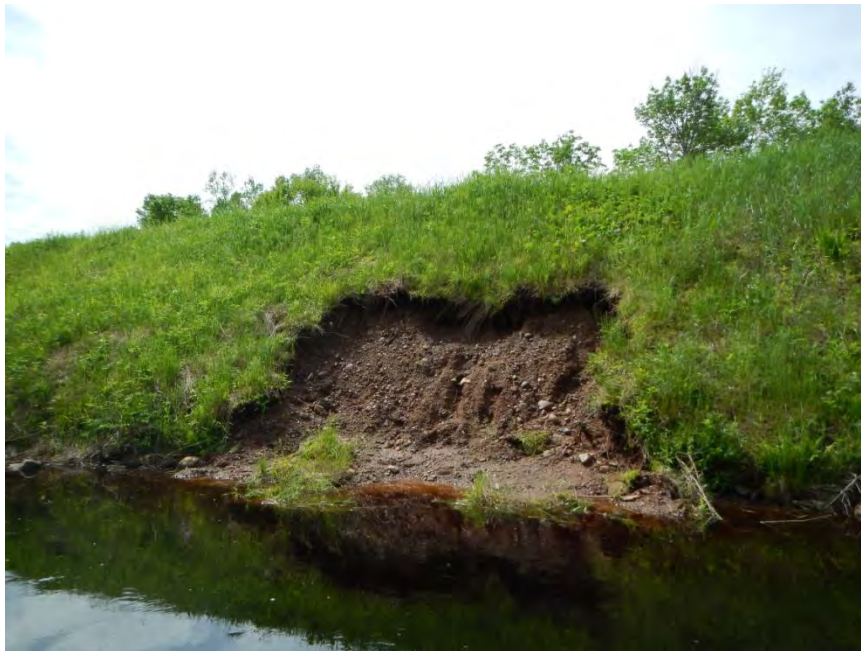
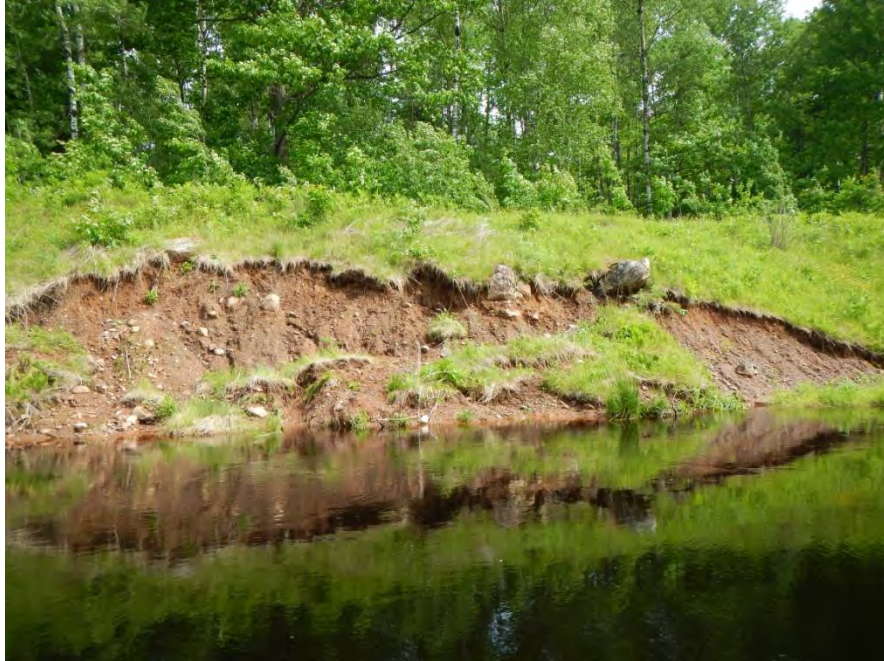
WNTR ER009 was first observed in 2017 along the right bank and left bank (ER009b) facing upstream (Figure 22). All three sites are Moderate in condition. Slumping of the bank due to weathering was the cause of this erosion and grasses are present (Figure 14, 14a, and 14b).

Figure 14. WNTR ER009 (Photo ID 3840) 6/14/2017

Figure 14a. WNTR ER009a (Photo ID 3841) 6/14/2017

Figure 14b. WNTR ER009b (Photo ID 3842) (6/14/2017)

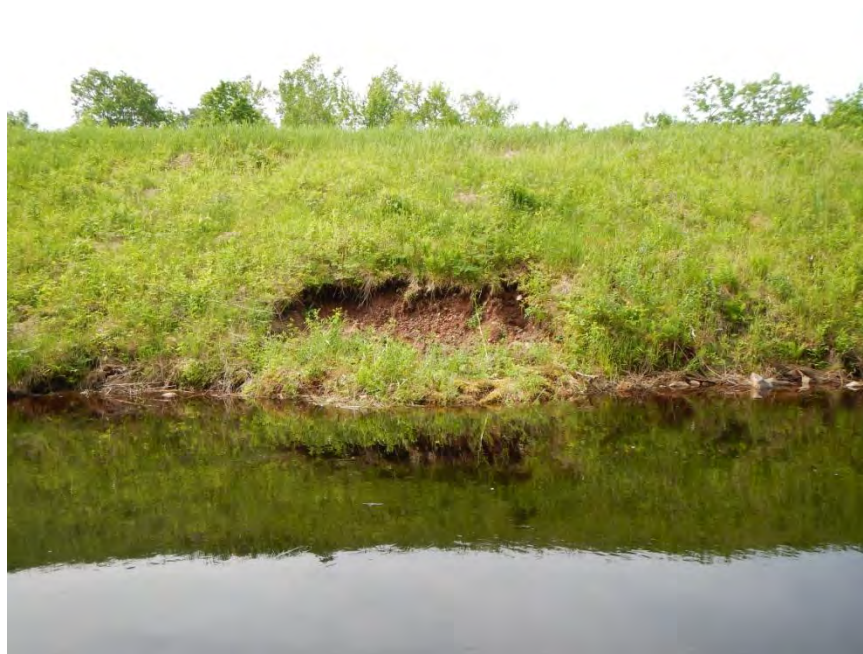
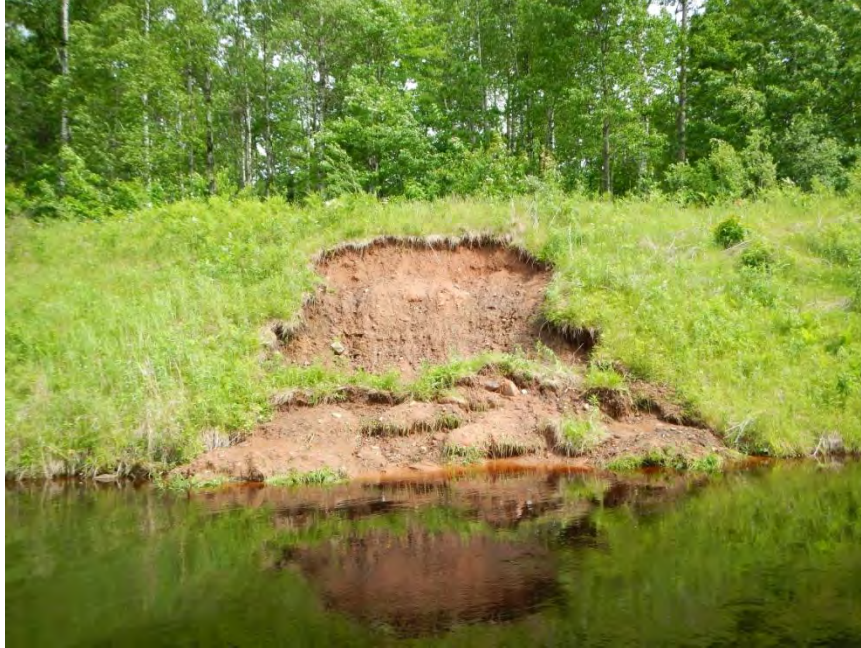
WNTR ER010 was first observed in 2017 along the left bank facing upstream (Figure 22). It is Minor (ER010) and Severe (ER010a) in condition. Slumping of the bank due to weathering was the cause of this erosion and grasses are present (Figure 15 and 15a).

Figure 15. WNTR ER010 (Photo ID 3844) 6/14/2017

Figure 15a. WNTR ER010a (Photo ID 3845) 6/14/2017

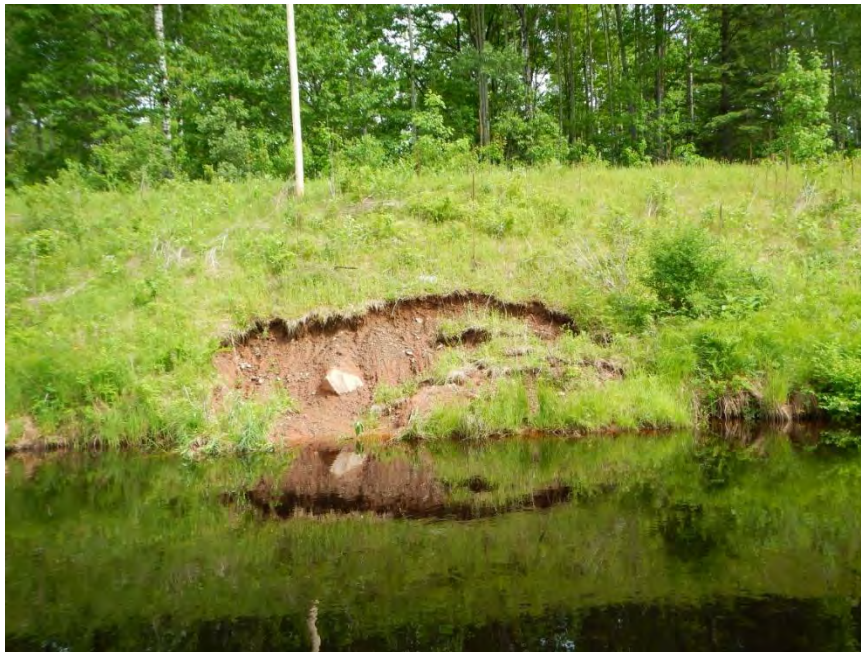
WNTR ER011 was first observed in 2017 along the left bank facing upstream (Figure 23). It is Moderate in condition. Slumping of the bank due to weathering was the cause of this erosion and grasses are present (Figure 16).

Figure 16. WNTR ER011 (Photo ID 3846) 6/14/2017

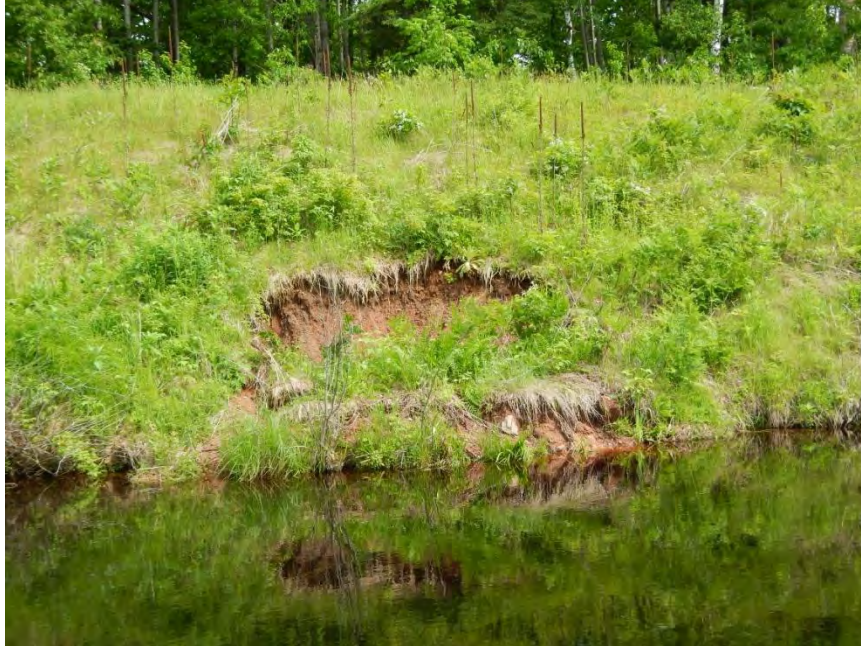
WNTR ER012 was first observed in 2017 along the left bank facing upstream (Figure 23). It is Moderate in condition. Slumping of the bank due to weathering was the cause of this erosion and grasses are present (Figure 17).

Figure 17. WNTR ER012 (Photo ID 3847) 6/14/2017

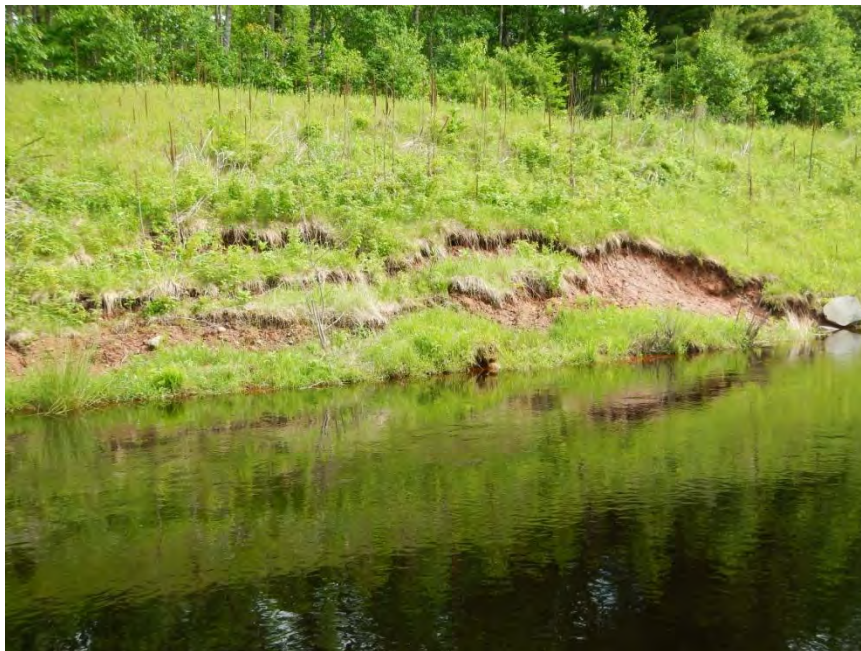
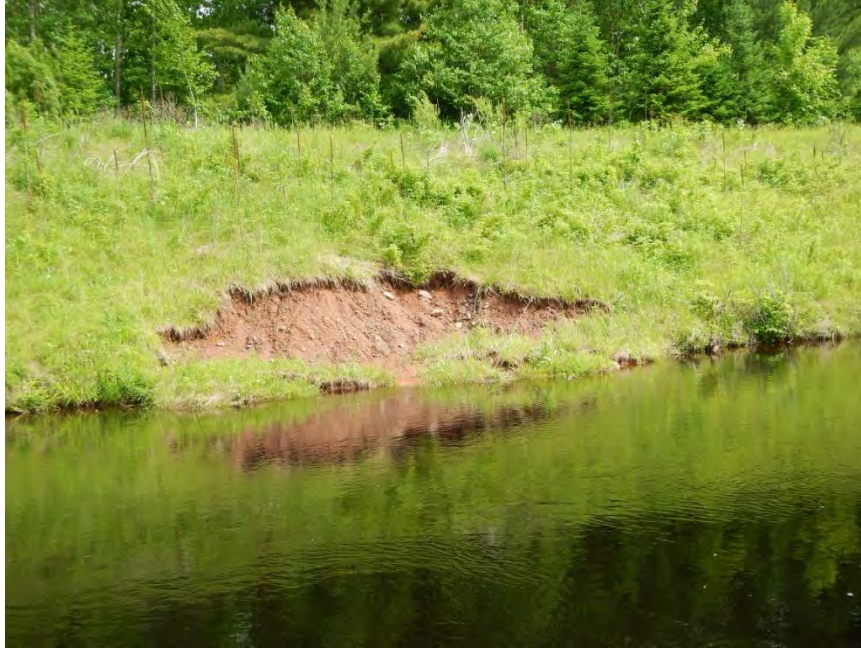
WNTR ER013 was first observed in 2017 along the left bank facing upstream (Figure 23). Both sites are Moderate in condition. Slumping of the bank due to weathering was the cause of this erosion and grasses are present (Figure 18).

Figure 18. WNTR ER013 (Photo ID 3849) 6/14/2017

Figure 18a. WNTR ER013a (Photo ID 3850) 6/14/2017

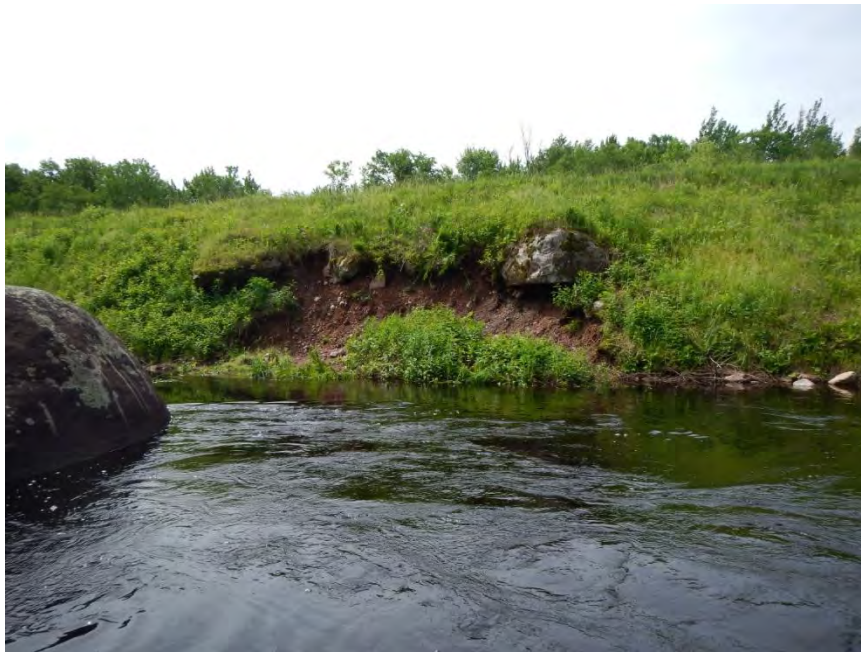
WNTR ER014 was first observed in 2017 along the right bank facing upstream (Figure 23). Both sites are Moderate in condition. Slumping of the bank due to weathering was the cause of this erosion and grasses are present (Figure 19).

Figure 19. WNTR ER014 (Photo ID 3851) 6/14/2017
