2021 Purple Loosestrife Inventory
for
Flambeau Crowley Hydroelectric Project
FERC Project #2473
Flambeau Hydro, LLC
Price County, Wisconsin

Summary of Purple Loosestrife Inventory for Flambeau Crowley Hydroelectric Project, FERC #2473

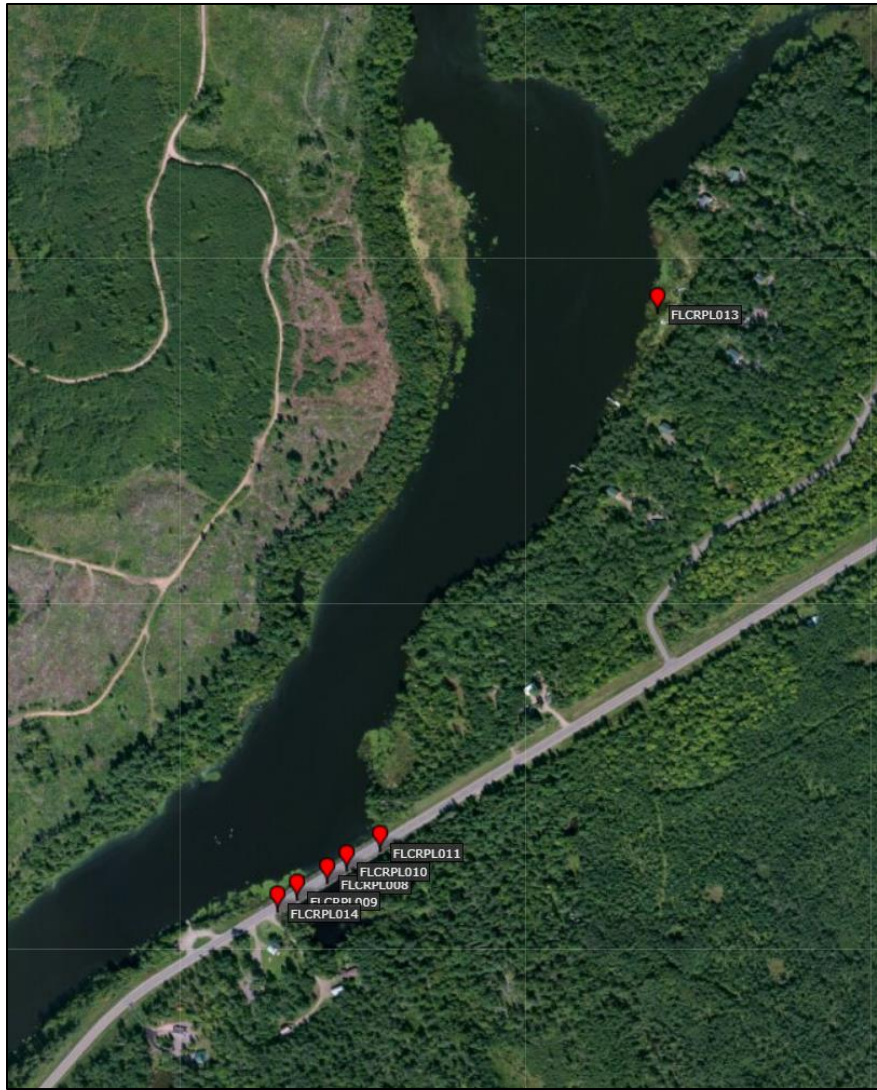
Map 1. Locations of purple loosestrife at Flambeau Crowley in 2021.

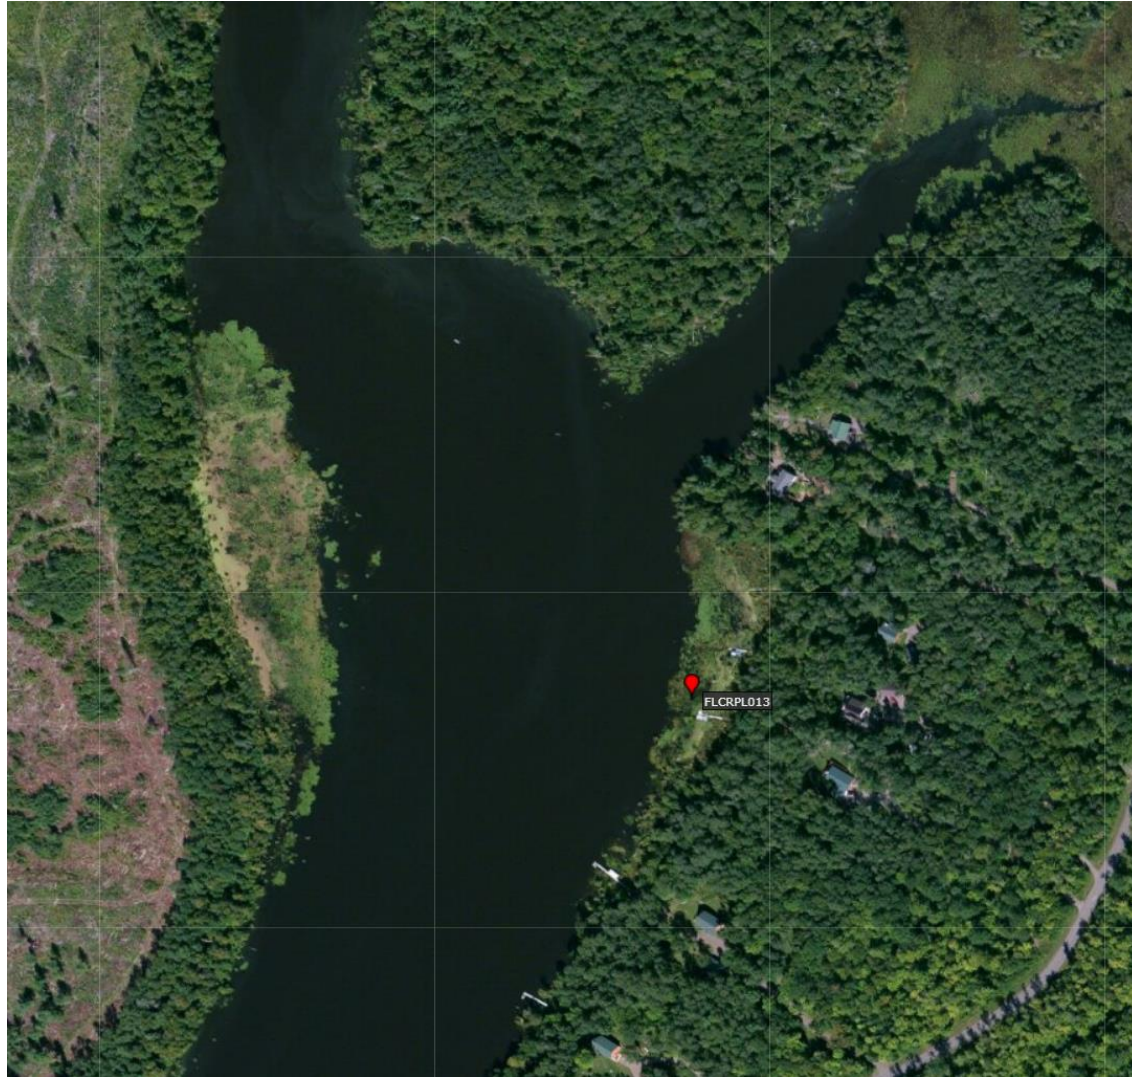
Map 2. Locations of purple loosestrife at Flambeau Crowley in 2021 (CRPL2).

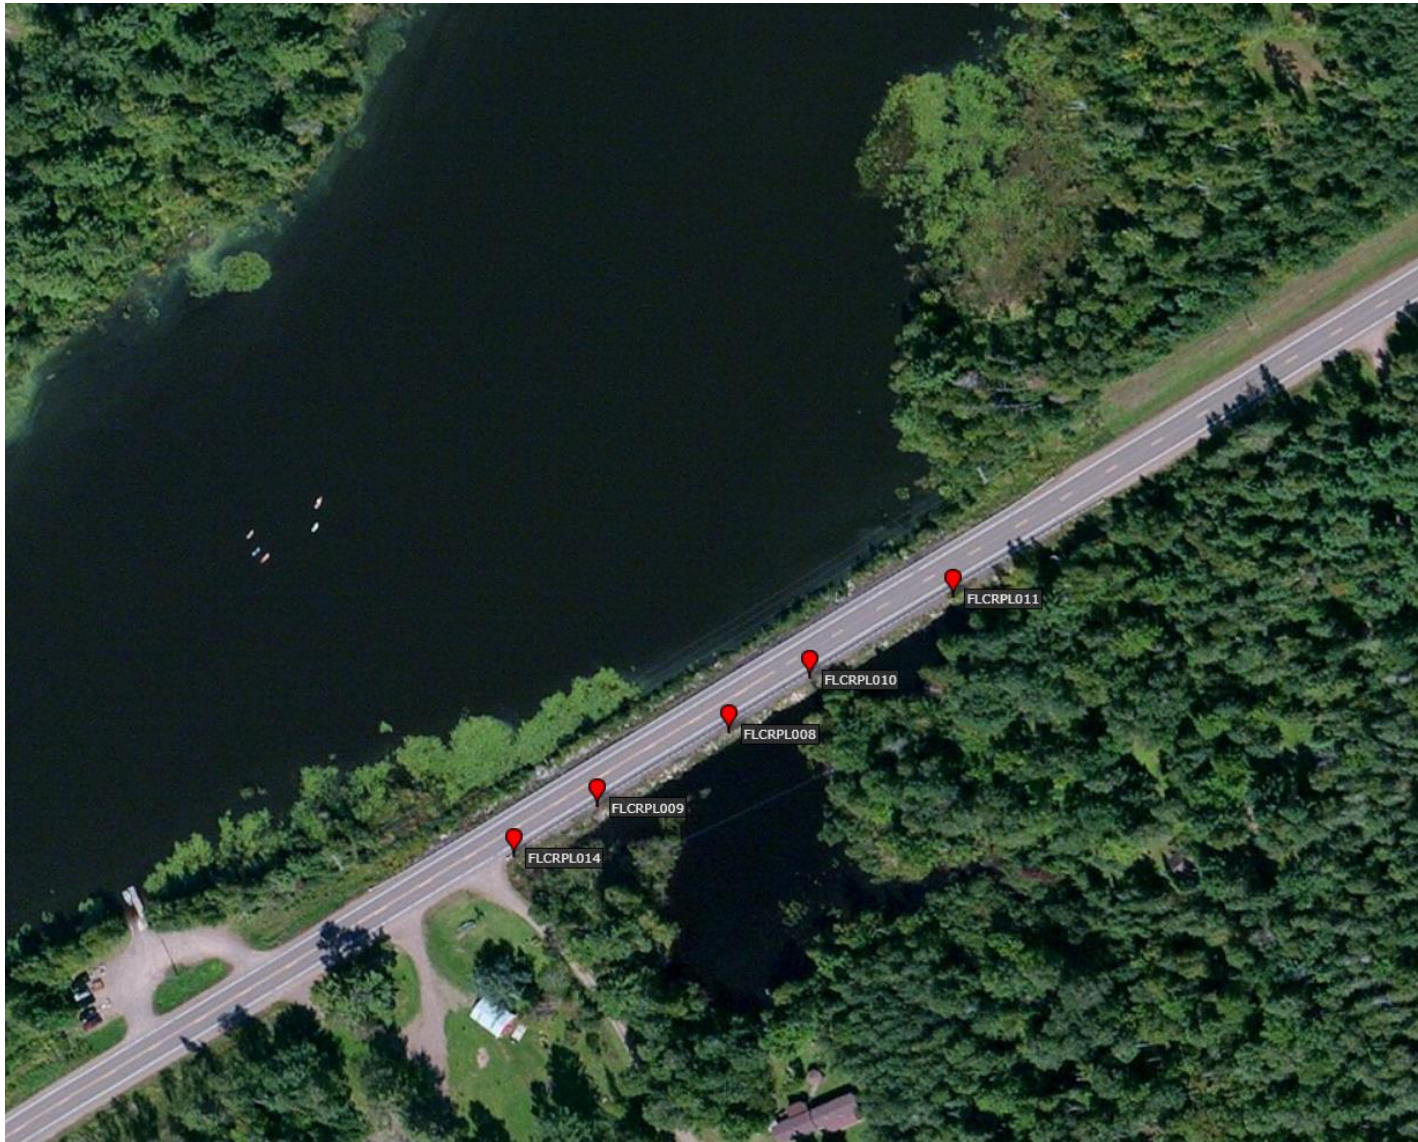
Site CRRL had 20+ plants with no treatment. FLCRPL002 had three plants and could not be reached.

Map 3. Locations of purple loosestrife at Flambeau Crowley in 2021 (Combined to CRRL).

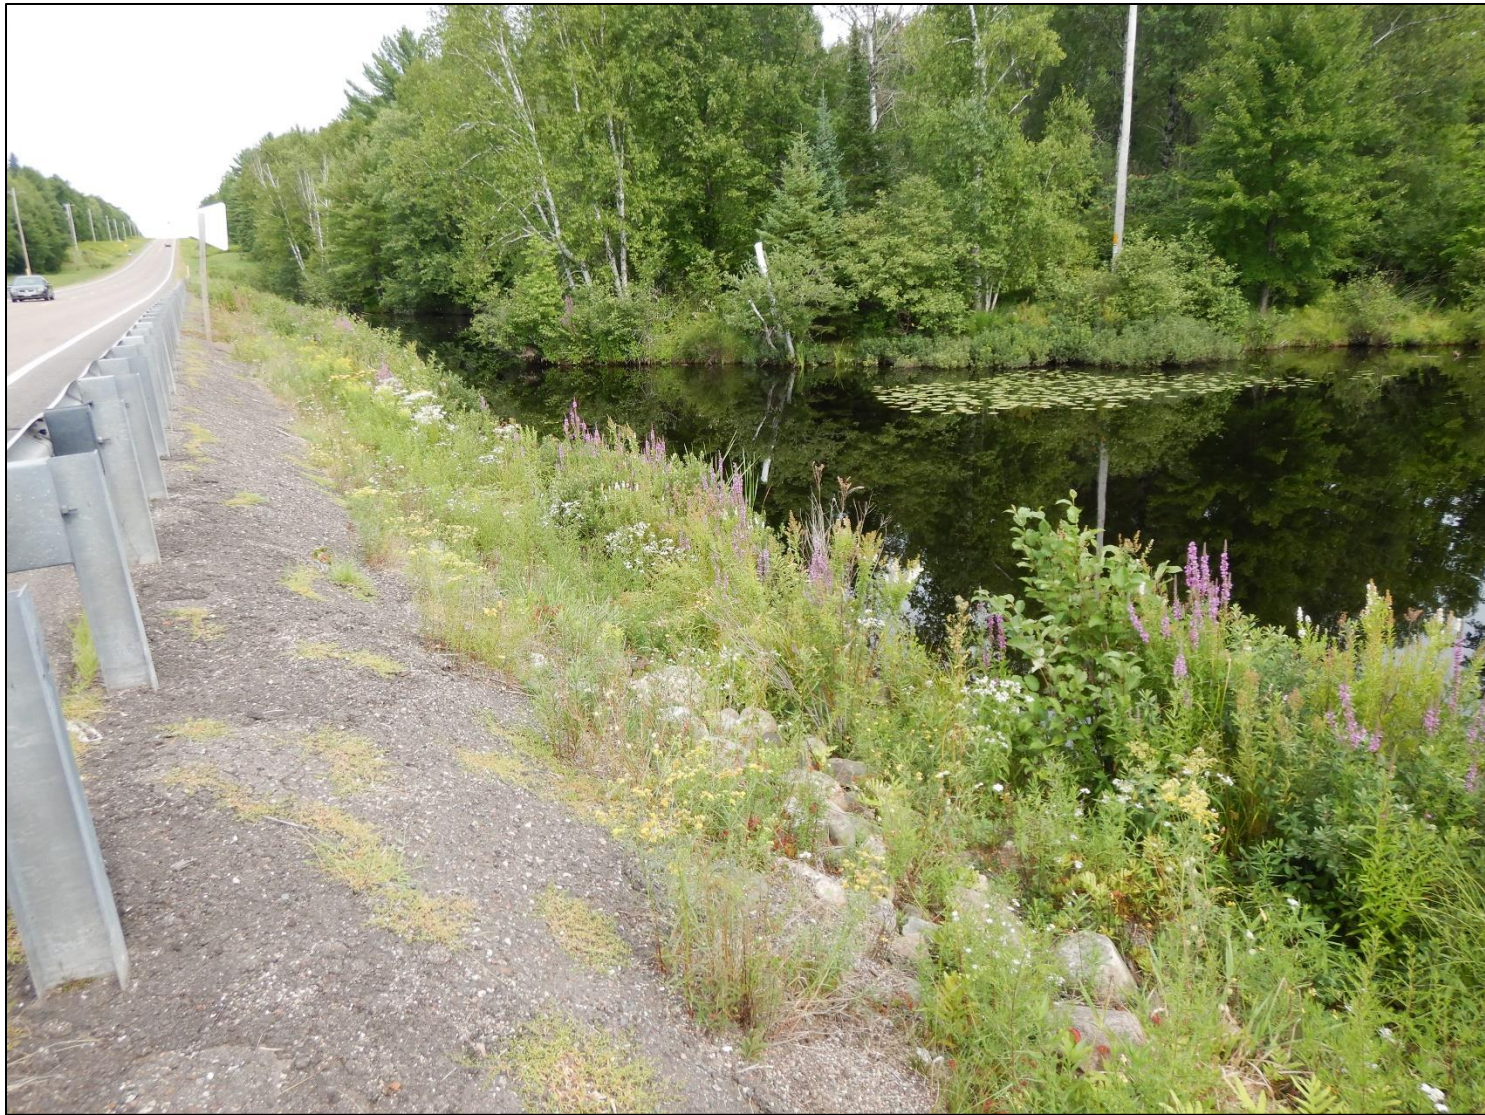
Photo 1. Purple loosestrife growing along roadside (photo from 2020). No hand-pulling same location 2021 (CRRL).

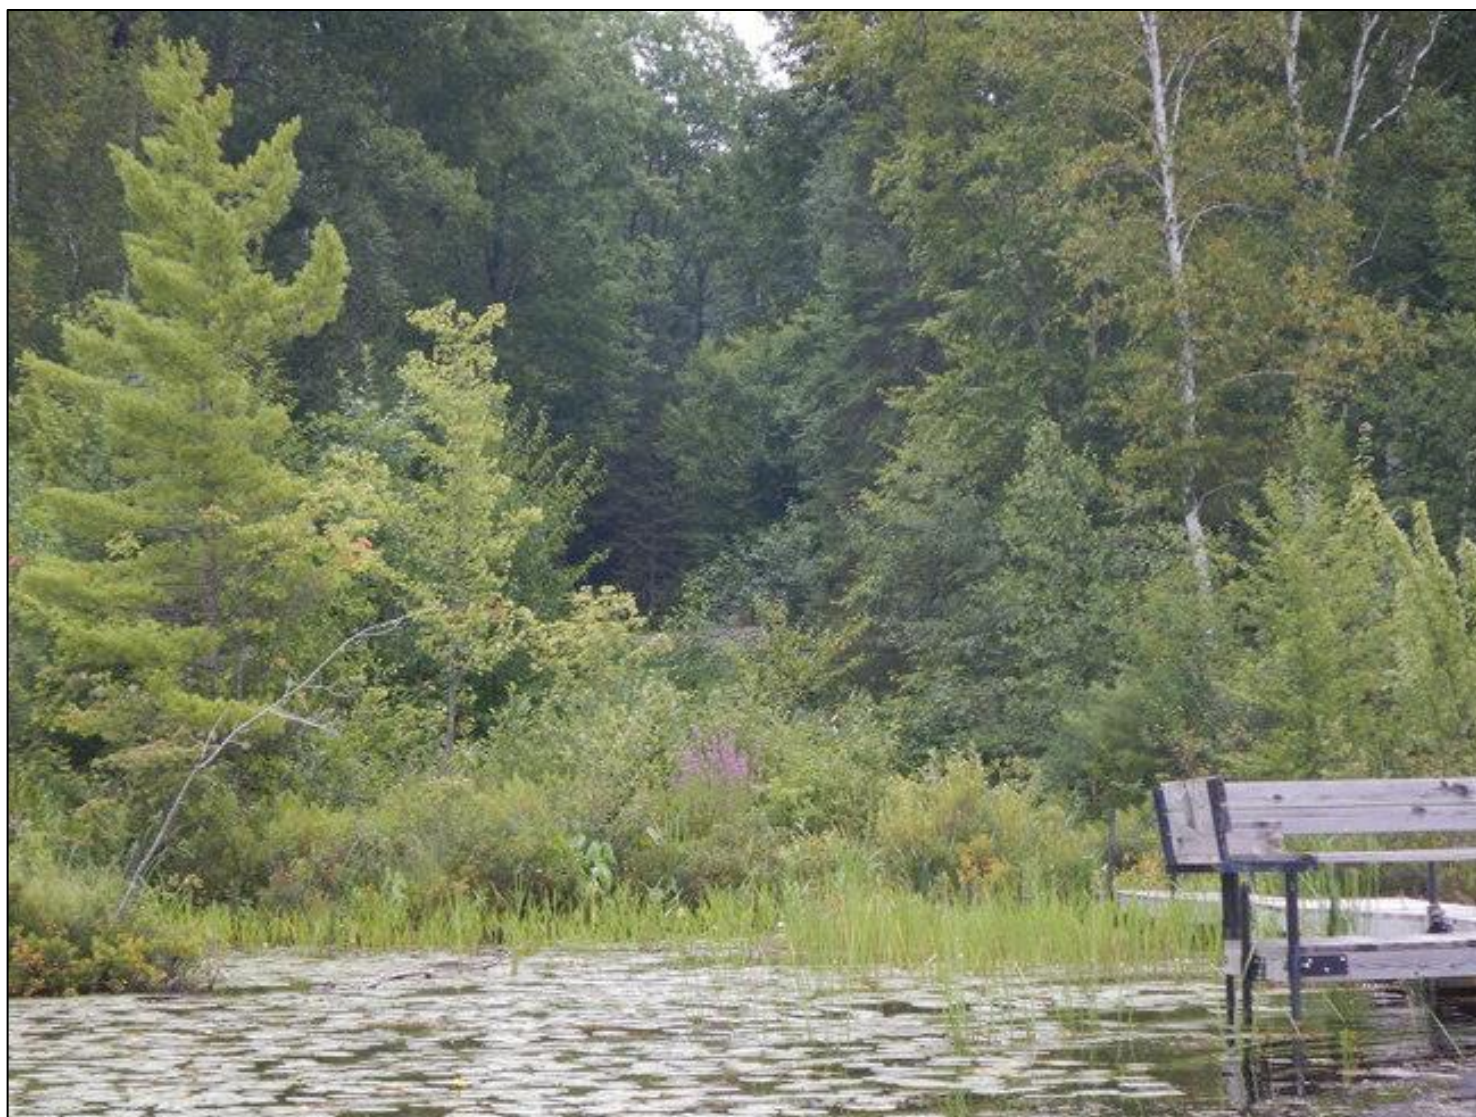
Photo 2. Purple loosestrife growing on wooded bank (CRPL002).
