2021 Purple Loosestrife Inventory
for
Flambeau Lower Hydroelectric Project
FERC Project #2421
Flambeau Hydro, LLC
Price County, Wisconsin

Summary of Purple Loosestrife Inventory for Flambeau Lower Hydroelectric Project, FERC #2421

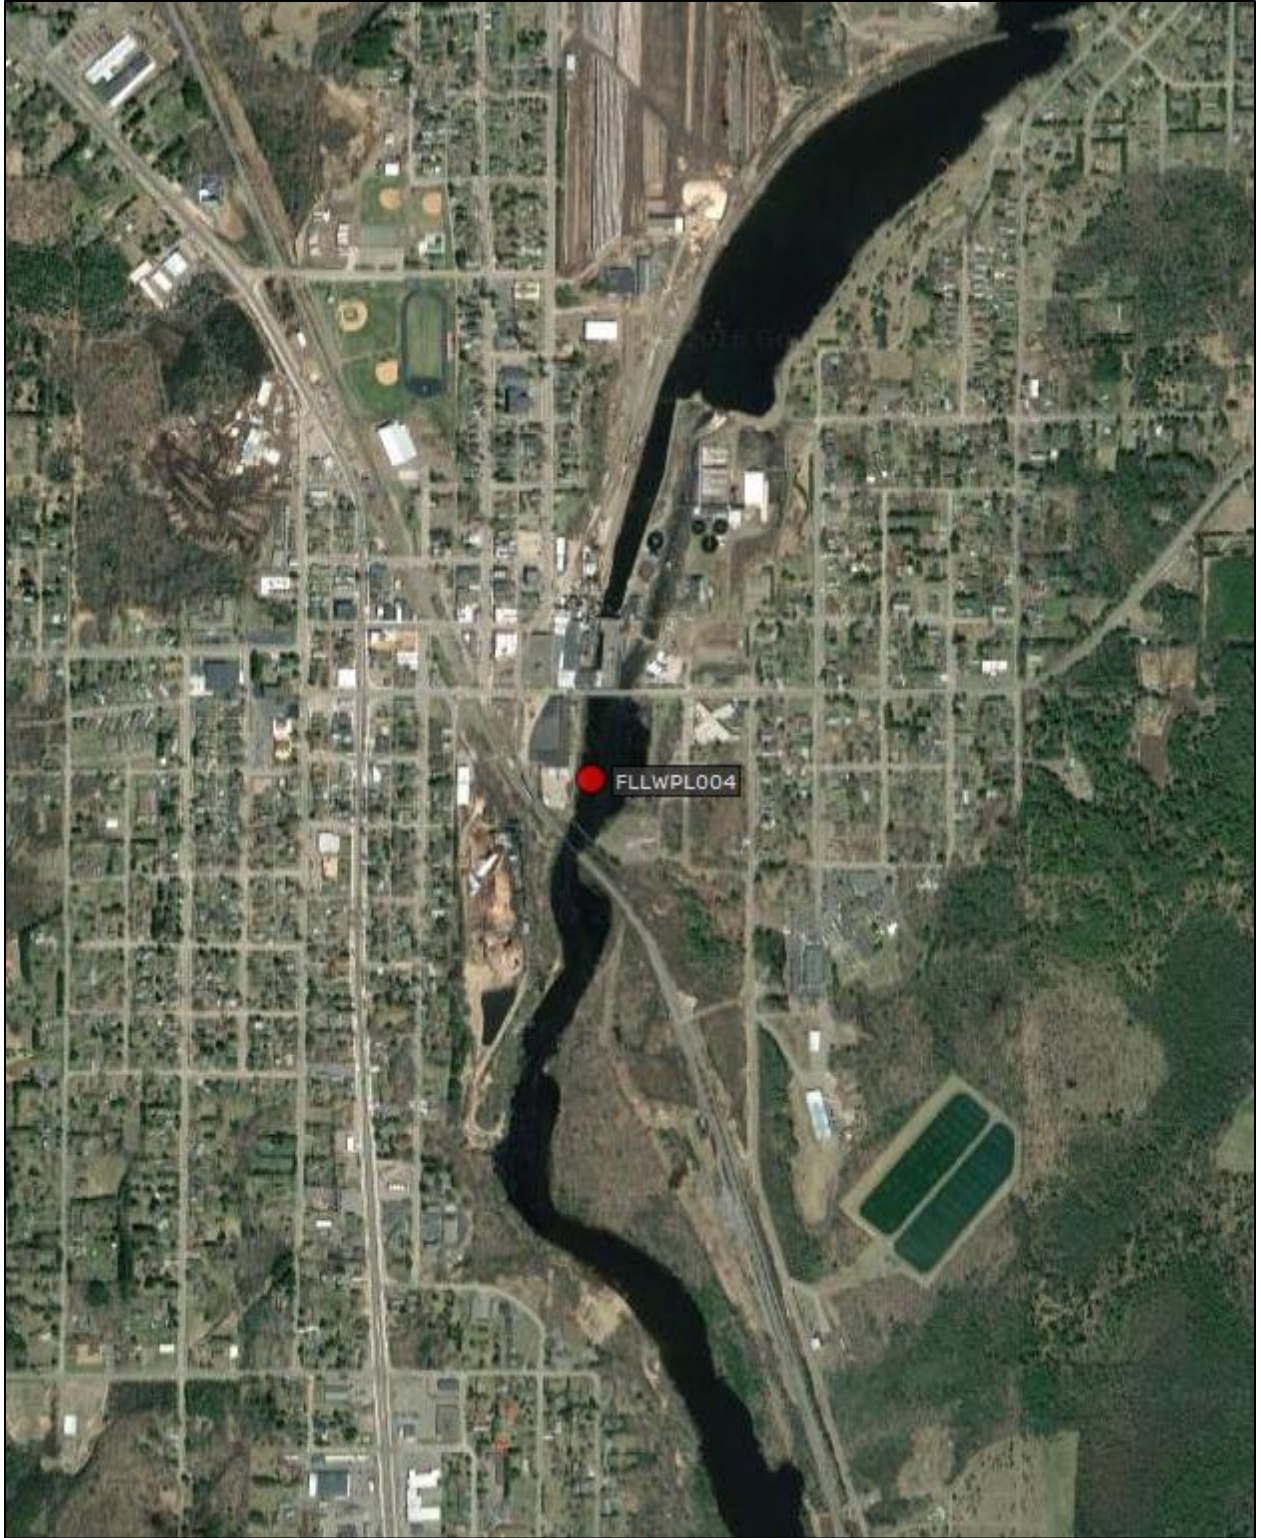
The impoundment was surveyed by boat. One multi-stem purple loosestrife plant was observed and all of the tops were cut off and bagged but the plant roots and stems were too large to remove.

Map 1. Locations of purple loosestrife at Flambeau Lower observed in 2021.

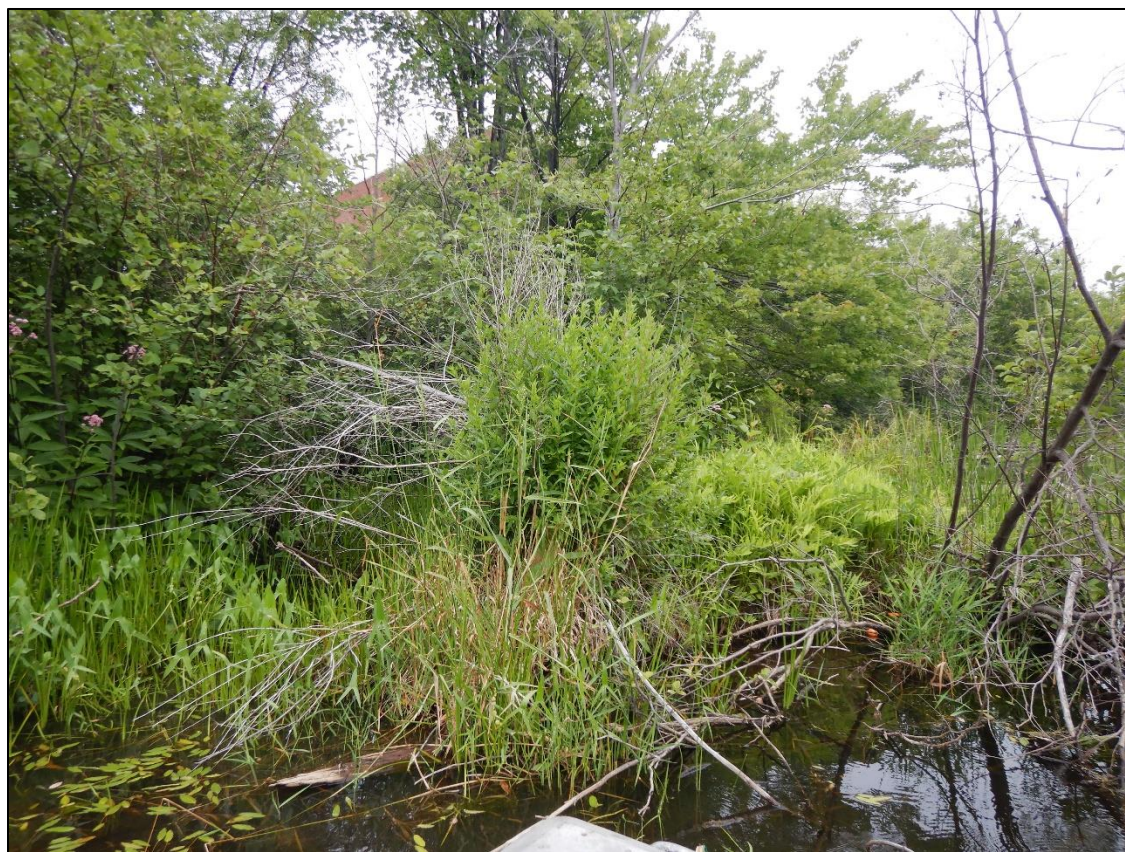
Photo 1. Purple loosestrife growing in wetland area.

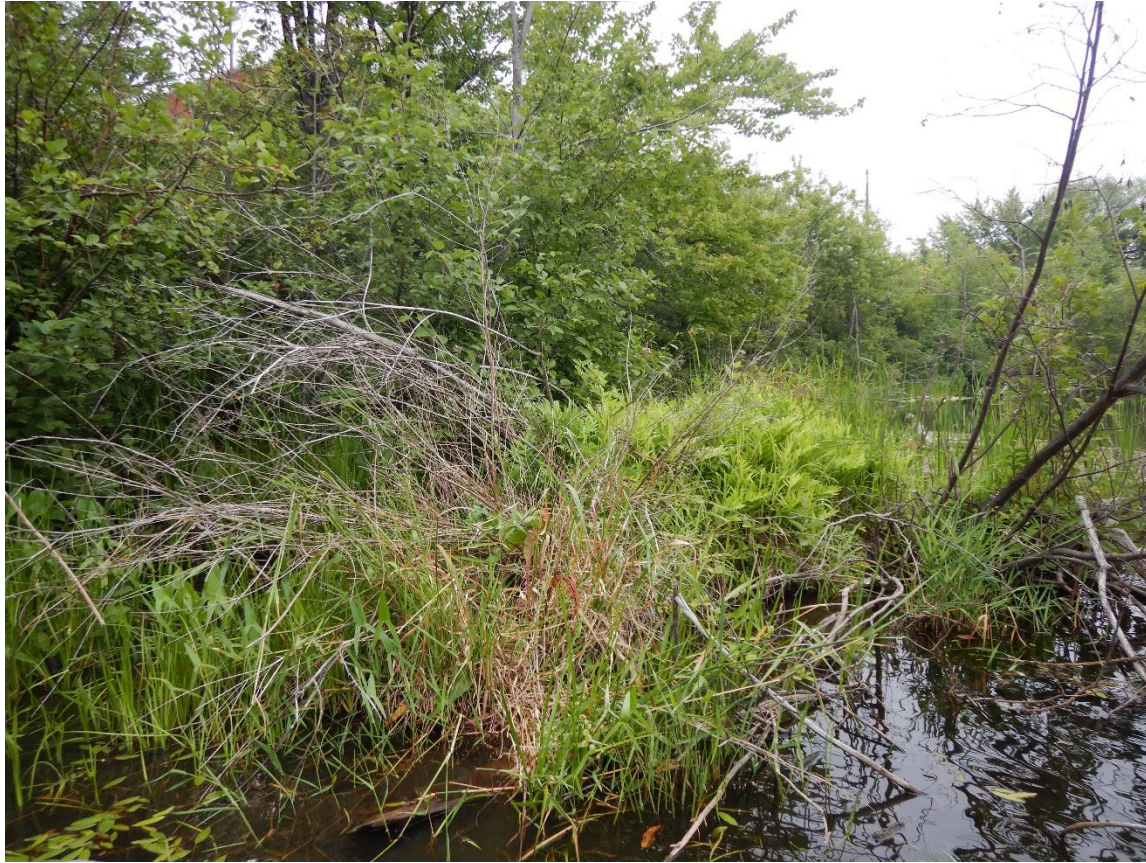
Photo 2. Photo after the stems were cut on the purple loosestrife plant.
