DATE: 4-25-2024 FILE REF: NA

SUBJECT: Puris Proteins, Unnamed Tributary to S. Branch Beaver Brook (WBIC 2624400), Barron County

Summary of recommendations

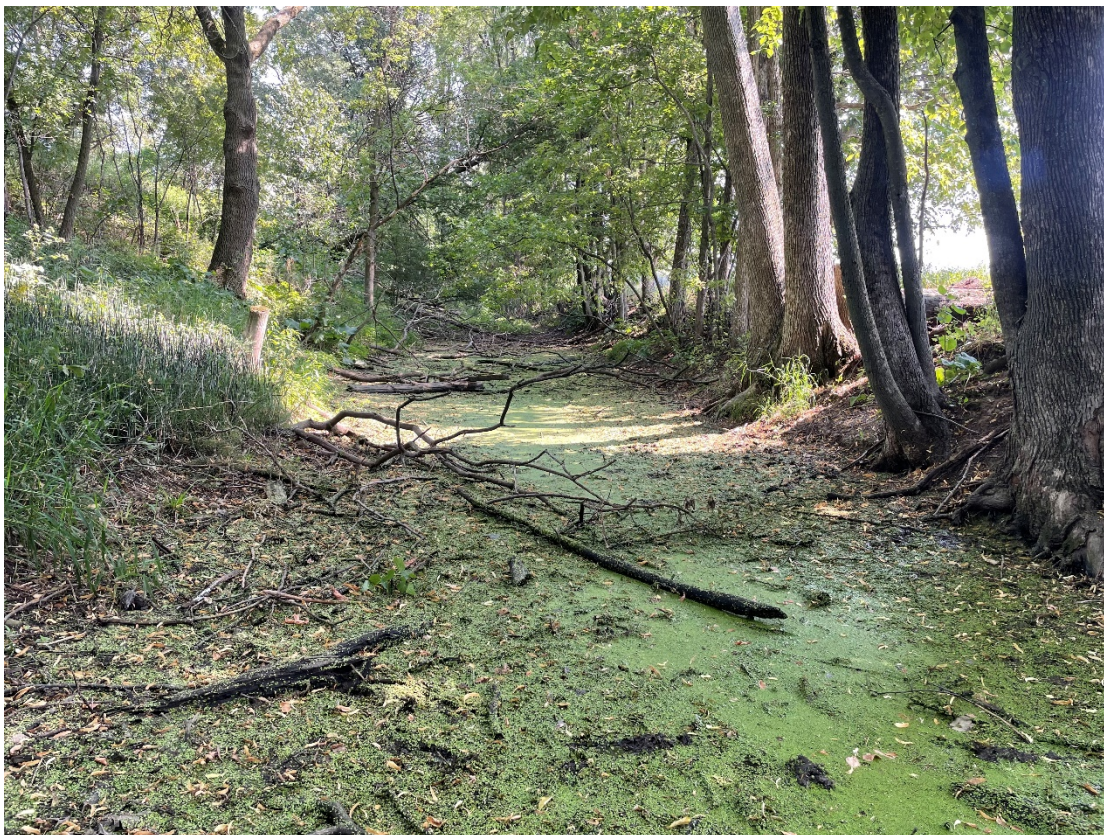
- **Segment 1: Ditch running parallel to Cattail Tail from outfall to confluence with stormwater input**
Near the outfall the ditch has a high amount of vegetation in it, including ferns, shrubs, and herbaceous plants. As water moves west along the ditch, vegetation thins, and plants are restricted to the agricultural field edge and the old railroad embankment that Cattail Trail is on. At this point aquatic duckweed was found on wet mud. Upstream 100m from the confluence the ditch held shallow water. Water became deeper as it approached the confluence. At least 2 other aquatic plants were present in the ditch, and horsetails were growing thickly on the trail embankment up to the top. The ditch channel narrowed as it connected to the stormwater flow coming from under Cattail Trail via a culvert.

Photo 1. Upstream view of Segment 1 above fish survey end.

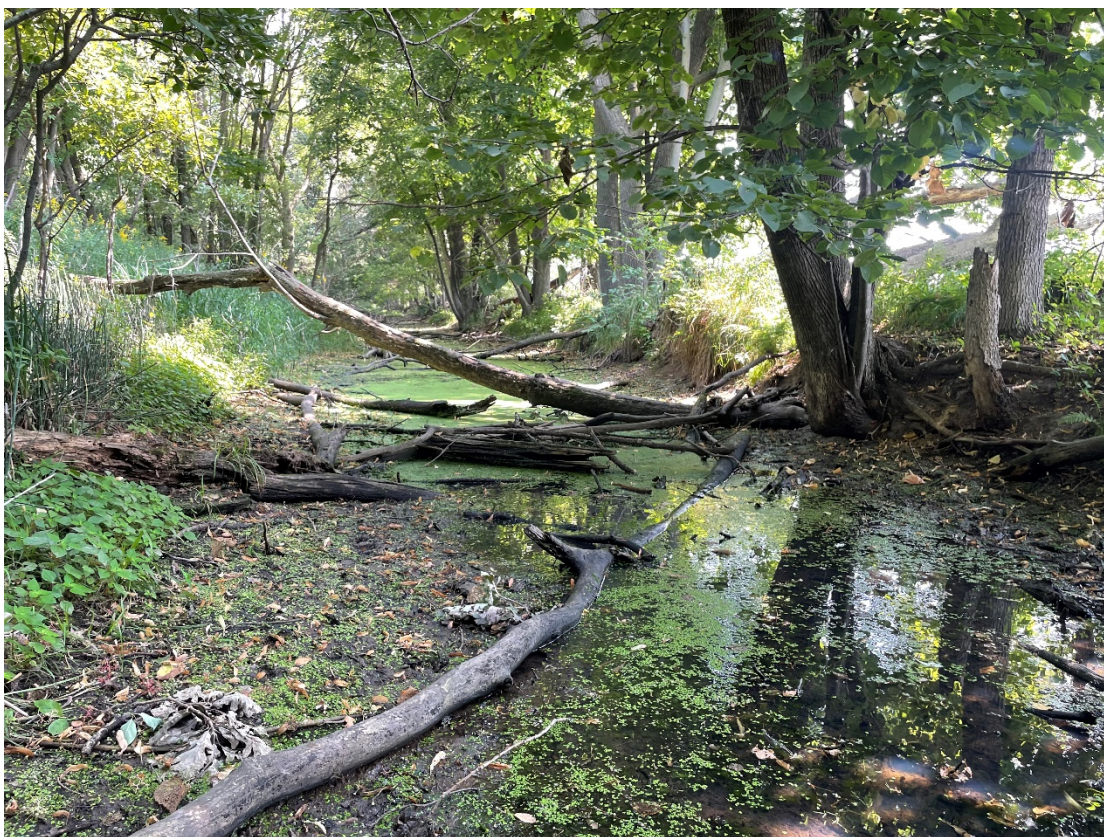
- **Segment 1: Ditch running parallel to Cattail Tail from outfall to confluence with stormwater input**
A fish survey was conducted in the water present from the confluence with the intermittent stream to 100m upstream (Table 1). Ten central mudminnows were captured. Capture was impeded by thick aquatic plants, so more fish could be present than were captured. Abundant macroinvertebrates were observed. The ditch was wide and depth varied along its length with an average depth of 0.5 - 1 foot. The habitat was monotonous and substrate was fine sediments (Table 2). The aquatic plants provided cover for fish and there was some woody debris. Qualitative habitat score was 20.

Photo 2. Upstream view of Segment 1 in fish survey.

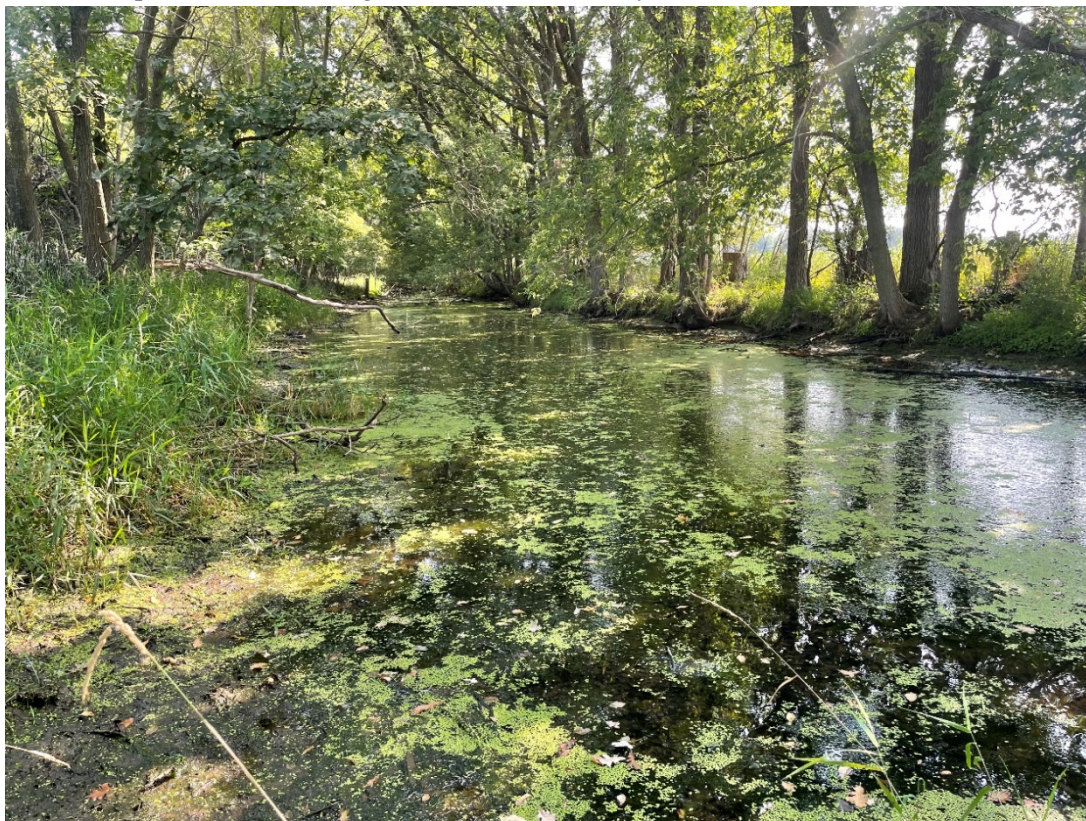
Photo 3. Upstream view of Segment 1 near fish survey start.

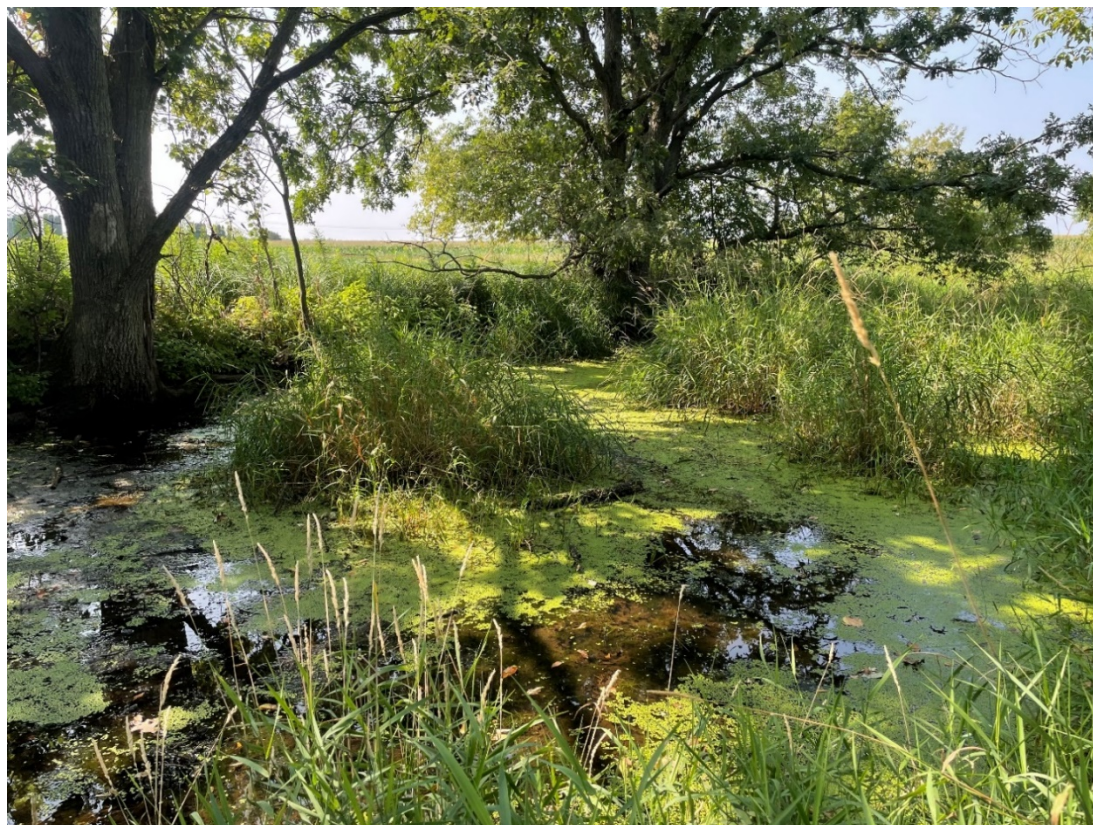
Photo 4. Downstream view of Segment 1 near fish survey start.

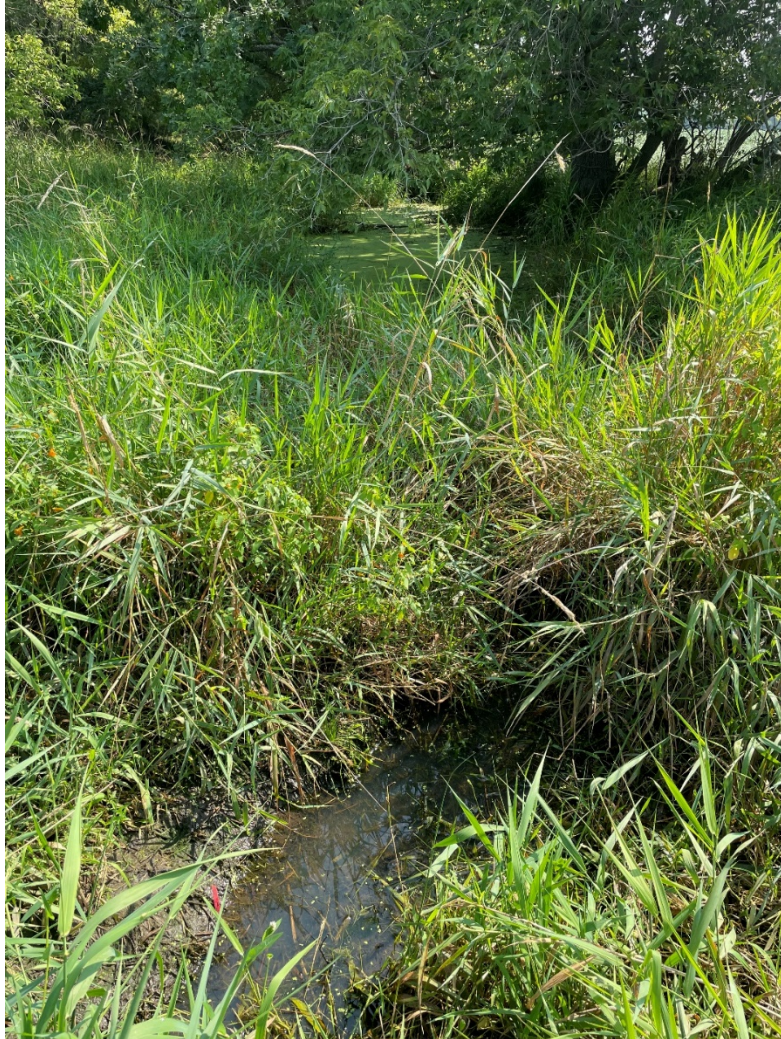
Photo 5. Upstream view of Segment 1 and fish survey start.

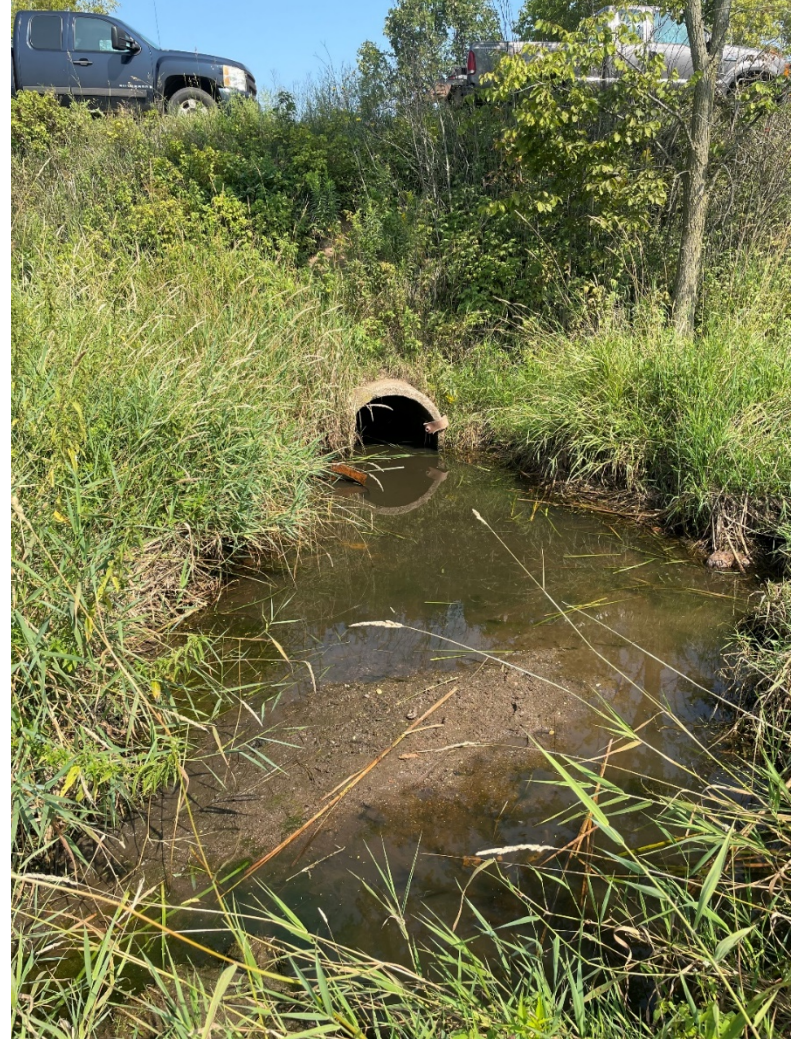
Photo 6. Upstream view of stormwater culvert pool.

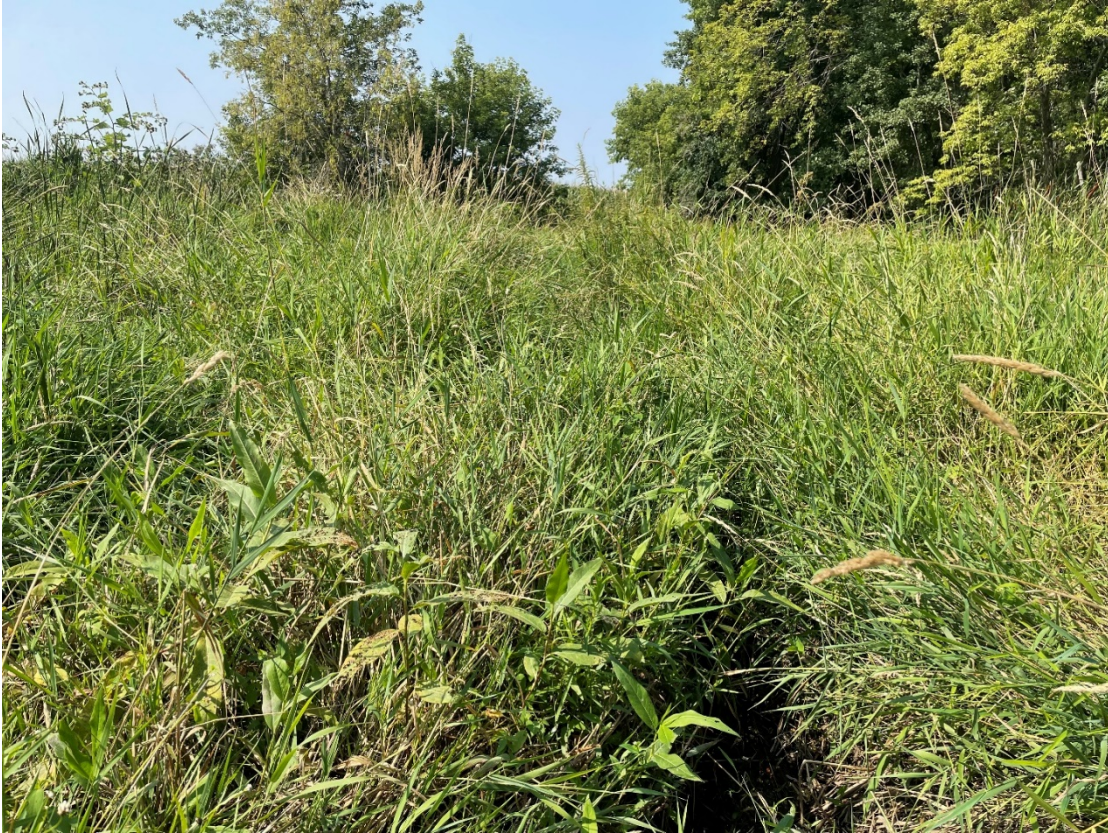
- **Segment 2: Intermittent stream from confluence with stormwater input to S. Branch Beaver Brook**
An intermittent stream formed below the confluence of the stormwater input and the ditch. A meandering channel with thick reed canary grass on the banks went out into an agricultural field. The channel was dry during the site visit but distinct with no vegetation growing in it. Staff did not have permission to enter the agricultural field, so the state of the channel at the confluence with South Branch Beaver Brook is unknown.

Photo 7. Downstream view of intermittent stream downstream of stormwater culvert.

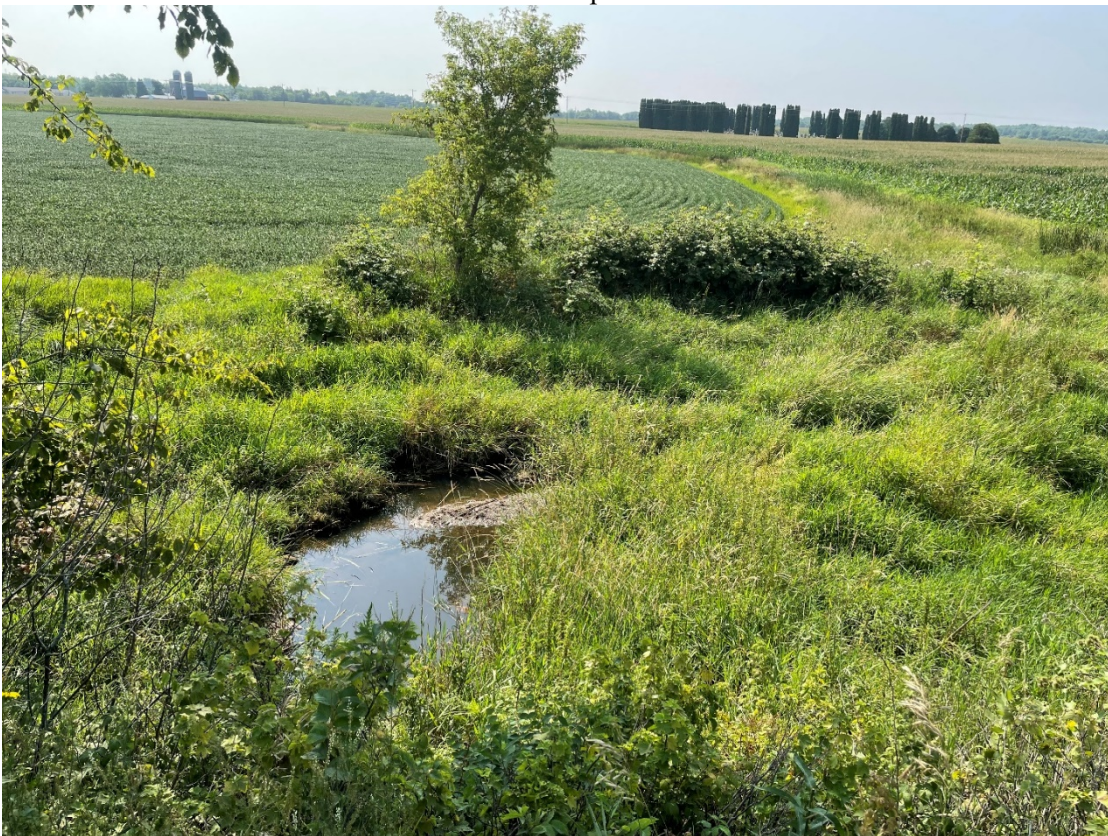
Photo 8. Downstream view of stormwater culvert pool and intermittent stream from Cattail Trail.

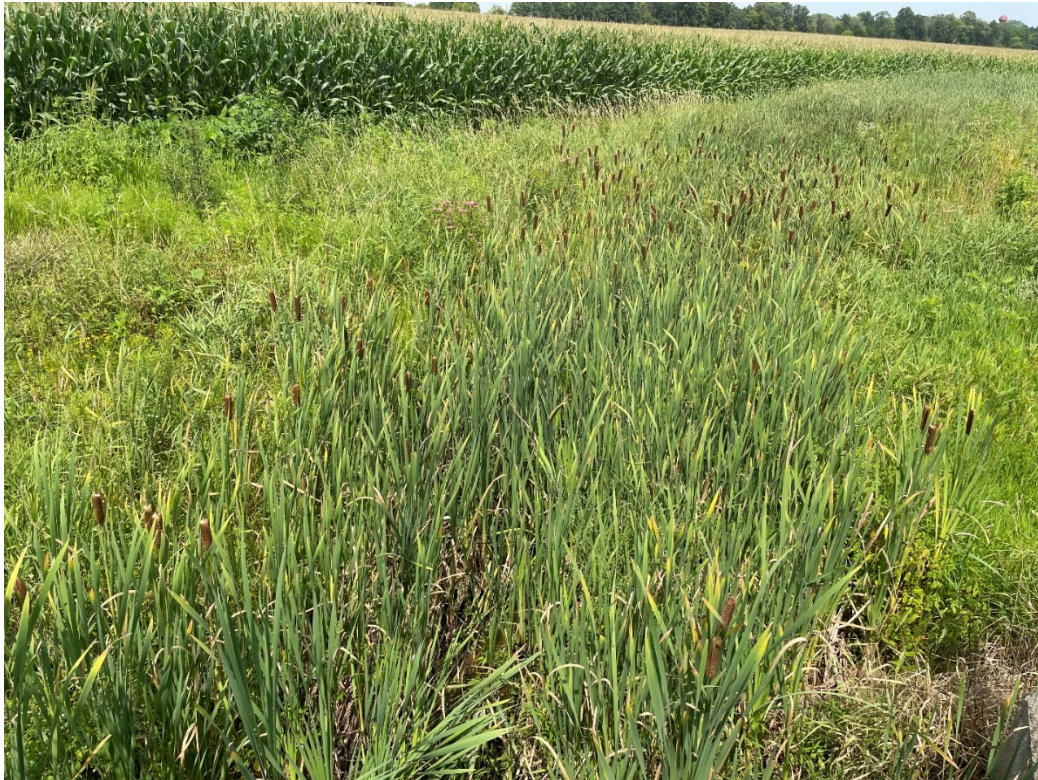
- **Segment 3: South Branch Beaver Brook**
At 125th Avenue, South Branch of Beaver Brook had standing water both upstream and downstream of the crossing on August 1, 2023. Cattails were in the channel upstream. Algae was present in the channel downstream.

Photo 9. Upstream view of S Branch Beaver Brook upstream of 125th Ave.

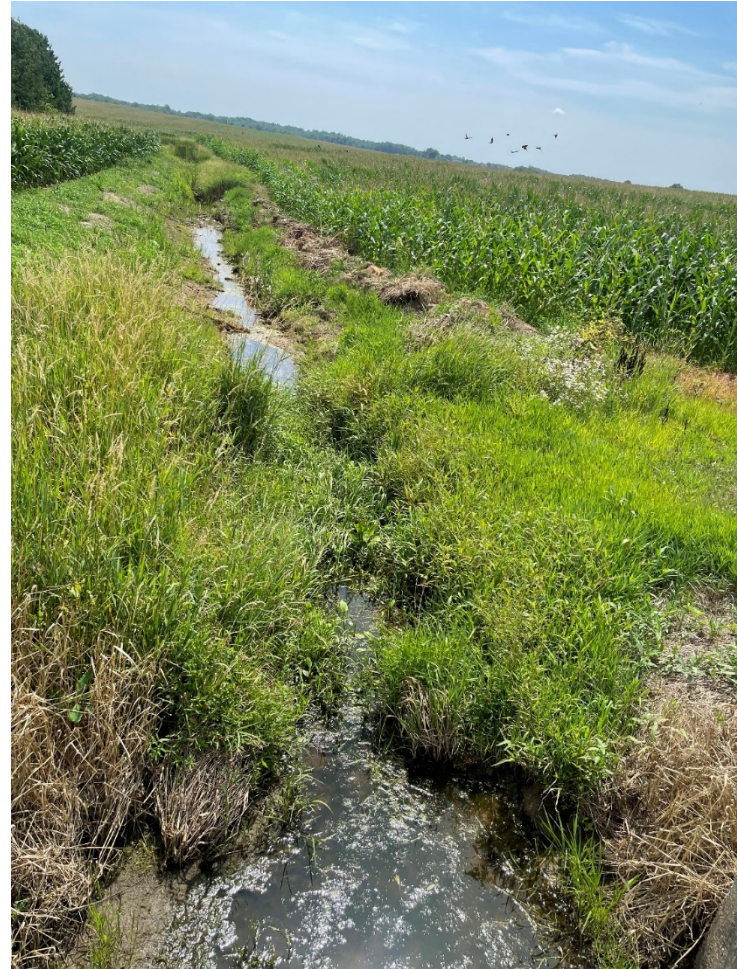
Photo 10. Downstream view of S Branch Beaver Brook downstream of 125th Ave.

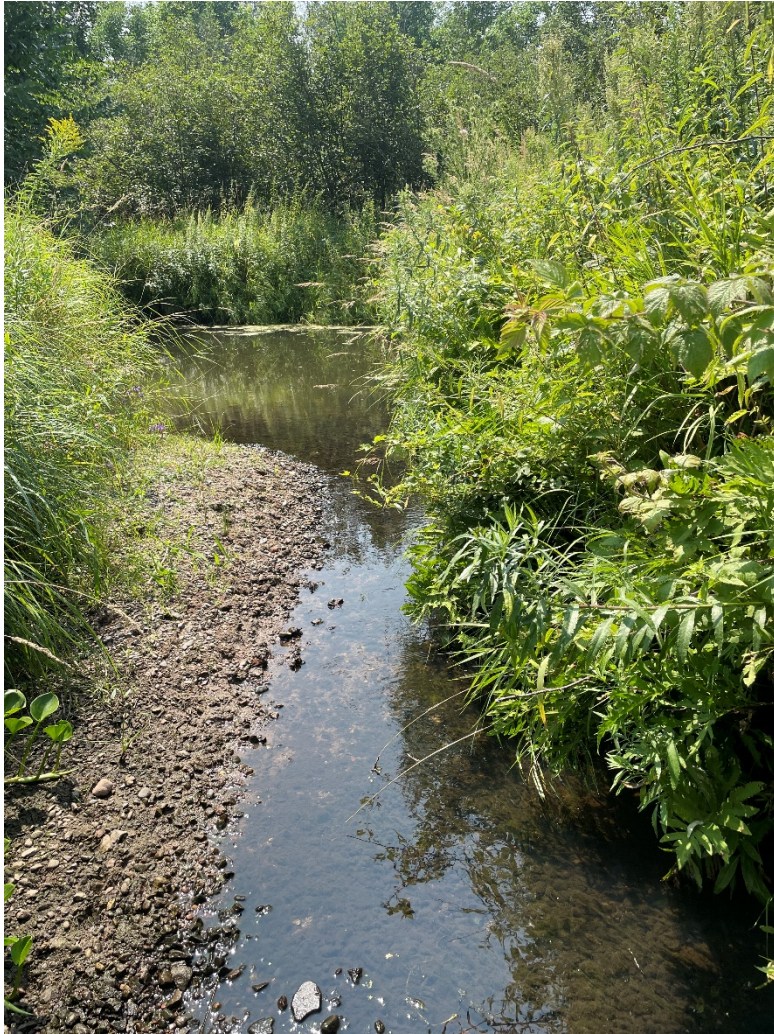
- A 100m survey was conducted ~ 3 mi downstream of 125th Avenue in a perennial stretch of South Branch Beaver Brook to assess the fish community potential of the stream. The survey was done downstream of 25th Street (Table 3). A total of 147 fish were caught of 9 species, including one game fish: northern pike. Thick aquatic vegetation inhibited capture of fish, so more fish were present than what is reported. The stream had good depth with good pool areas, many bends, and undercut banks (Table 4). A diverse aquatic plant community was present. Overall qualitative habitat score was 65. A natural community verification could not be done on this survey with the high number of tolerant species. The observed fish community is typical of a cool-warm headwater. However, a cool-cold community as modeled may be possible if land use practices improved.

Photo 11. S. Branch of Beaver Brook looking upstream at fish survey end.

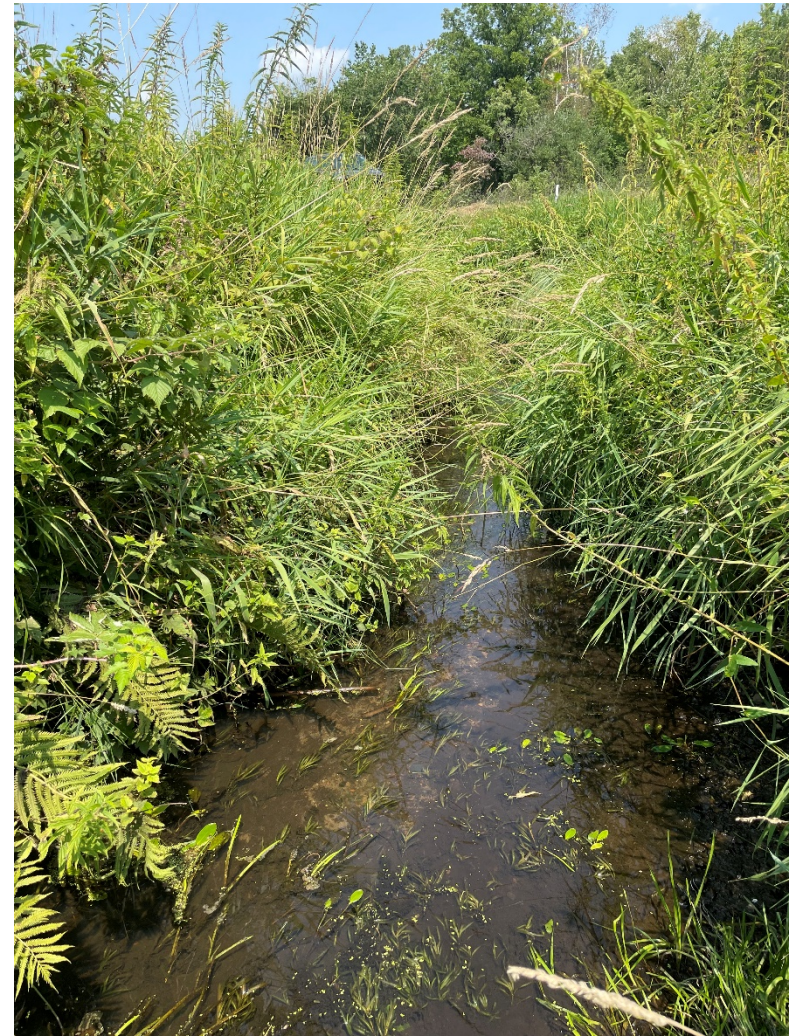
Photo 12. S. Branch of Beaver Brook looking downstream in fish survey.
