Curly-leaf pondweed Density and Bed Mapping, and Warm Water Point Intercept Macrophyte Surveys Long Lake - Washburn County, WI (WBIC: 2106800)

Survey Conducted by and Report Prepared by: Endangered Resource Services, LLC Matthew S. Berg, Research Biologist St. Croix Falls, Wisconsin May 26, June 4-5, 11, and July 27-31, 2011

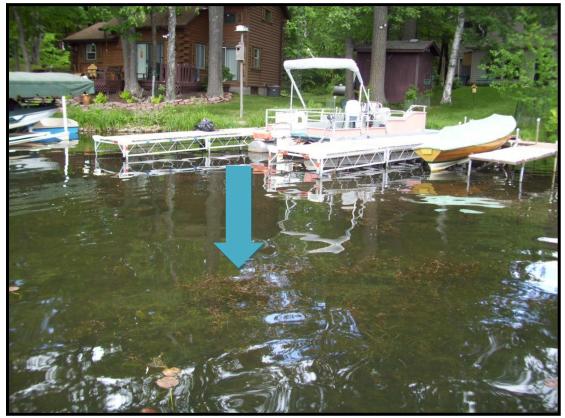
Figure 5: Canopied CLP Plants in Bed 2 South of Holy Island

**Bed 2** – Located just west of the road to Holy "Island", Bed 2 had low to moderate densities of plants that were canopied in 3-5ft of water. The area barely qualified as a bed as CLP was not more than 50% of the plant community. A local resident we spoke to was concerned about plant growth and said plants (CLP?) historically has canopied throughout the entire area (Figure 5).

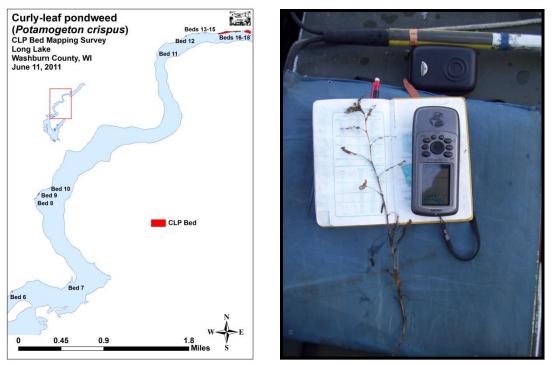
Figure 6: CLP Map of Beds 7-18 and Mature CLP with Turion in Bed 7

**Bed 7** – This area occurred in front of a narrow inlet that led to several residences. We noted most CLP was canopied, but the total population was likely <100 plants. Because it occurred in low densities and appeared to be "just another plant" in the macrophyte community, this area may have been better described as a High Density Area. Plants had already set turions (Figure 6).

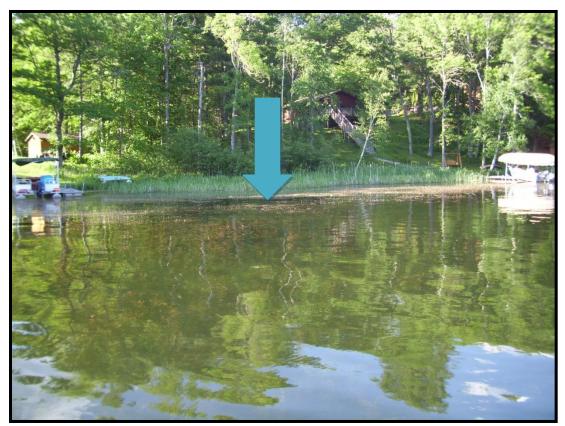
Figure 7: Canopied CLP in Bed 16 West of the Narrows

**Bed 16** – Stretching from approximately 400 yards down the shoreline, Bed 16 was monotypic, dense, and canopied on the inner half before becoming fragmentary and mixed with natives (primarily Coontail (*Ceratophyllum demersum*), Common waterweed (*Elodea canadensis*), Large-leaf pondweed (*Potamogeton amplifolius*), Fries pondweed (*Potamogeton friesii*), Clasping-leaf pondweed (*Potamogeton richardsonii*), and Flat-stem pondweed (*Potamogeton zosteriformis*)) on the outer half (Figure 7). The bed was likely an annoyance to local residents, but, due to its narrow nature, they probably would have had to clear their props only once to get to deeper water.

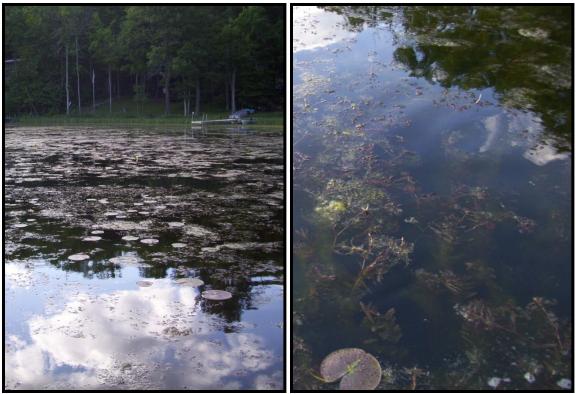
Figure 8: CLP Bed 17 West of the Narrows

**Bed 17** – Located near Duffy's boat-up bar, Bed 17 was easily the worst CLP area on the lake. The bed was 120 yards long by 60 yards wide and was a rake fullness of 3 throughout. We noted numerous prop trails throughout the bed, and boaters likely had to clear their motors several times to navigate through the area. Other than CLP, White water lily (*Nymphaea odorata*) and blobs of filamentous algae were the only other common plants we documented (Figure 8).

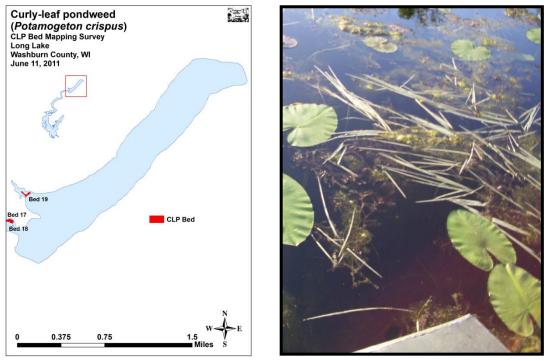
Figure 9: CLP Map of Beds 17-19 and Rice/CLP in Bed 19

**Bed 19** – Located in the bay just around the corner from/north of the Narrows boat landing, Bed 19 barely qualified as a bed as the CLP was highly fragmented. Rake fullness values were also highly variable from <1-3 with the majority of areas rating a 1. Northern wild rice (*Zizania palustris*), Spatterdock (*Nuphar variegata*), and blobs of filamentous algae were mixed in throughout the area (Figure 9).

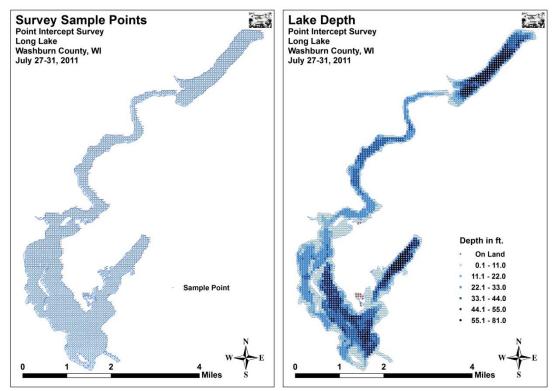
Figure 10: Survey Sample Points and Lake Depth

Depth soundings taken at Long Lake's 2,128 accessible survey points revealed both the northeast bay and the "thumb" were classic glacial lake areas with deep trenches and rapid drop-offs from shore. The channel region was also generally trench-like with sharp drop-offs, but the main basin had highly variable underwater topography with many bars projecting from shore, as well as several sunken islands (Figure 10) (Appendix V).

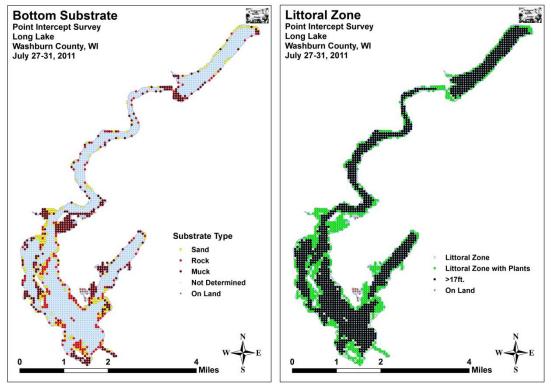
Figure 11: Bottom Substrate and Littoral Zone

Of the 698 survey points where we could determine the substrate, 46.4% were muck, 27.0% were rock, and 26.6% were pure sand. Nutrient rich organic muck dominated the lake bottom in shallow side bays while sandy muck was common in deeper areas with limited plant growth. The lake shore was extremely variable, but we found most locations were some combination of sand and rock. In the main basin, most of the exposed points, bars, and islands were also sandy or rocky in nature (Figure 11). We found plants growing at 584 sites or approximately 27.4% of the entire lake bottom and in 84.8% of the littoral zone. Despite a lake wide littoral upper limit of 17.0ft, most plant growth ended in 14.0ft of water (Figure 11) (Table 2) (Appendix V).

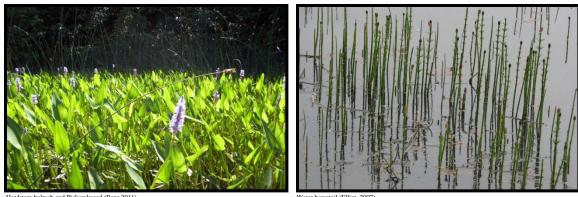
Hardstem bulrush and Pickerelweed (Berg 2011)

Over firm sand and gravel, Hardstem bulrush (*Schoenoplectus acutus*), Water horsetail (*Equisetum fluviatile*), Pickerelweed (*Pontederia cordata*), and Common bur-reed (*Sparganium eurycarpum*) were common species. They were replaced by Softstem bulrush (*Schoenoplectus tabernaemontani*) and Cattails (*Typha* spp.) in areas that had firm nutrient rich organic muck. In shallow boggy bay areas with stumps, Northern wild rice, Bald spikerush (*Eleocharis erythropoda*), Wild calla (*Calla palustris*), Short-stemmed bur-reed (*Sparganium emersum*), and tussocks of sedge (*Carex* spp.) were the most common emergent species.

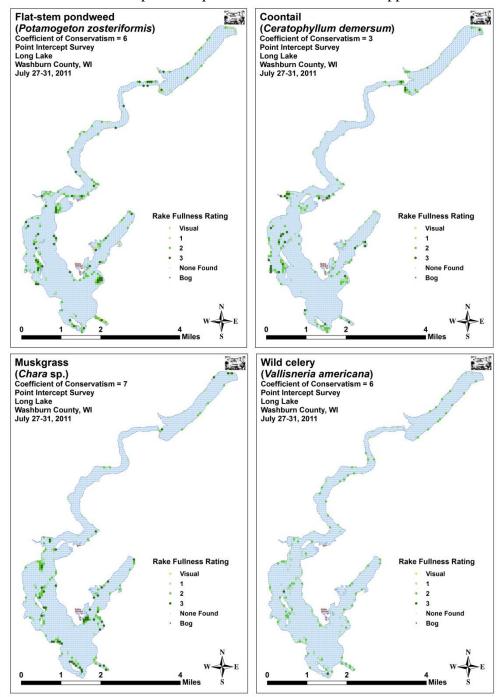
Figure 13: Long Lake's Most Common Macrophyte Species

When considering all the plants on the lake, Flat-stem pondweed, Coontail, Muskgrass, and Wild celery were the most common macrophyte species being found at 42.64%, 40.24%, 33.22%, and 31.34% of survey points with vegetation (Table 3) (Figure 13). Together, they combined for a very low 37.91% of the total relative frequency which indicated a high level of evenness in the plant community (Normally the top four species in a lake are >50%). Fries' pondweed (7.35), Northern water milfoil (6.25), Slender naiad (5.15), and Common waterweed (5.06) were the only other species with a relative frequency over 5.0 (Species accounts and distribution maps for all plants found are located in Appendices VII and VIII).

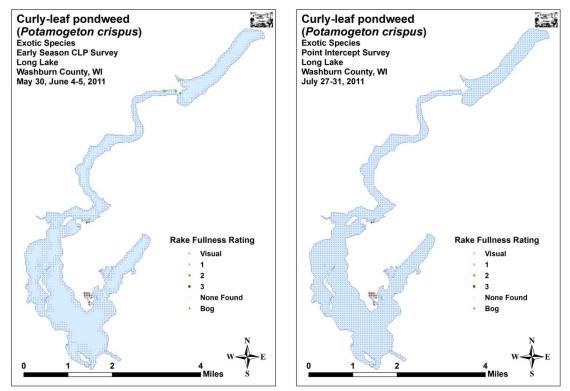
Figure 14: Long Lake's May-June/July CLP Distribution and Density

We did NOT find any evidence of Eurasian water milfoil in Long Lake during the May/June Curly-leaf pondweed surveys or the July full point intercept survey. By July, the limited amount of CLP we had seen in May and June had almost entirely senesced as we found a single CLP plant at each of only three points (Figure 14).

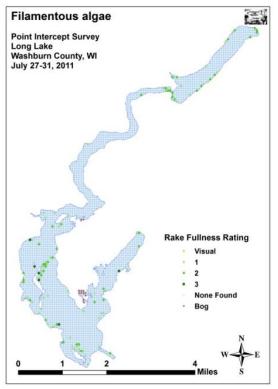
Figure 16: Long Lake's July Filamentous Algae Distribution and Density

We located filamentous algae at 107 sites throughout Long Lake. It was present at approximately 18% of sites with vegetation and had an average rake fullness value of 1.54. With the exception of the muck bottomed bay located at the Mud Lake Channel Outlet, almost all of these sites were located in front of residences (Figure 16). Normally, these algae proliferate in environments where there are excessive nutrients in the water.

Long Lake currently has generally good water clarity, but the presence of scattered patches of thick filamentous algae along stretches of the lake's more developed shorelines indicate there is still room for improvement. Even if some of these nutrients are coming from internal sediment loading/recycling, or some other source beyond the lake owners' control, anything residents can do to limit nutrient input into the system could help further improve water clarity and quality.

Continually educating lake residents about reducing nutrient input directly along the lake is one of the easiest ways to decrease algal growth and improve water clarity. Not mowing down to the shoreline, bagging grass clippings, switching to a phosphorus-free fertilizer or eliminating fertilizer altogether would all be positive steps towards this end. Wherever possible, restoring shorelines, constructing rain gardens and creating buffer strips of native vegetation would also enhance water quality by preventing erosion and runoff. We consistently noted that property owners that implemented at least some of these conservation measures had improved water quality/clarity in front of their residences while owners who did not had noticeably higher filamentous algae growth (Figure 19). Hopefully, a greater understanding of how individual property owners can have lakewide impacts will result in more people taking appropriate conservation actions to ensure improved water quality for all.

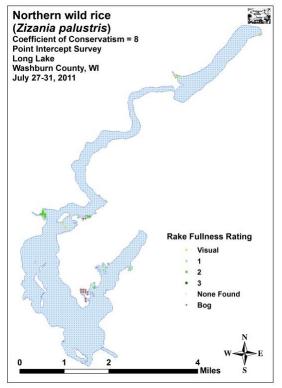
Figure 17: Long Lake's July Northern Wild Rice Distribution and Density

Northern wild rice, a plant of significant wildlife and cultural value, was widely scattered throughout Long Lake. We found most rice plants were growing in creek and seep inlets as well as in sheltered muck bottomed bays; especially those that had stump fields (Figure 17). Lakewide, it was present in the rake at 20 points. Of these, none had a rake fullness value of 3, eight were a 2, and the rest were a one. We also recorded rice as a visual at six additional points. With the possible exception of the bed that was established in the inlet of the unnamed creek that drains the Devils/Twin Lakes System, most rice was extremely patchy and not fit for harvest (Figure 18).

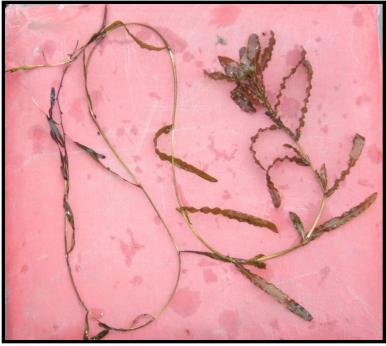
**Curly-leaf pondweed**

**DESCRIPTION:** Curly-leaf pondweed is an invasive aquatic perennial that is native to Eurasia, Africa, and Australia. It was accidentally introduced to United States waters in the mid-1880s by hobbyists who used it as an aquarium plant. The leaves are reddishgreen, oblong, and about 3 inches long, with distinct wavy edges that are finely toothed. The stem of the plant is flat, reddish-brown and grows from 1 to 3 feet long. The plant usually drops to the lake bottom by early July

**LIFE HISTORY AND EFFECTS OF INVASION:** Curly-leaf pondweed spreads through burr-like winter buds (turions), which are moved among waterways. These plants can also reproduce by seed, but this plays a relatively small role compared to the vegetative reproduction through turions. New plants form under the ice in winter, making curly-leaf pondweed one of the first nuisance aquatic plants to emerge in the spring.

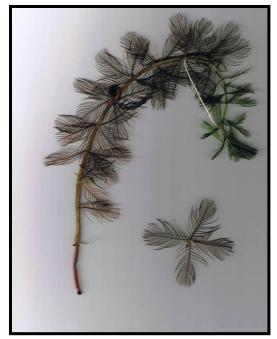
**Eurasian water milfoil**

**DESCRIPTION:** Eurasian water milfoil is a submersed aquatic plant native to Europe, Asia, and northern Africa. It is the only non-native milfoil in Wisconsin. Like the native milfoils, the Eurasian variety has slender stems whorled by submersed feathery leaves and tiny flowers produced above the water surface. The flowers are located in the axils of the floral bracts, and are either four-petaled or without petals. The leaves are threadlike, typically uniform in diameter, and aggregated into a submersed terminal spike. The stem thickens below the inflorescence and doubles its width further down, often curving to lie parallel with the water surface. The fruits are four-jointed nut-like bodies. Without flowers or fruits, Eurasian water milfoil is nearly impossible to distinguish from Northern water milfoil. Eurasian water milfoil has 9-21 pairs of leaflets per leaf, while Northern milfoil typically has 7-11 pairs of leaflets. Coontail is often mistaken for the milfoils, but does not have individual leaflets.

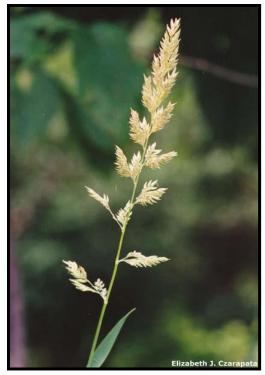
**Reed canary grass**

**DESCRIPTION:** Reed canary grass is a large, coarse grass that reaches 2 to 9 feet in height. It has an erect, hairless stem with gradually tapering leaf blades 3 1/2 to 10 inches long and 1/4 to 3/4 inch in width. Blades are flat and have a rough texture on both surfaces. The lead ligule is membranous and long. The compact panicles are erect or slightly spreading (depending on the plant's reproductive stage), and range from 3 to 16 inches long with branches 2 to 12 inches in length. Single flowers occur in dense clusters in May to mid-June. They are green to purple at first and change to beige over time. This grass is one of the first to sprout in spring, and forms a thick rhizome system that dominates the subsurface soil. Seeds are shiny brown in color.

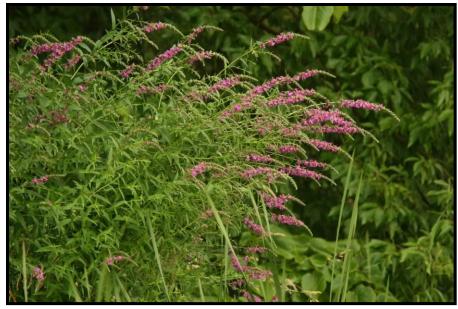
**Purple loosestrife** (Photo Courtesy Brian M. Collins)

**DESCRIPTION:** Purple loosestrife is a perennial herb 3-7 feet tall with a dense bushy growth of 1-50 stems. The stems, which range from green to purple, die back each year. Showy flowers vary from purple to magenta, possess 5-6 petals aggregated into numerous long spikes, and bloom from July to September. Leaves are opposite, nearly linear, and attached to four-sided stems without stalks. It has a large, woody taproot with fibrous rhizomes that form a dense mat.
