# Butternut and Franklin Lakes

Forest County, Wisconsin

## Comprehensive Management Plan

February 2014

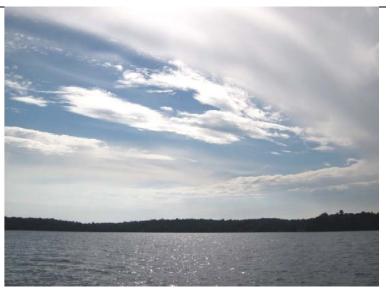
Photograph 1.0-1 Butternut Lake, Forest County

The western, open basin of Butternut Lake is characterized by a sandy/rock substrate with steep drop-offs. The eastern and southern bay contain more optimal conditions for aquatic plant growth, as well as locations of coarse woody habitat, an important habitat variable for aquatic organisms. Excellent water clarity observed during field work.

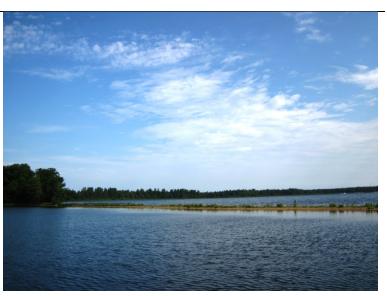
Photograph 1.0-2 Franklin Lake, Forest County

The lake's western lobe is primarily shallow, with organic substrates and abundant aquatic plant growth. In contrast, the northern/eastern lobe achieves depths of up to 46 feet, and is predominantly sandy in the littoral zone. Signs of lower water level apparent. Excellent water clarity observed during field work.

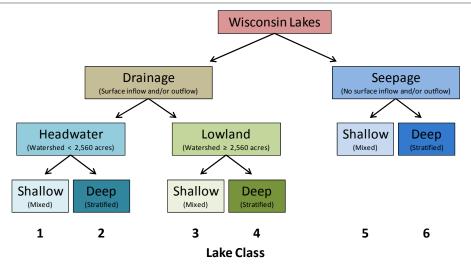
**Figure 3.1-1. Wisconsin Lake Classifications.** Butternut Lake and Franklin Lake are classified as deep (stratified), lowland drainage lakes (Class 4). Adapted from WDNR (2009).

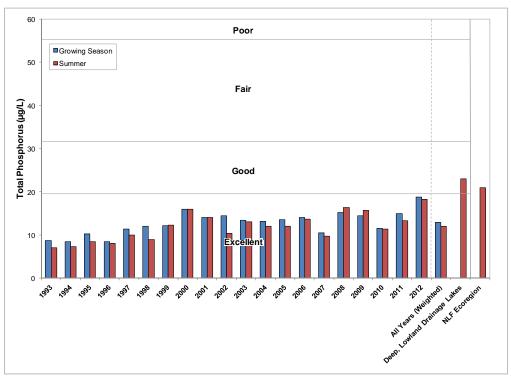
**Figure 3.1-3. Butternut Lake, state-wide class 4 lakes, and regional total phosphorus concentrations.** Mean values calculated with summer month surface sample data. Water Quality Index values adapted from WDNR (2009).

Upon close inspection of the data from Butternut Lake, a slight increase in annual phosphorus concentrations was observed. Annual average summer concentrations were analyzed using a Mann-Kendall test for trend detection. The resulting Mann-Kendall test statistic (S) indicates how strong the trend in the given variable is, and whether or not the variable is increasing or decreasing without the influence of chance (a statistically significant change). The results of the Mann-Kendall statistic (S statistic,  $\alpha$ =0.05) indicate a statistically significant increasing trend in annual average summer total phosphorus concentrations. While this increase is slight, as previously mentioned phosphorus concentrations are not unexpected from what would typically be found in a lake such as Butternut Lake. As discussed further within the Watershed Section, there were no "unaccounted for" sources of phosphorus to Butternut Lake that a watershed model could pick up upon.

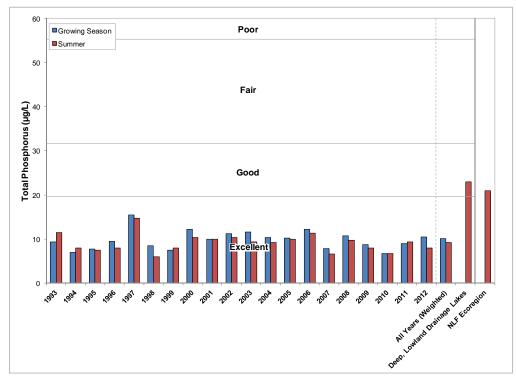
**Figure 3.1-4.** Franklin Lake, state-wide class 4 lakes, and regional total phosphorus concentrations. Mean values calculated with summer month surface sample data. Water Quality Index values adapted from WDNR (2009).

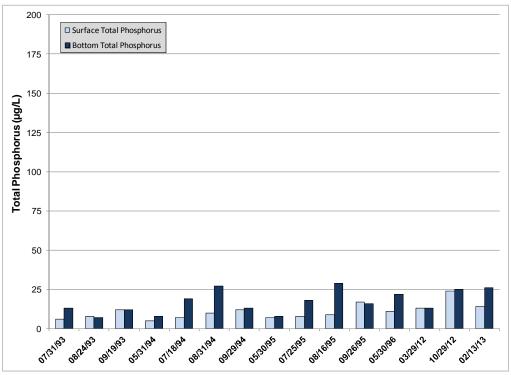
**Figure 3.1-5. Butternut Lake surface and bottom total phosphorus concentrations.** Data collected from historical records (WDNR SWIMS) and Onterra 2012-2013 sampling. All concentrations are actual values, not averages.

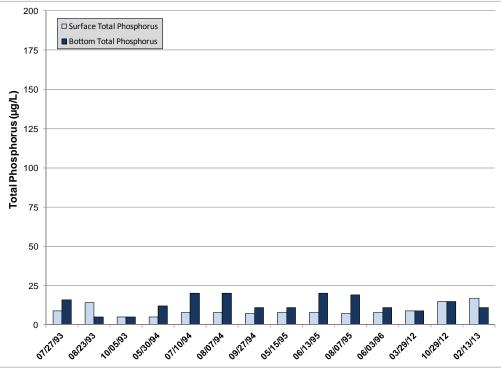
**Figure 3.1-6. Franklin Lake surface and bottom total phosphorus concentrations.** Data collected from historical records (WDNR SWIMS) and Onterra 2012-2013 sampling. All concentrations are actual values, not averages.

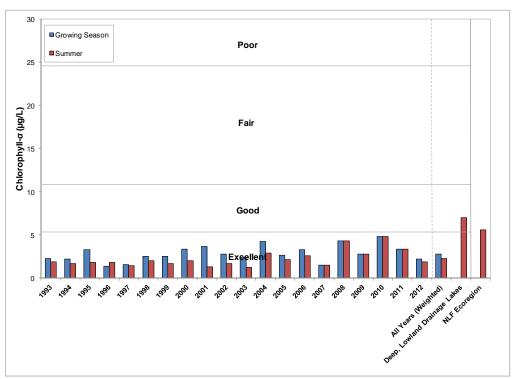
**Figure 3.1-7. Butternut Lake, state-wide class 4 lakes, and regional chlorophyll-***a* **concentrations.** Mean values calculated with summer month surface sample data. Water Quality Index values adapted from WDNR (2009).

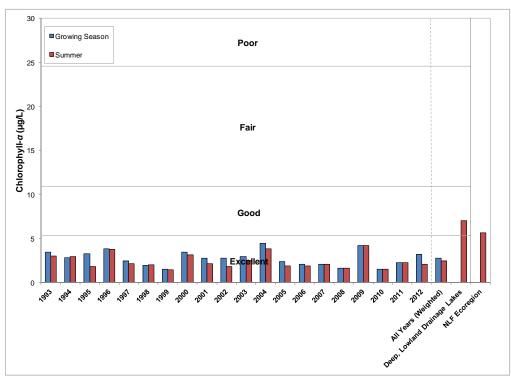
**Figure 3.1-8. Franklin Lake, state-wide class 4 lakes, and regional chlorophyll-***a* **concentrations.** Mean values calculated with summer month surface sample data. Water Quality Index values adapted from WDNR (2009).

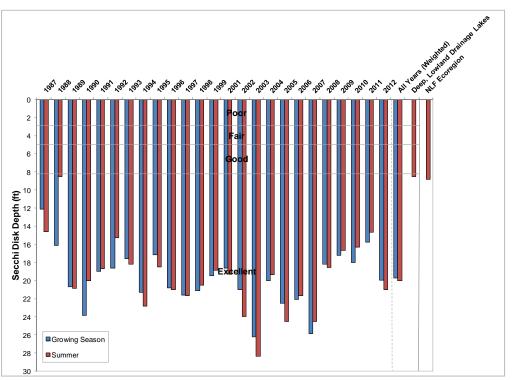
Figure 3.1-9. Butternut Lake, state-wide class 4 lakes, and regional Secchi disk clarity values. Mean values calculated with summer month surface sample data. Water Quality Index values adapted from WDNR (2009).

Figure 3.1-9 and 3.1-10 contain the TSI values for Butternut Lake and Franklin Lake, respectively. The TSI values calculated with Secchi disk, chlorophyll-*a*, and total phosphorus values range in values spanning from middle oligotrophic to middle mesotrophic for both lakes. In general, the best values to use in judging a lake's trophic state are the biological parameters; therefore, relying primarily on total phosphorus and chlorophyll-*a* TSI values, it can be concluded that both Butternut Lake and Franklin Lake are in an upper oligotrophic state.

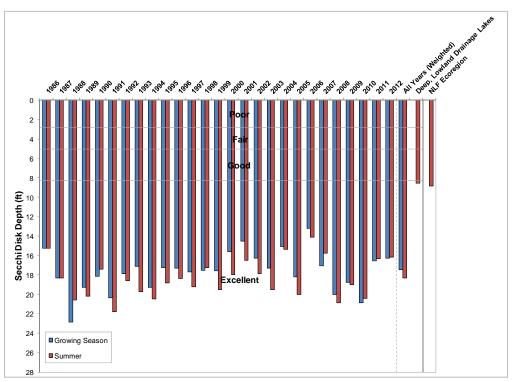
**Figure 3.1-10.** Franklin Lake, state-wide class 4 lakes, and regional Secchi disk clarity values. Mean values calculated with summer month surface sample data. Water Quality Index values adapted from WDNR (2009).

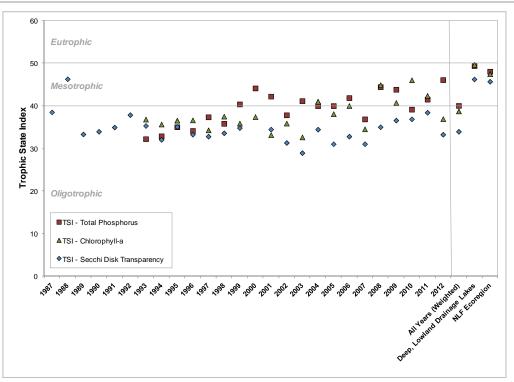
Figure 3.1-11. Butternut Lake, state-wide class 4 lakes, and regional Trophic State Index values. Values calculated with summer month surface sample data using WDNR (2009).

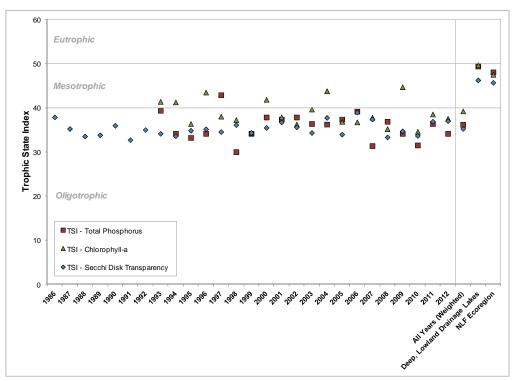
**Figure 3.1-12.** Franklin Lake, state-wide class 4 lakes, and regional Trophic State Index values. Values calculated with summer month surface sample data using WDNR (2009).

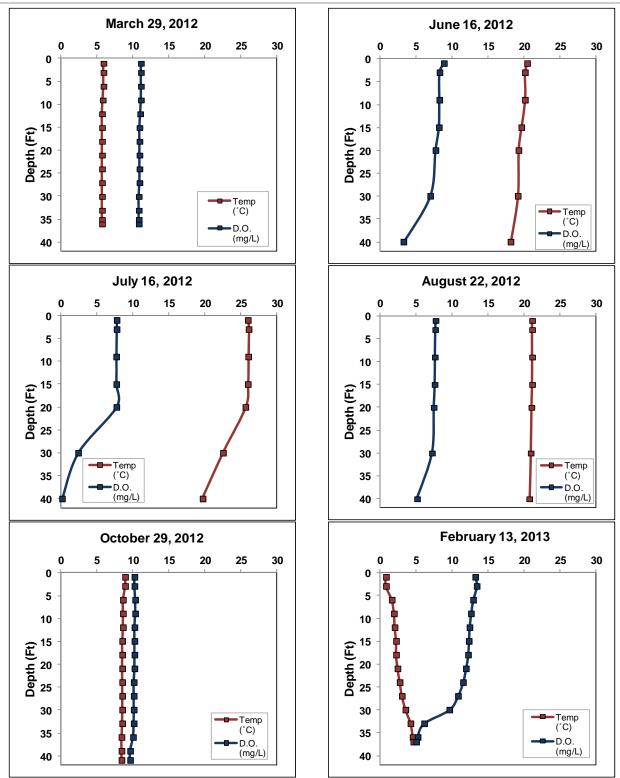
Figure 3.1-13. Butternut Lake dissolved oxygen and temperature profiles.

In both Butternut Lake and Franklin Lake, the entire water column was found to be completely mixed during the early spring. Once the ice leaves a lake, water temperatures are fairly consistent through the water column which allows for complete mixing of oxygen and other elements. As the open water season progresses, the top layer of water will warm, while the bottom layers may remain a bit cooler. During this time, oxygen may decrease at the bottom of the lake while bacteria break down accumulating organic material (fish, plants, algae, etc.). In August of 2012, winds were sufficient to re-mix Butternut Lake, while Franklin Lake remained slightly stratified. In October, as the surface water cooled, both lakes mixed completely as they did in the past spring.

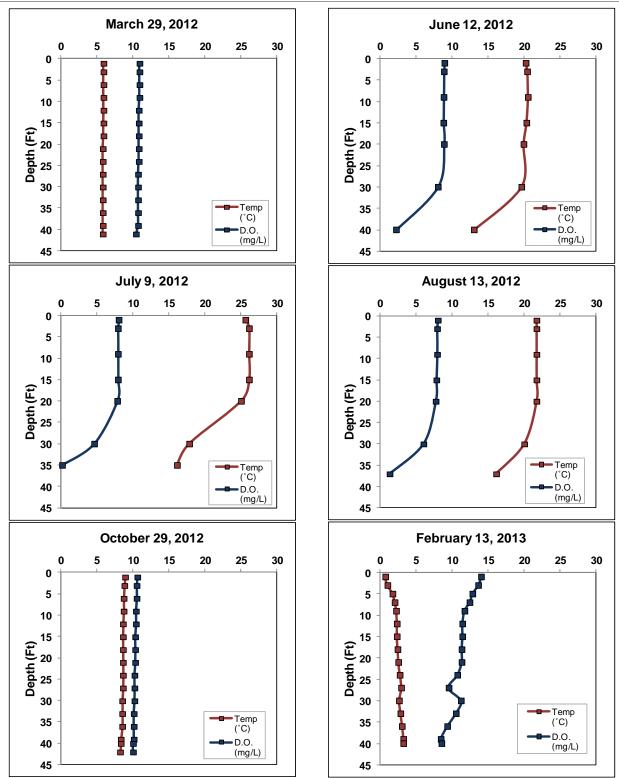
Figure 3.1-14. Franklin Lake dissolved oxygen and temperature profiles.

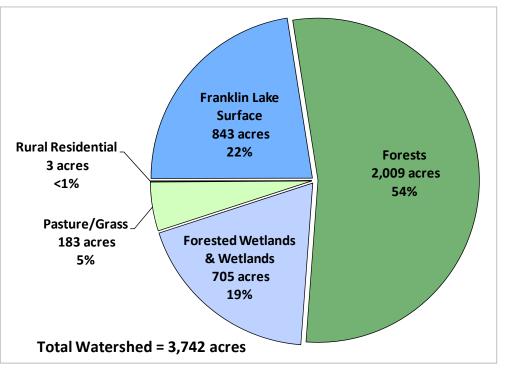
**Figure 3.2-1. Franklin Lake watershed land cover types in acres.** Based upon National Land Cover Database (NLCD – Fry et. al 2011).

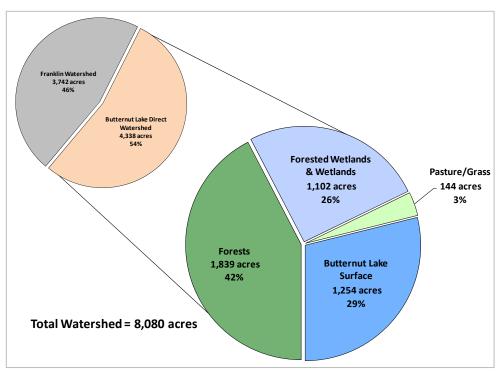
**Figure 3.2-2. Butternut Lake watershed land cover types in acres.** Based upon National Land Cover Database (NLCD – Fry et. al 2011).

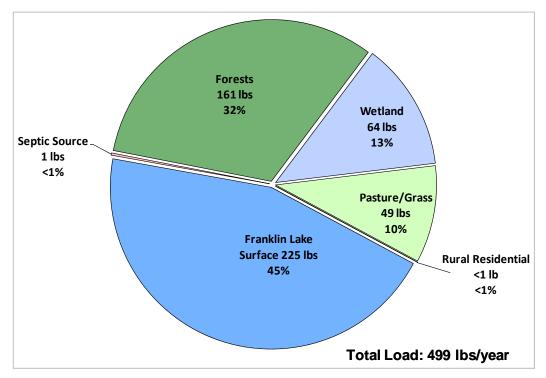
**Figure 3.2-3. Franklin Lake watershed phosphorus loading in pounds.** Based upon Wisconsin Lake Modeling Suite (WiLMS) estimates.

For Franklin Lake's model, WiLMS calculated a growing season mean phosphorus value of 16  $\mu$ g/L, while an actual value was 10  $\mu$ g/L in 2012. As previously mentioned, WiLMS is best suited for modeling drainage waterbodies and thus may overestimate the phosphorus load to a drained lake. So while the modeled growing season mean phosphorus value and the 2012 measured phosphorus value differ for the Franklin Lake, this is likely due to limitations of the WiLMS program and the drought-like conditions that this region is experiencing.

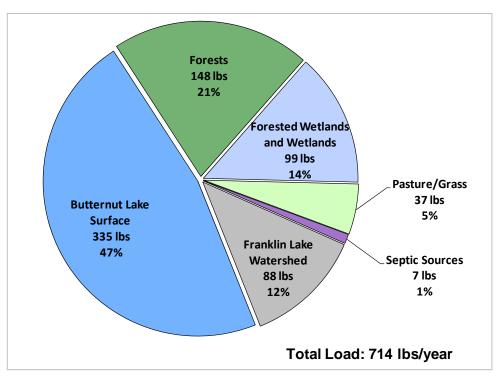
**Figure 3.2-4. Butternut Lake watershed phosphorus loading in pounds.** Based upon Wisconsin Lake Modeling Suite (WiLMS) estimates.

The regional drought-like conditions were acknowledged during the Butternut Lake modeling process. WiLMS was utilized to model this watershed with an input from Franklin Lake of 88 lbs of phosphorus per year, and also model the watershed without this input. This would allow for examination of the lake's annual phosphorus load when the unnamed creek between Butternut Lake and Franklin Lake is running, and when it is not. WiLMS predicted a growing season mean of 14  $\mu$ g/L in Butternut Lake with the inclusion of the 88 lb input from Franklin Lake. In comparison to the measured value of 14  $\mu$ g/L found in Butternut Lake in 2012, the conclusion is that the watershed was accurately modeled. Because of Franklin Lake's minimal contribution to the Butternut Lake annual phosphorus load (12% of 741 lbs), re-modeling the watershed with this input produced a negligible difference in the predicted vs. measured growing season mean calibration analysis. This analysis indicates that the modeled watershed load matches what is expected to be seen within the lake (e.g. there no "unaccounted for" phosphorus sources to the lake).

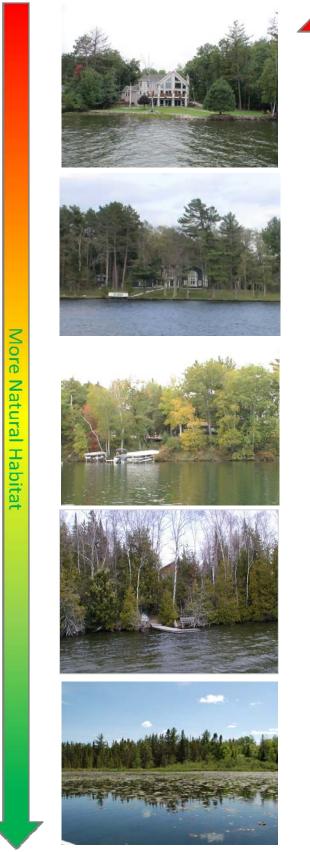
Figure 3.3-1. Shoreland assessment category descriptions.

A lake's shoreland zone can be classified in terms of its degree of development. In general, more developed shorelands are more stressful on a lake ecosystem, while definite benefits occur from shorelands that are left in their natural state. Figure 3.3-1 displays a diagram of shoreland categories, from "Urbanized", meaning the shoreland zone is completely disturbed by human influence, to "Natural/Undeveloped", meaning the shoreland has been left in its original state.

**Urbanized**: This type of shoreland has essentially no natural habitat. Areas that are mowed or unnaturally landscaped to the water's edge and areas that are rip-rapped or include a seawall would be placed in this category.

**Developed-Unnatural**: This category includes shorelands that have been developed, but only have small remnants of natural habitat yet intact. A property with many trees, but no remaining understory or herbaceous layer would be included within this category. Also, a property that has left a small (less than 30 feet), natural buffer in place, but has urbanized the areas behind the buffer would be included in this category.

On Butternut Lake and Franklin Lake, the development stage of the entire shoreland was surveyed during late summer of 2012 using a GPS unit to map the shoreland. Onterra staff only considered the area of shoreland 35 feet inland from the water's edge, and did not assess the shoreland on a property-by-property basis. During the survey, Onterra staff examined the shoreland for signs of development and assigned areas of the shoreland one of the five descriptive categories in Figure 3.3-1.

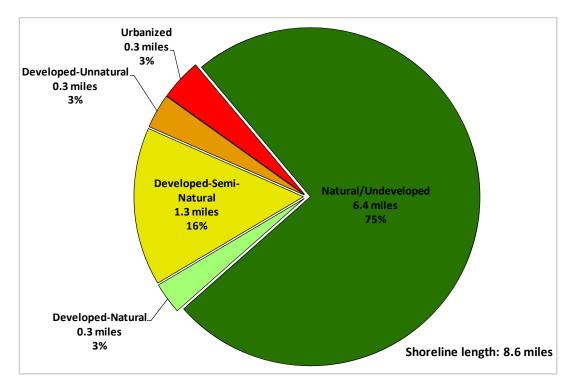
**Figure 3.3-2. Butternut Lake shoreland categories and total lengths.** Based upon a late summer 2012 survey. Locations of these categorized shorelands can be found on Map 3.

Both Butternut and Franklin Lake have stretches of shoreland that fit all of the five shoreland assessment categories. The results of this survey show that the majority of the shorelands on these lakes are in a natural/undeveloped or developed-natural state; 78% of the Butternut Lake shoreland and 82% of the Franklin Lake shoreland were assigned these classifications in 2012 (Figures 3.3-2 and 3.3-3). These shoreland types provide the most benefit to the lake and should be left in their natural state if possible. Minimal areas were found to be highly developed, with 6% of the Butternut Lake shoreland and 5% of the Franklin Lake shoreland being classified as either urbanized or developed-unnatural. If restoration of the Butternut Lake shoreland is to occur, primary focus should be placed on these shoreland areas as they currently provide little benefit to, and actually may harm, the lake ecosystem. Maps 3 and 4 display the location of these shorelands.

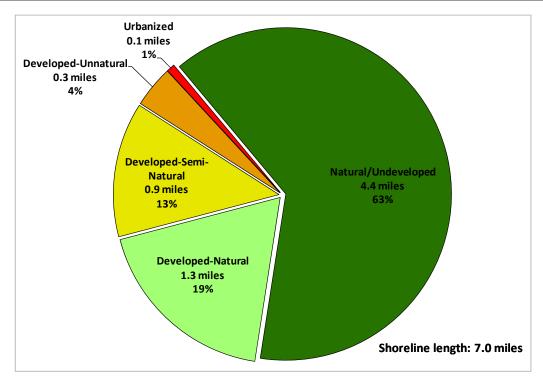
**Figure 3.3-3.** Franklin Lake shoreland categories and total lengths. Based upon a late summer 2012 survey. Locations of these categorized shorelands can be found on Map 4.

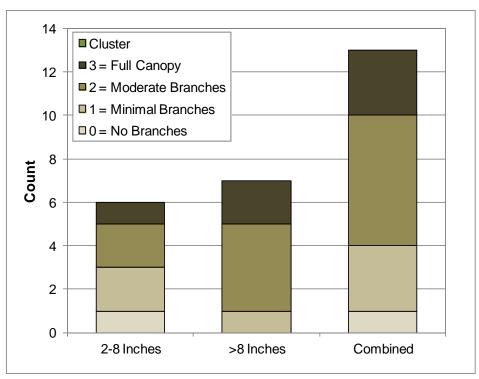
**Figure 3.3-4. Butternut Lake coarse woody habitat survey results.** Based upon a late summer 2012 survey. Locations of coarse woody habitat can be found on Map 5.

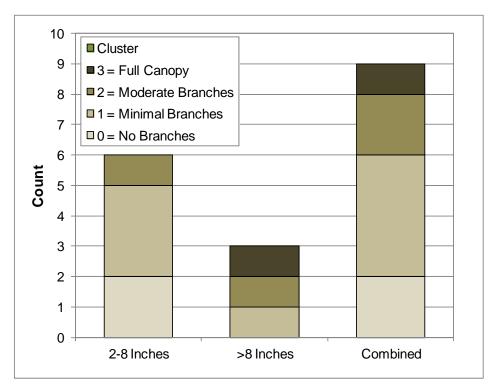
**Figure 3.3-5.** Franklin Lake coarse woody habitat survey results. Based upon a late summer 2012 survey. Locations of coarse woody habitat can be found on Map 6.

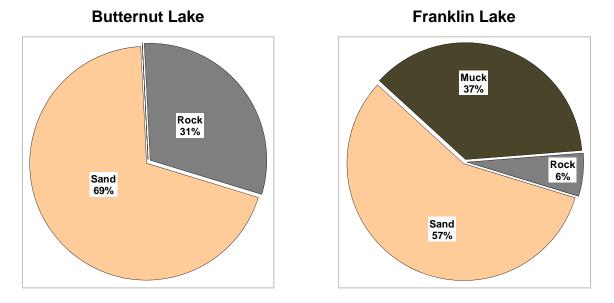
Figure 3.4-3. Butternut Lake (left) and Franklin Lake (right) proportion of substrate types within littoral areas. Created using data from July 2012 aquatic plant point-intercept survey.

At each point-intercept location 12 feet of depth or less, data was collected regarding the sediment type. These data indicate that both Butternut Lake and Franklin Lake have a predominately sandy substrate, though they differ slightly with Butternut including vast areas of rocky substrate and Franklin Lake having substantial organic (muck) substrate (Figure 3.4-3; Maps 7 and 8).

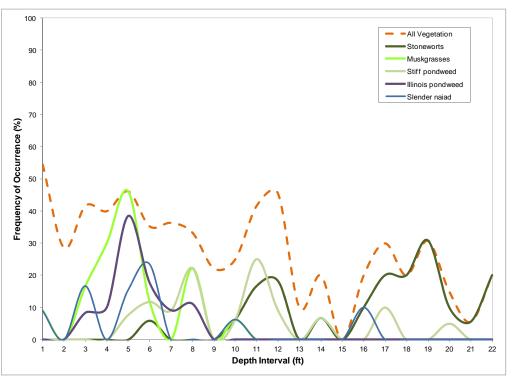
Figure 3.4-4. Frequency of occurrence at littoral depths for several Butternut Lake plant species. Created using data from July 2012 aquatic plant point-intercept survey.

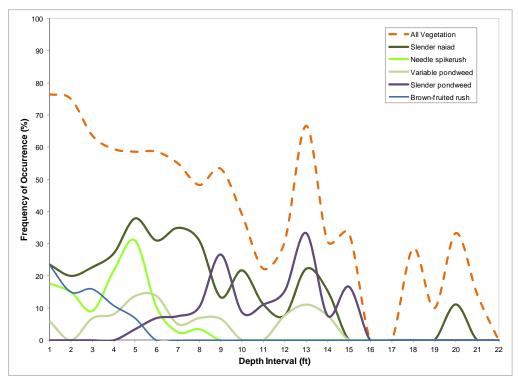
Figure 3.4-5. Frequency of occurrence at littoral depths for several Franklin Lake plant species. Created using data from July 2012 aquatic plant point-intercept survey.

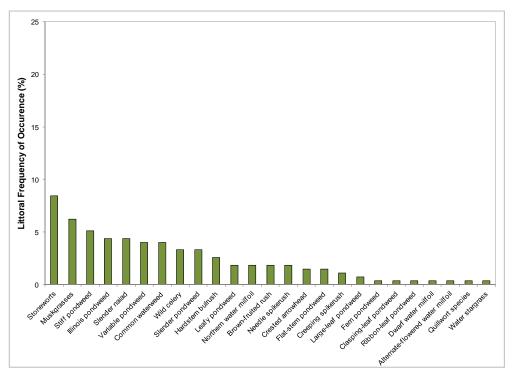
**Figure 3.4-6 Butternut Lake aquatic plant littoral frequency of occurrence.** Created using data from July 2012 surveys.

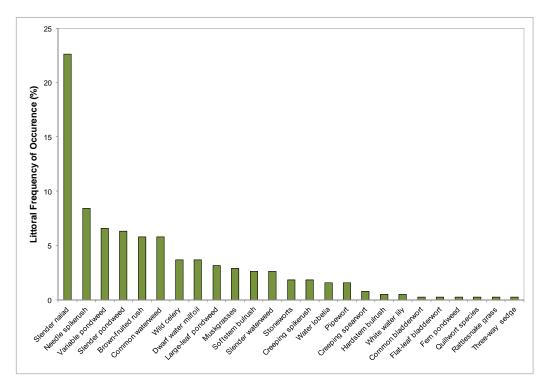
**Figure 3.4-7 Franklin Lake aquatic plant littoral frequency of occurrence.** Created using data from July 2012 surveys.

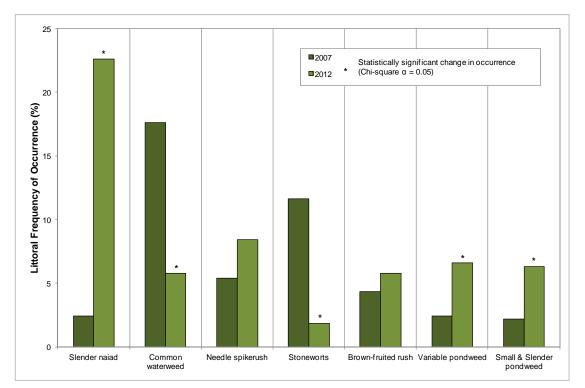
**Figure 3.4-8 Franklin Lake littoral occurrence of native aquatic plants, 2007 & 2012.** Species with an occurrence of at least 4% in either survey represented. Created using data from 2007 Northern Environmental (now Stantec) and 2012 Onterra point-intercept surveys.

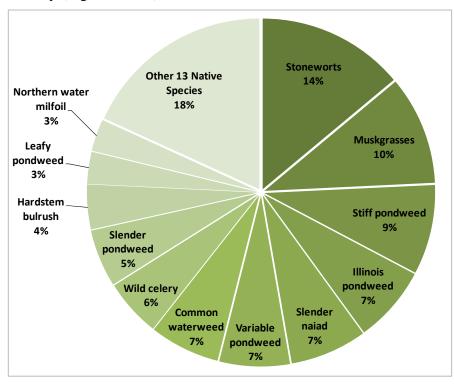
**Figure 3.4-9 Butternut Lake aquatic plant relative frequency of occurrence.** Created using data from July 2012 surveys.

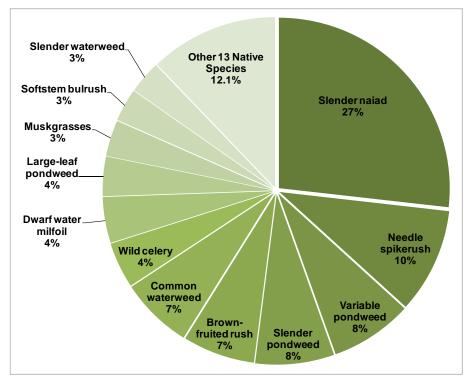
Figure 3.4-10 Franklin Lake aquatic plant relative frequency of occurrence. Created using data from July 2012 surveys.

half of the plant community in Butternut Lake. On Franklin Lake, four species comprise half of the plant community (Figure 3.4-10).

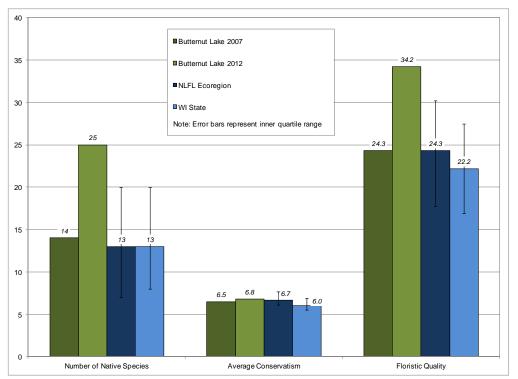
**Figure 3.4-11. Butternut Lake Floristic Quality Assessment.** Created using data from 2007 and 2012 surveys. Analysis following Nichols (1999) where NLFL = Northern Lakes and Forest Lakes Ecoregion.

The species that are present in these lakes are indicative of high-quality conditions. Data collected from the aquatic plant surveys show that the 2012 average conservatism values (6.8 for Butternut Lake, 7.3 for Franklin Lake) are well above the Northern Lakes and Forest Lakes Ecoregion and Wisconsin State medians (Figure 3.4-11 and 3.4-12), indicating that the majority of the plant species found in these lakes are considered sensitive to environmental disturbance and their presence signifies excellent environmental conditions.

Combining each lake's aquatic plant species richness and average conservatism values to produce its Floristic Quality Index (FQI) results in exceptionally high 2012 values of 34.2 for Butternut Lake and 35.4 for Franklin Lake (equation shown below). These calculated values are well above the median values for the ecoregion and state (Figure 3.4-11 and 3.4-12), as well as values calculated through 2007 aquatic plant studies. This further illustrates the quality of Butternut and Franklin Lake's plant community.

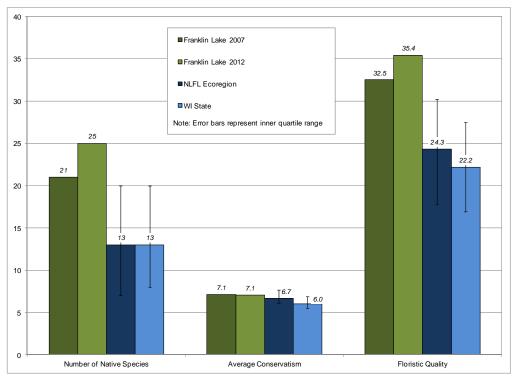
**Figure 3.4-12.** Franklin Lake Floristic Quality Assessment. Created using data from 2007 and 2012 surveys. Analysis following Nichols (1999) where NLFL = Northern Lakes and Forest Lakes Ecoregion.

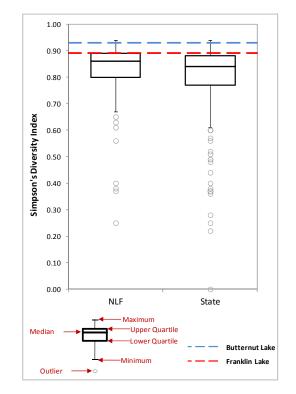
Figure 3.4-13. Butternut Lake and Franklin Lake species diversity index. Created using data from July 2012 aquatic plant surveys. Ecoregion data provided by WDNR Science Services.

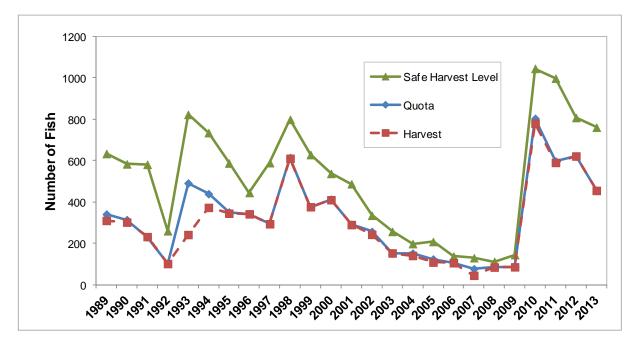
**Figure 3.5-3. Butternut Lake walleye spear harvest data.** Annual walleye spear harvest statistics are displayed since 1989 (T. Cichosz, personal communication).

Walleye open water spear harvest records are provided in Figure 3.5-3. One common misconception is that the spear harvest targets the large spawning females. Tribal spearers may only take two walleyes over twenty inches per nightly permit; one between 20 and 24 inches and one of any size over 20 inches (GLIWC 2013B). This regulation limits the harvest of the larger, spawning female walleye.

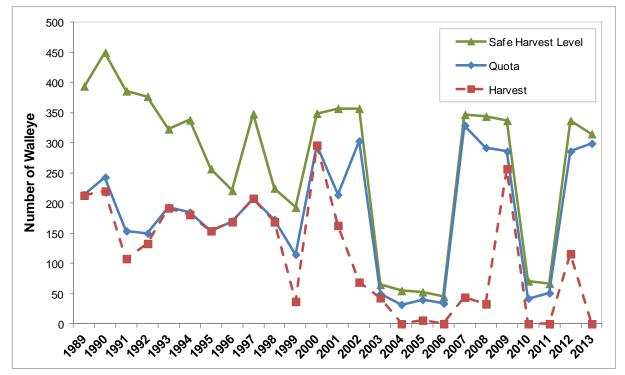
**Figure 3.5-4.** Franklin Lake walleye spear harvest data. Annual walleye spear harvest statistics are displayed since 1989 (T. Cichosz, personal communication).
