# Little Platte River

# 2010 Water Quality Management Plan Update

Grant-Platte Basin, Wisconsin

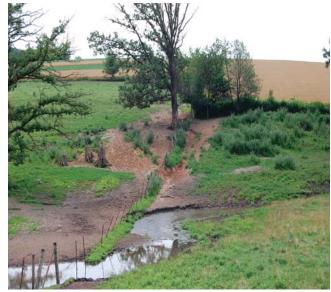
This tributary to Little Platte River shows bare soil and erosion caused by over grazing and stream bank trampling (2010).

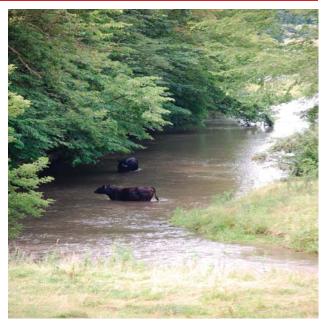
Allowing cattle uncontrolled access to streams often leads to increased sediment and nutrient delivery due to loss of stream bank vegetation and manure washing from the stream bank or being directly deposited in the stream when cattle wade or stand in water.

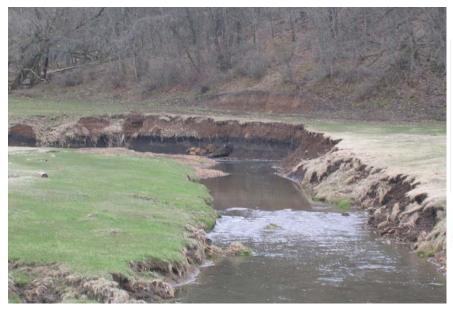
$Severely\ eroded\ streambanks\ of\ Coon\ Creek.\ Photo\ by\ Peggy\ Compton,\ UW\ Basin\ Educator.$
