# PREOPERATIVE POINT SOURCE IMPACT STUDY OF THE EMBARRASS RIVER RELATED TO THE VILLAGE OF EMBARRASS PUBLICLY OWNED TREATMENT WORKS

Performed as part of the 1981 Lake Michigan District Basin Assessment Survey Program

Publication Date: February 1982

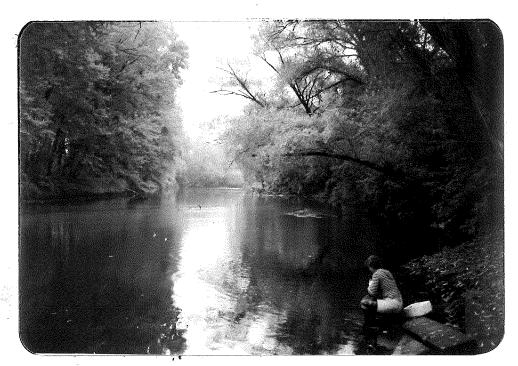
Embarrass River looking downstream from the park boat landing beyond the Village of Embarrass POTW outfall located approximately 1/2 inch from the right edge of the photograph (September 3, 1981).

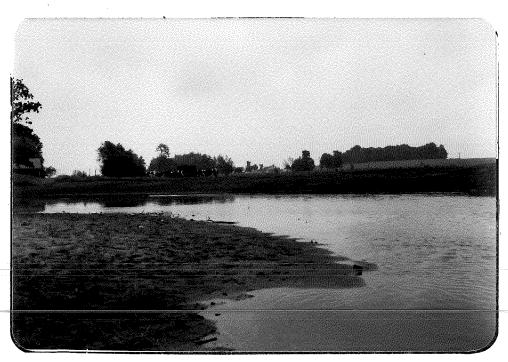
Macroinvertebrate Site 2 looking upstream. It was assumed the effluent from the POTW was mixed sufficiently at this point for a Macroinvertebrate site. Note the nonpoint sources. (September 3, 1981).

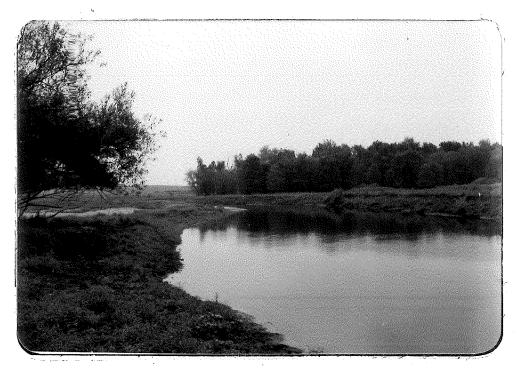
Embarrass River looking upstream toward macro-invertebrate site 2 which was located just around the corner. The new POTW outfall is just to the right outside the photograph. (September 3, 1981).

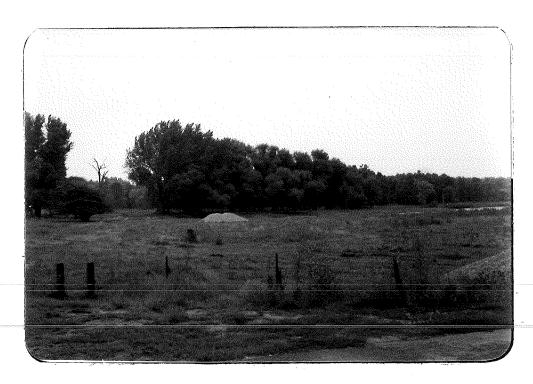
This photograph was taken from the old POTW parking lot. The new POTW outfall is located to the left of the white-grey stone pile. (September 3, 1981).

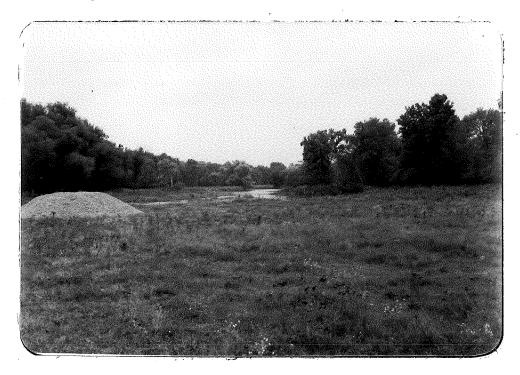
Embarrass River looking downstream past the new POTW outfall. (September 3, 1981).

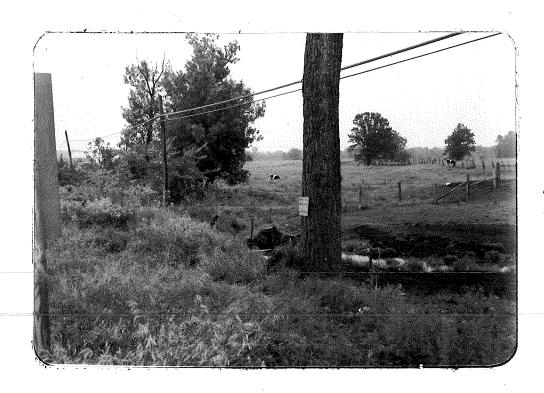
Tributary looking downstream from Jepson Road. Note the non-point source impact. (September 3, 1981).

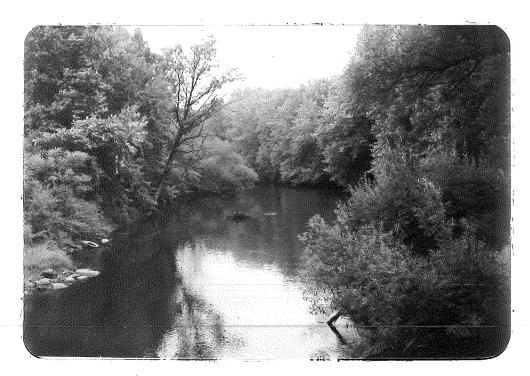
Embarrass River looking downstream from Behnke Road. Macroinvertebrate Site 3 was located at the bottom of the photograph. (September 3, 1981).
