# Targeted Watershed Assessment Report for Tributaries on the South Side of Big Green Lake, Green Lake County, Wisconsin

### December 2015

EGAD 3200-2015-35

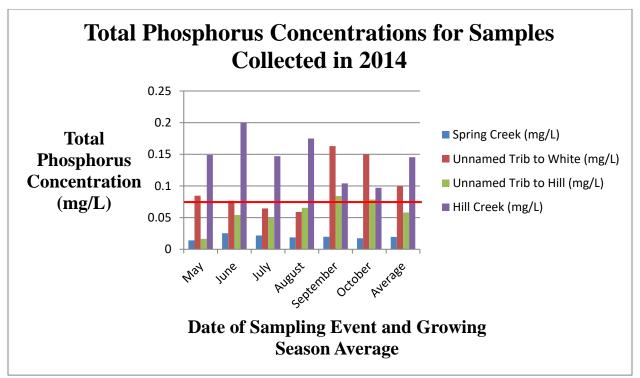
All inorganic chemistry samples were sent to the WISLOH in Madison for analysis. Two of the four creeks' samples in this project had an average TP concentration (mg/L) exceeding the NR 102 water quality criteria (WQC) for creeks and rivers of 0.075 mg/L (Table 5, Chart 1). Wisconsin Consolidated Assessment and Listing Methodology (WisCALM 2014) requires a parametric statistical approach to assess creek TP data against the applicable water quality criterion found in NR 102. This approach involves the calculation of a 90% confidence limit around the median of a TP sample dataset. If the lower 90% confidence limit (LCL) exceeds the criterion for TP, then that creek segment (assessment unit) is considered to be exceeding the criterion. The LCLs were calculated for each creek's TP samples (Table 6). Three of the 4 creeks' samples LCLs met the water quality criterion for TP, while 1 exceeded (Table 6, Chart 2).

Chart 1: Total Phosphorus Concentrations and Averages in Creeks Sampled in 2014 (with 0.075 mg/L WQC red line) in the Southern Big Green Lake Watershed in 2014.

Reference average stream conditions for the SWTP ranged from 0.080 mg/L (USEPA 2000-2001) to 0.042 mg/L TP (USGS 2006). Three of the four average TP concentrations in this project were above the modeled reference conditions (USEPA 2000-2001 & USGS 2006) (Table 5, Chart 1). The land use in this study area has had a significant impact on the TP in 3 of the 4 creeks. Response thresholds of water quality to changes in nutrient concentrations for macroinvertebrates in Wisconsin wadable streams are 0.088 mg/L for TP (USGS 2006). Two of the 4 sites demonstrated TP concentrations over response thresholds of water quality (USGS 2006) (Table 5, Chart 1). Water quality has been impacted by the TP concentrations in the creeks of this project.

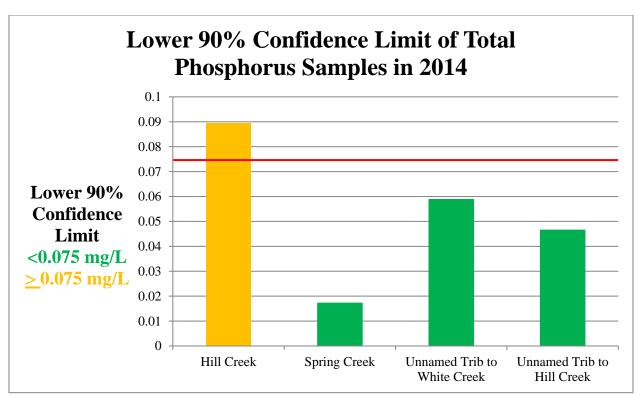
Chart 2: Total Phosphorus Lower 90% Confidence Limit in Creeks Sampled in 2014 (with 0.075 mg/L WQC red line) in the Southern Big Green Lake Watershed in 2014.

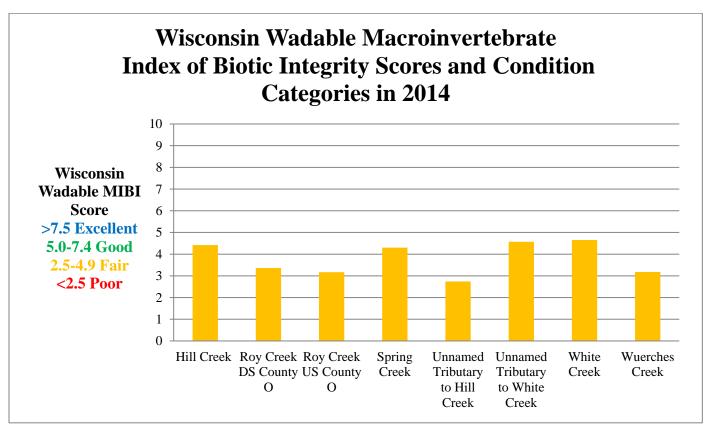
In October 2014, each of the 7 streams in Table 2 was sampled for aquatic macroinvertebrate communities. Some aquatic macroinvertebrate species are tolerant of environmental degradation, while some species are moderately tolerant, and some others are intolerant. Based upon the representative macroinvertebrate sample collected and their associated tolerance to environmental degradation, an Index of Biotic Integrity (MIBI) was calculated to indicate the water quality condition of the stream (Table 7, Chart 3). The MIBI scores ranged from 3.17 at Roy Creek upstream of County Hwy O to 4.65 at White Creek upstream of Spring Grove Road (Table 7, Chart 3). The Condition Categories for the 8 sites were all Fair (Table 7, Chart 3). All 7 streams demonstrated a macroinvertebrate community significantly impacted by environmental degradation.

Chart 3: Aquatic Macroinvertebrate Index of Biotic Integrity Scores and Water Quality Condition Category in the Southern Big Green Lake Watershed in October 2014.

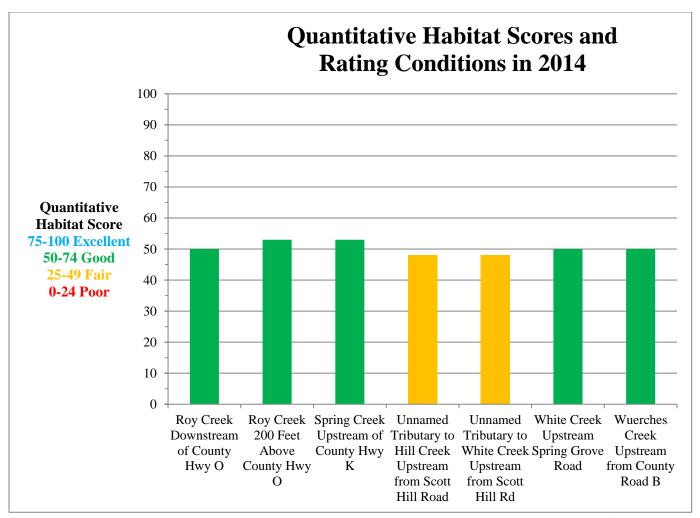
Between August and September 2014, quantitative habitat surveys were conducted at the 6 creeks listed in Table 3 (7 sites). Quantitative habitat assessments evaluate a representative stream reach (35 X Mean Stream Width) for the quantity and quality of habitat for game fish and compare the habitat to reference streams in Wisconsin. Based upon the assessment data collected during the 2014 surveys, a habitat rating was calculated for the 6 creeks (Table 8, Chart 4). The habitat rating scores were relatively similar for all creeks. The habitat rating scores ranged from 48 at the Unnamed Tributaries to White and Hill Creeks to 53 at Roy and Spring Creek (Table 8, Chart 4). Five of the 7 surveys demonstrated a Condition Category of Good, with scores ranging from 50-53 (Table 8, Chart 4). The remaining survey stations (the two Unnamed Tributaries) scored a Fair Condition Category, with a score of 48 (Table 8, Chart 4).

Chart 4: Quantitative Habitat Survey Scores and Rating Conditions for 6 Creeks in the Southern Big Green Lake Watershed in 2014.

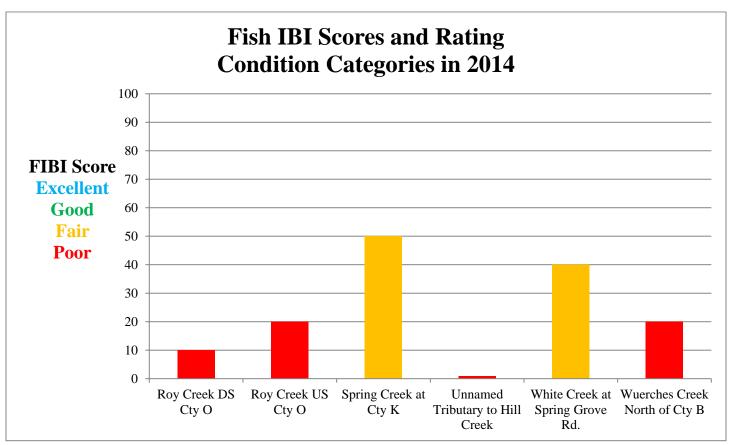
Between July and September 2014, each of the creeks in Table 4 were surveyed for representative fish communities. Some fish species are tolerant of environmental degradation, while some species are moderately tolerant, and some others are intolerant. Based upon the representative fish collected during the survey and their associated tolerance to environmental degradation, an Index of Biotic Integrity (FIBI) was calculated to indicate the water quality of the creek (Table 9, Chart 5). The FIBI scores ranged from 0 at the Unnamed Tributary to Hill Creek (SWIMS 10041578), to 50 at Spring Creek (SWIMS 243026) (Table 9, Chart 5). The Condition Category for the 6 sites ranged from Poor to Fair. Four of the 6 surveys had a Condition Category of Poor, while the remaining 2 surveys had a Condition Category of Fair (Table 9, Chart 5).

Chart 5: Wisconsin Wadable Fish Index of Biotic Integrity Scores and Condition Categories for 6 Creeks in the Southern Big Green Lake Watershed in 2014.

The one of the largest sources of sedimentation and phosphorus in Roy, Wuerches, Hill, and White Creeks, and their associated Unnamed Tributaries is excessive streambank erosion. The poor to fair FIBI scores reflect the effects of sedimentation and high nutrient loads from the subwatersheds (Table 9, Chart 5). Green Lake County LCD conducted an inventory of Roy, Wuerches, Hill, and White Creeks, and their associated Unnamed Tributaries to assess the condition of their riparian buffers, streambank erosion, and instream habitat. Derek Kavanaugh—Green Lake County Soil Conservation Technician—completed a summary report of the 2014 buffer assessment, "Green Lake Buffer Assessment Project" (Buffer Assessment Report 2014). In Kavanaugh's Buffer Assessment Report, Roy, Wuerches, Hill, and White Creek subwatersheds averaged 11.25% of their stream length had unstable banks with active erosion (Buffer Assessment Report 2014) (Photo 1-3, Table 13, Chart 10). According to data collected at the USGS Gauge Station 04073458, Roy Creek discharged a total of 240 tons of suspended sediment and 740 lbs of TP in 2013 (USGS 2013). The majority of this sediment and nutrient discharge occurred in early spring during snowmelt and rain events. Rain events and snowmelt carry sediment and TP into the creek in addition to increasing water velocity and discharge volume. The increased velocity and discharge during this period increases the potential for bank erosion on the unstable banks in the subwatersheds. One of the easiest and most cost-effective ways to decrease the sediment and TP load into these subwatersheds and eventually into Big Green Lake is to restore the identified unstable streambanks (Buffer Assessment 2014) (Photo 4).

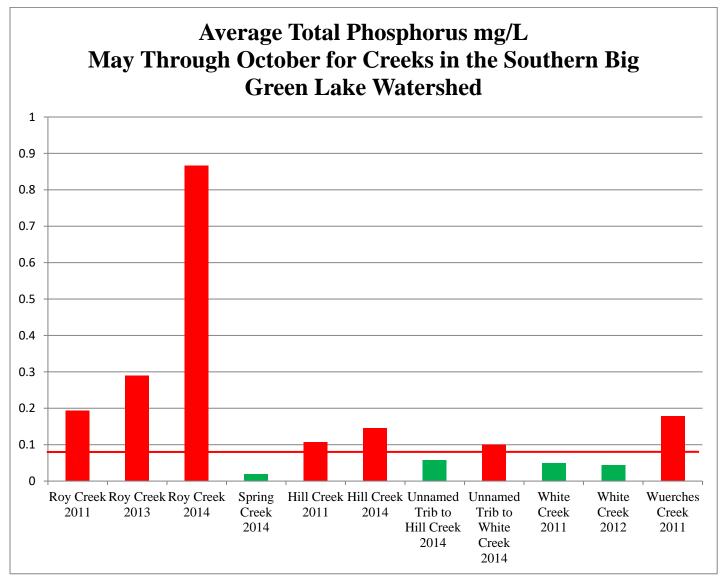
Chart 6: Average Total Phosphorus (mg/L) of All Data May through October 2011-2014 for Creeks in the Southern Big Green Lake Watershed (red line WQC at 0.075 mg/L).

through the 2012 growing season. Spring, Hill, and the two Unnamed Tributaries to Hill and White Creeks were monitored as part of this 2014 project. The two Hill Creek data years are comparable due to the similar number of sampling events and dates. The Hill Creek TP average concentration increased from 0.107 mg/L to 0.145 mg/L in 2011 and 2014, respectively. There was also less variability in the TP concentrations during the growing season of 2014 versus 2011 in Hill Creek. Both years' average TP data on Hill Creek exceeded the WQC of 0.075 mg/L. Hill Creek was recommended for the 2016 CWA 303d Impaired Waters List and will be added to the 2016 CWA 303d Impaired Waters List for degraded biological community due to the pollutant phosphorus on 4/1/2016. White Creek 2011 data is fairly comparable to the 2012 data. There were significantly more sampling events in 2012 than 2011 in White Creek in the DNR SWIMS database, but the average concentration was about the same. The 2014 Roy Creek data is difficult to compare to other years as a significant (~80%) portion of the sampling events occurred during June when there was high runoff and flow. The average TP concentration in the available data for 2014 at Roy Creek was significantly higher than 2011 and 2013 due to the high number of sampling events in June.

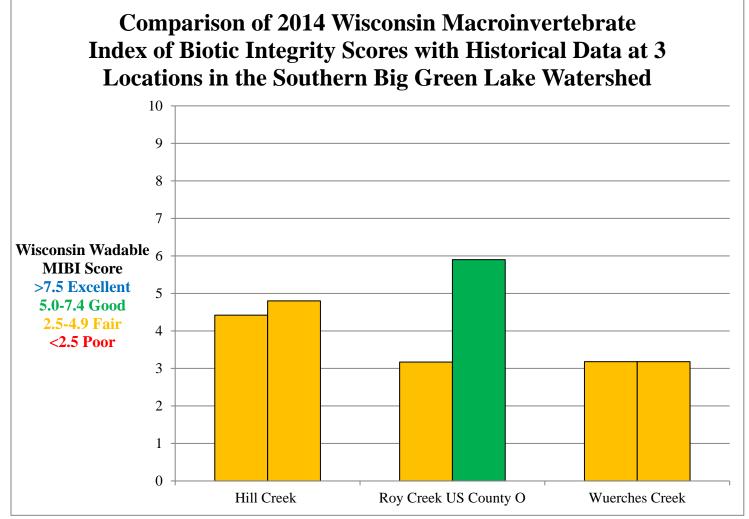
A summary of historical aquatic macroinvertebrate survey results was listed for 4 locations in 2011 in the Big Green Lake Watershed (Johnson et. al. 2011). Three of the 2011 Assessment 4 streams monitored were monitored as part of this project: Roy Creek, Hill Creek, and Wuerches Creek. The MIBI scores from 2014 are fairly similar to historical surveys (Chart 7). The largest difference between a historical MIBI score and the 2014 MIBI score was 2.2 at Roy Creek upstream of County Hwy O (Chart 7). That difference seen between the 2011 survey and the 2014 may be the result of recent habitat improvement work done where the sample was collected. The macroinvertebrate community may not have recovered yet from the disturbance and changes made to the habitat in early 2013. In the 2011 Assessment, Johnson reports the macroinvertebrate survey results in the form of Hilsenhoff's Biotic Index (HBI) score which refers to William H. Hilsenhoff's 1987 "An improved biotic index of organic stream pollution". One of the basic differences between reading the HBI scores versus the MIBI scores is that the higher the MIBI the better condition while the higher the HBI the poorer the condition. One of the fundamental differences between the HBI and MIBI is that the HBI focuses more on impacts to the macroinvertebrate community from organic pollution and increased nutrients while the MIBI also ties in impacts from habitat degradation. The historical HBI scores were fairly similar to the 2014 HBI scores (Chart 8). The largest difference between the historical HBI score and the 2014 HBI was 0.6 (Chart 8).

Chart 7: Comparison of 2014 Wisconsin MIBI (Left Column) Scores to 2007-2009 Wisconsin MIBI (Right Column) Scores at 3 Locations in the Southern Big Green Lake Watershed.

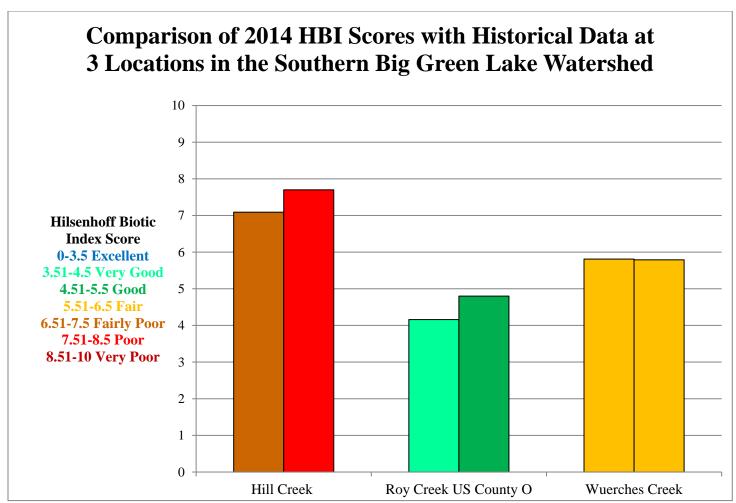
Chart 8: Comparison of 2014 HBI (Left Column) Scores to 2007-2009 HBI (Right Column) Scores at 3 Locations in the Southern Big Green Lake Watershed.

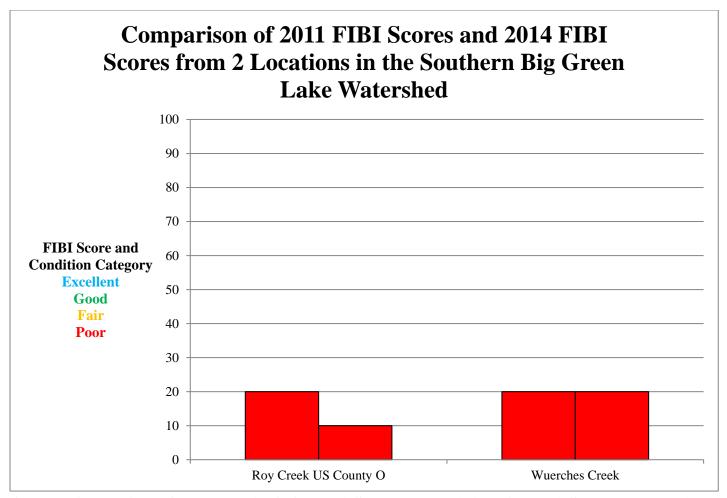
Fish surveys were conducted in 2011 by the WDNR in Roy and Wuerches Creeks (Johnson et. al. 2011). The 2014 project also conducted fish surveys at those two locations (Table 9, Chart 5). The FIBI were similar from 2011 to 2014 with all condition categories listed as Poor (Chart 9).

Chart 9: Comparison of 2014 FIBI (Left Column) Scores to FIBI (Right Column) Scores at 2 Locations in the Southern Big Green Lake Watershed.

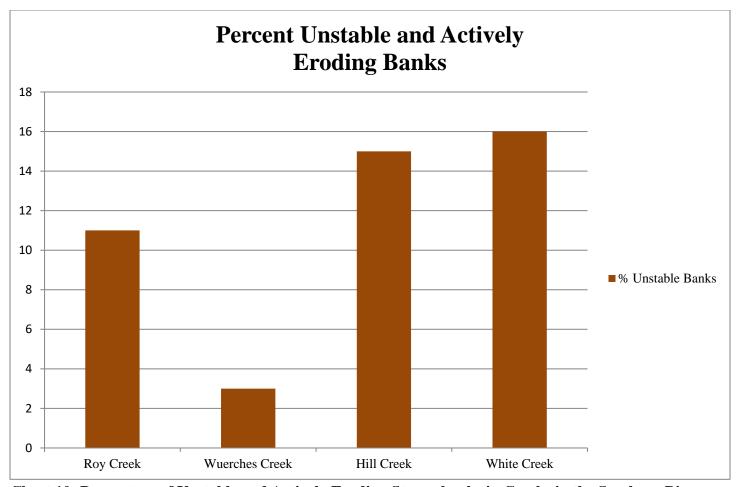
Chart 10: Percentage of Unstable and Actively Eroding Streambanks in Creeks in the Southern Big Green Lake Watershed (Green Lake County LCD 2014).

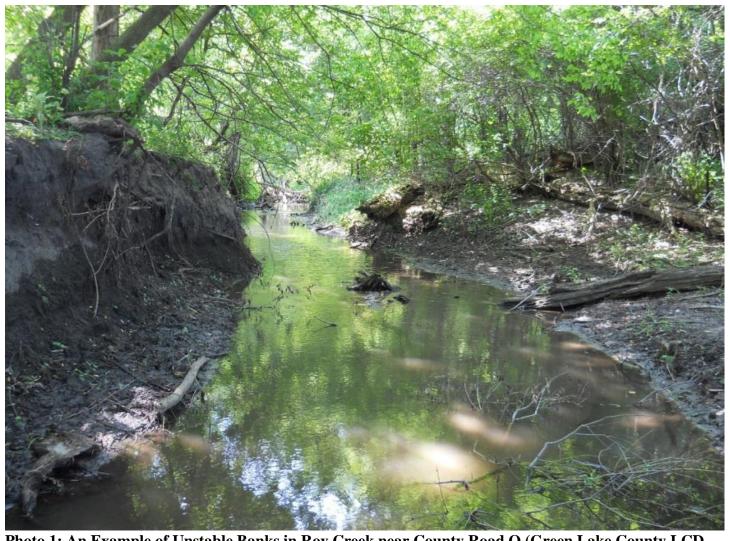
Photo 1: An Example of Unstable Banks in Roy Creek near County Road O (Green Lake County LCD 2012)

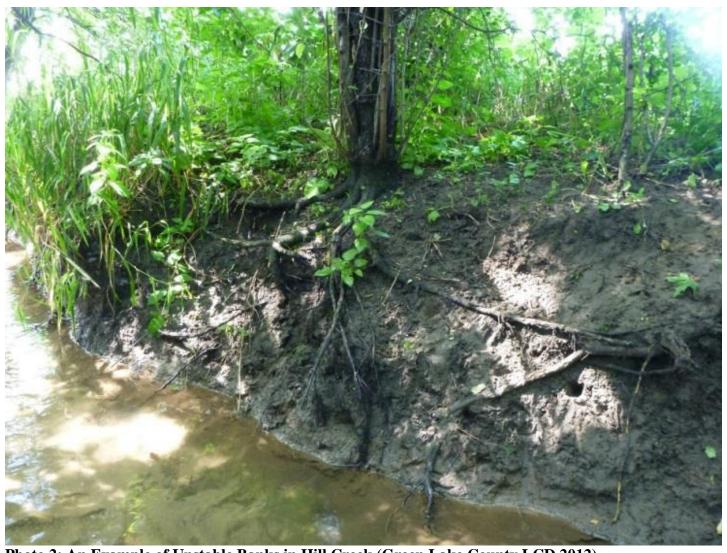
Photo 2: An Example of Unstable Banks in Hill Creek (Green Lake County LCD 2012)

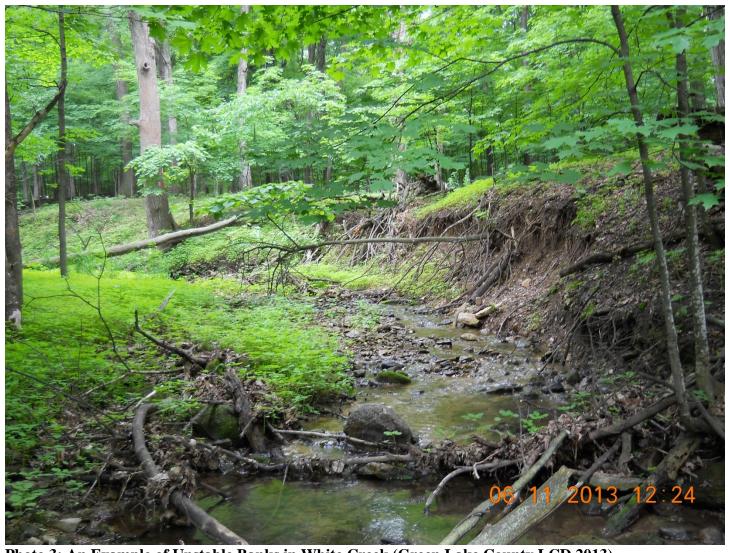
**Photo 3: An Example of Unstable Banks in White Creek (Green Lake County LCD 2013)**

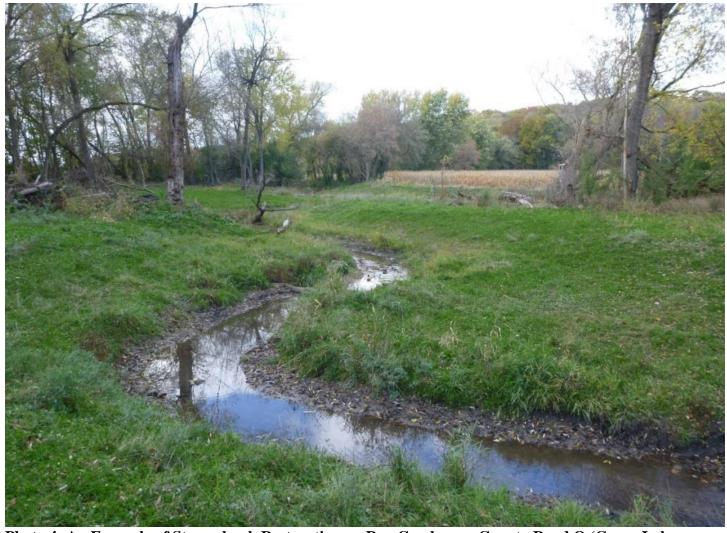
Photo 4: An Example of Streambank Restoration on Roy Creek near County Road O (Green Lake County LCD 2013)

Increasing vegetative and forested buffer widths along the creeks in this project can also have a positive impact on the sediment and nutrient load reaching the creeks (Photo 4). Roy, Wuerches, Hill, and White Creek subwatersheds averaged 22.25% of their stream length with less than 35' buffer width (Buffer Assessment 2014) (Table 14, Chart 11).

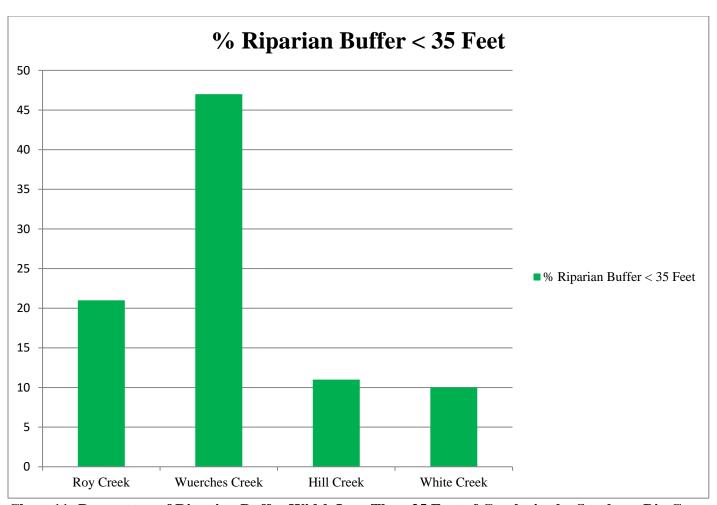
Chart 11: Percentage of Riparian Buffer Width Less Than 35 Feet of Creeks in the Southern Big Green Lake Watershed (Green Lake LCD 2014).

Recommended buffer widths vary significantly in published research (there is no one-size-fits all), but the majority of research recommends vegetative buffers >35', with 35' being on the lower end of recommended buffer widths. In general, as the land slope along a creek increases, the riparian buffer width recommendation increases. Due to the nature of the steep slopes in the watersheds of the creeks in this project, increasing buffer widths in all of these subwatersheds will likely have a nutrient and sediment reduction effect. The type of vegetative buffer is also critical to reducing sediment and nutrients reaching the creeks of this project. A combination of forest and native grass buffers may have a better nutrient reduction than strictly grassed buffers.
