Re: ***Oconto Falls Upper Hydroelectric Project***
Project No. 2523, Article 407
N.E.W. Hydro, Inc.
Submittal of Purple Loosestrife / Eurasian Watermilfoil Inventory for Year 2008

**Oconto Falls Upper Project Purple Loosestrife & Eurasian Watermilfoil Inventory
August 6, & August 7, 2008
FERC Project #2523 Article 407**

**NEW Hydro, Inc.
116 State St.
Neshkoro, WI 54960**

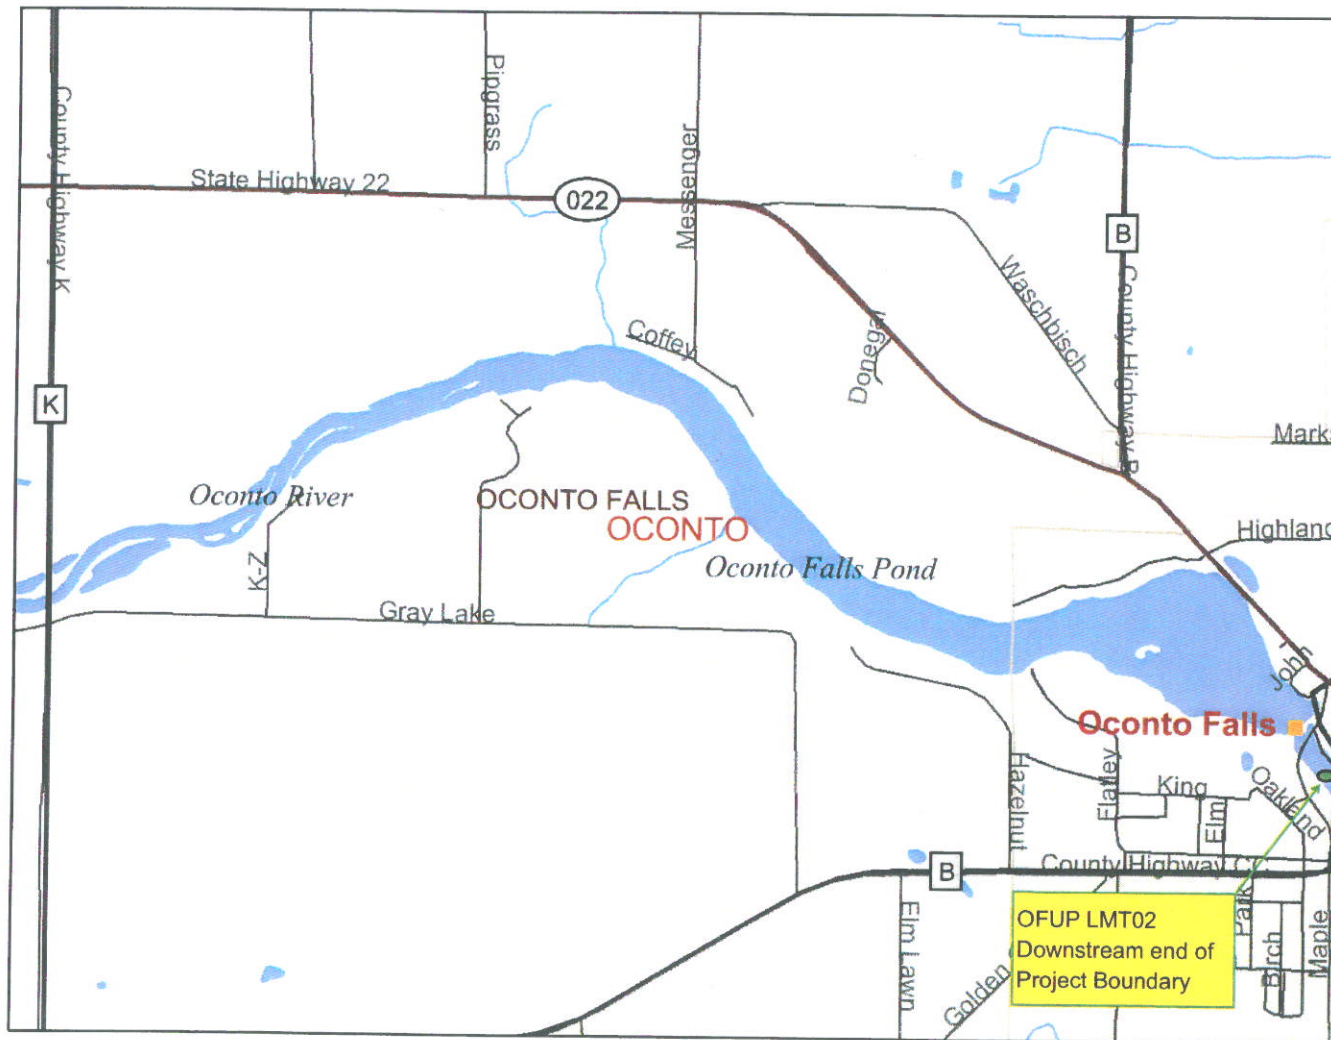
Oconto Falls Upper #2523 Purple Loosestrife Survey 2008

The headwaters were surveyed by boat. Seven occurrences of purple loosestrife plants were observed in this area and are noted on the lake map and survey comments at the end of this report. One of these occurrences appears to be on project owned land and is so noted.

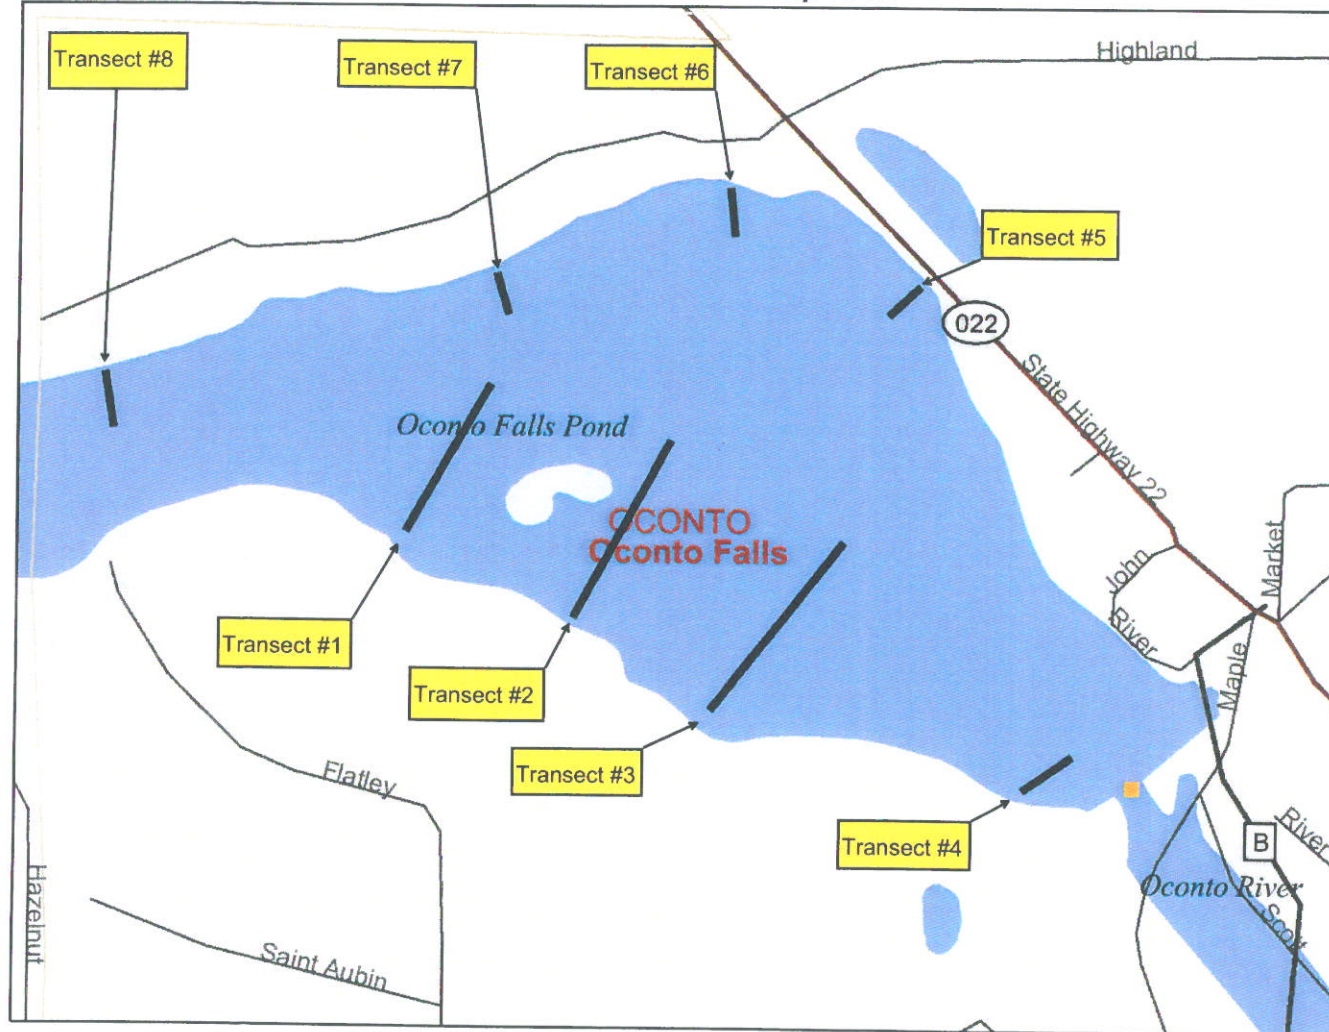
Transect Location Map 2008

The *main basin* was surveyed visually and with the use of a 14" wide garden rake attached to an 18' aluminum pole. Eight transects were established in 2000 in this area with sample points at 1.5', 5', and 10' depths. Each sample point of each transect was an 8' circle divided into quadrants. Each quadrant was sampled using the rake. If the teeth of the rake contained less than 50% Eurasian watermilfoil, a rating of 1 was assigned, and if 50% or more, a rating of 2 was assigned. In addition, areas of weed growth were visually searched while skirting the perimeter of weed beds and shoreline.

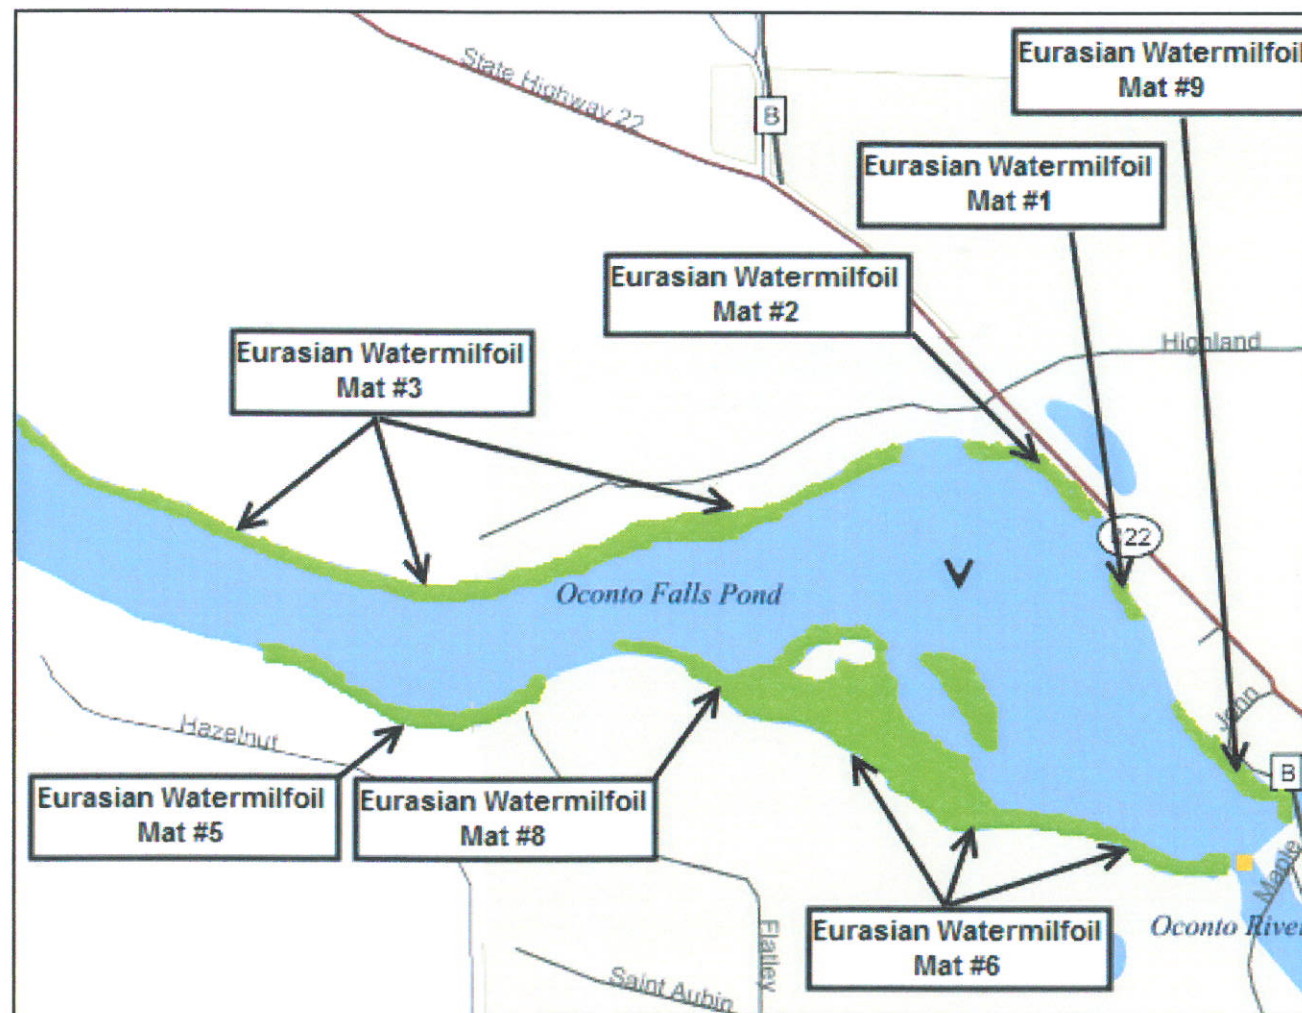
Oconto Falls Upper #2523 Eurasian Watermilfoil Mat Locations 2008

Twelve mats containing Eurasian watermilfoil were identified within the project boundary of which mat #1, #2, #3, and #4 were first identified in the 2000, mat #5 was first identified in 2001, mat #6 was first identified in 2003, mat #8 was first identified in 2005, mat #9, #10, and #11 were first identified in 2006, and mat #12 was first identified in 2008. Mat #7 was not found in 2008. All twelve mats were discovered using the visual search method. All of these mats were interspersed with other types of plants and all of the mats had Eurasian watermilfoil densities as noted in the survey comments at the end of this report. Mats #1 through #10 are located in the *main basin* while mat #11 and #12 are located in the *headwaters*.
