Re: Oconto Falls Upper Project, No. 2523, NEW Hydro, LLC
Article 407, Purple Loosestrife Eurasian Watermilfoil Inventory

**Oconto Falls Upper Project Purple Loosestrife & Eurasian Watermilfoil Inventory
August 11, & August 12, 2010
FERC Project #2523 Article 407**

**NEW Hydro, Inc.
116 State St.
Neshkoro, WI 54960**

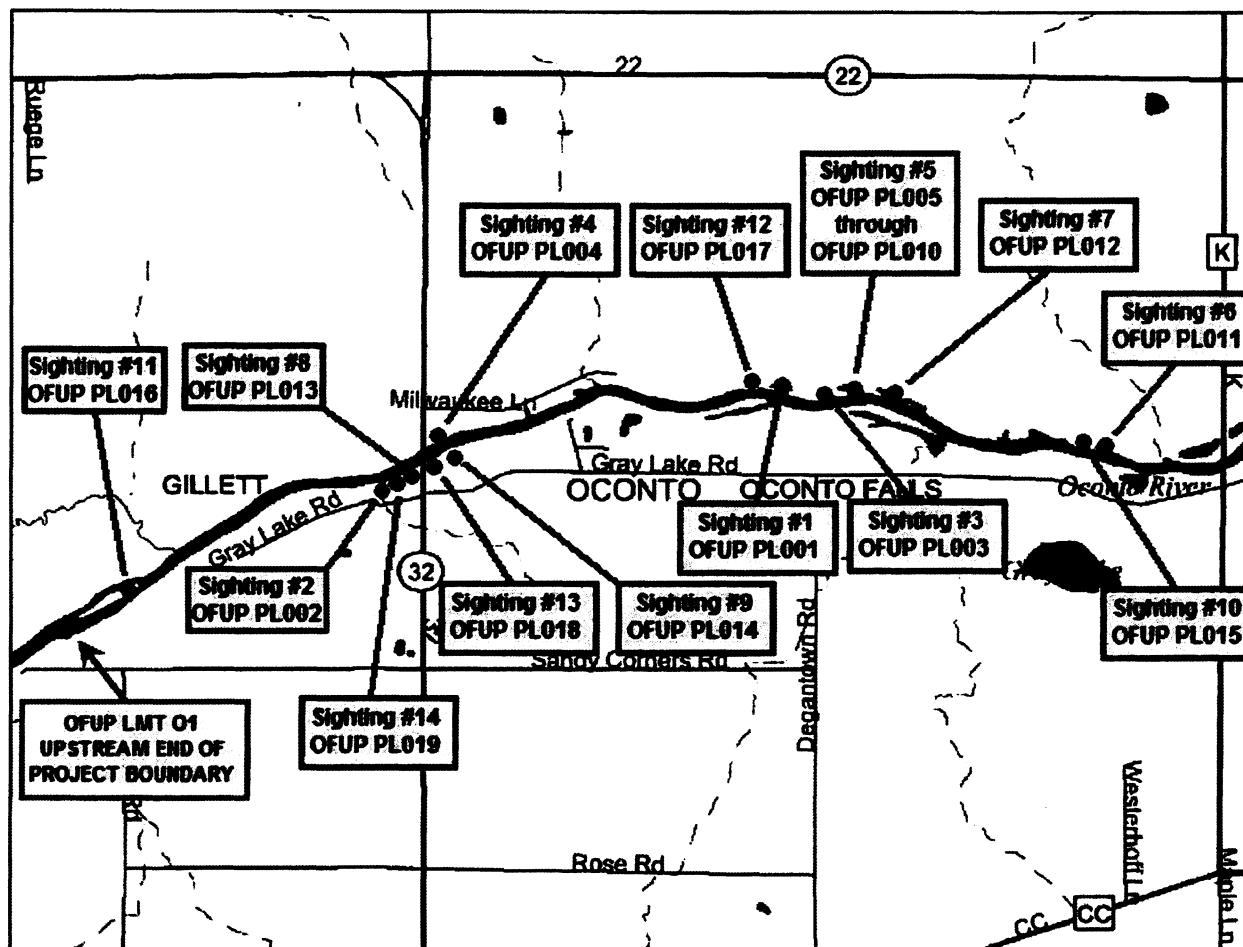
Oconto Falls Upper, Purple Loosestrife Location Map 2010 Oconto Falls WI, FERC #2623

Purple Loosestrife
Observed in 2010

Purple Loosestrife
Observed in
Previous Years and
not in 2010

The headwaters were surveyed by boat. Four occurrences of purple loosestrife plants were observed in this area and are noted on the lake map and survey comments at the end of this report. One of these occurrences appears to be on project owned land and is so noted.

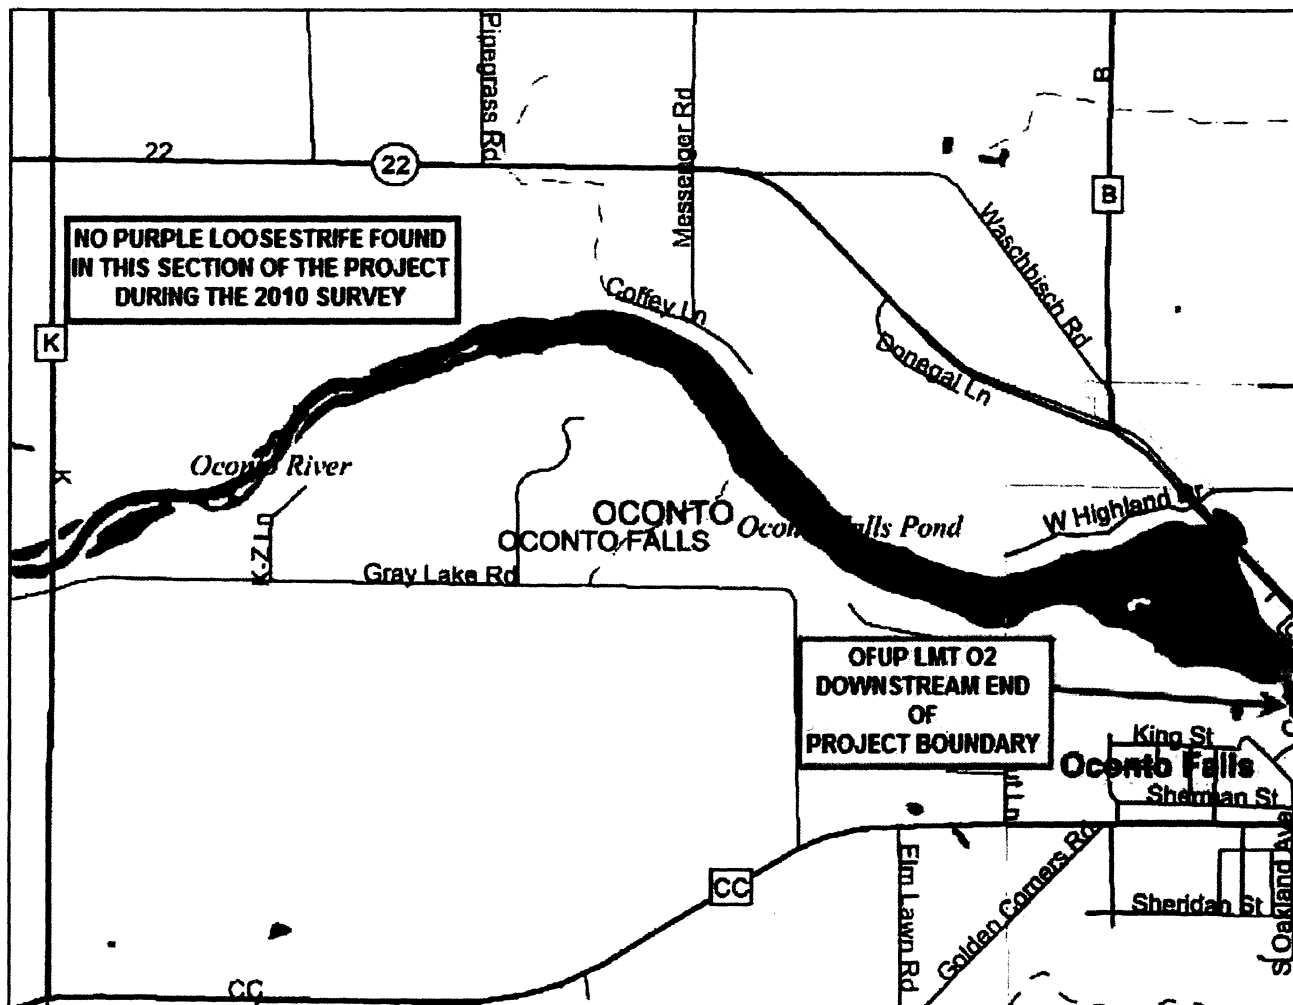
Oconto Falls Upper, Purple Loosestrife Location Map 2010

Purple Loosestrife
Observed in 2010

Purple Loosestrife
Observed in
Previous Years and
not in 2010

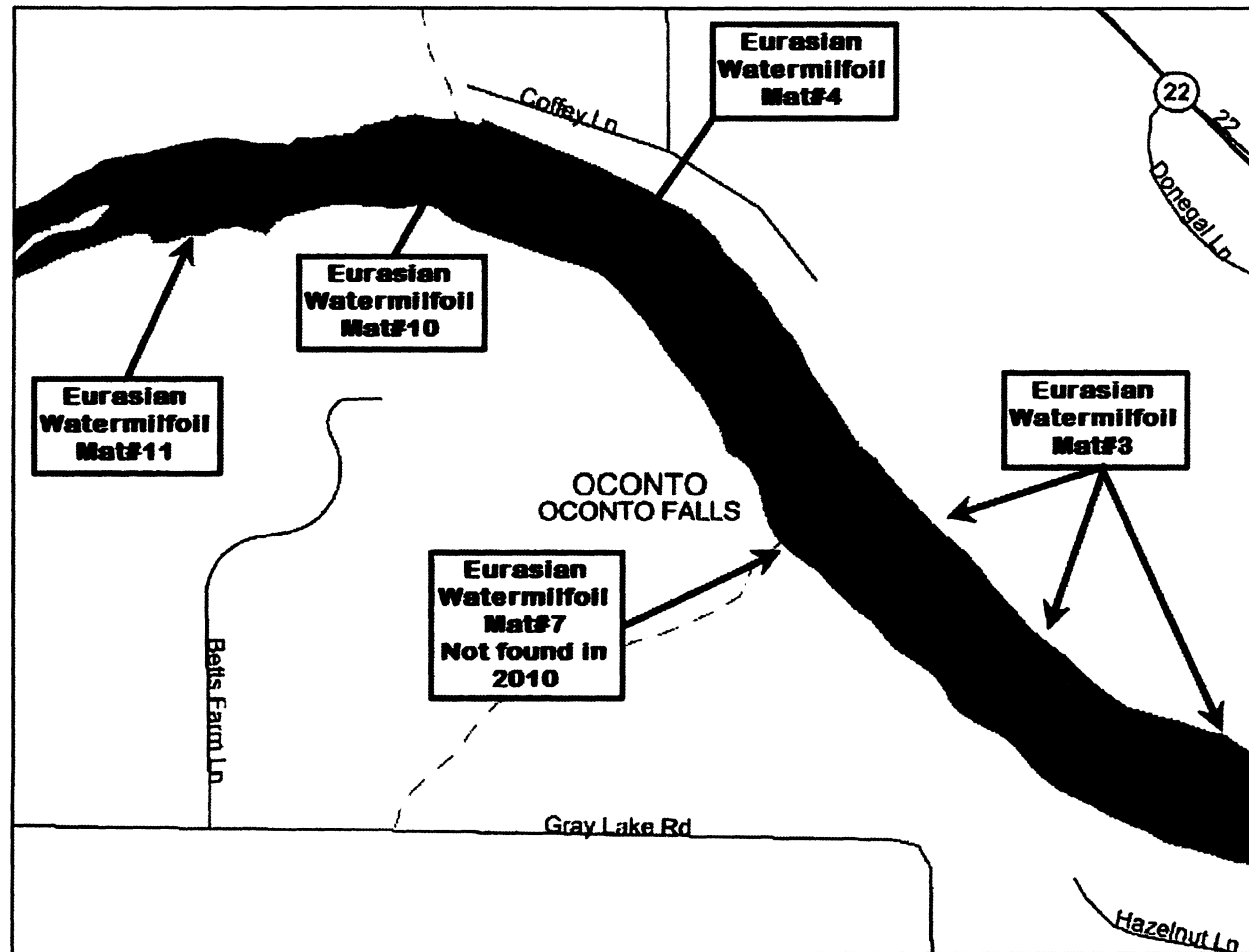
Oconto Falls Upper, Eurasian Watermilfoil Mat Location Map 2010

Fourteen mats containing Eurasian watermilfoil were identified within the project boundary of which mats #1, #2, #3, and #4 were first identified in the 2000, mat #5 was first identified in 2001, mats #6 and #7 were first identified in 2003, mat #8 was first identified in 2005, mats #9, #10, and #11 were first identified in 2006, and mat #12 was first identified in 2008. Two new mats were identified in 2009 and were labeled mat #13 and mat #14. All fourteen mats were discovered using the visual search method. All of these mats were interspersed with other types of plants and all of them had Eurasian watermilfoil densities as noted in the survey comments at the end of this report. Mats #1 through #10 are located in the *main basin* while mats #11, #12, #13 and #14 are located in the *headwaters*.
