**RE: Oconto Falls Upper - FERC P-2523  
NEW Hydro LLC  
Article 407 - 2012 Purple Loosestrife and Eurasian Watermilfoil Inventory**

**The 2012 Purple Loosestrife & Eurasian Watermilfoil Inventory**  
**For the**  
**Oconto Falls Upper Hydroelectric Project**  
**Oconto County, Wisconsin**  
**FERC Project #2523 License Article 407**

**2012 Final Report**

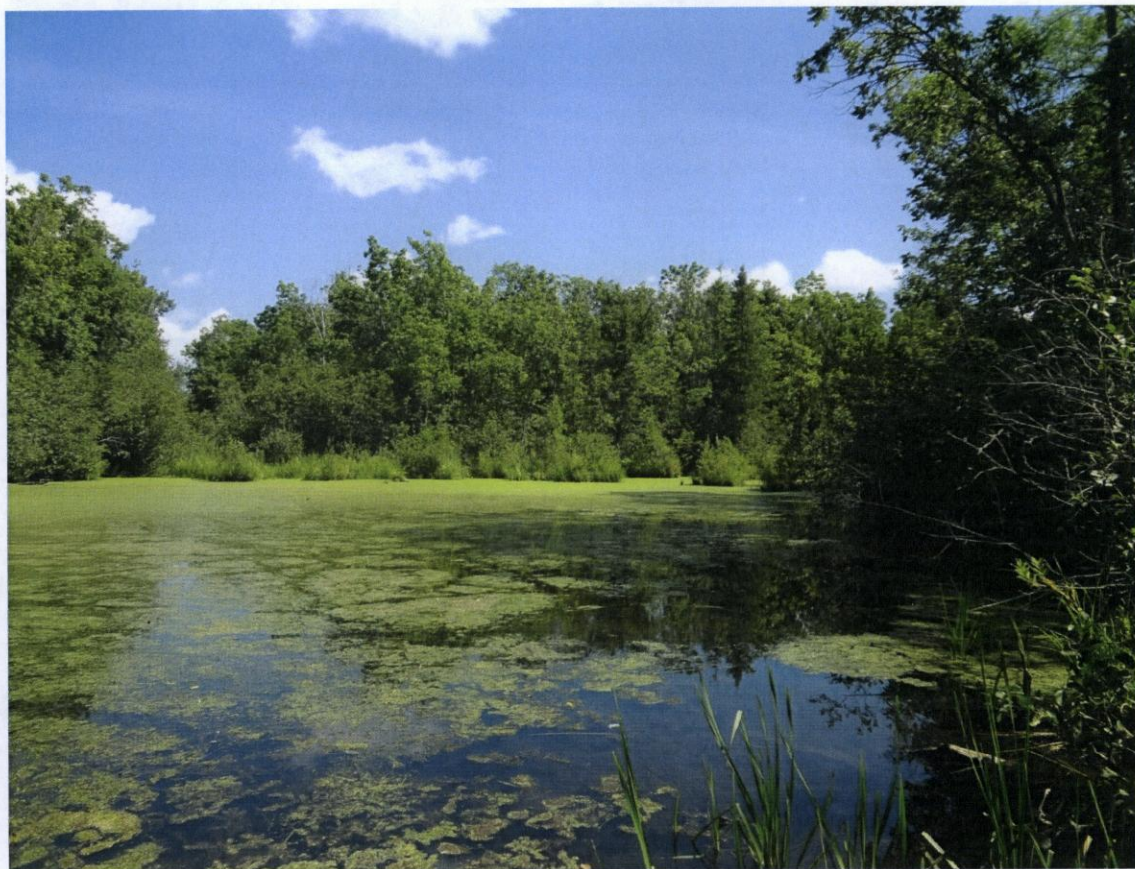
Photo of site #OFUP PL001 from the 2012 survey.

At the Oconto Falls project there are approximately eighteen sites where purple loosestrife is known to exist or did exist and has been eradicated. Of all the PL locations within the project only one, GPS point OFUP PL001 has had a long history of having consistent stands of PL growing annually at the site. The site is surrounded by a slough adjacent to the river and is located on property owned by NEW Hydro LLC. The slough is surrounded by dense woodland cover and makes an ideal environment for PL to prosper. This site has been monitored since 2000 and has been treated with a WDNR approved herbicide beginning in 2003 through 2011. Biological control in the form of Galerucella beetles (Cella) have been positively identified on plants beginning in 2007. The 2012 survey results indicated a total of only two plants (less than 1' tall) were located at the site. It should be noted that unusually dry weather conditions in 2012 appeared to be unfavorable for optimum PL growth.

| GPS Point | Latitude | Longitude | Plant Height | Stand Area | Beetle Damage | Comments |
|---|---|---|---|---|---|---|
| OFUP PL001 | N44°53.0397' | W088°13.7630' | Less than 1' | 2 Plants | Yes | First observed in 2000. Located 30 yards bearing 0° (north) of GPS point on the north side of a marshy slough. Appears to be on a snowmobile trail, as snowmobile trail signs are on either side of slough opening into the river channel. In 2012, only 2 plants were located of which one was pulled. No treatment on remaining plants due to established Galerucella beetle population. The number of plants and plant size has dropped considerably compared to last year. The plants are all located on project owned lands. Video tape in 2000. Video taken of damaged plants in 2005. Galerucella beetles were positively identified on plants each year from 2007-2012. All plants sprayed with herbicide each year from 2003-2011. No herbicide spraying in 2012. |
