**RE:** Oconto Falls Upper FERC Project P-2523  
NEW Hydro, LLC  
Article 407 – 2016 Purple Loosestrife – Eurasian Watermilfoil Inventory

**FINAL**  
**2016 Purple Loosestrife & Eurasian**  
**Watermilfoil Inventory**  
For the  
**Oconto Falls Upper Hydroelectric Project**  
Oconto County, Wisconsin  
FERC Project P-2523 NATDAM ID WI00763  
License Article 407

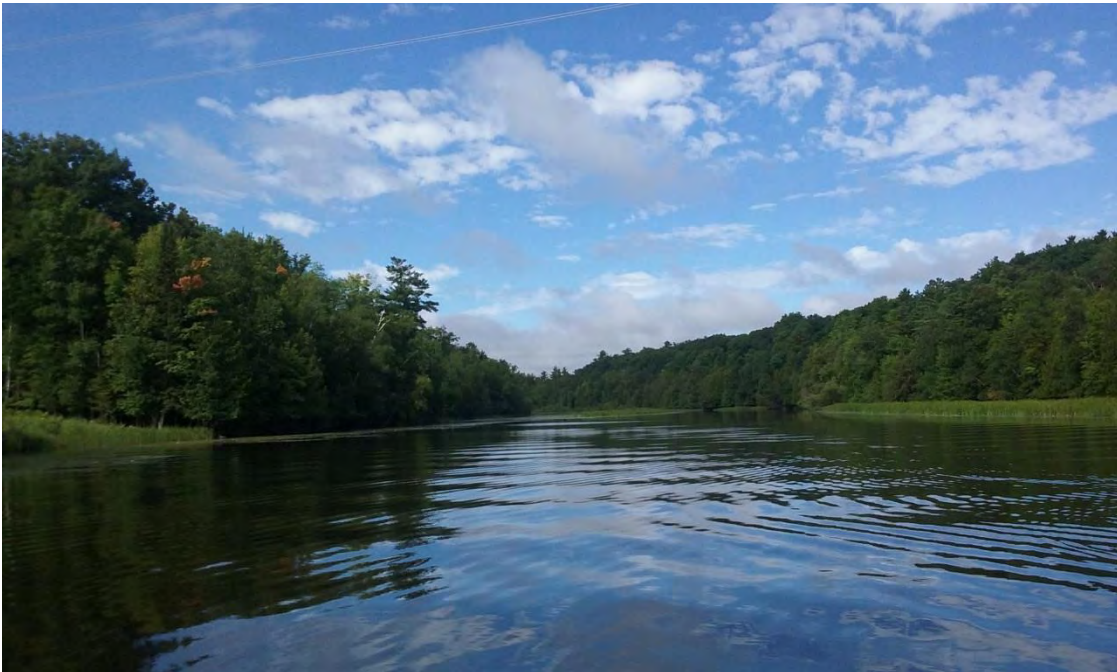
Weather conditions at the time of the survey were fair with overcast cloud cover early in the morning. Conditions shifted to sunny with moderate wind speeds (ideal conditions for the survey) in the mid-morning, afternoon and into the evening hours. During the survey, purple loosestrife (PL) was located within the project boundary, but densities were reduced from previous year's survey totals.

Photo of weather conditions during the 2016 survey
