OAK CREEK FRONTAL LAKE MICHIGAN TWA WQM PLAN 2017

*Oak Creek (SE05)
HUC: 040400020102
Monitored 2015*

EGAD # 3200-2017-11
Water Quality Bureau,
Wisconsin DNR

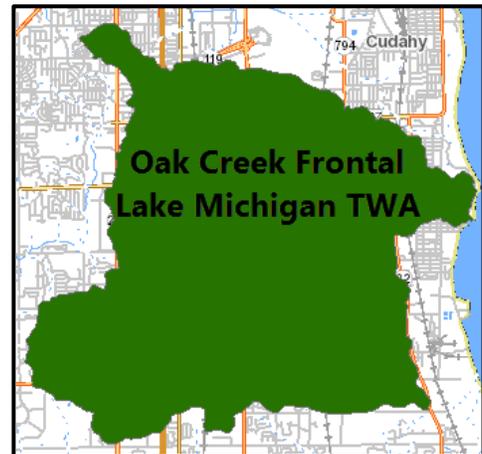
Figure 1: Oak Creek Frontal Lake Michigan TWA Watershed.

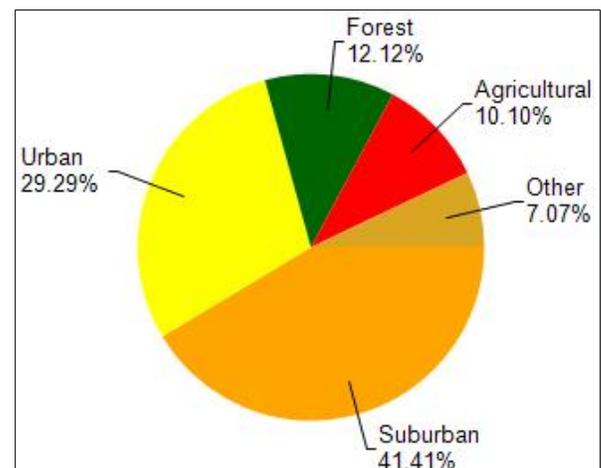
Figure 2: Land use in Oak Creek Watershed (SE05).

The Oak Creek watershed is 26.19 mi². Land use in the watershed is primarily suburban (41%), urban (29%) and a mix of forest (12%) and other uses (17%). This watershed has 48.46 stream miles, 28.09 lake acres and 440.81 wetland acres.

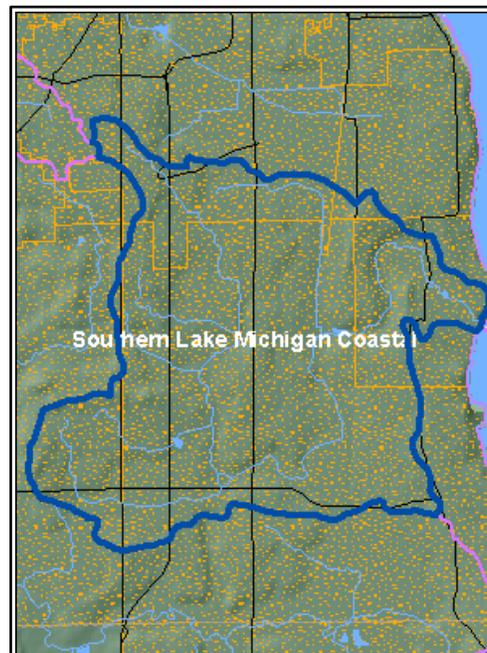
Figure 3: Ecological Landscapes in Oak areas Creek Watershed (SE05).

The Southern Lake Michigan Coastal Ecological Landscape is located in the southeastern corner of Wisconsin along Lake Michigan. The landforms in this Ecological Landscape are characteristic of glacial lake influence, with ridge and swale topography, clay bluffs, and lake plain along Lake Michigan. Further inland, ground moraine is the dominant landform. Soils typically have a silt-loam surface overlying loamy and clayey tills. The historic vegetation in the northern part of this Ecological Landscape was dominated by sugar maple-basswood-beech forests with some oak while the southern part was dominated by oak forest, oak savanna and prairies. Wet, wet-mesic, and lake plain prairies were common in this area. Black ash and relict cedar and tamarack swamps were found in this Ecological Landscape. Today, most of the area is dominated by dairy and cash grain agriculture and intense urban development. Only about 8% of the Ecological Landscape is forested. Maple-beech forests are about half of the remaining forest types with the remainder split equally between oak-hickory and lowland hardwood forest types. There are some of wet-mesic and wet prairie but only small preserves remain since the landscape is heavily disturbed and fragmented. Because of this isolation, fragmentation, and high level of disturbance, non-native plants are abundant.

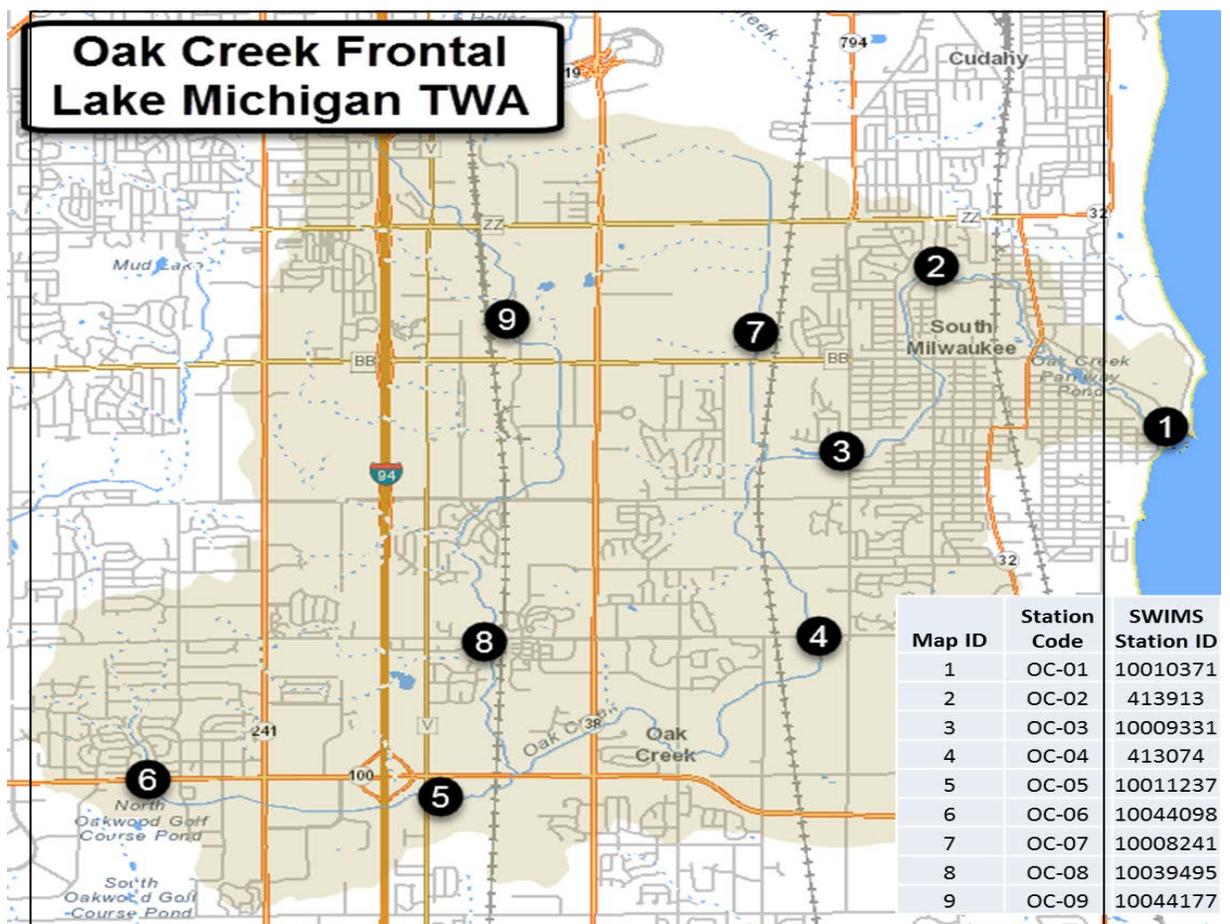
Figure 4: Map of monitored stations in the Oak Creek Frontal Lake Michigan TWA.

This 2015 study collected data on fish assemblage, qualitative habitat, and macroinvertebrates at nine sites (Figure 4 and Table 2). Phosphorus data was collected five times during the growing season from the pour point of the watershed, near the mouth of Oak Creek, as well as one time at each of the other sites. Data was collected during the field season (May to September) of the 2015 calendar year and was entered into the Fish Database and SWIMS.

Water Body Name	WBIC	Station Code	Station ID	Station Name
Oak Creek	14500	OC-01	10010371	Oak Creek at Beach Bridge (63m Upstream)
Oak Creek	14500	OC-02	413913	Oak Creek at 15 th Ave N of Beech St
Oak Creek	14500	OC-03	10009331	Oak Creek at Pennsylvania Ave
Oak Creek	14500	OC-04	413074	Oak Creek at Puetz Road, upstream of RR tracks
Oak Creek	14500	OC-05	10011237	Oak Creek at 13 th Street
Oak Creek	14500	OC-06	10044098	Oak Creek at Ryan Road
Unnamed	14800	OC-07	10008241	Mitchell Field Drainage Ditch at Rawson Avenue
Unnamed	14900	OC-08	10039495	North Branch Oak Creek at Puetz Avenue
Unnamed	14900	OC-09	10044177	North Branch Oak Creek along 6 th Street
