*A Watershed Report  
created by the Bureau  
of Water Quality in  
support of the Clean  
Water Act.*

# NORTH BRANCH BEAVER CREEK TWA WQM PLAN 2017

*Little Peshtigo River (GB08)  
HUC: 040301050503, Monitored in 2014*

EGAD # 3200-2017-22  
Water Quality Bureau,  
Wisconsin DNR

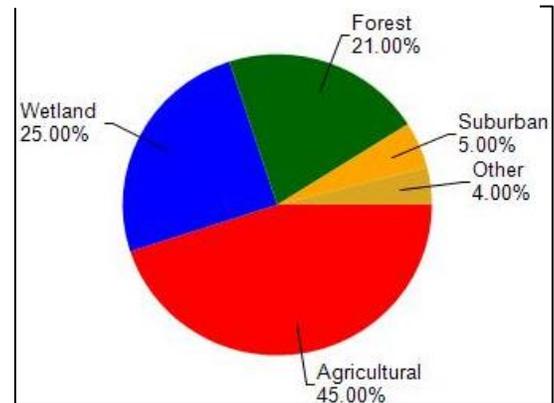
Figure 2: Land use in the Little Peshtigo River.

North Branch Beaver Creek is located in the Little Peshtigo River watershed which is 158.43 mi<sup>2</sup>. Land use in the watershed is primarily agricultural (45%), wetland (25%) and a mix of forest (21%) and other uses (9%) (Figure 2). This watershed has 206.41 stream miles, 2,168.89 lake acres and 24,619.22 wetland acres.

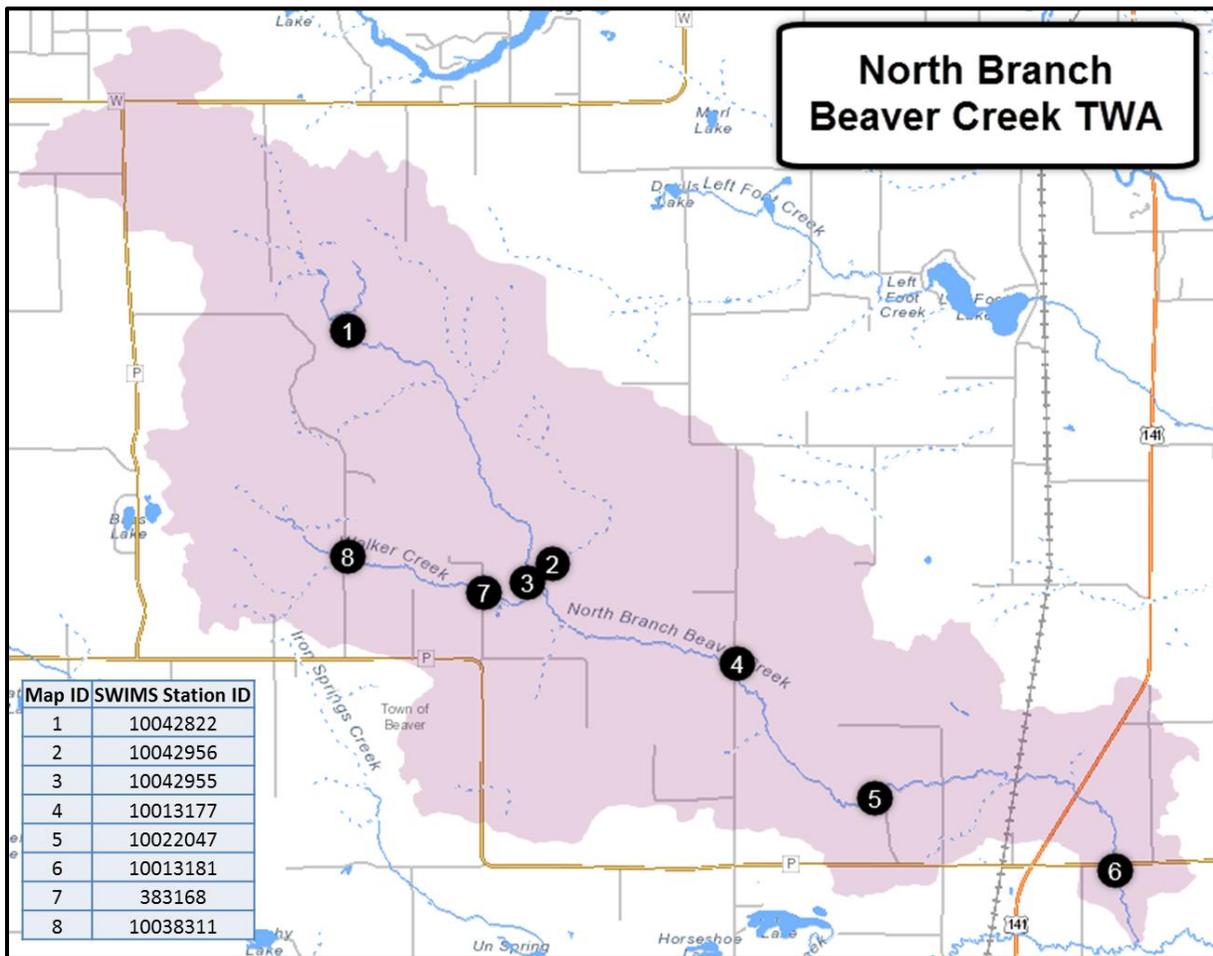
Figure 5: Map of the monitoring stations for the North Branch Beaver Creek TWA.

The study sites were selected so to reduce bias for a specific type of stream order, location, or natural community; however, sites may have been targeted based on ease of access and the need to update information due to limited or outdated data for a particular stream reach. Data collection stations were established to limit outside influences and to enable staff to use DNR field procedures that require 35 times the mean stream width (Modified from Simonson, et al. 1994) for fish and habitat parameters. Stations were established to ensure that no less than the minimum of 100 meters -- and no more than the maximum of 400 meters -- were sampled.

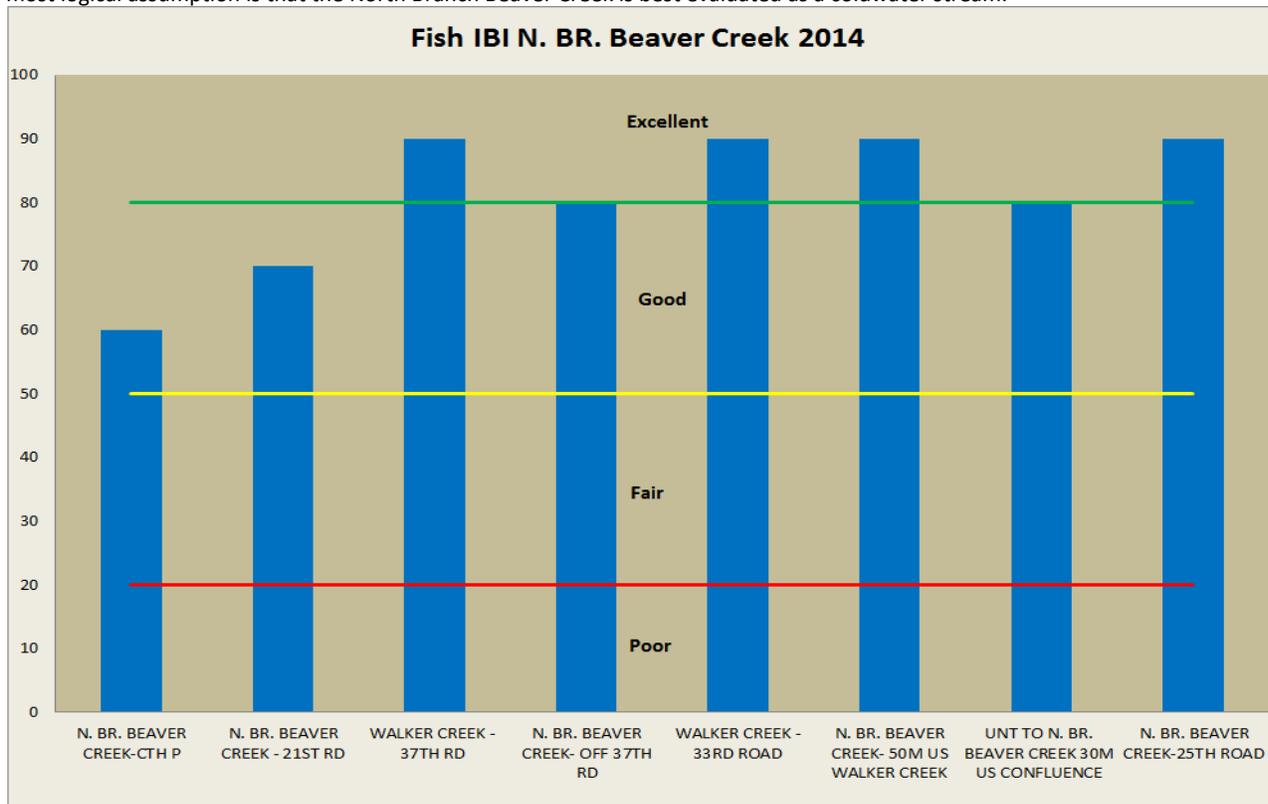
Results of the fisheries surveys are summarized in Table 5. The Wisconsin Stream Natural Community Model results (Lyons, 2008) indicate that the streams in the North Branch of Beaver Creek are a mix of Cool-Warm Headwater, Cool-Warm Mainstem, Cool-Cold Headwater, and Coldwater streams. Utilizing the natural community verification draft guidance (Lyons, 2013), based on the fish assemblages observed, seven of eight streams monitored do not fit the respective modeled natural community. All stream sites, with the exception of the North Branch of Beaver Creek at CTH P, exhibited a “best fit” for thermal and size guild matched with coldwater streams. The stream reach at North Branch Beaver Creek at CTH P fits a Cool-Cold Headwater; however, this station is the furthest downstream segment and the flows observed do not fit a headwater stream. As such, the small stream/intermittent FIBI metric not an appropriate tool and should not be applied to this section the stream. The next most logical assumption is that the North Branch Beaver Creek is best evaluated as a coldwater stream.

Figure 6: Fish IBI scores for North Branch Beaver Creek Watershed Survey 2014.

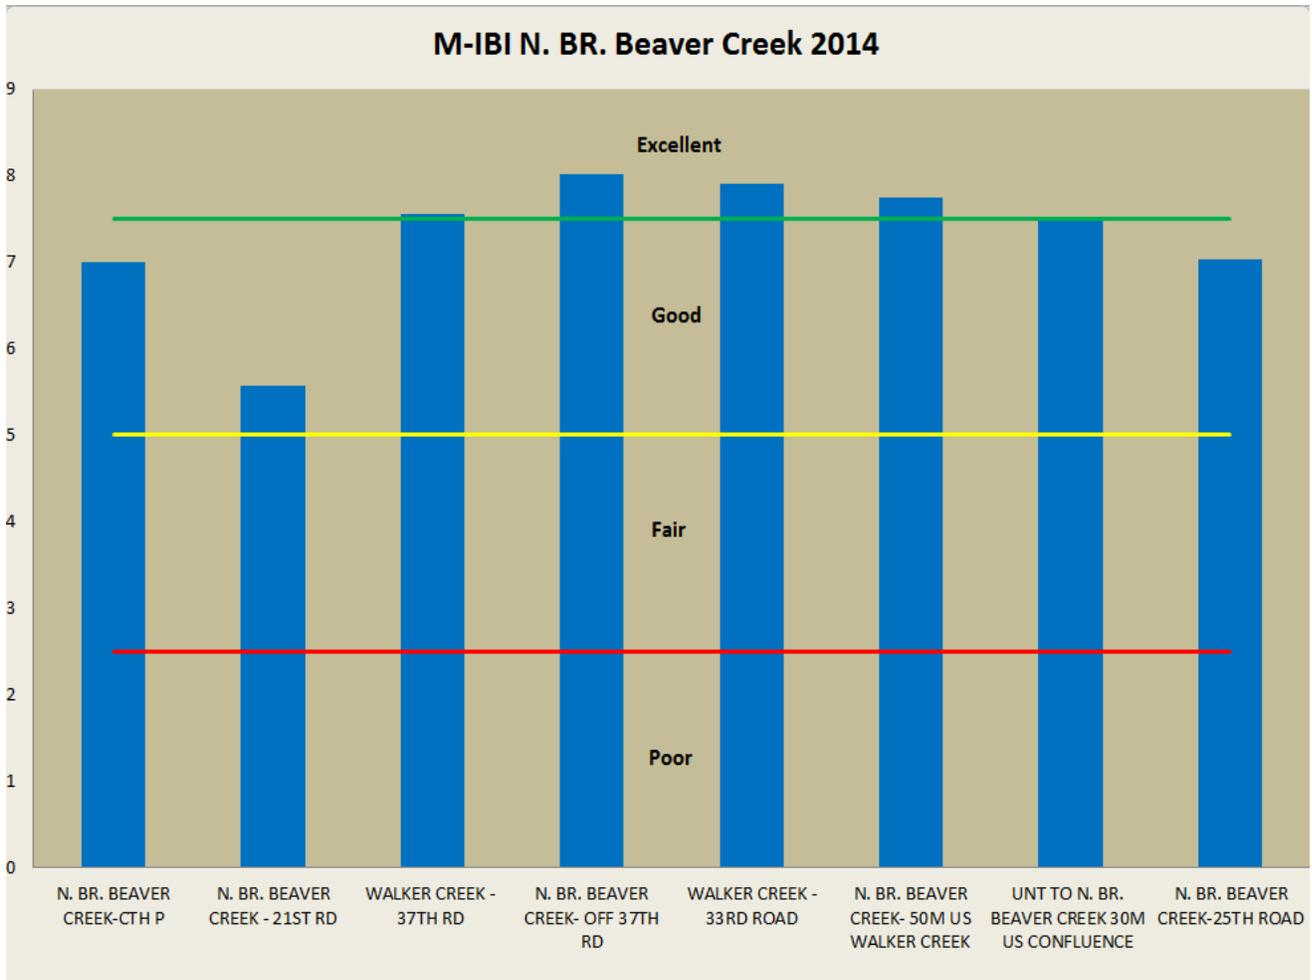
Macroinvertebrate samples were collected at all sites and evaluated with the Hilsenhoff Biotic indices (HBI) (Hilsenhoff, 1987), Family level Biotic Indices (FBI) (Hilsenhoff 1988) and the Macroinvertebrate Index of Biotic Integrity (MIBI) (Weigel, 2003). Results were fairly consistent among sites sampled – all sites rated as good to excellent (Table 6).

Figure 7: MIBI values for selected streams and stations in the North Branch Beaver Creek Watershed Survey 2014.

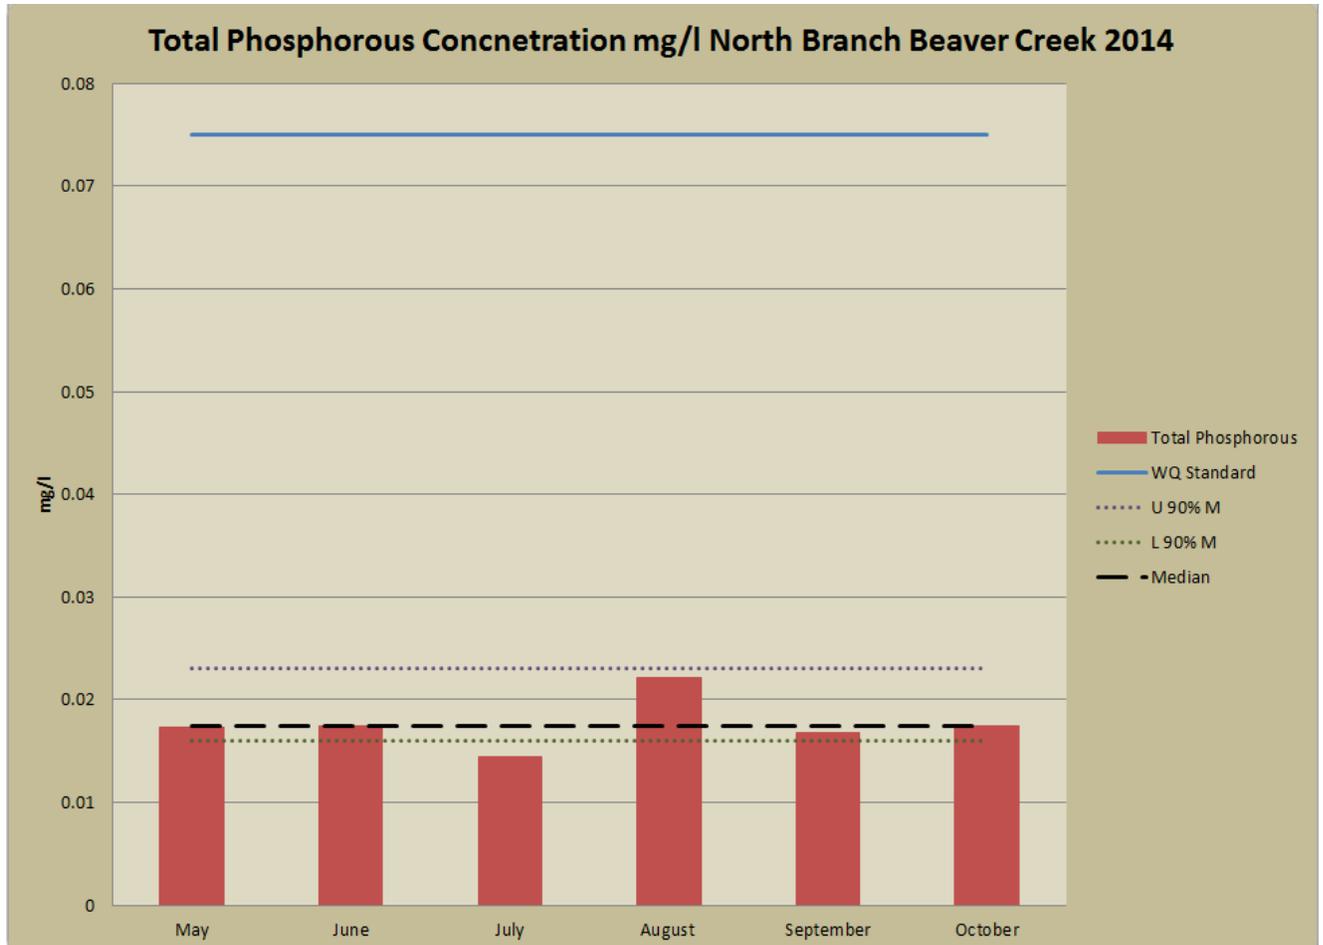
During the monthly growing season total phosphorous samples were collected from the furthest downstream pour point on the North Branch of Beaver Creek at CTH P. The results indicated that the state standards for total phosphorous were met and that total phosphorous concentrations were in 2014 below levels that would result in impairments within the stream (Figure 8).

Figure 8: Total Phosphorous Monitoring Results North Branch Beaver Creek at CTH P 2014
