## **PROJECT SETTING**

### **DESCRIPTION OF PROJECT**

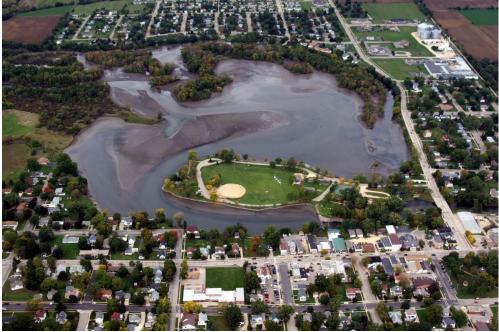
Photo 1: Lake Belle View Prior to Construction (2010 Drawdown)

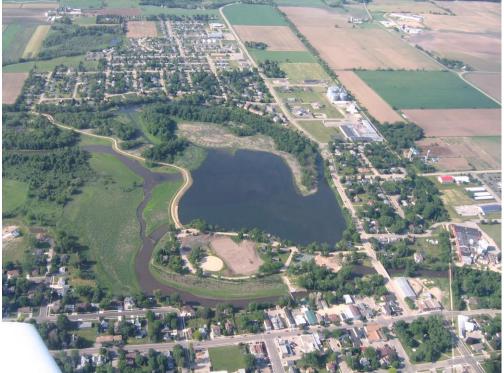
- Water Quality Improvement Significant qualitative improvement in the water quality of the restored portion of the lake has been observed (Photos 2 & 4). Photo2 clearly indicates significant improvement in water clarity when comparing the Sugar River on the west side of the separation berm to the restored portion of Lake Belle View on the east side of the separation berm. Quantitative measurements of water quality improvement will be collected starting this fall and will be ongoing for at least the next five years per permit requirements.

Photo 2: Lake Belle View After Construction of Separation Berm, Lake Deepening, and Habitat Earthwork (June 2011)

lake, and discharges over the existing dam. Berm and landscaping construction is complete. This project is now being monitored for proper vegetation restoration. Water clarity has been greatly improved as noted on the before and after photos included at the end of this report. Note the high sediment load within the Sugar River and the visibility of the bottom in the newly restored portion of Lake Belle View.

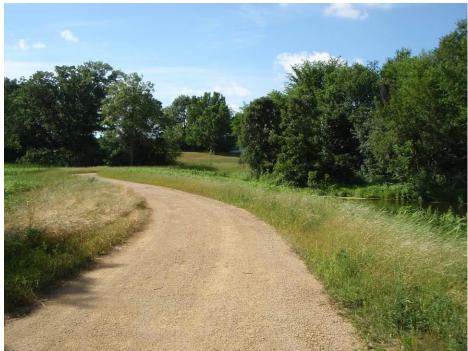
Photo 3: Separation Berm and Walking Path (June 2011)

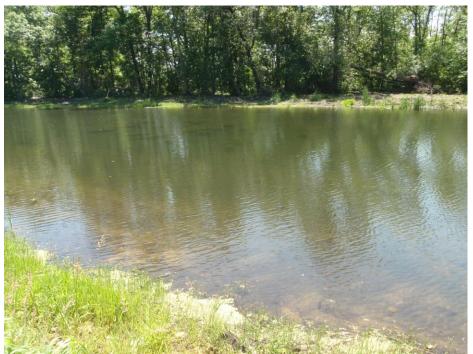
Photo 4: North Channel Portion of Lake Belle View Water Depths ~4 feet - Note the Water Clarity (June 2011)
