# Big Green Lake TWA WQM Plan 2017

## *Big Green Lake (UF07)*

*A Watershed Report created by the Bureau of Water Quality in support of the Clean Water Act.*

EGAD # 3200-2017-14  
Water Quality Bureau,  
Wisconsin DNR

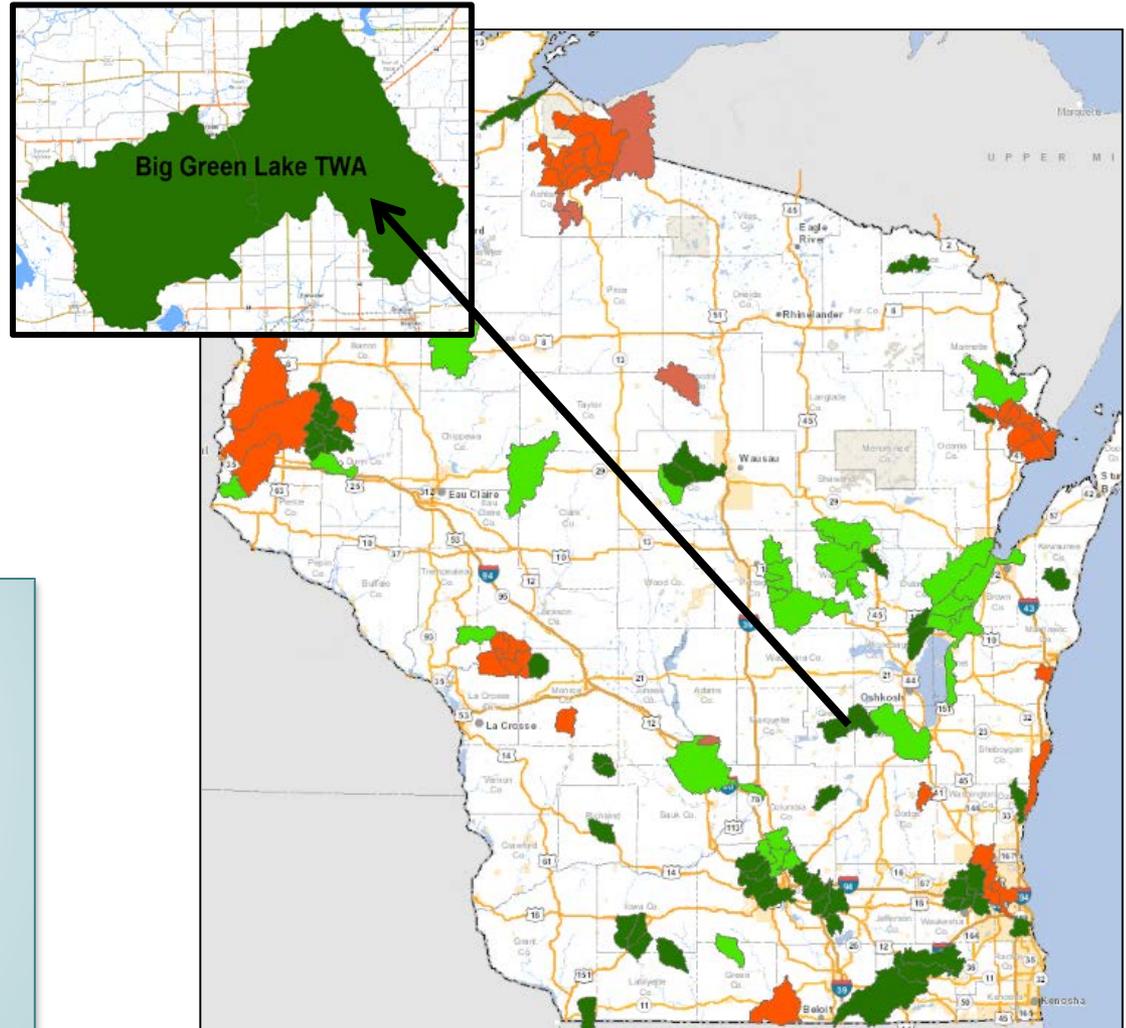
Land Use	Acres	% of Area
Agriculture	44,639.76	65.00%
Open Land and Water	10,665.47	15.53%
Forest	6,016.07	8.76%
Wetland	3,935.17	5.73%
Suburban	2,211.38	3.22%
Urban	597.49	0.87%
Grassland	556.28	0.81%
Barren	48.07	0.07%
Total Acres in Watershed	68,676.55

The majority of the land cover in the Big Green Lake Watershed is Agriculture (65%) followed by Open Land and Water (15.53%). Forest also covers a sizeable portion of the watershed (8.76%) followed by Wetlands, which constitute approximately five and three-quarters of the watershed. The last reasonably sized land cover is Suburban (3.22%).

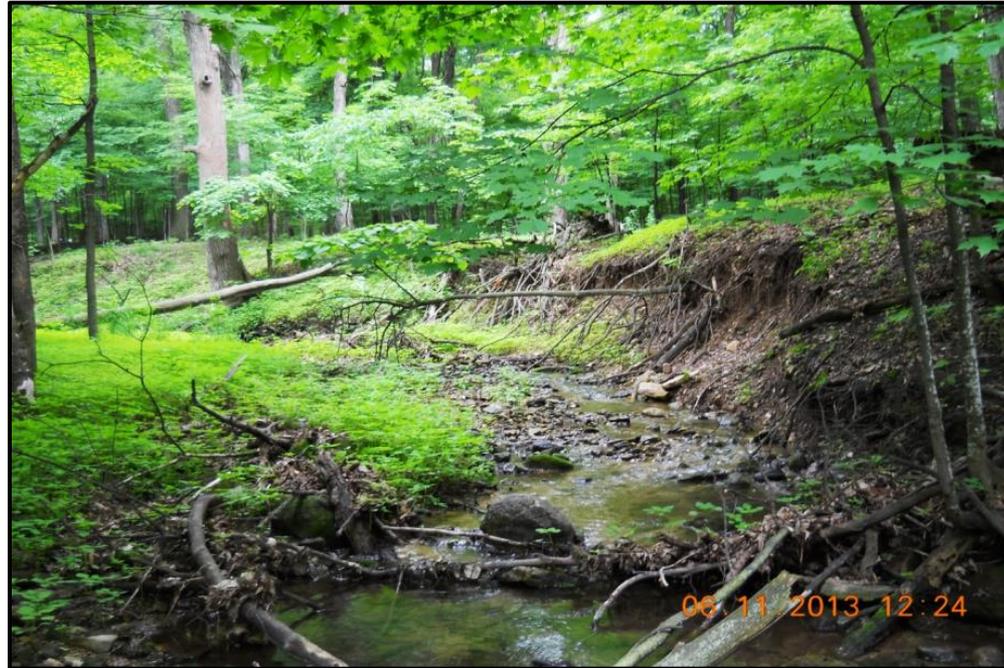
Unstable banks in White Creek

- Add Hill Creek to Wisconsin's impaired waters list for phosphorus
- Restore unstable streambanks with partners
- Implement cover crops to reduce erosion
- Increase buffer widths in subwatersheds to decrease nutrient and sediment runoff
- Replace culverts to increase fish habitat

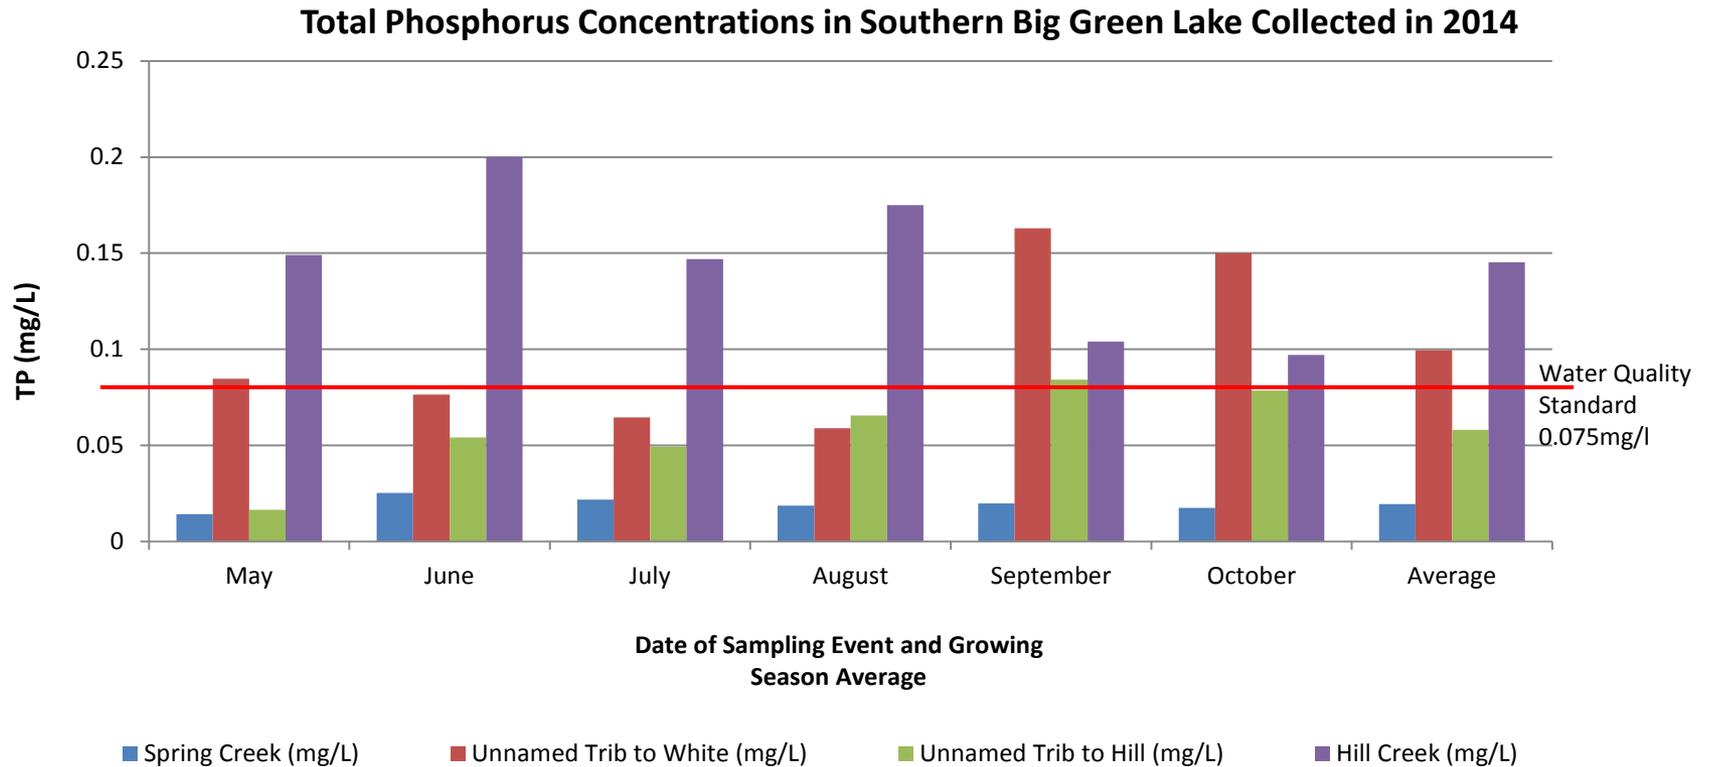
Two of the four creeks' samples in the Southern Big Green Lake watershed had an average TP concentration (mg/L) exceeding the NR 102 water quality criteria (WQC) for creeks and rivers of 0.075 mg/L

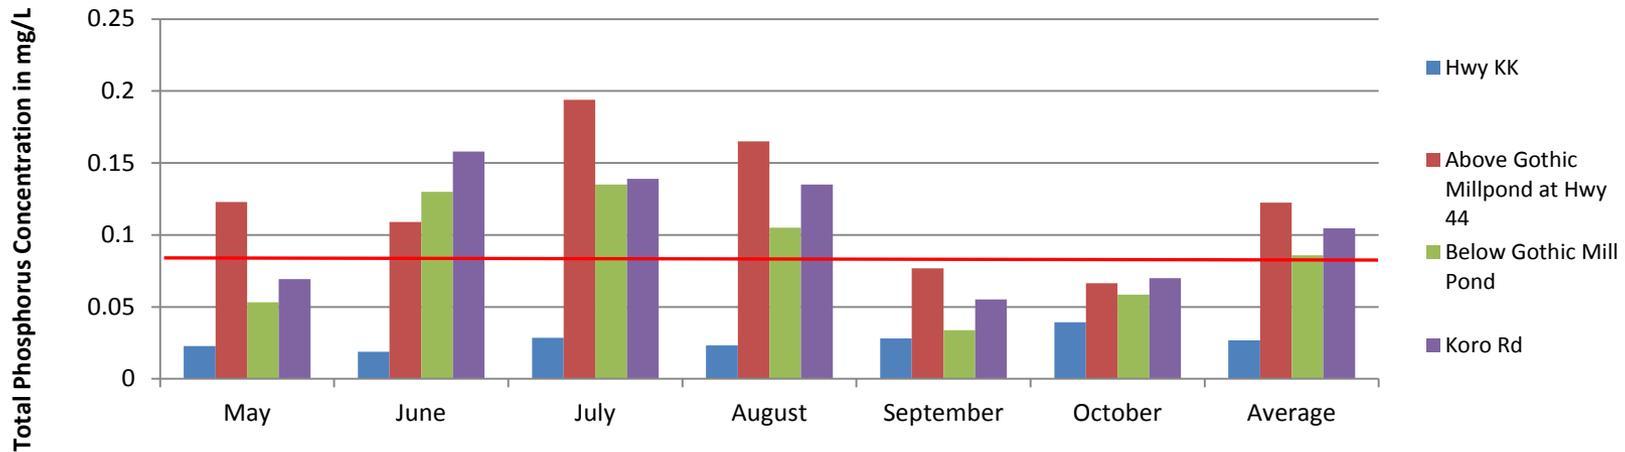
## Total Phosphorus Results and Averages for 2014 Samples in the Silver Creek Mainstem

Eight of the 11 sites in the Silver Creek watershed had an average TP concentration (mg/L) exceeding the NR 102 WQC for creeks at 0.075 mg/L.

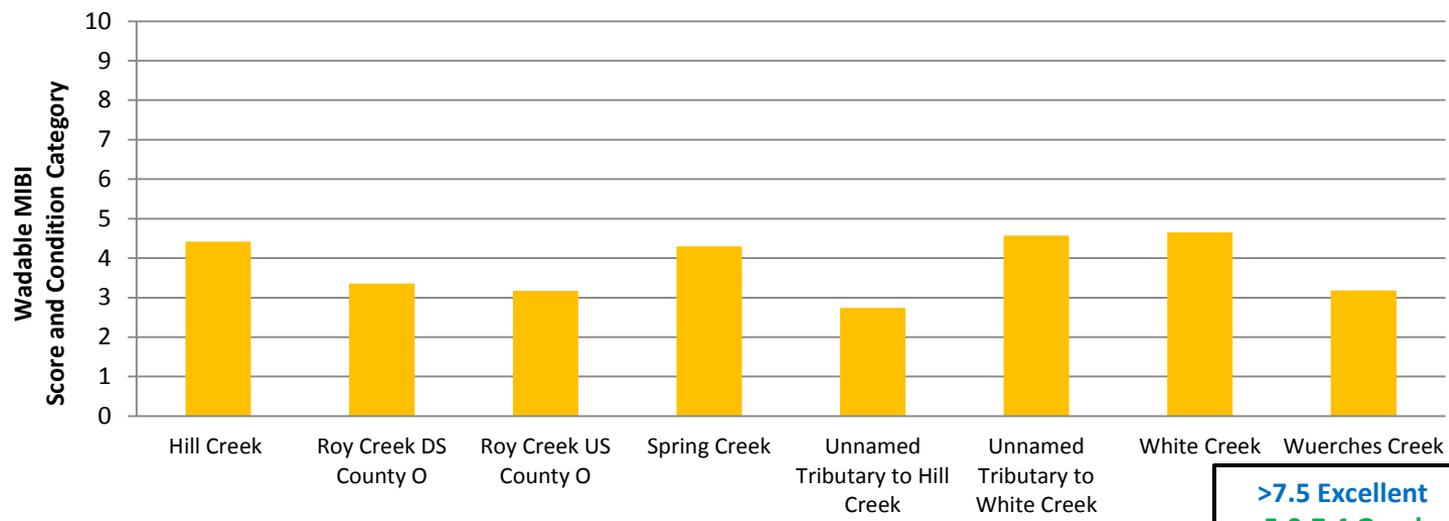
## Wisconsin Wadable Macroinvertebrate Index of Biotic Integrity Values & Condition in 2014

All streams demonstrated a macroinvertebrate community significantly impacted by environmental degradation.

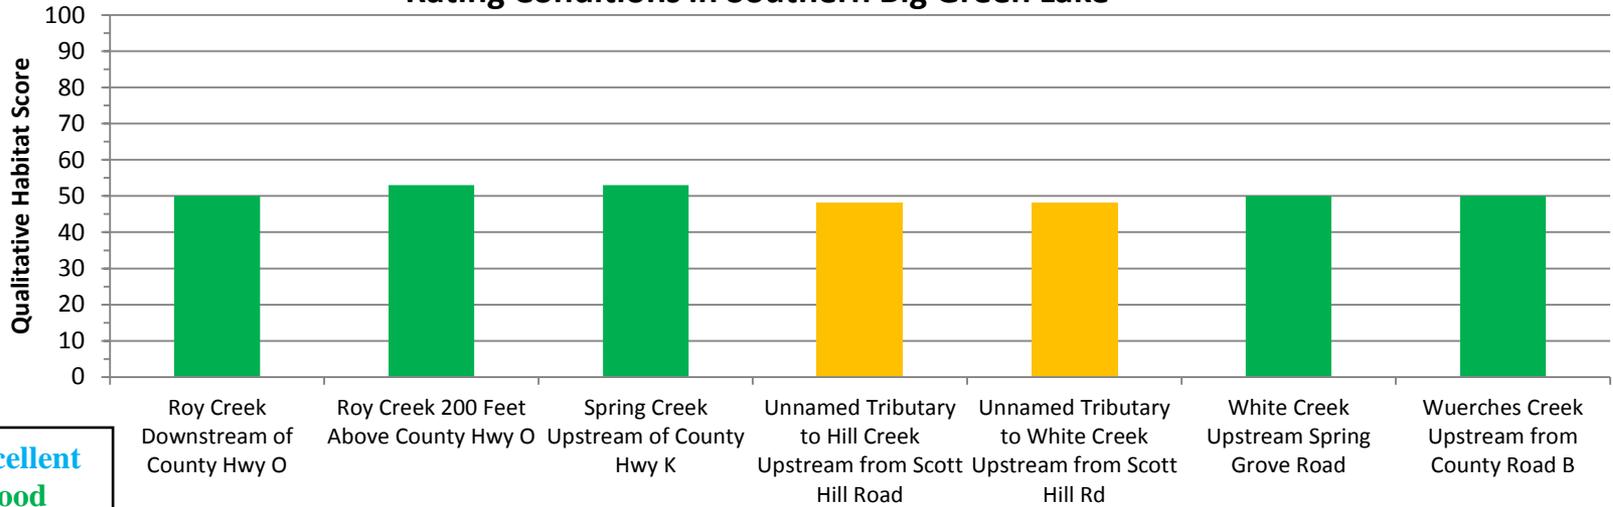
**Qualitative Habitat Scores and Rating Conditions in Southern Big Green Lake**

**75-100 Excellent**  
**50-74 Good**  
**25-49 Fair**  
**0-24 Poor**

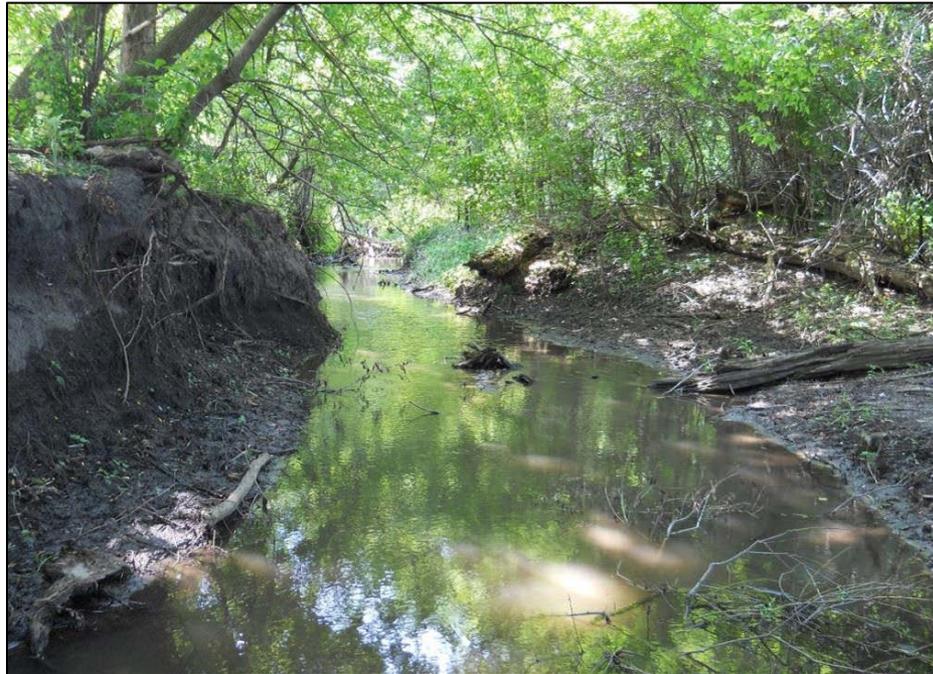
An example of an unstable bank on Roy Creek

- Encourage restoration of streambanks
- Reduce erosion
- Explore forested and native grass buffers compare to grassed buffers for nutrient reduction
- Collaborate with partners including: Green Lake County LCD, Green Lake Sanitary District, Green Lake Association, NRCS, and USGS
