THUNDER LAKE PLANNING GRANT

INVENTORY & RECOMMENDATIONS

THUNDER LAKE
PROTECTION & REHABILITATION
DISTRICT

RAND ATKINSON AQUATIC RESOURCES, INC.

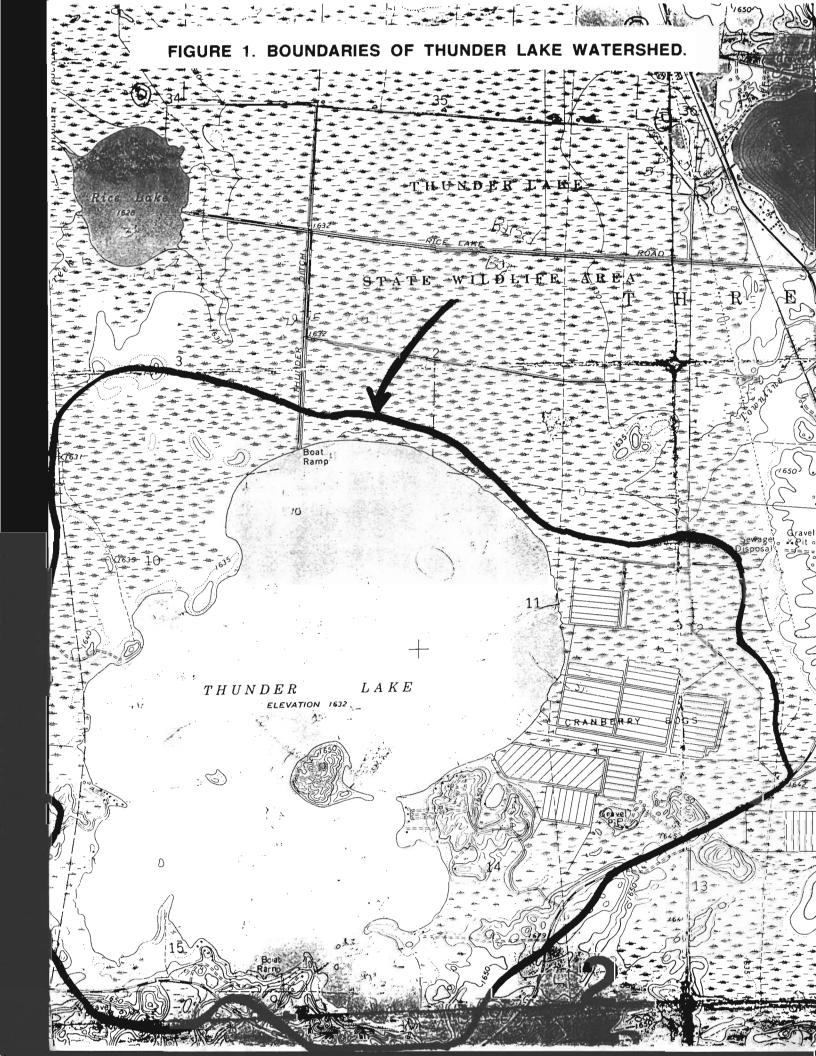
Thunder Lake's watershed to the south and west is easily defined by the hilly terrain with many streams flowing away to the south and west (Figure 1). The watershed is approximately 2,230 acres, which is primarily lowlands. Direction of ground water movement adjacent to Thunder Lake was evaluated in a1980 study to develop a nutrient budget for the lake. Groundwater in peat soils moves laterally with little change in gradients and any physical obstruction either from beneath the peat (such as subterrainian clay deposits or impermeable subsoils) or at the land surface (roads, dikes, culverts, dams, and beaver dams) can change direction of water flow. Pumping of large volumes of water can also seasonally effect these gradients. The 1980 study concluded in general that the horizontal gradient or the general movement of water in the bog ecosystem that surroundsThunder Lake was from south to north.

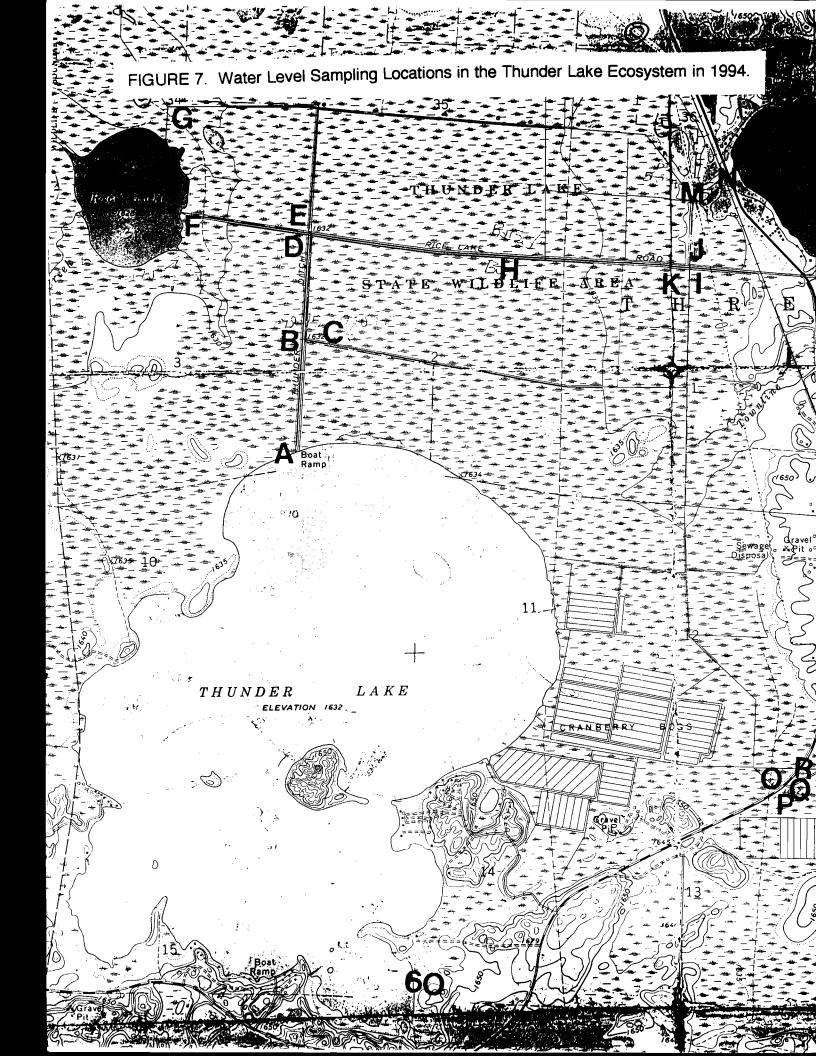
This investigation centered on the pattern of water levels and related flows in this low gradient system through a growing season. Water level sampling locations were chosen thoroughout the Thunder Lake system where roads, culverts, and dams had interrupted the natural lateral movement of water through this wetland system. These locations are marked in FIGURE 7.
