**THE AQUATIC PLANT COMMUNITY OF  
MASON LAKE,  
ADAMS/MARQUETTE COUNTY, WI.  
DECEMBER 2010**

**Presented by Reesa Evans, CLM, Lake Specialist  
Adams County Land & Water Conservation Department  
P.O. Box 287                      Friendship, WI 53934  
608-339-4268**

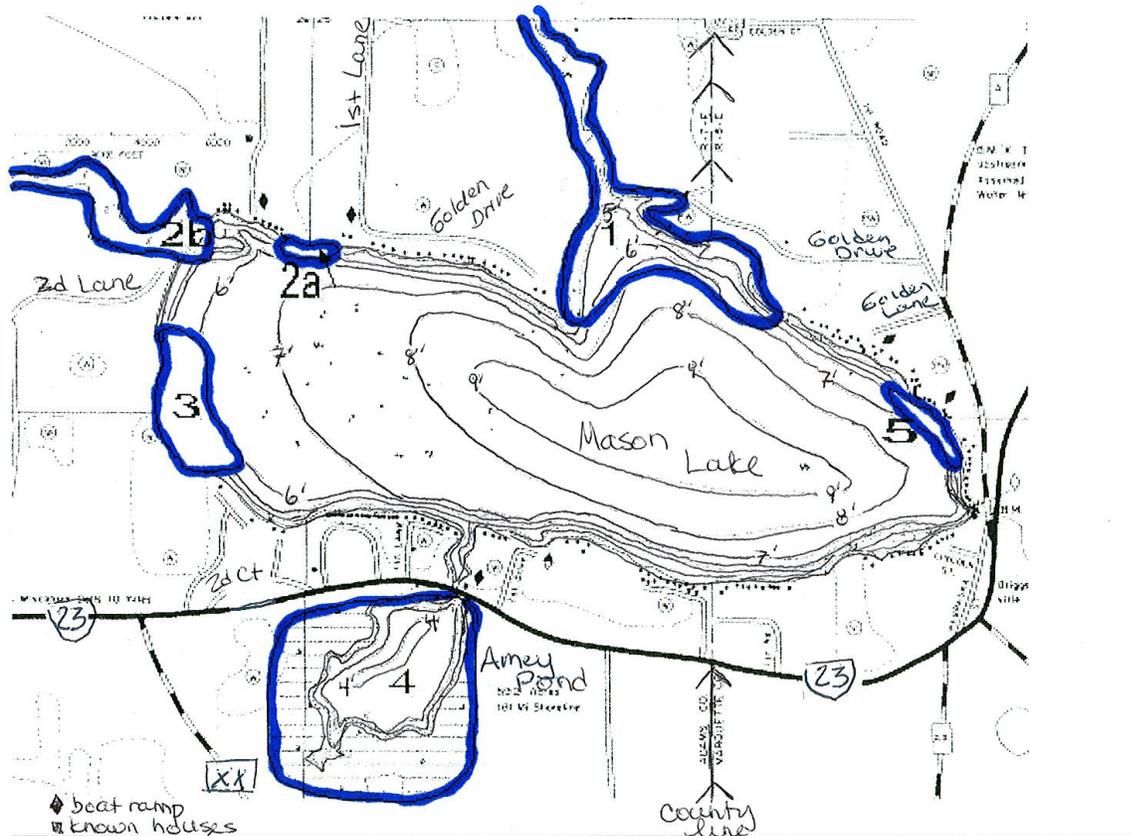
**Figure 2: Critical Habitat Areas on Mason Lake**

This sensitive area extends along approximately 4000 feet of shoreline in the cove and up the stream, averaging 3 feet in depth and supports important near-shore terrestrial habitat, shoreline habitat and shallow water habitat. The sediment is sand, silt, rock and peat. This area is also important for maintaining water quality, since it is the site of one of the tributaries feeding into Mason Lake and has a large wetland

area that serves as a filter. It has a fairly diverse terrestrial and aquatic plant community (compared to other parts of this lake) and has natural scenic beauty, since it is one of the few fairly undeveloped areas of the lake shore.

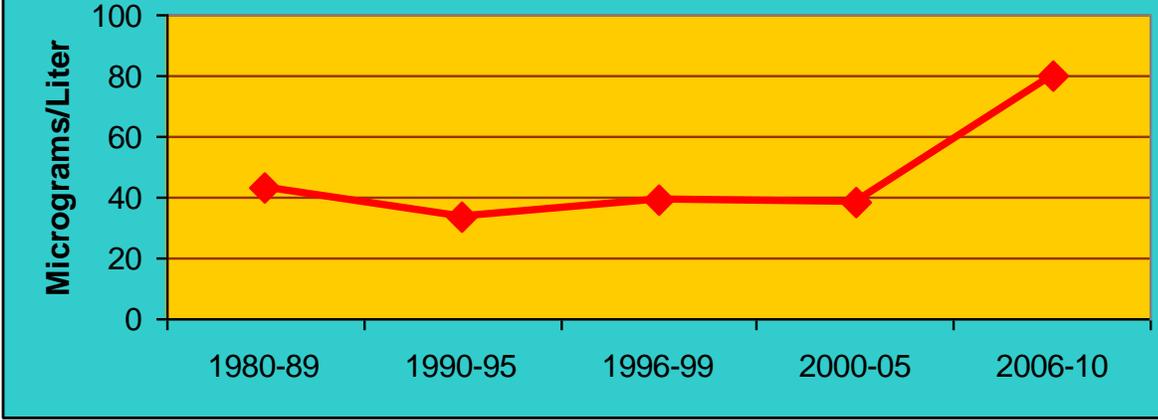
**Figure 3: Average Growing Season Total Phosphorus**

Since Mason Lake is one of the WDNR trend lakes, there is water quality information going back to 1973. The average overall growing season (May through September) Total Phosphorus was 93.9 micrograms/liter from 1973 through 2010. The level was fairly steady from the 1970s into the early 2000s, but it has nearly doubled in the past 5 years (Figure 3). The highest growing season total phosphorus level was recorded in July 2010, when the reading was 702 micrograms/liter. The lowest was 20 micrograms/liter in May 1996.

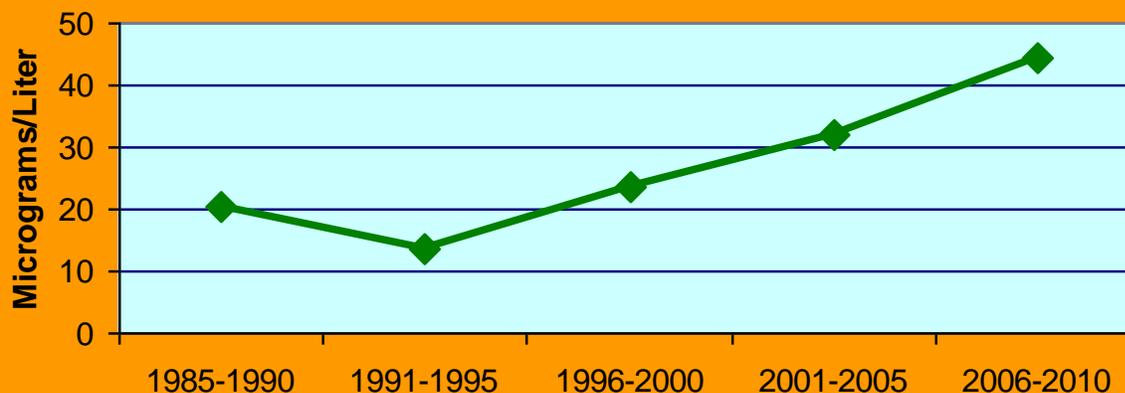
**Figure 4: Average Growing Season Chlorophyll-a Levels**

Chlorophyll-a growing season levels are available for Mason Lake back to 1980. The overall growing season chlorophyll-a average from 1985 through 2010 is 26.9 micrograms/liter. A look back at the changes since 1980 show that chlorophyll-a (and thus algae levels) decreased in the early 1990s, but started rising again in the late 1990s and have continued to rise (see Figure 4). The overall growing season chlorophyll-a average from 1977 through 2010 is 45.2 micrograms/liter.

The late 1980s average was 20.6 micrograms/liter, dipping to 13.8 micrograms/liter in the early 1990s, then rising to 23.7 micrograms/liter in the late 1990s. It kept rising in the 2000s, up to an average of 44.5 micrograms/liter by 2006-2010. The highest growing season chlorophyll-a level reported was 125.0 micrograms/liter in August 1996, with the lowest found in June 1995 when it was 1.9 micrograms/liter.

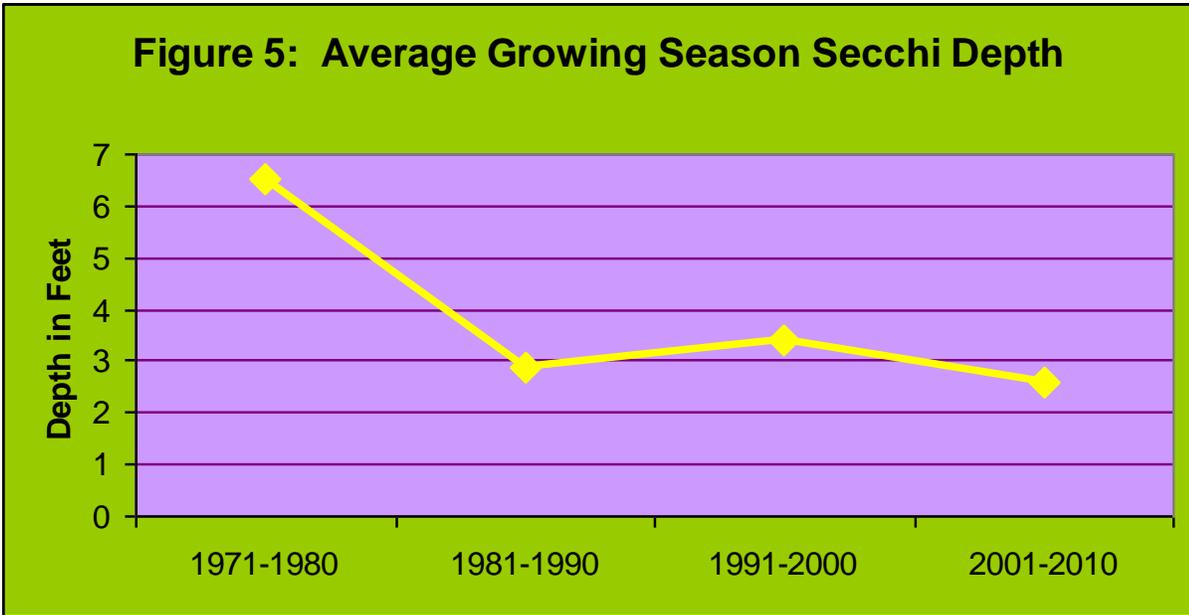
Water clarity is a critical factor for aquatic plants, because if they don't get more than 2% of surface illumination, they won't survive (Chambers and Kalff 1985, Duarte et. al. 1986, Kampa 1994). Water clarity is reduced by turbidity (suspended materials such as algae and silt) and dissolved organic chemicals that color the water. Water clarity is measured with a Secchi disc that shows the combined effect of turbidity and color. Mason Lake has traditionally had low Secchi disk readings, since they were first taken in May 1973. Secchi disk readings have shown a significant downward trend since 1973 (see Figure 5).

The overall growing season mean for Secchi disk readings in Mason Lake is 3.2 feet. This goes from a high average of 6.9 feet in the 1970s to the 2.6 feet average of the 2000s. The lowest growing season Secchi disk recorded was .66 feet in August 1997; the highest recorded was 8 feet, found in May 1973, July 1977, June 1992, June 1994, May 1998 and July 2001.

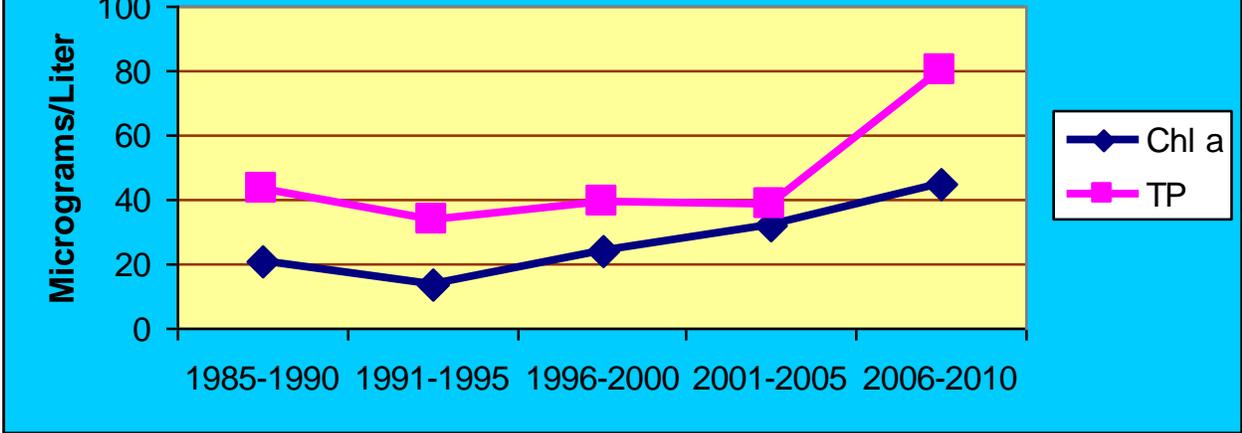
**Figure 6: Average Growing Season TP & Chlorophyll-a**

The combination of phosphorus concentration, chlorophyll concentration and water clarity indicate that Mason Lake is an eutrophic to hypereutrophic lake with high total phosphorus levels and low Secchi disk readings, plus high chlorophyll-a levels. Graphing the average growing season total phosphorus against the average growing season chlorophyll-a levels show that both have been increasing (Figure 6). Comparing Figure 6 to Figure 5 reveals that as Secchi disk readings have gone down, both Total Phosphorus and Chlorophyll-a have gone up.

This trophic state indicates a turbid system dominated by algae, instead of a clear water system dominated by aquatic plants. Frequent and/or ongoing algal blooms would be expected.

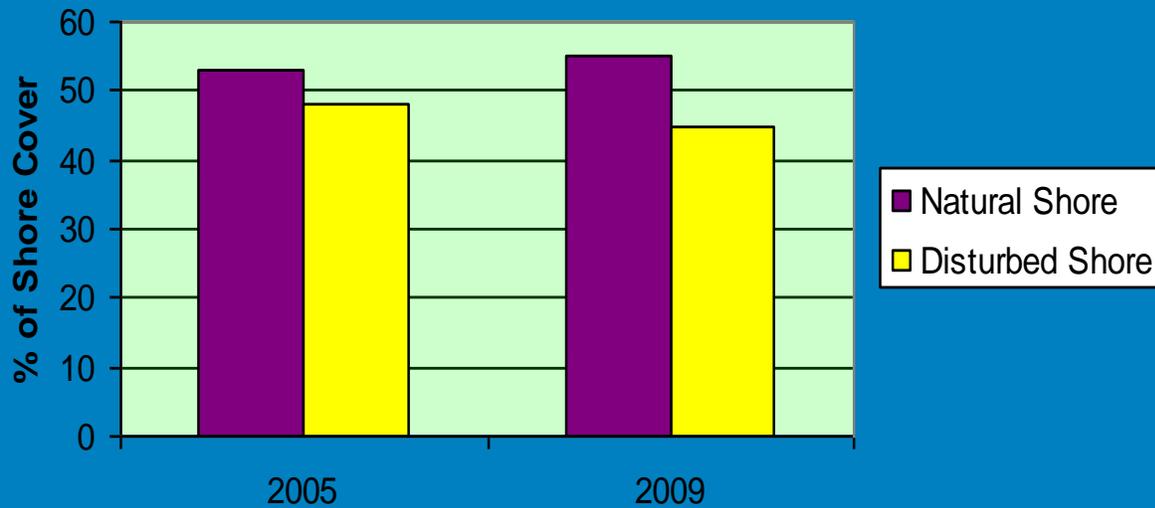
**Figure 10: Changes in Shore Cover 2005 to 2009**

Some type of natural shoreline (wooded, shrub, native herbaceous) covered 53% all of the sites in 2005. The coverage occurrence of natural shoreline in 2009 was raised slightly to 55%. Some type of disturbed shoreline (cultivated lawn, rock riprap, hard structure, pavement, etc) covered 45% of the sites in 2009, down slightly from 47% in 2005 (see Figure 10).

The frequency of occurrence of cultivated lawns stayed the same in 2005 and 2009—both surveys showed a 62% occurrence frequency of cultivated lawn. However, hard structures (piers, boathouses, wooden walkways) increased in frequency of occurrence from 38% to 50% and rock/pavement increased in occurrence frequency from 38% to 54%.

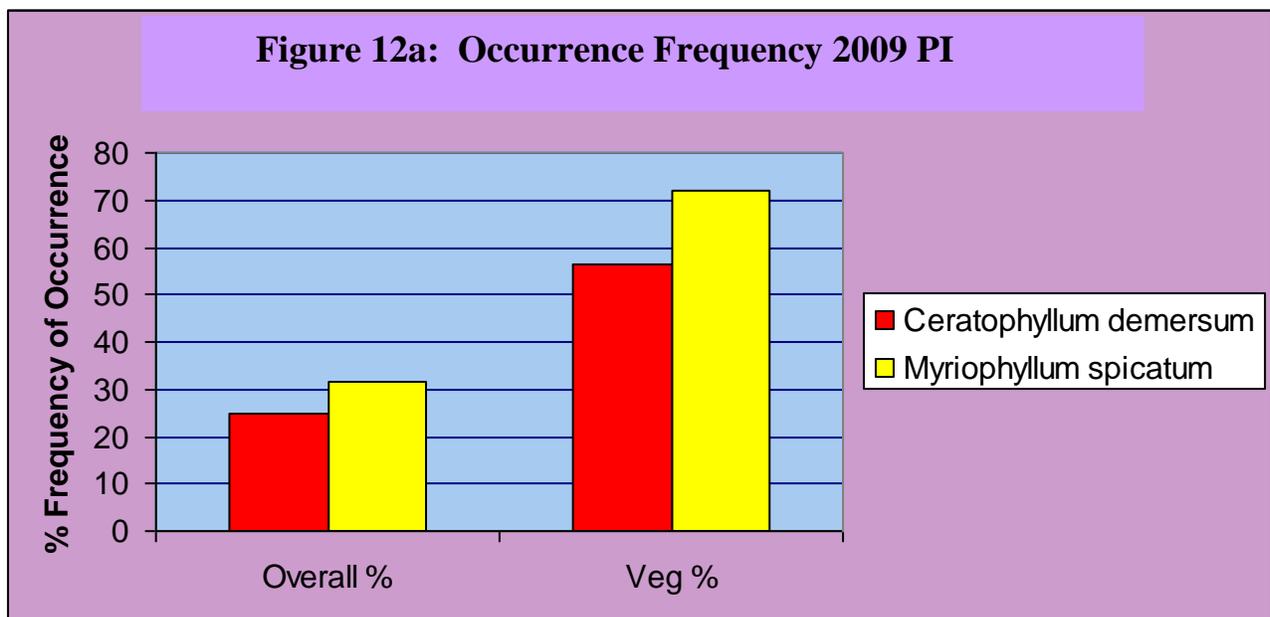
The invasive aquatic plant, *Myriophyllum spicatum* (Eurasian watermilfoil) was the most frequently-occurring plant in the PI survey, with an occurrence frequency over 31% in 2009 and over 42% in 2010. The next most frequently-occurring plant in this survey was *Ceratophyllum demersum* (Coontail), a native plant found in many aquatic habitats, with an occurrence frequency of nearly 25% (see Figure 12a). All other species had occurrence frequencies of less than 8% in the PI survey.

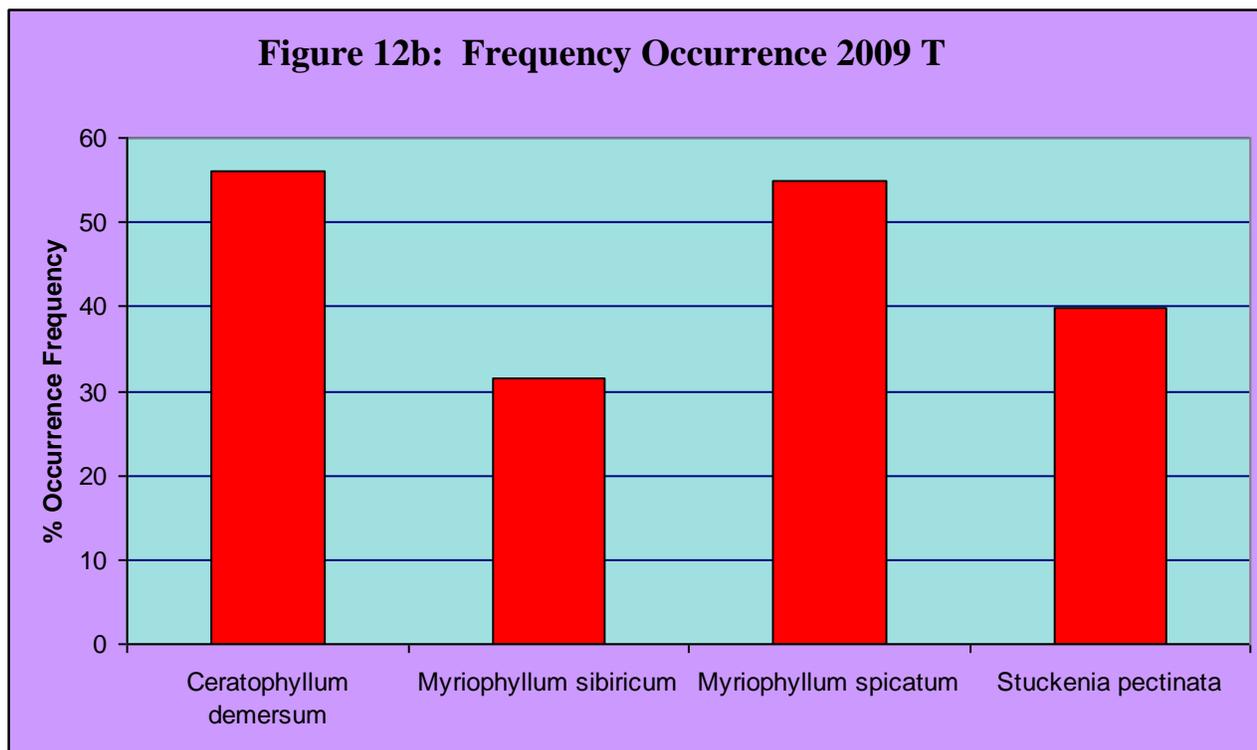
The most frequently-occurring aquatic plant in the transect survey in 2009 was *Ceratophyllum demersum*, with an occurrence frequency of 56%, but it was followed closely by *Myriophyllum spicatum* with an occurrence frequency of 55%. Both

*Myriophyllum sibiricum* (Northern watermilfoil) and *Stuckenia pectinata* (Sago pondweed) had occurrence frequencies between 30% and 40% (see Figure 12b). All other plants occurred at less than 13% frequency.

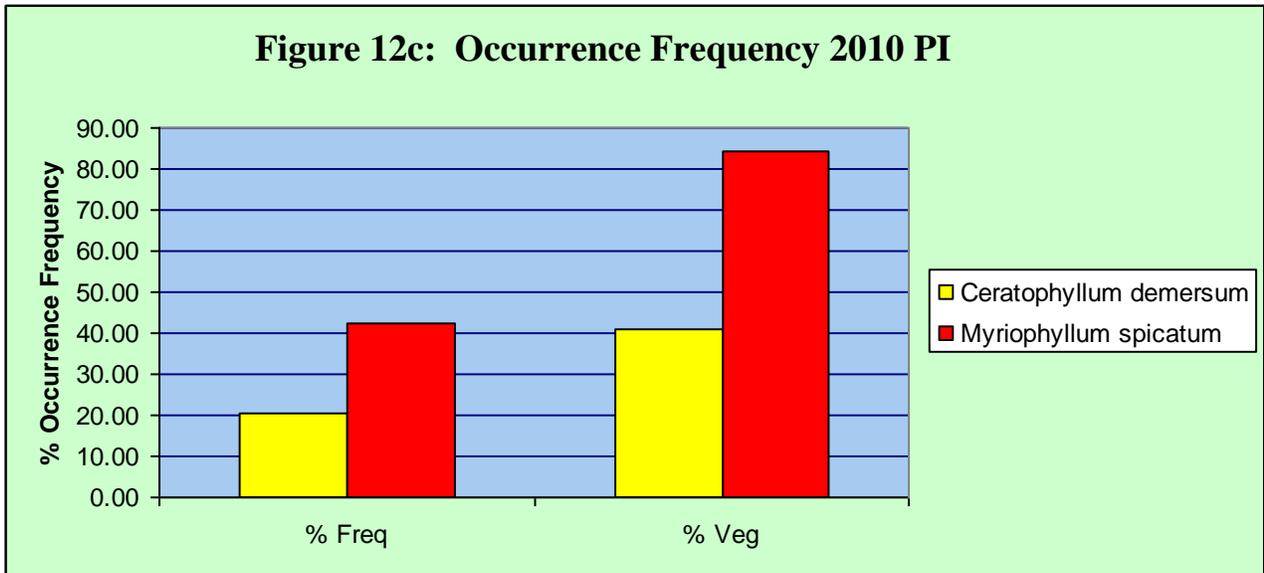
**Figure 12c: Occurrence Frequency 2010 PI**

The only two species with any significant frequency of occurrence in the 2010 PI survey were *Myriophyllum spicatum* and *Ceratophyllum demersum*. All of the rest of the species found in 2010 had less than 3% frequency of occurrence overall and less than 5% frequency of occurrence where vegetation was found.

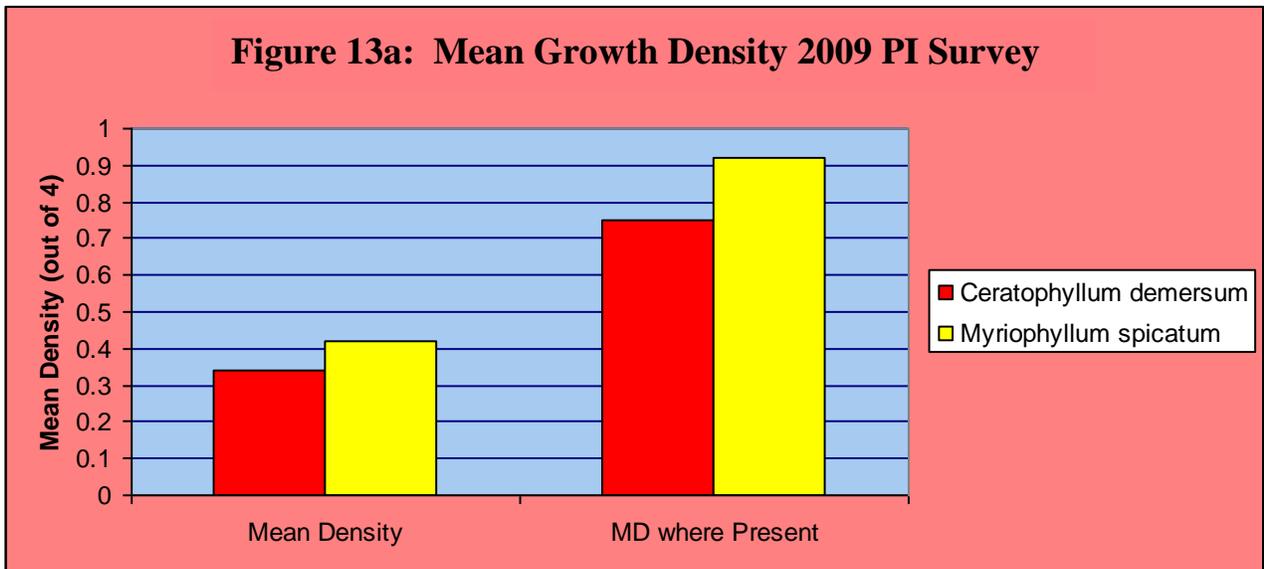
**Figure 13a: Mean Growth Density 2009 PI Survey**

In the 2009 PI survey, the aquatic plants with the highest density were *Myriophyllum spicatum* and *Ceratophyllum demersum* (see Figure 13a). No aquatic species had a more than average density of growth either in overall density or in density where present under the PI results.

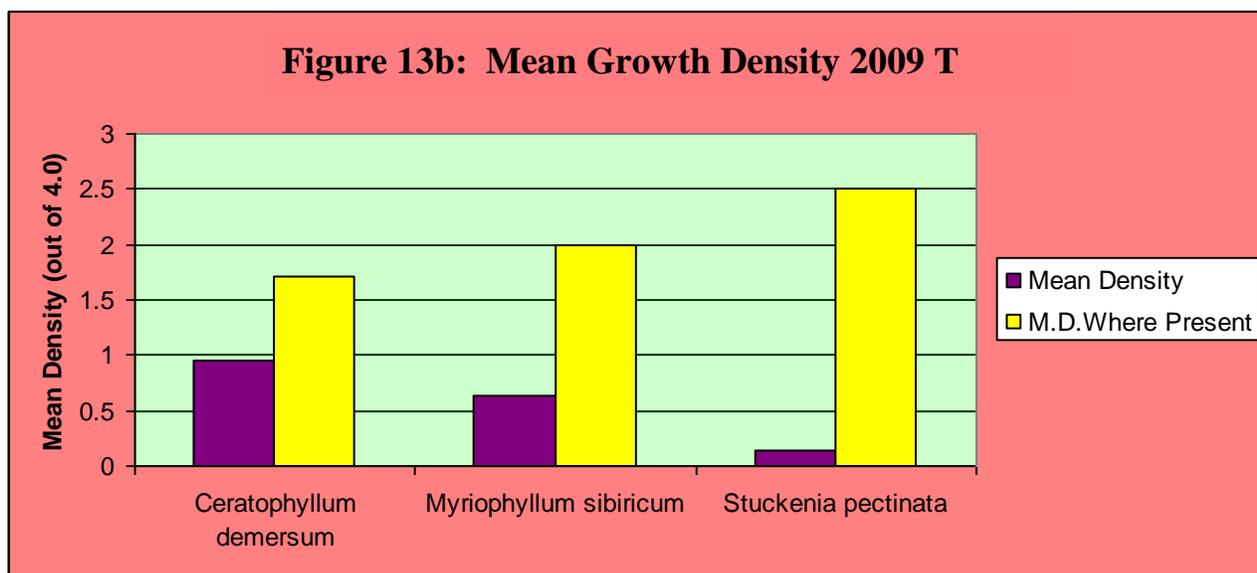
The transect survey yielded slightly different results. *Ceratophyllum demersum* and *Myriophyllum spicatum* switched places, with the former occurring more densely than the latter. However, *Myriophyllum spicatum* had a higher density where present than did *Ceratophyllum demersum*, although neither had a higher growth density than average. *Potamogeton nodosus*, also known as Long-Leaved Pondweed, had a low density overall, but had a higher than average density of growth where present (see Figure 13b).

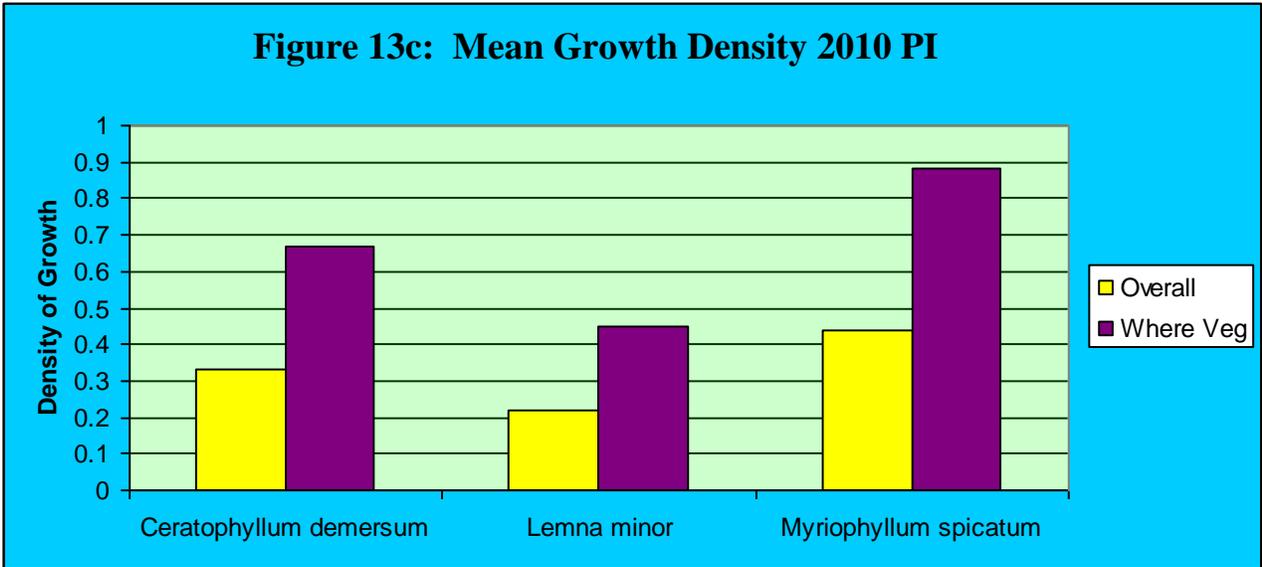
In the 2010 PI survey, even the most frequently-occurring aquatic plants had a low growth density. All of the species had a less than 1 (on 4-point scale) growth density, even just using data from vegetated sites. Highest growth density was found in *Ceratophyllum demersum* and *Myriophyllum spicatum* (see Figure 13c).

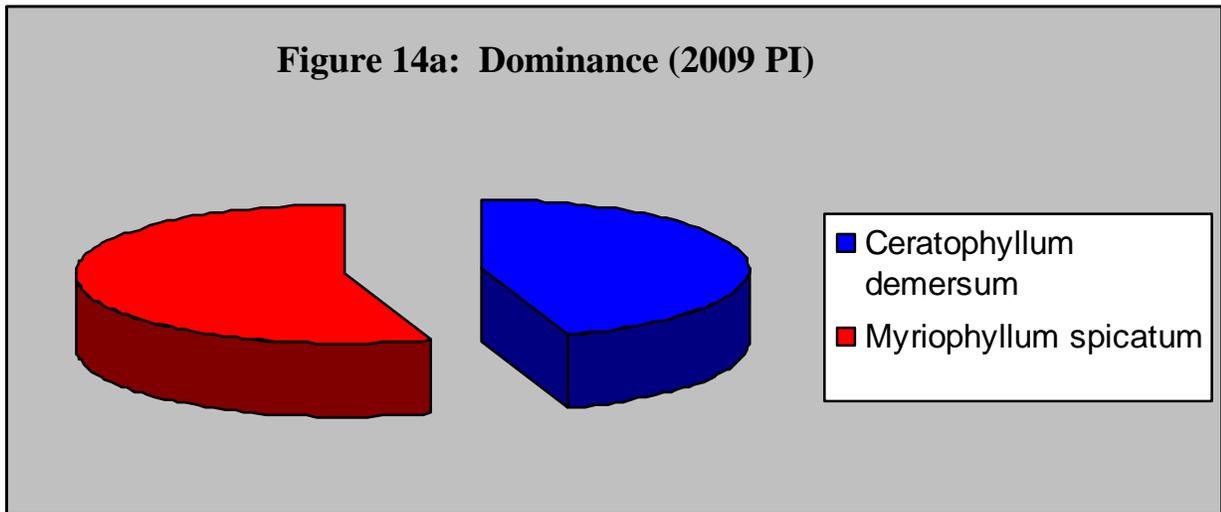
Combining the relative frequency and relative density of a species into a Dominance Value illustrates how dominant that species is within the aquatic plant community. Based on the Dominance Value, the 2009 PI survey showed that *Myriophyllum spicatum* was the dominant aquatic plant species in Mason Lake during 2009 (Figure 14a). *Ceratophyllum demersum* was sub-dominant.

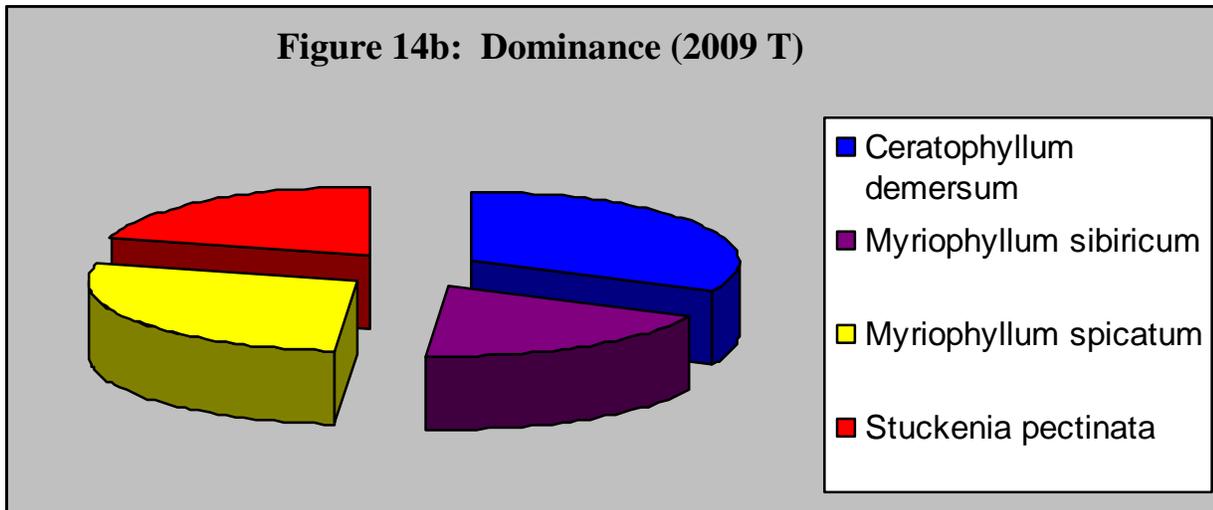
In the transect method, *Ceratophyllum demersum* and *Myriophyllum spicatum* reversed their positions in from the dominance in the PI survey. The former was dominant, with the latter sub-dominant. Third most dominant species were *Potamogeton pectinatus* and *Myriophyllum sibiricum* (see Figure 14b).

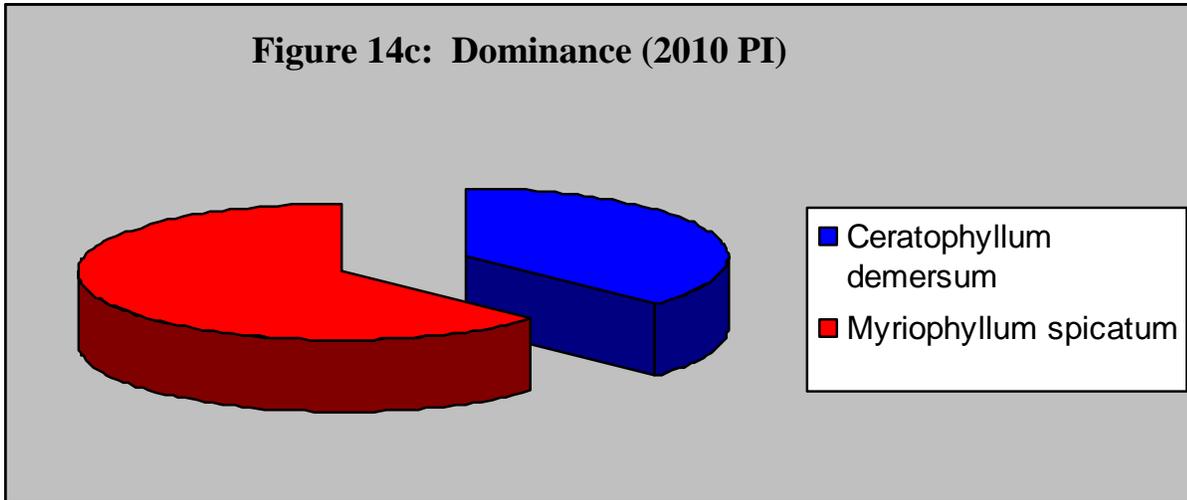
**Figure 14c: Dominance (2010 PI)**

In the 2010 PI survey, only *Ceratophyllum demersum* and *Myriophyllum spicatum* had any significant dominance values. The latter had a dominance value 1.7 times that of *Ceratophyllum demersum* and a dominance value over 4 times more than the next highest dominance value, *Lemna minor*.

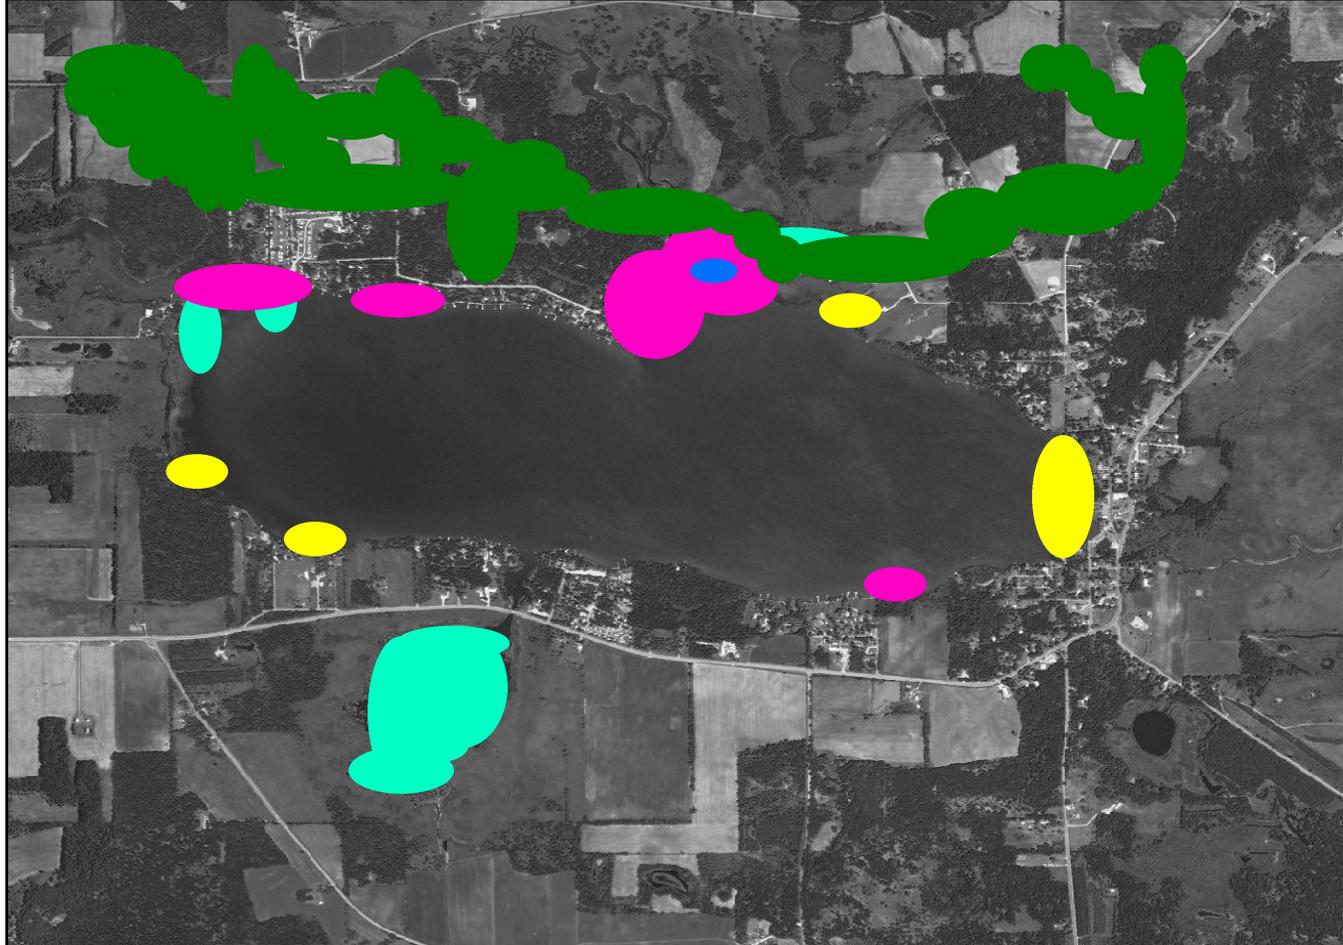
**Figure 15a: Location of Emergent, Floating-Leaf & Free-Floating Plants  
Mason Lake 2009 (PI)**

These maps, drawn from the 2009 PI survey results, visually outline the lack of aquatic plants in the deeper areas of the lake. During the PI survey, the only rooted

plant found in water over 6 feet deep was the invasive Eurasian watermilfoil (*Myriophyllum spicatum*), and no plants at all were found in water more than 7.5 feet deep. As Figures 15a and 15b also show, very little of Mason Lake has a diversity of plant structure, i.e., a combination of submergent, emergent, free-floating and rooted floating-leaf aquatic plants. Emergent and rooted floating-leaf plants are especially sparse in Mason Lake.

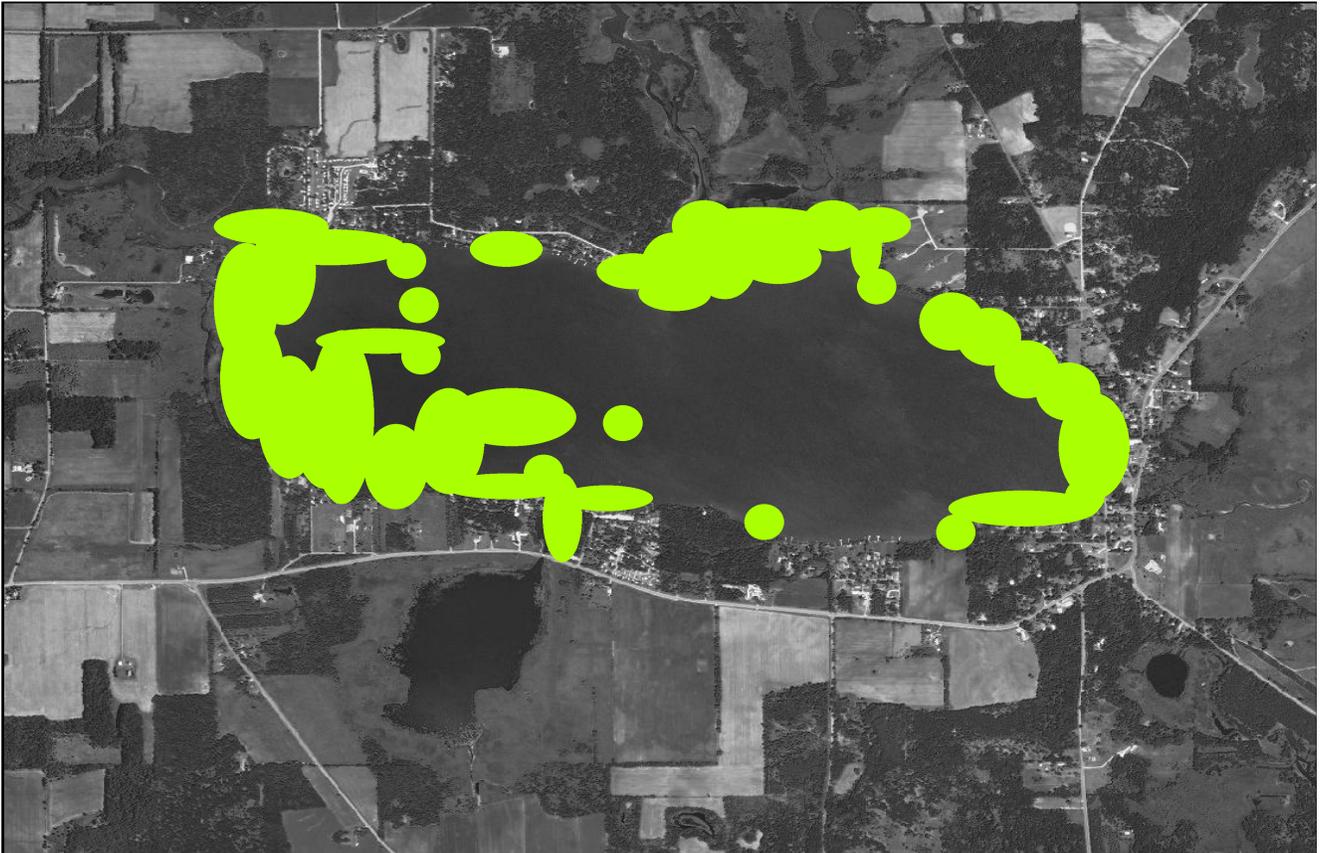
**Figure 16a: Distribution of Submerged Plants in Mason Lake—2010 PI**

The 2010 PI survey continued to show reduced areas of vegetation. Figures 16a and 16b show what was found during the 2010 survey. Both the 2009 and 2010 PI surveys revealed that depths over 7 feet in Mason Lake are either sparsely vegetated

or not vegetated at all. It is possible that this condition existed prior to 2009, since the prior transect surveys usually had maximum sample sites at slightly more than 7 feet, rather than between 8 and 9 feet.

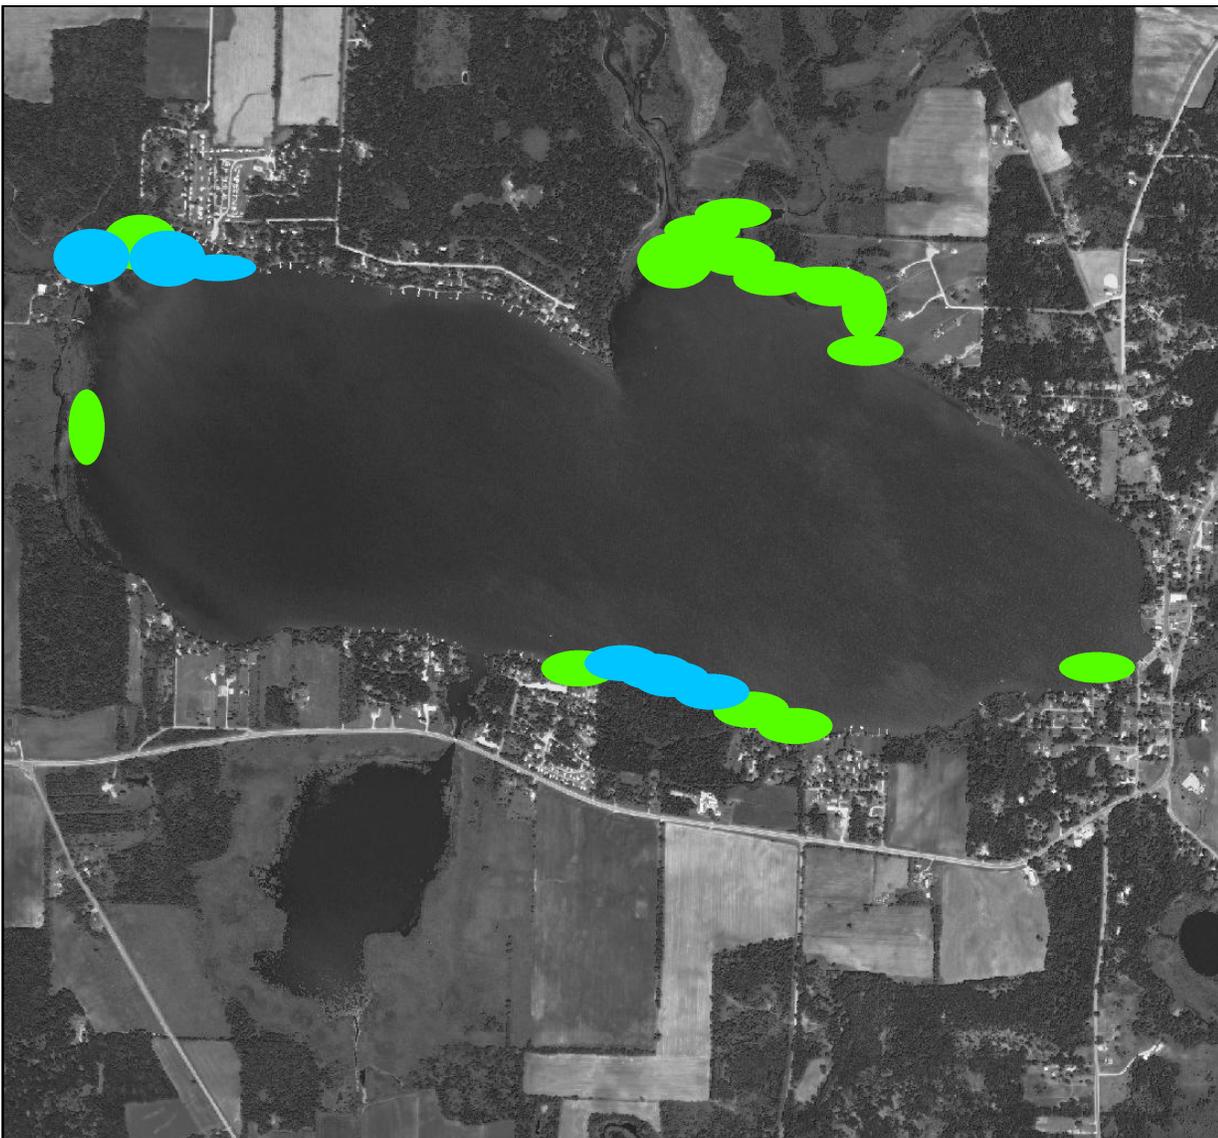
**Figure 17a: Emergent Plants (T) 2009 marked in green—Both Free-Floating & Emergent Plants marked in blue**

Although the transect survey was done in July 2009 and the PI survey done in August 2009, results from the transect survey similarly showed no rooted plants found in over 7 feet of water (see Figures 17a and 17b). Eurasian watermilfoil, Northern milfoil (*Myriophyllum sibiricum*) and Sago pondweed (*Stuckenia pectinata*) were found in water between 6 and 7 feet deep. 41% of the sites over 5 feet deep had no vegetation or only the unrooted Coontail (*Ceratophyllum demersum*).

No rooted floating-leaf plants were found during the transect survey and only a few free-floating plants were found. The most frequent aquatic vegetation found in Mason Lake during the transect survey was submergent plants.

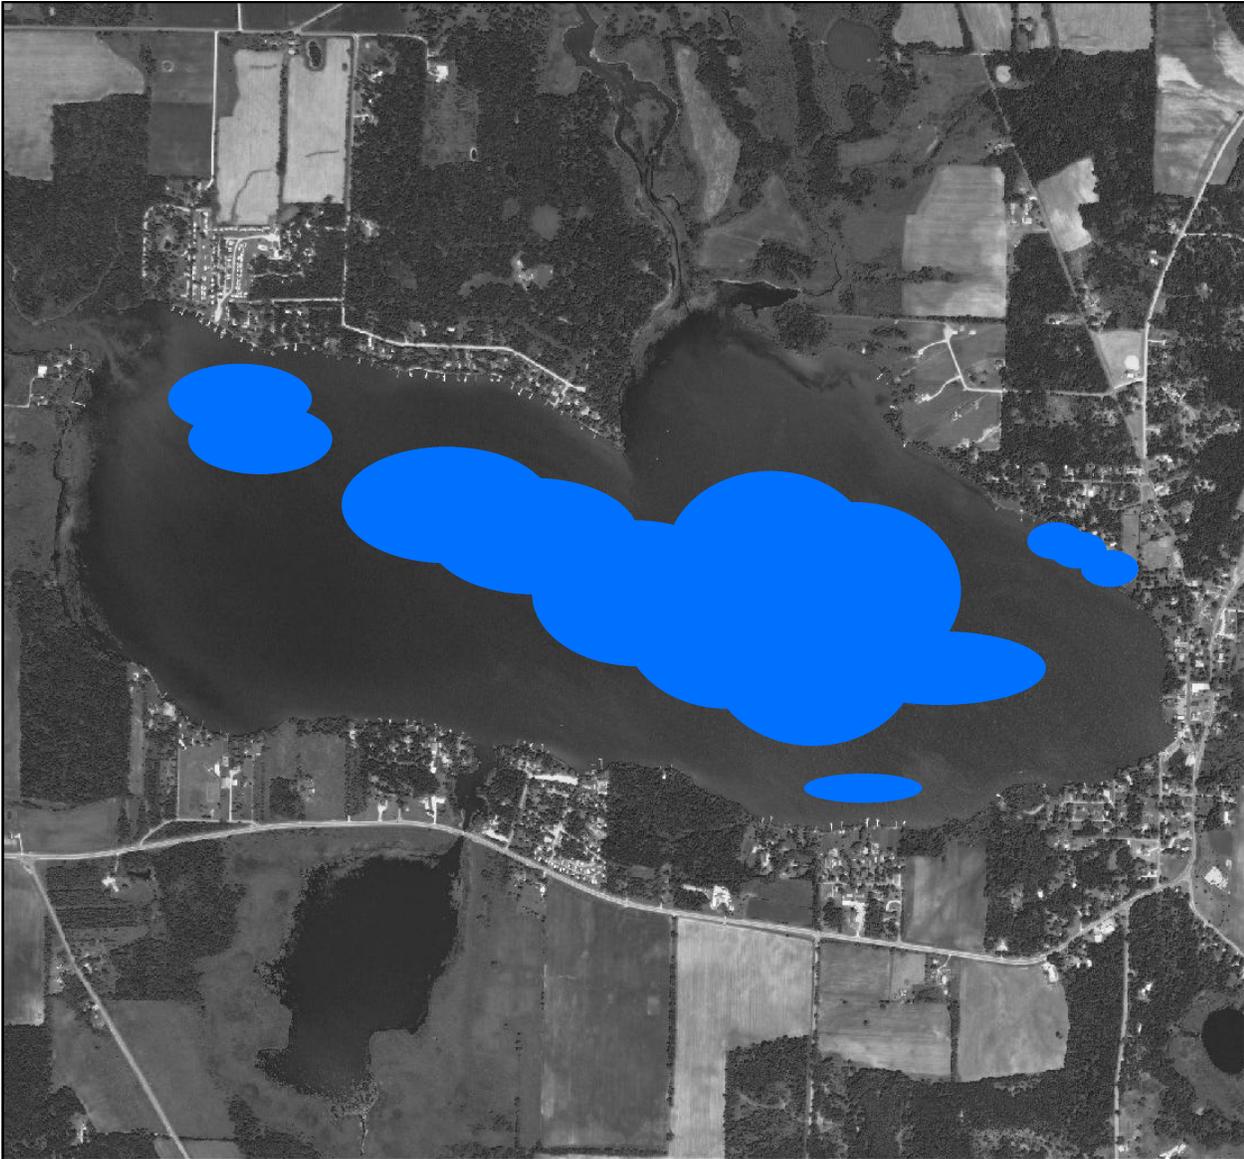
**Figure 17b: Submergent Plants (T) 2009 found in lake areas not marked in blue**

As Figure 16b shows, although the transect survey found more submergent aquatic plants in more areas than did the PI survey, aquatic vegetation still tended to be sparse or non-existent in the deeper areas of the lake. Under the transect method, aquatic vegetation in the deeper water in 2009 was confined to Coontail, a submerged unrooted native plant; Northern milfoil, a submerged rooted native plant; Sago pondweed, a submerged rooted native plant; and Eurasian watermilfoil, an aquatic invasive that has plagued Mason Lake for many years. Eurasian watermilfoil was found at ½ of the sites located in over 5 feet of water. Sago pondweed was found in only one spot. The other two plants were found at 32% of the sites in water over 5 feet deep.

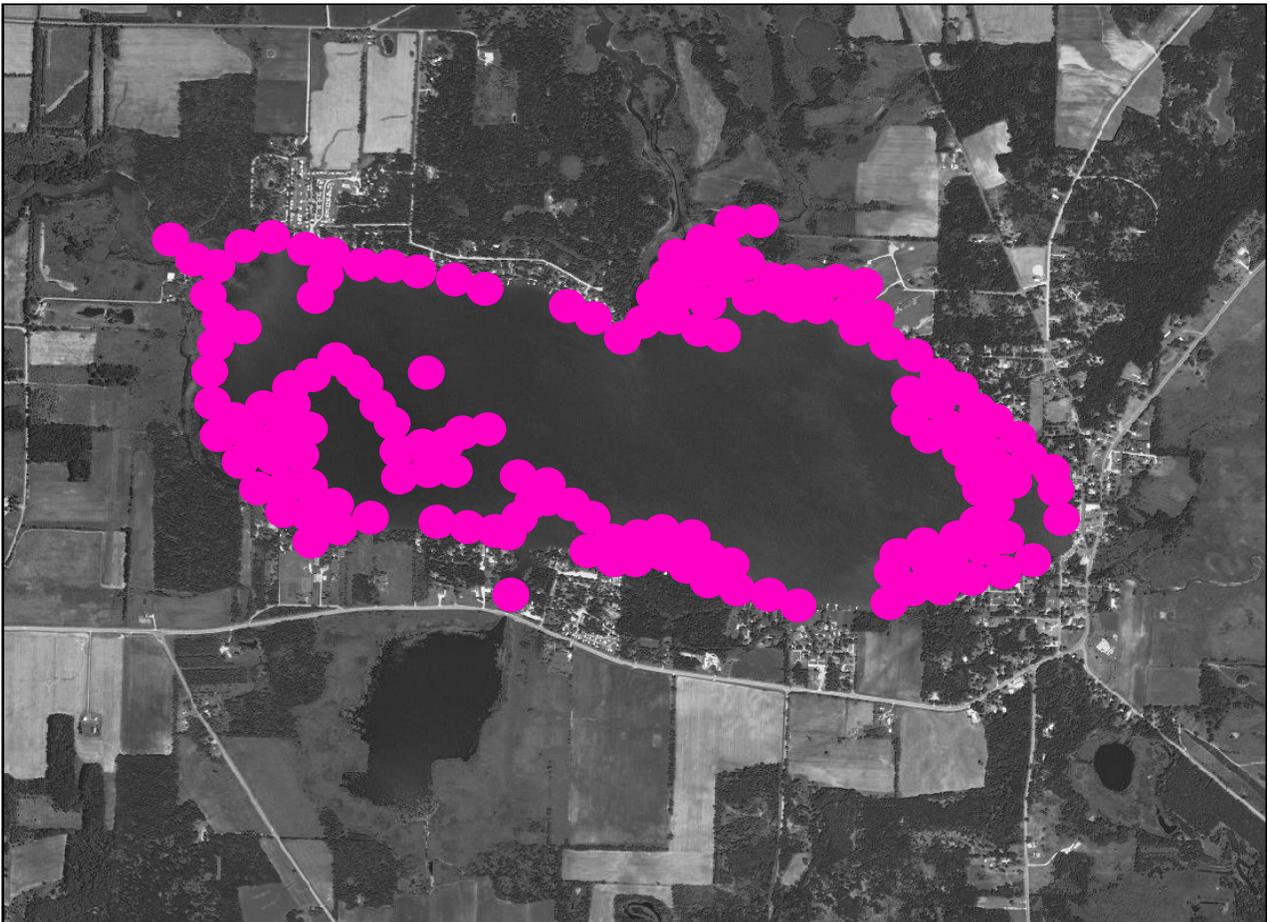
**Figure 18: Location of Eurasian Watermilfoil in Mason Lake 2009**

*Myriophyllum spicatum* (Eurasian watermilfoil) was the dominant species in 1992 and dominated at depths greater than 1.5 feet. *M. spicatum* declined in 1998, but increased again in 2001, becoming the dominant species again, this time dominating depths greater than 5 feet deep. *M. spicatum* declined again in 2005 to its lowest frequency. In the past, the frequency and density of *M. spicatum* has increased with increasing depth, perhaps due to the winter drawdowns that control this species in the shallow water areas. However, in 2009 (transect), *M. spicatum* had its highest

frequency in the 0 to 1.5 feet depth (69.23%), with its frequency decreasing to 33.33% in the over 5 feet deep area. Its overall frequency in the 2009 transect survey was nearly 60% and went up to over 65% in vegetated spots. The 2009 PI survey also found *M. spicatum* over all the lake at about 32%, but it increased to over 71% in vegetated areas. Figure 18 shows the distribution of *M. spicatum* in 2009 from both surveys.

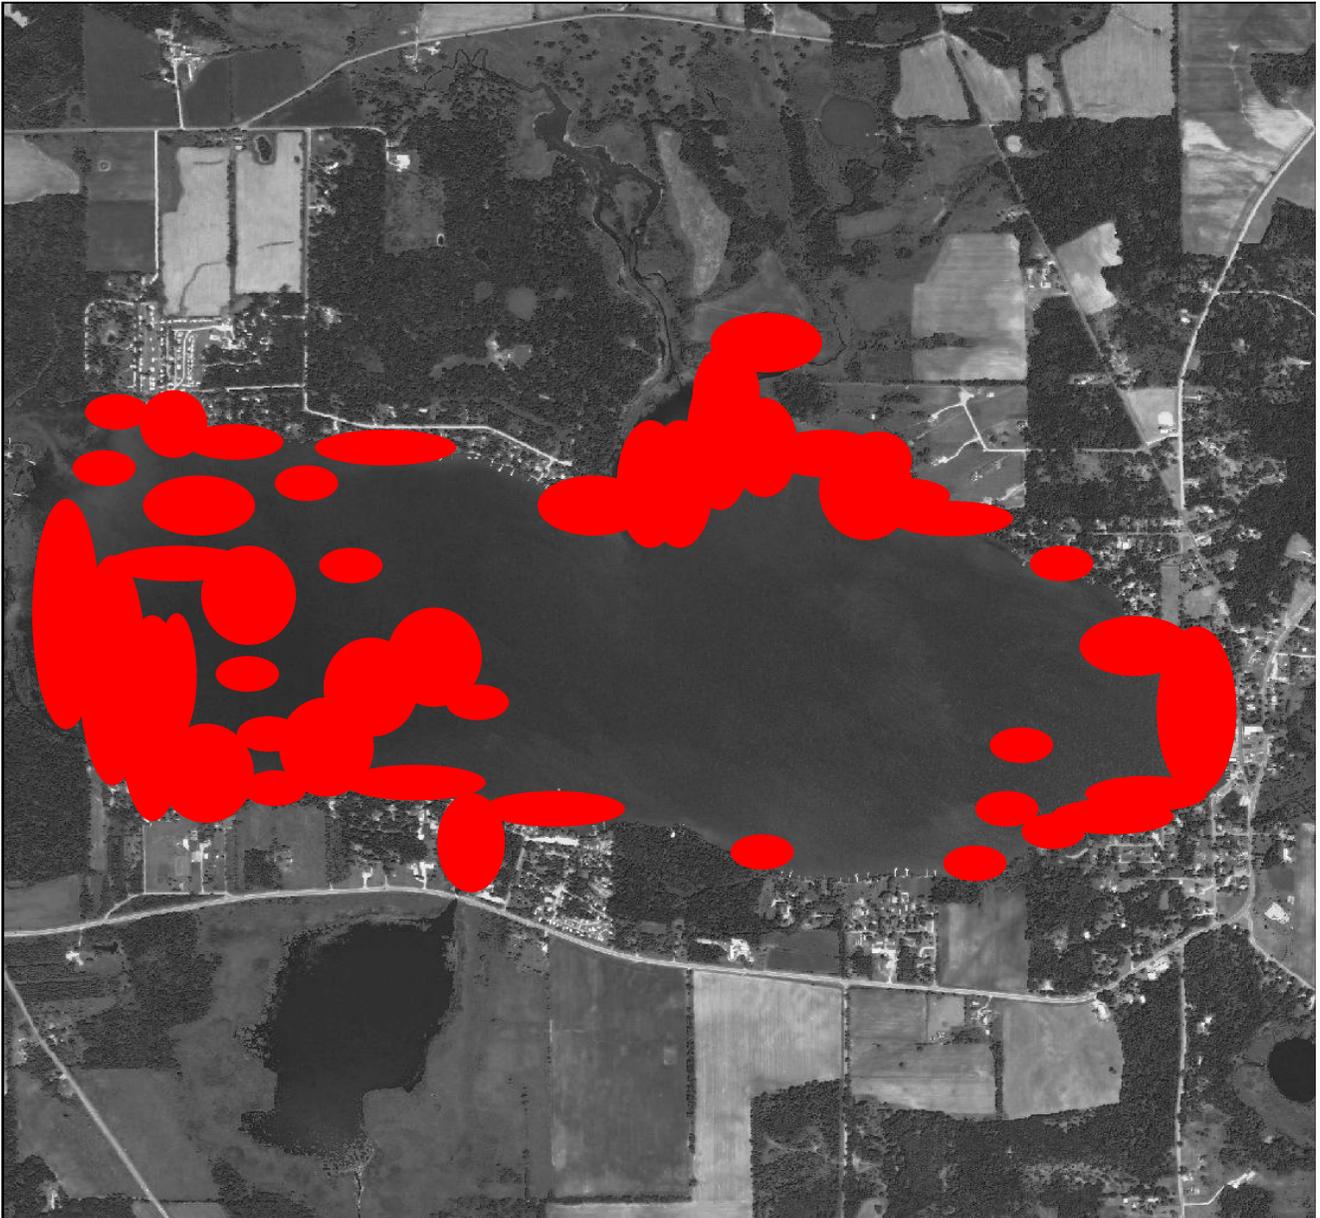
**Figure 19: Distribution of Eurasian Watermilfoil in 2010 (PI)**

In the 2010 PI survey, overall frequency of occurrence of *M. spicatum* increased to just over 42% and, in vegetated portions, it had over 84% frequency of occurrence (see Figure 19).
