**THE AQUATIC PLANT COMMUNITY OF  
MASON LAKE,  
ADAMS/MARQUETTE COUNTY, WI.  
DECEMBER 2010**

**Presented by Reesa Evans, CLM, Lake Specialist  
Adams County Land & Water Conservation Department  
P.O. Box 287                      Friendship, WI 53934  
608-339-4268**

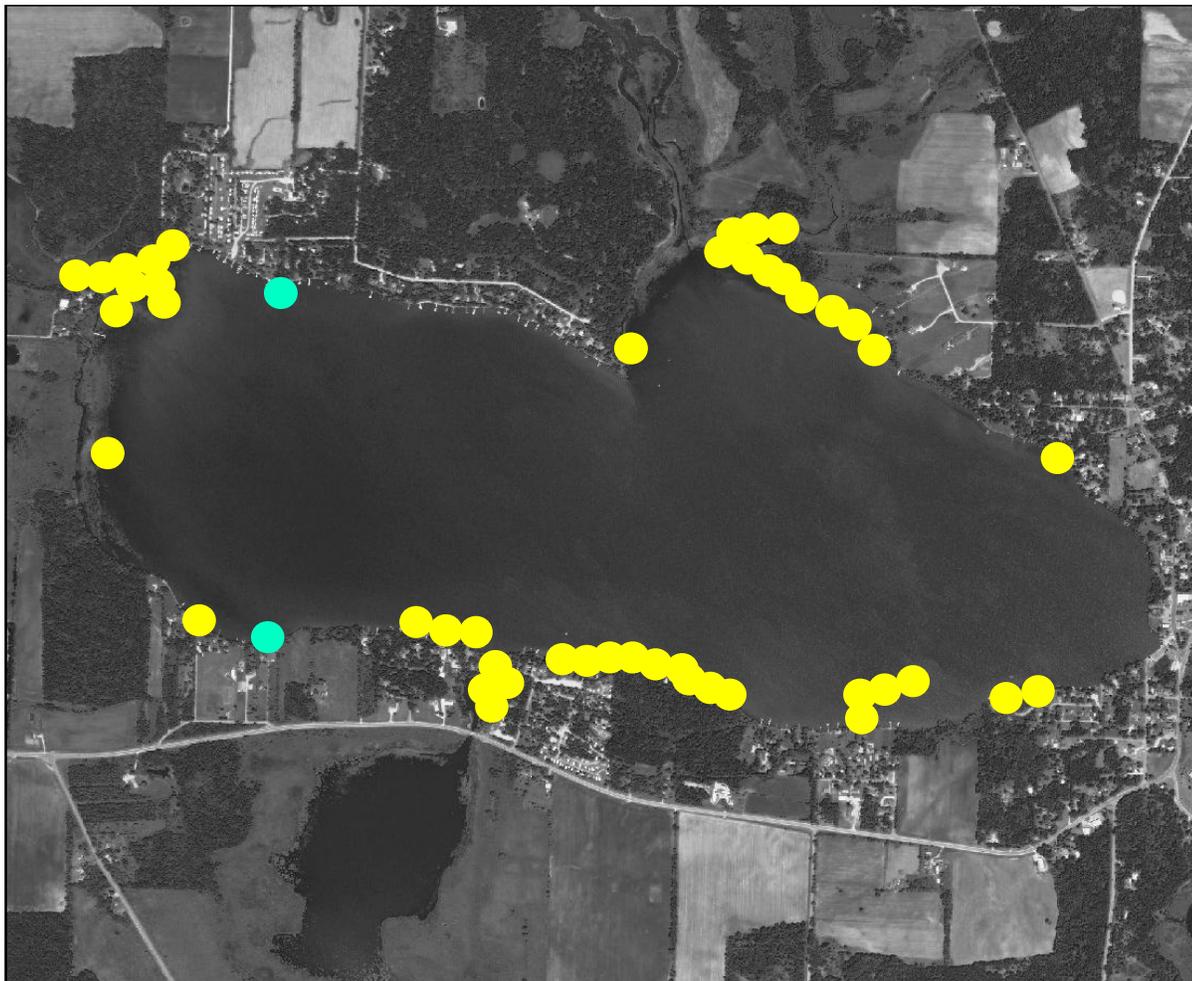
**Figure 20: Location of Curly-Leaf Pondweed in Mason Lake 2009-2010**

*Potamogeton crispus* (Curly-Leaf Pondweed) has decreased in Mason Lake since 2005. In 2005, *P. crispus* was found with 22.1% frequency (transect), with its highest frequency of occurrence found in over 5 feet of water, where it had a 43.5% frequency of occurrence. However, in 2009, not only had the occurrence frequency (transect) declined to 12.3%, but its maximum frequency of occurrence was found in

less than 1.5 feet of water, with none at all found in over 5 feet of water. In the PI survey, *P. crispus* had an occurrence frequency of only 2.91%. Since the PI survey was done in late August 2009, the occurrence frequency probably underrepresents the occurrence of Curly-Leaf Pondweed, which is a plant that usually dies off by mid-July.

Curly-Leaf Pondweed was only found in two spots in the 2010 survey.

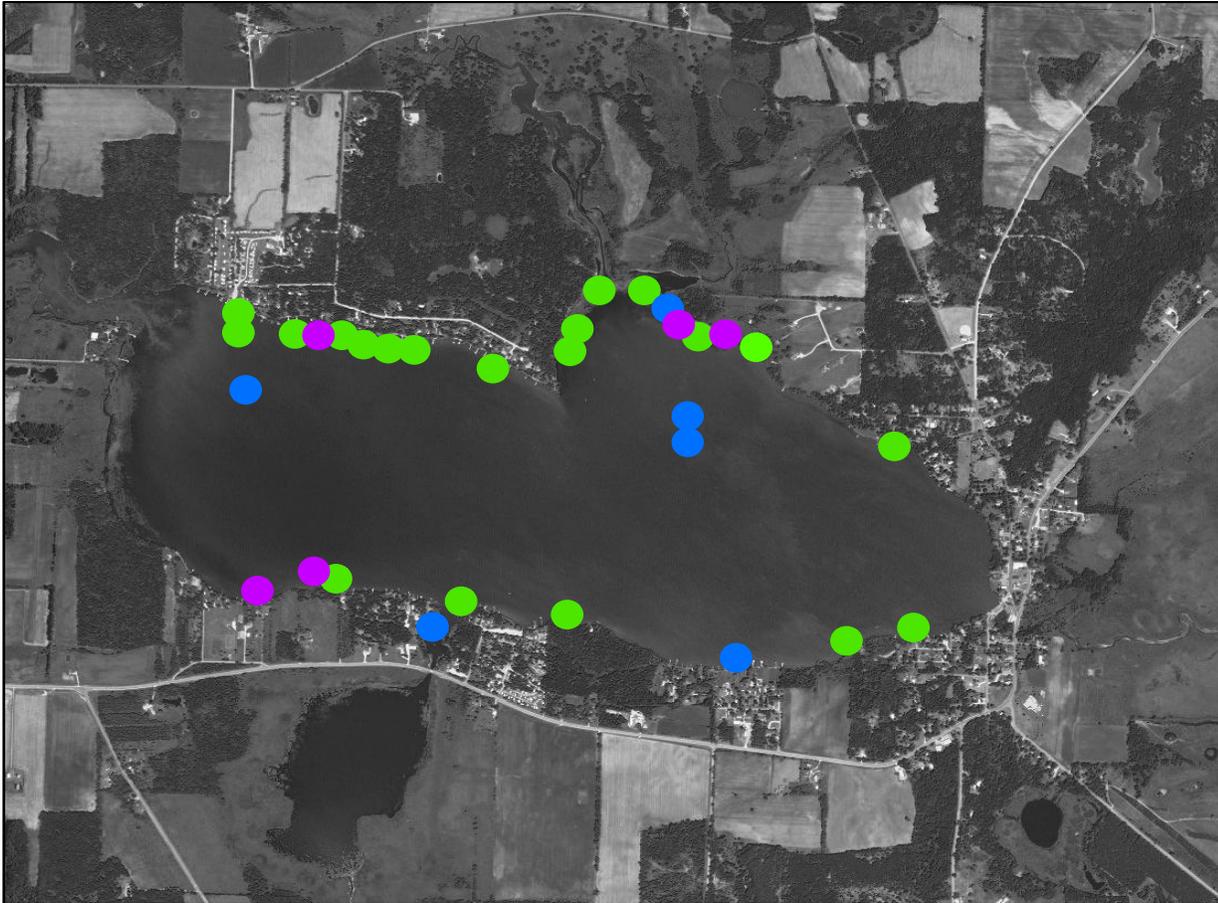
**Figure 21: Location of Brittle Nymph in Mason Lake 2009-2010**

However, a new invasive found in Mason Lake in 2009, *Najas minor* (Brittle Nymph), was found at several places throughout the lake. Mason Lake was only the second lake in Wisconsin in which *Najas minor* has been found. In 2009, it had a 4% frequency of occurrence in the lake overall and a 9% occurrence frequency in vegetated sites on the lake. Since this is such a new invasive to Wisconsin, this population will need to be watched closely to determine if any control action will be required. In the 2010 survey, *Najas minor* occurred only at 1.7% overall frequency and only at 3.4% frequency in vegetated sites.

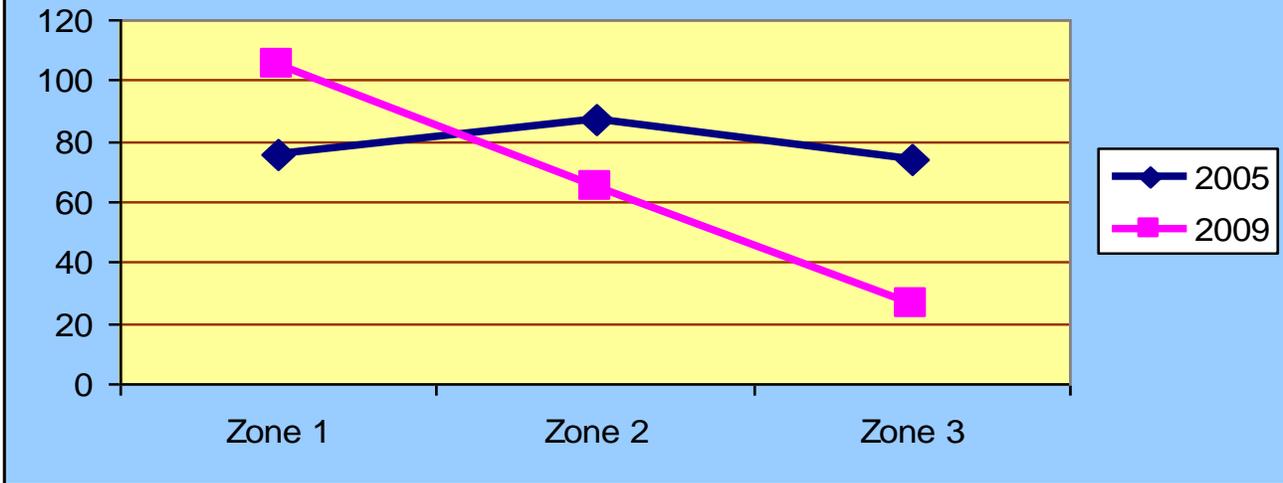
**Figure 22: Zone Frequency of Occurrence (T)**

A comparison of the zone frequency of occurrence and zone density of occurrence between 2005 and 2009 further illustrates what a drop there was by 2009 in the deeper waters of Mason Lake. While the frequency of occurrence in the 0 to 1.5 deep zone increased between 2005 and 2009, there was a decrease in the 1.5 to 5 foot depth zone and a large decrease in the over 5 feet depth zone (see Figure 22). A similar pattern was found when comparing the zone density of occurrence of the two years (see Figure 23).

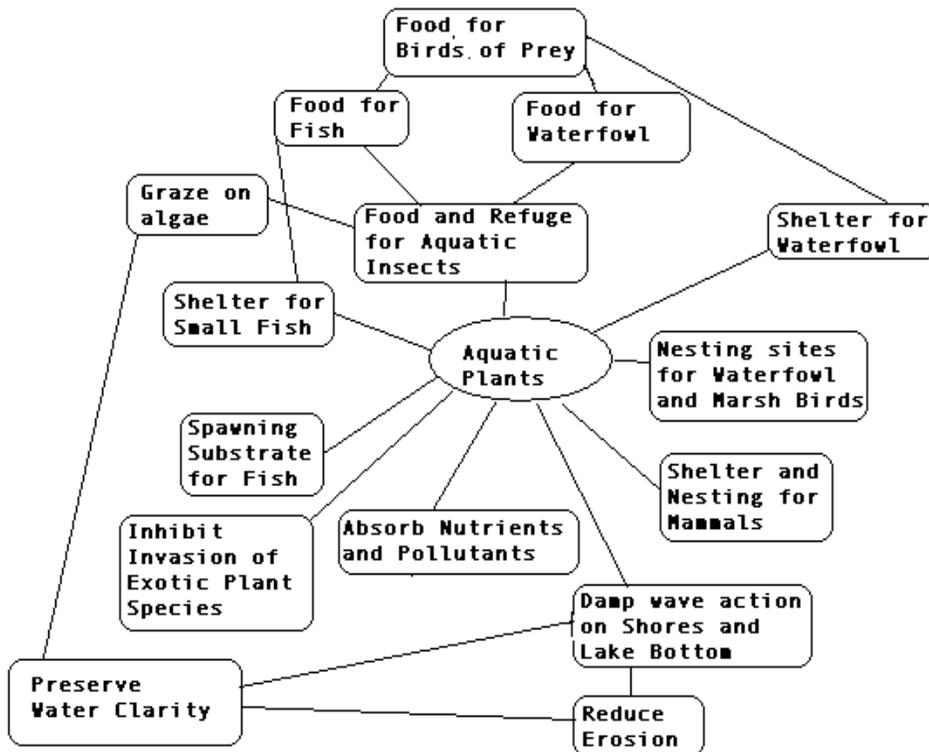
**Figure 33:  
Ecological  
Web**

Aquatic plant communities provide important fishery and wildlife resources. Plants and algae start the food chain that supports many levels of wildlife, and at the same time produce oxygen needed by animals. Plants are used as food, cover and nesting/spawning sites by a variety of wildlife and fish and are an essential part of the ecological web of a lake (Figure 33).
