HARRY AND LAURA NOHR CHAPTER OF TROUT UNLIMITED

BLUE RIVER HABITAT IMPROVEMENT PROJECT 2016

Report Prepared by the
Project Committee
Harry and Laura Nohr Chapter of Trout Unlimited

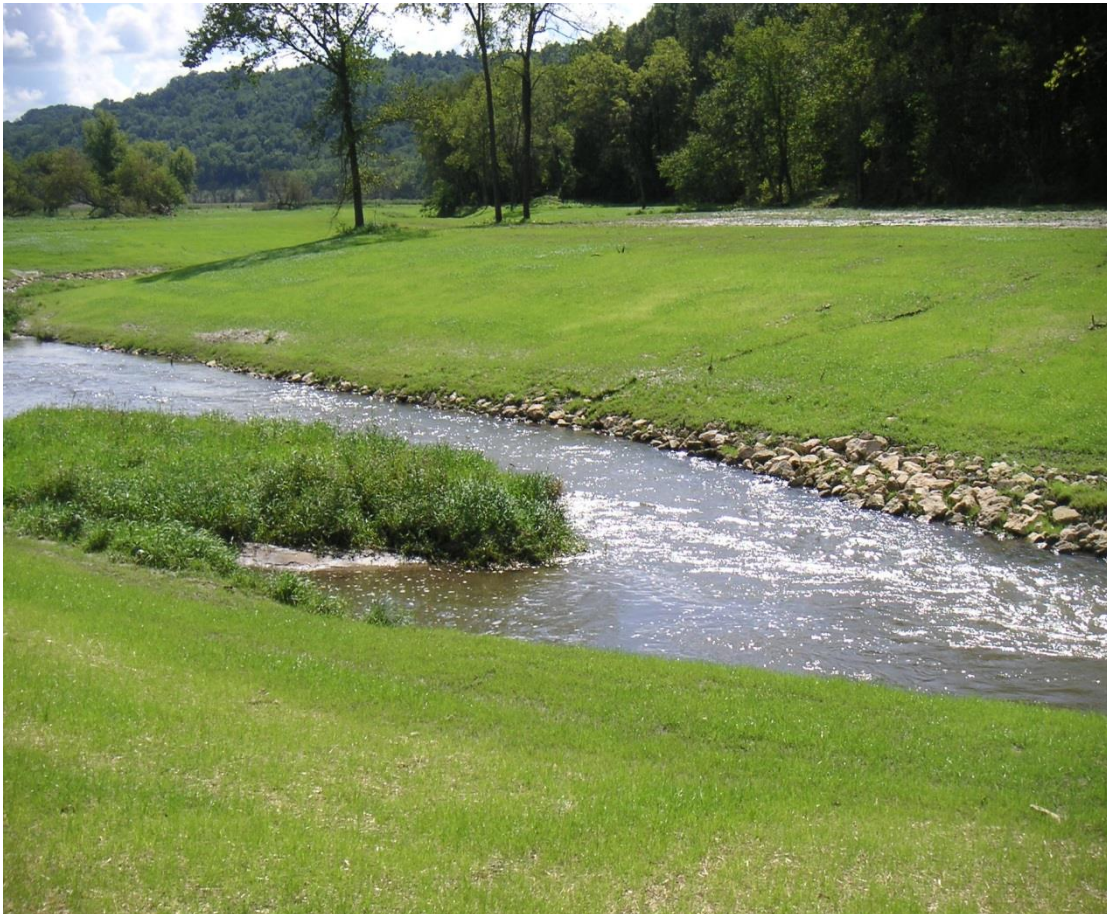
A back water area created when a tall vertical bank was tapered to an island

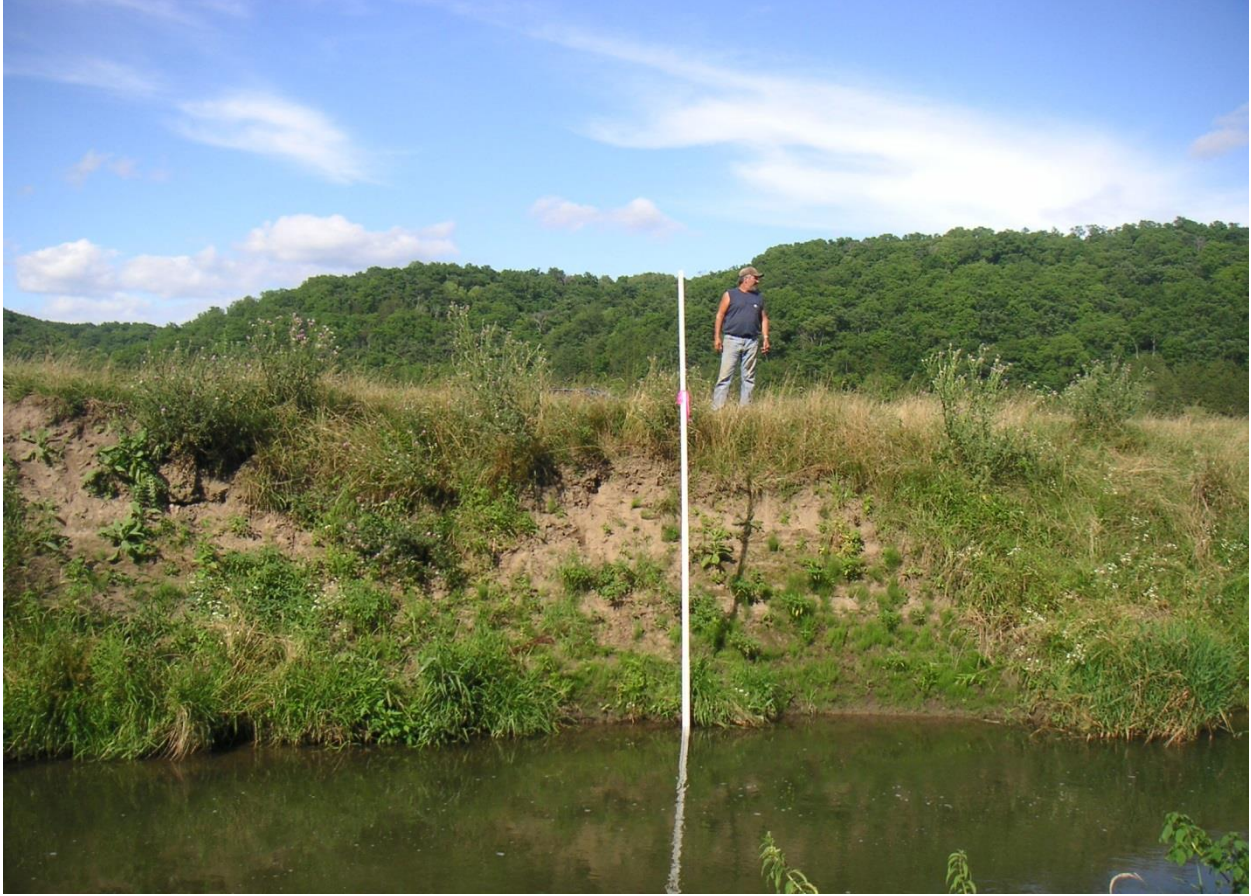
Pink ribbon was tied on at twelve feet.

This project started where our 2012-2013 work concluded. The habitat in this section of stream was as bad, or worse than the 2012-2013 site. The entire section was severely entrenched with vertical eroding banks as high as 13 feet. Prior to the project, the stream held trout but the habitat was in poor condition. The stream bed was heavily silted in most places and very wide in some. The project section ran through actively grazed pasture. In addition, much of this stream section ran against steep hillsides undercutting trees which caused continuously eroding banks and made the work much more difficult. About half way through the project site a severely incised ditch extended from the stream across the pasture to a fence. This ditch drains a huge area of uplands. A crossing needed to be installed across the ditch to enable access to the upper half of the project.

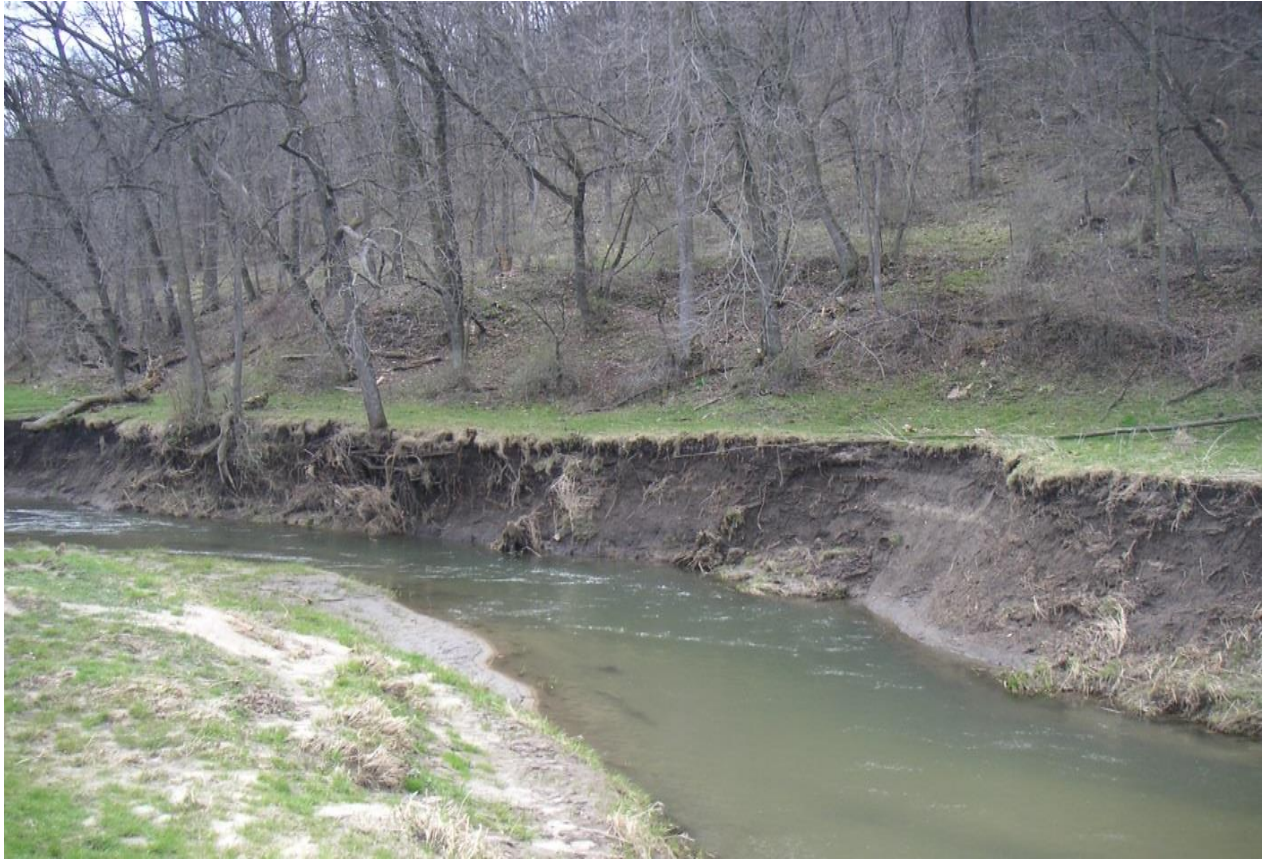
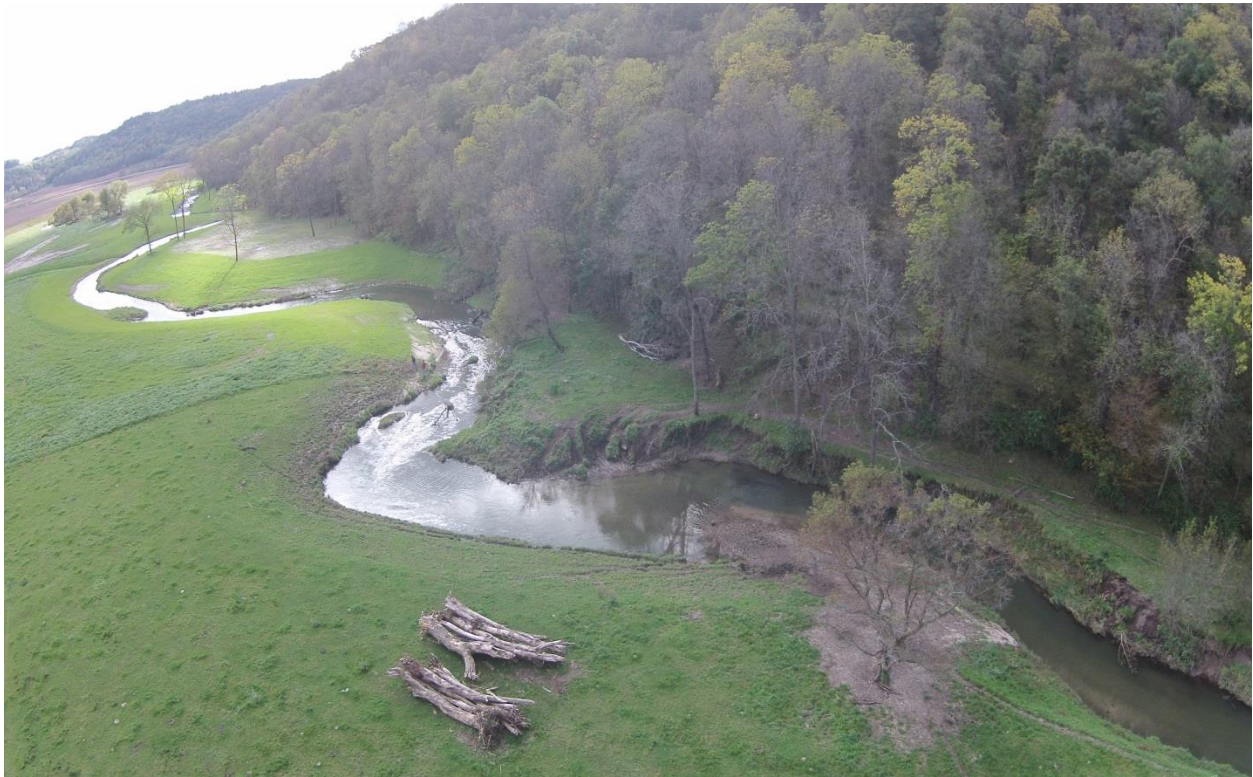
Upper stream section in this photo shows work that was finished in the summer before all the rain events that postponed the lower third of the project (part of which is visible in the lower part of this picture) into the fall.

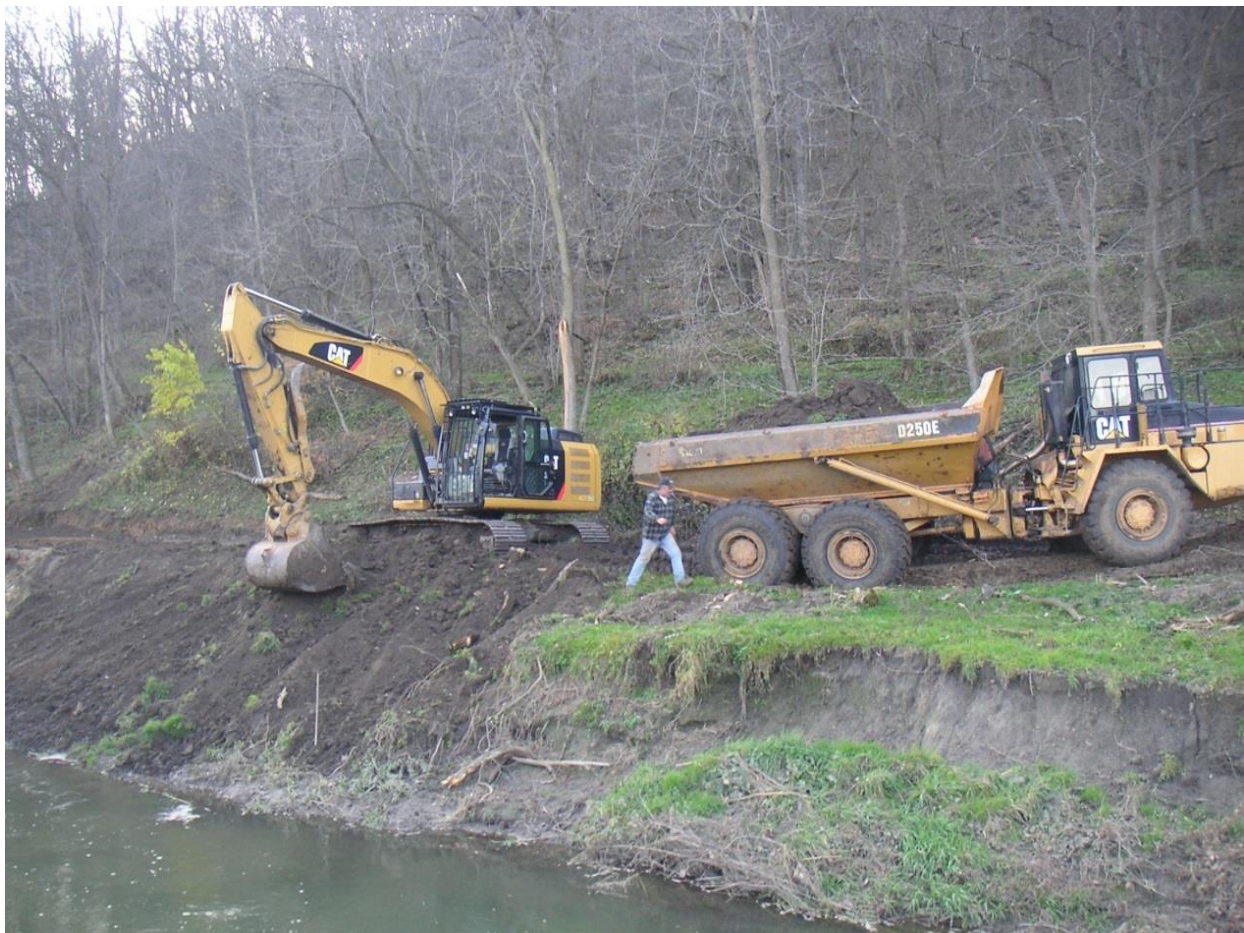
A section of stream against the hillside being tapered. Notice the large section of bank that sluffed off during one of the large rain events that occurred while the work was in progress. This happened in several other areas as well.

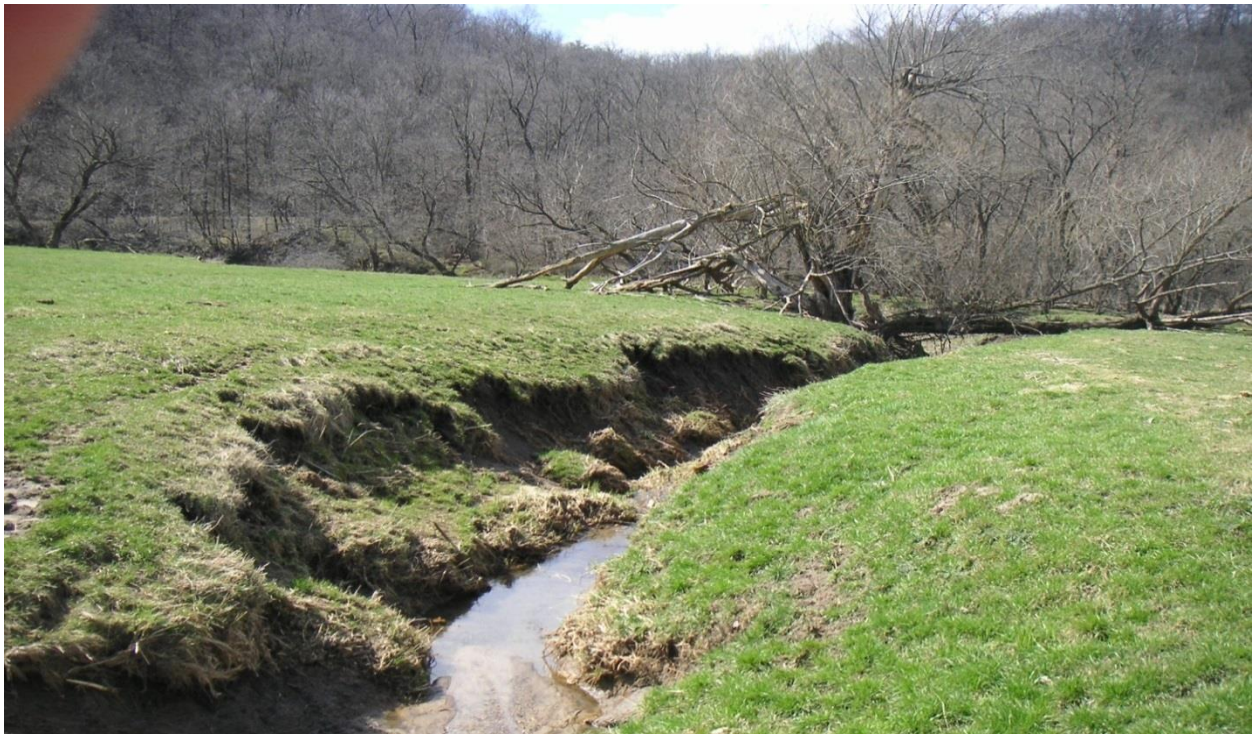
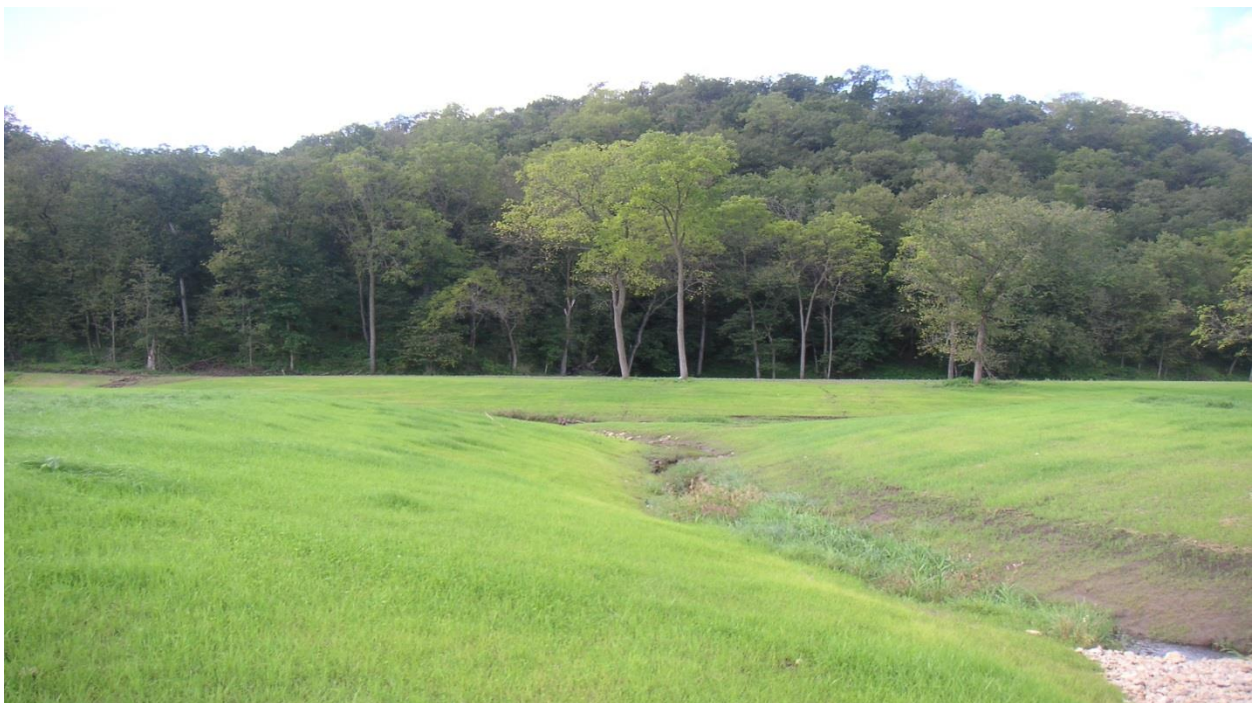
Before and after photos of drainage ditch that crossed the pasture. To access the upper end of the project we had to be able to cross this ditch. Three large pipes were installed in the upper end and covered with rock and breaker run which allowed trucks to cross. When the work was finished above this site the banks were sloped back and seeded, the pipes were removed, and the rock was used to make a cattle crossing that fit the contour of the ditch.

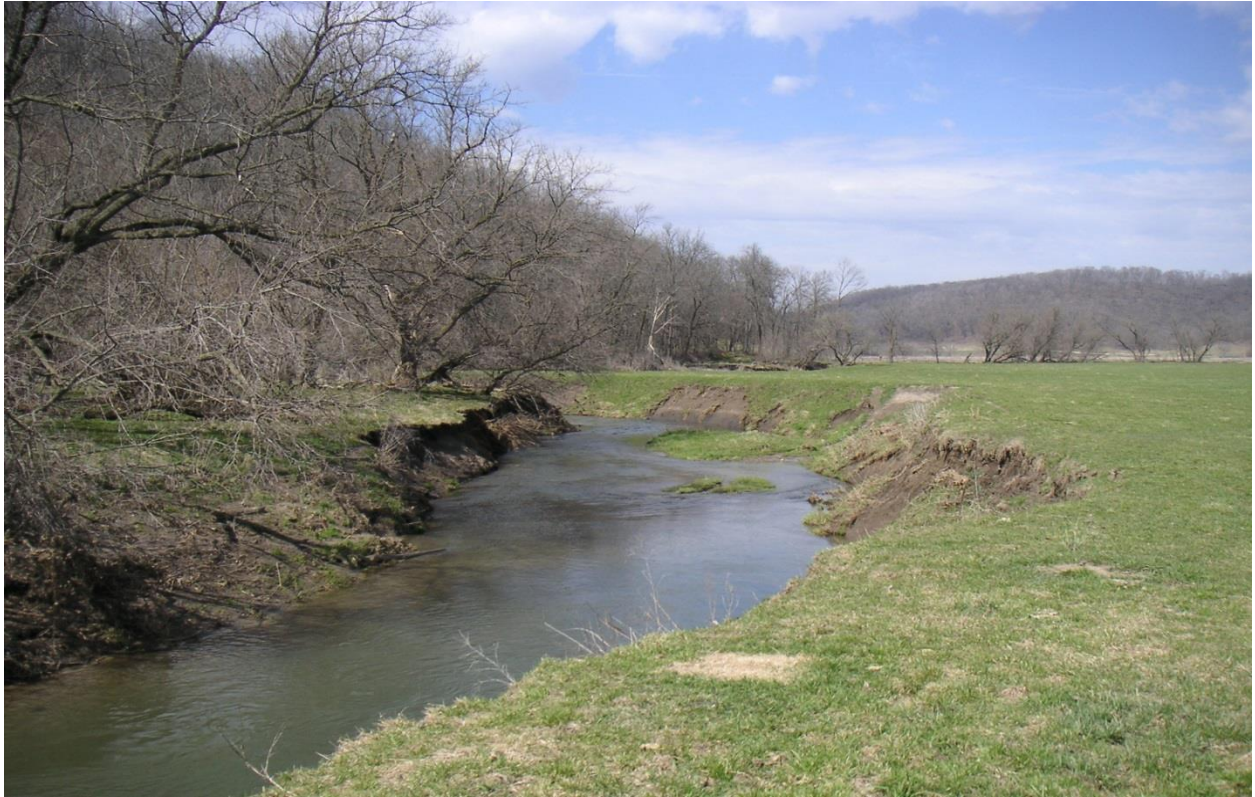
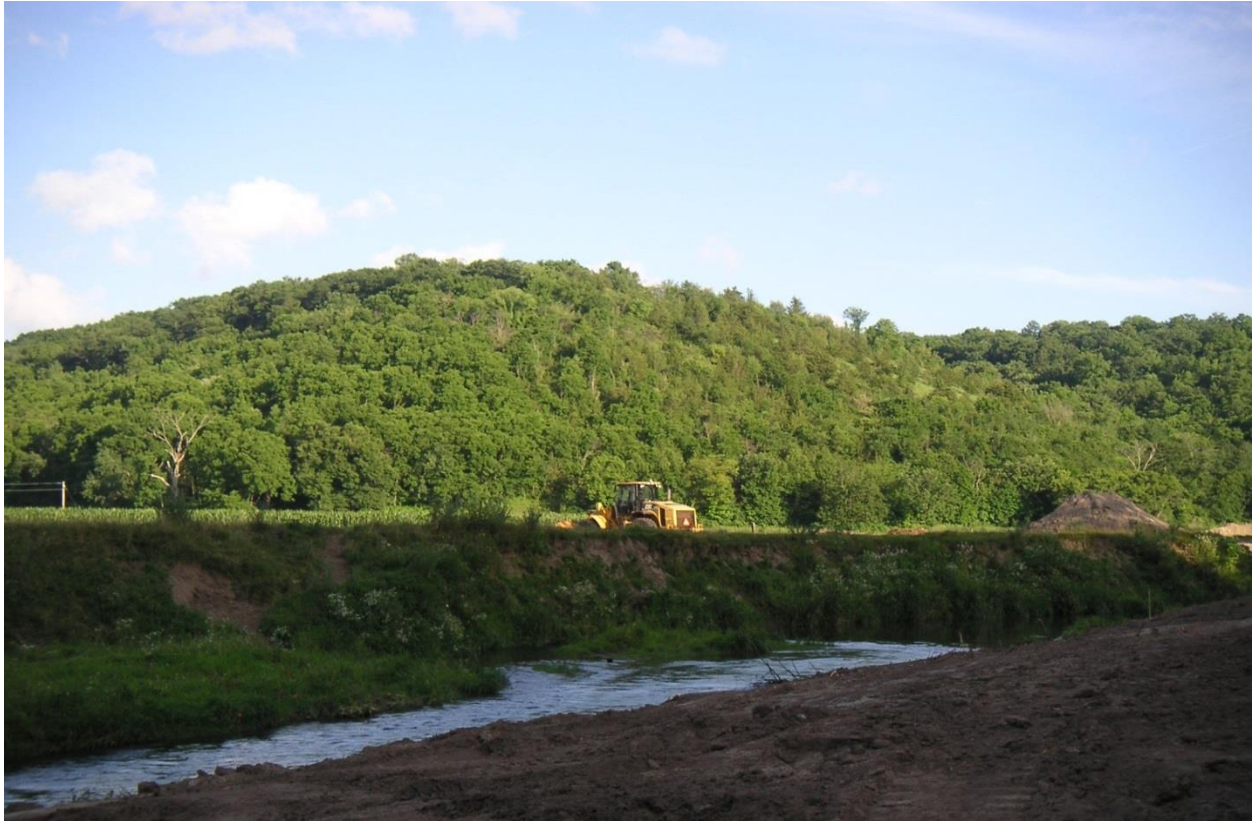
The photo above shows the banks before shaping. The lower photo shows the inside bank with box elders removed and the start of bank shaping. This section is just below where the drainage ditch enters the stream. The majority of the project site consisted of vertical banks similar to these or higher on both sides of the stream.

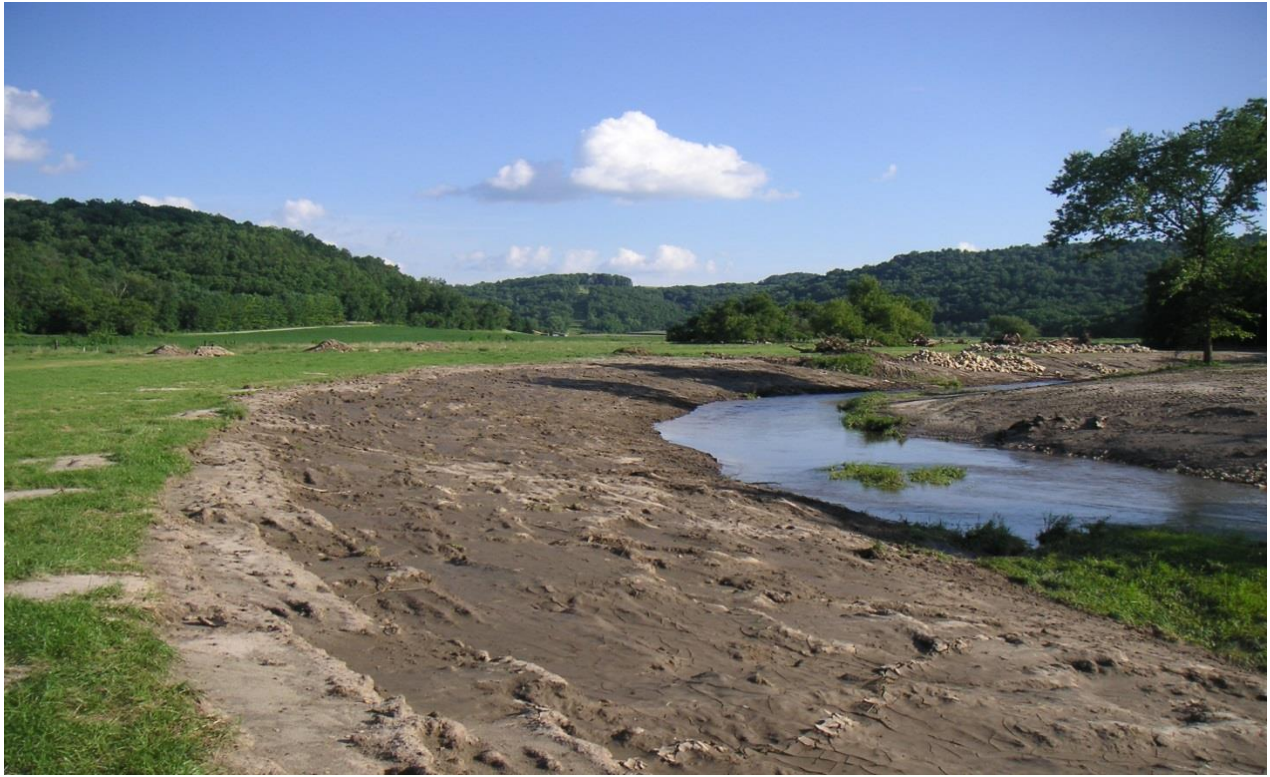
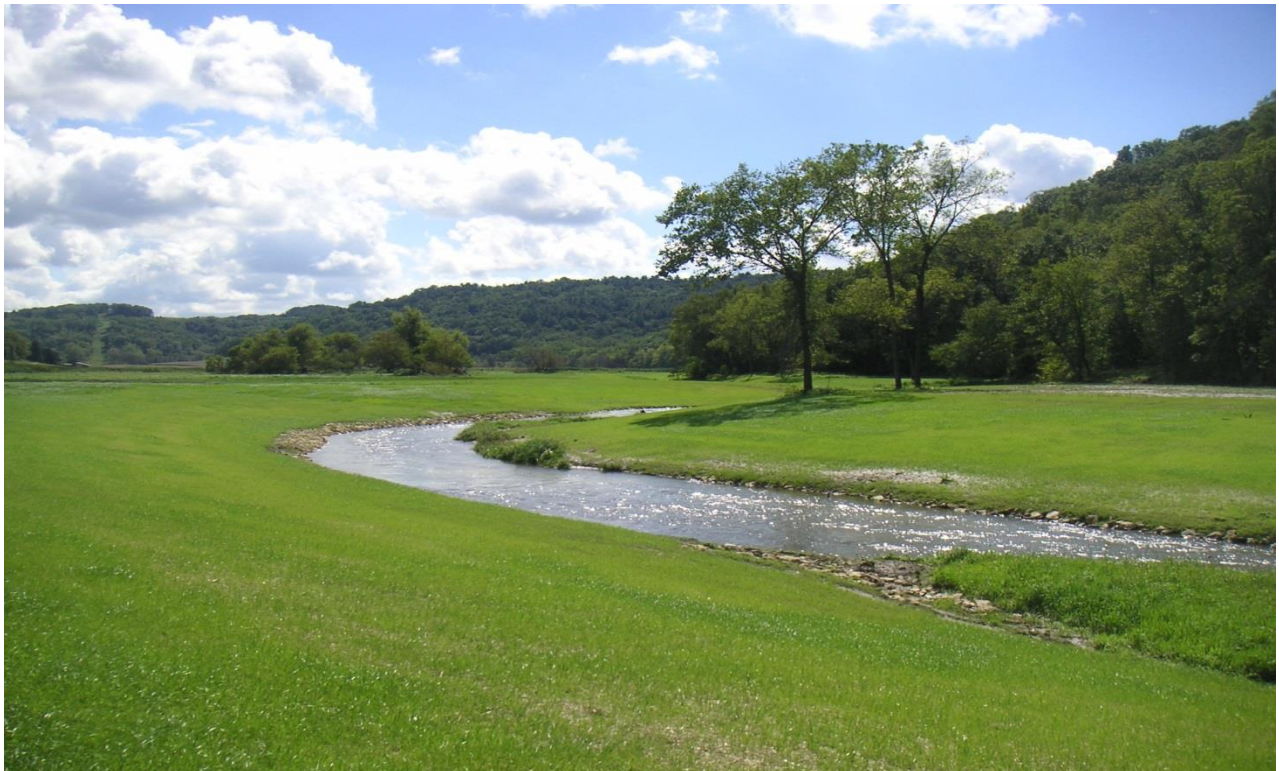
The photo above was taken after a large rain event. You can see where the stream rose all the way to the top of this tapered bank. This is the outside bank in the photos on the previous page. It rose this high twice, and went four to five feet out of its banks several other times. This caused us to have to reseed this site four times. The photo below shows the finished section with grass becoming established.

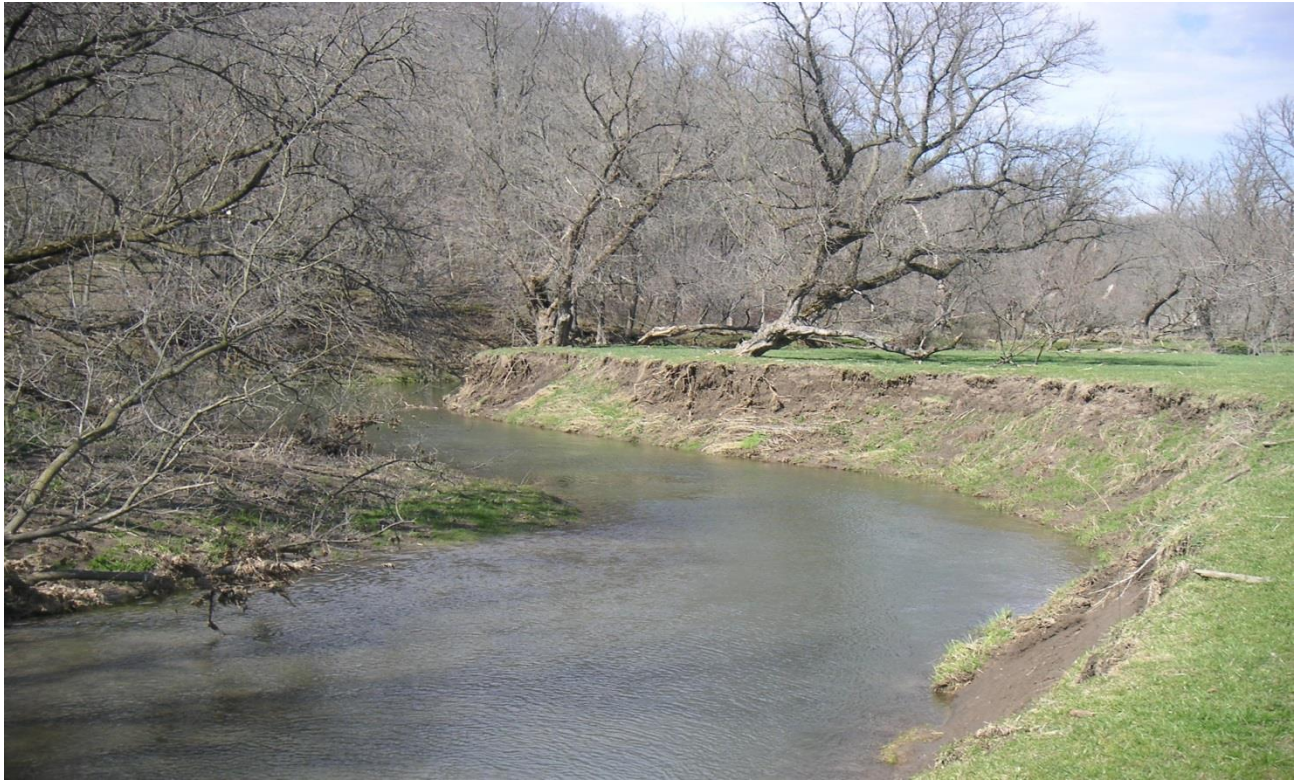
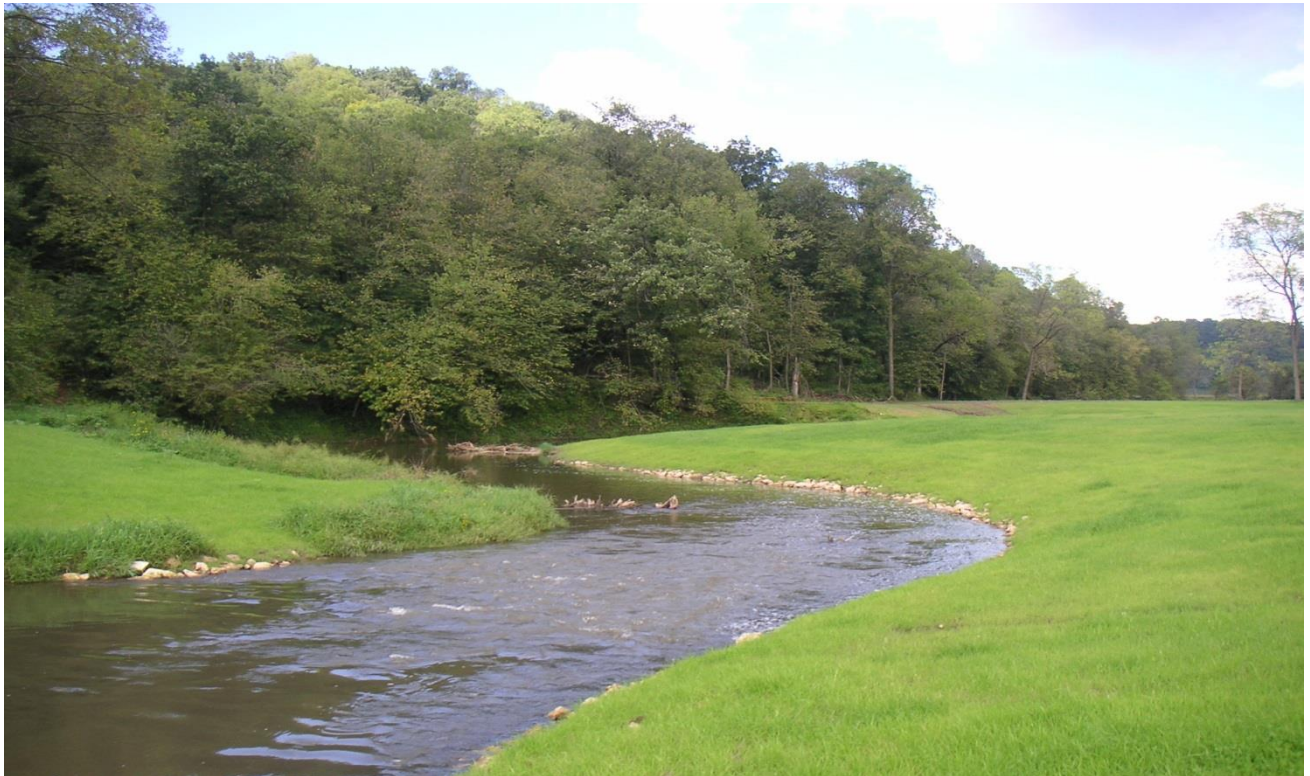
The raw high banks in the top photo are another example of what existed throughout the majority of the project site. The lower after photo shows the same site after bank shaping, and a weir, root wad, and two log deflector sets were installed.

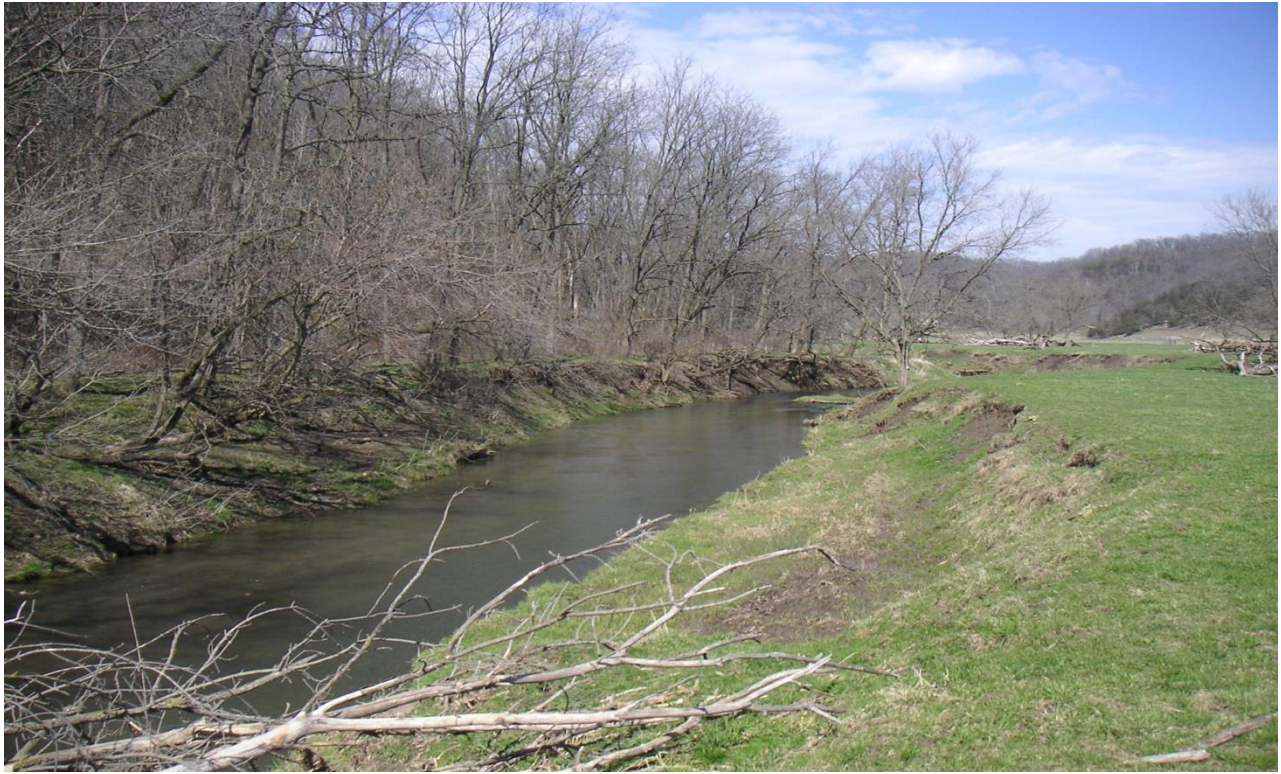
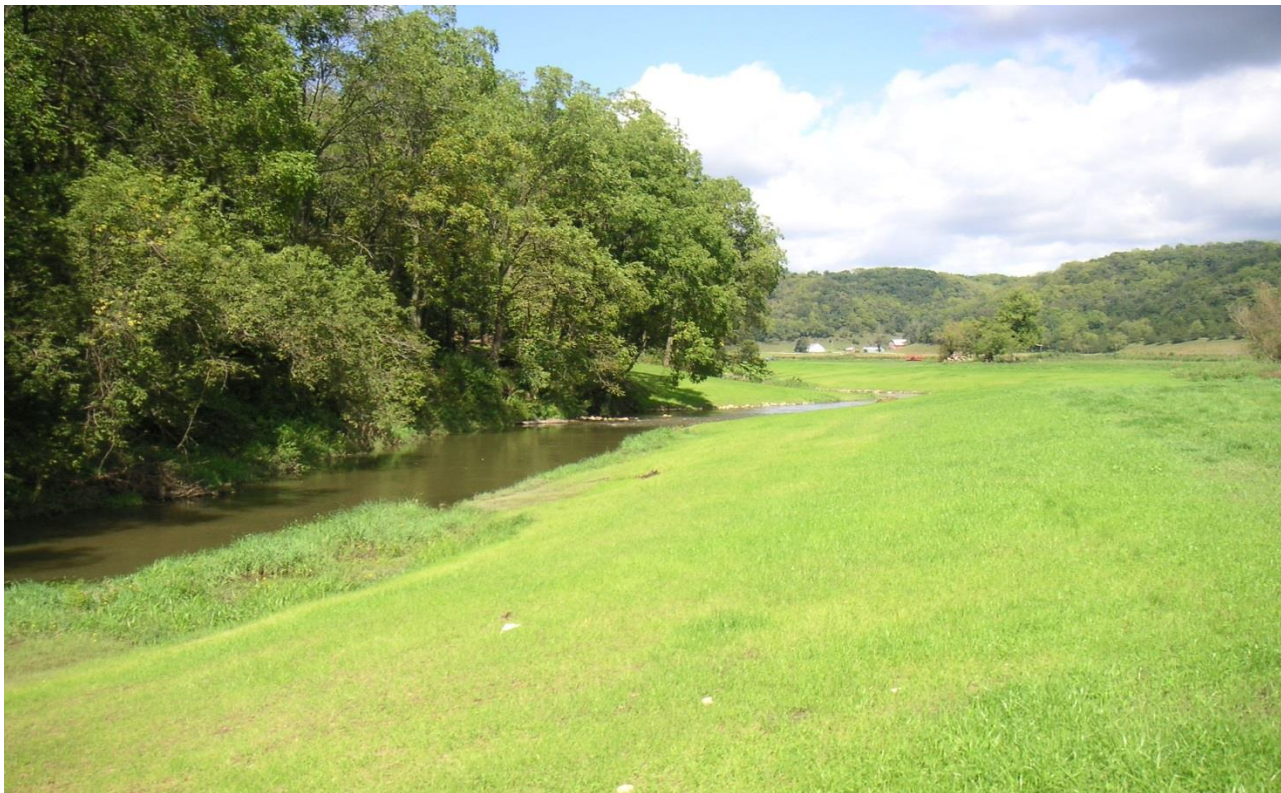
This before and after sequence is from the upper most section of the 2016 project site. We crossed the fence that exists just above this photo and separates this pasture section from the field section that was the end of the 2012-13 project site. This tied the two finished projects together.
