Re: *Lake Belle View Restoration Project – 2015 Monitoring Summary*
MARS Project Number: 1428-011

Lake Belle View Restoration Project
2015 Lake Water Levels - Continuous Monitoring

**2015 MONITORING REPORT
FOR
LAKE BELLE VIEW RESTORATION PROJECT**

Lake Belle View AIS Carp Removal Progress Report

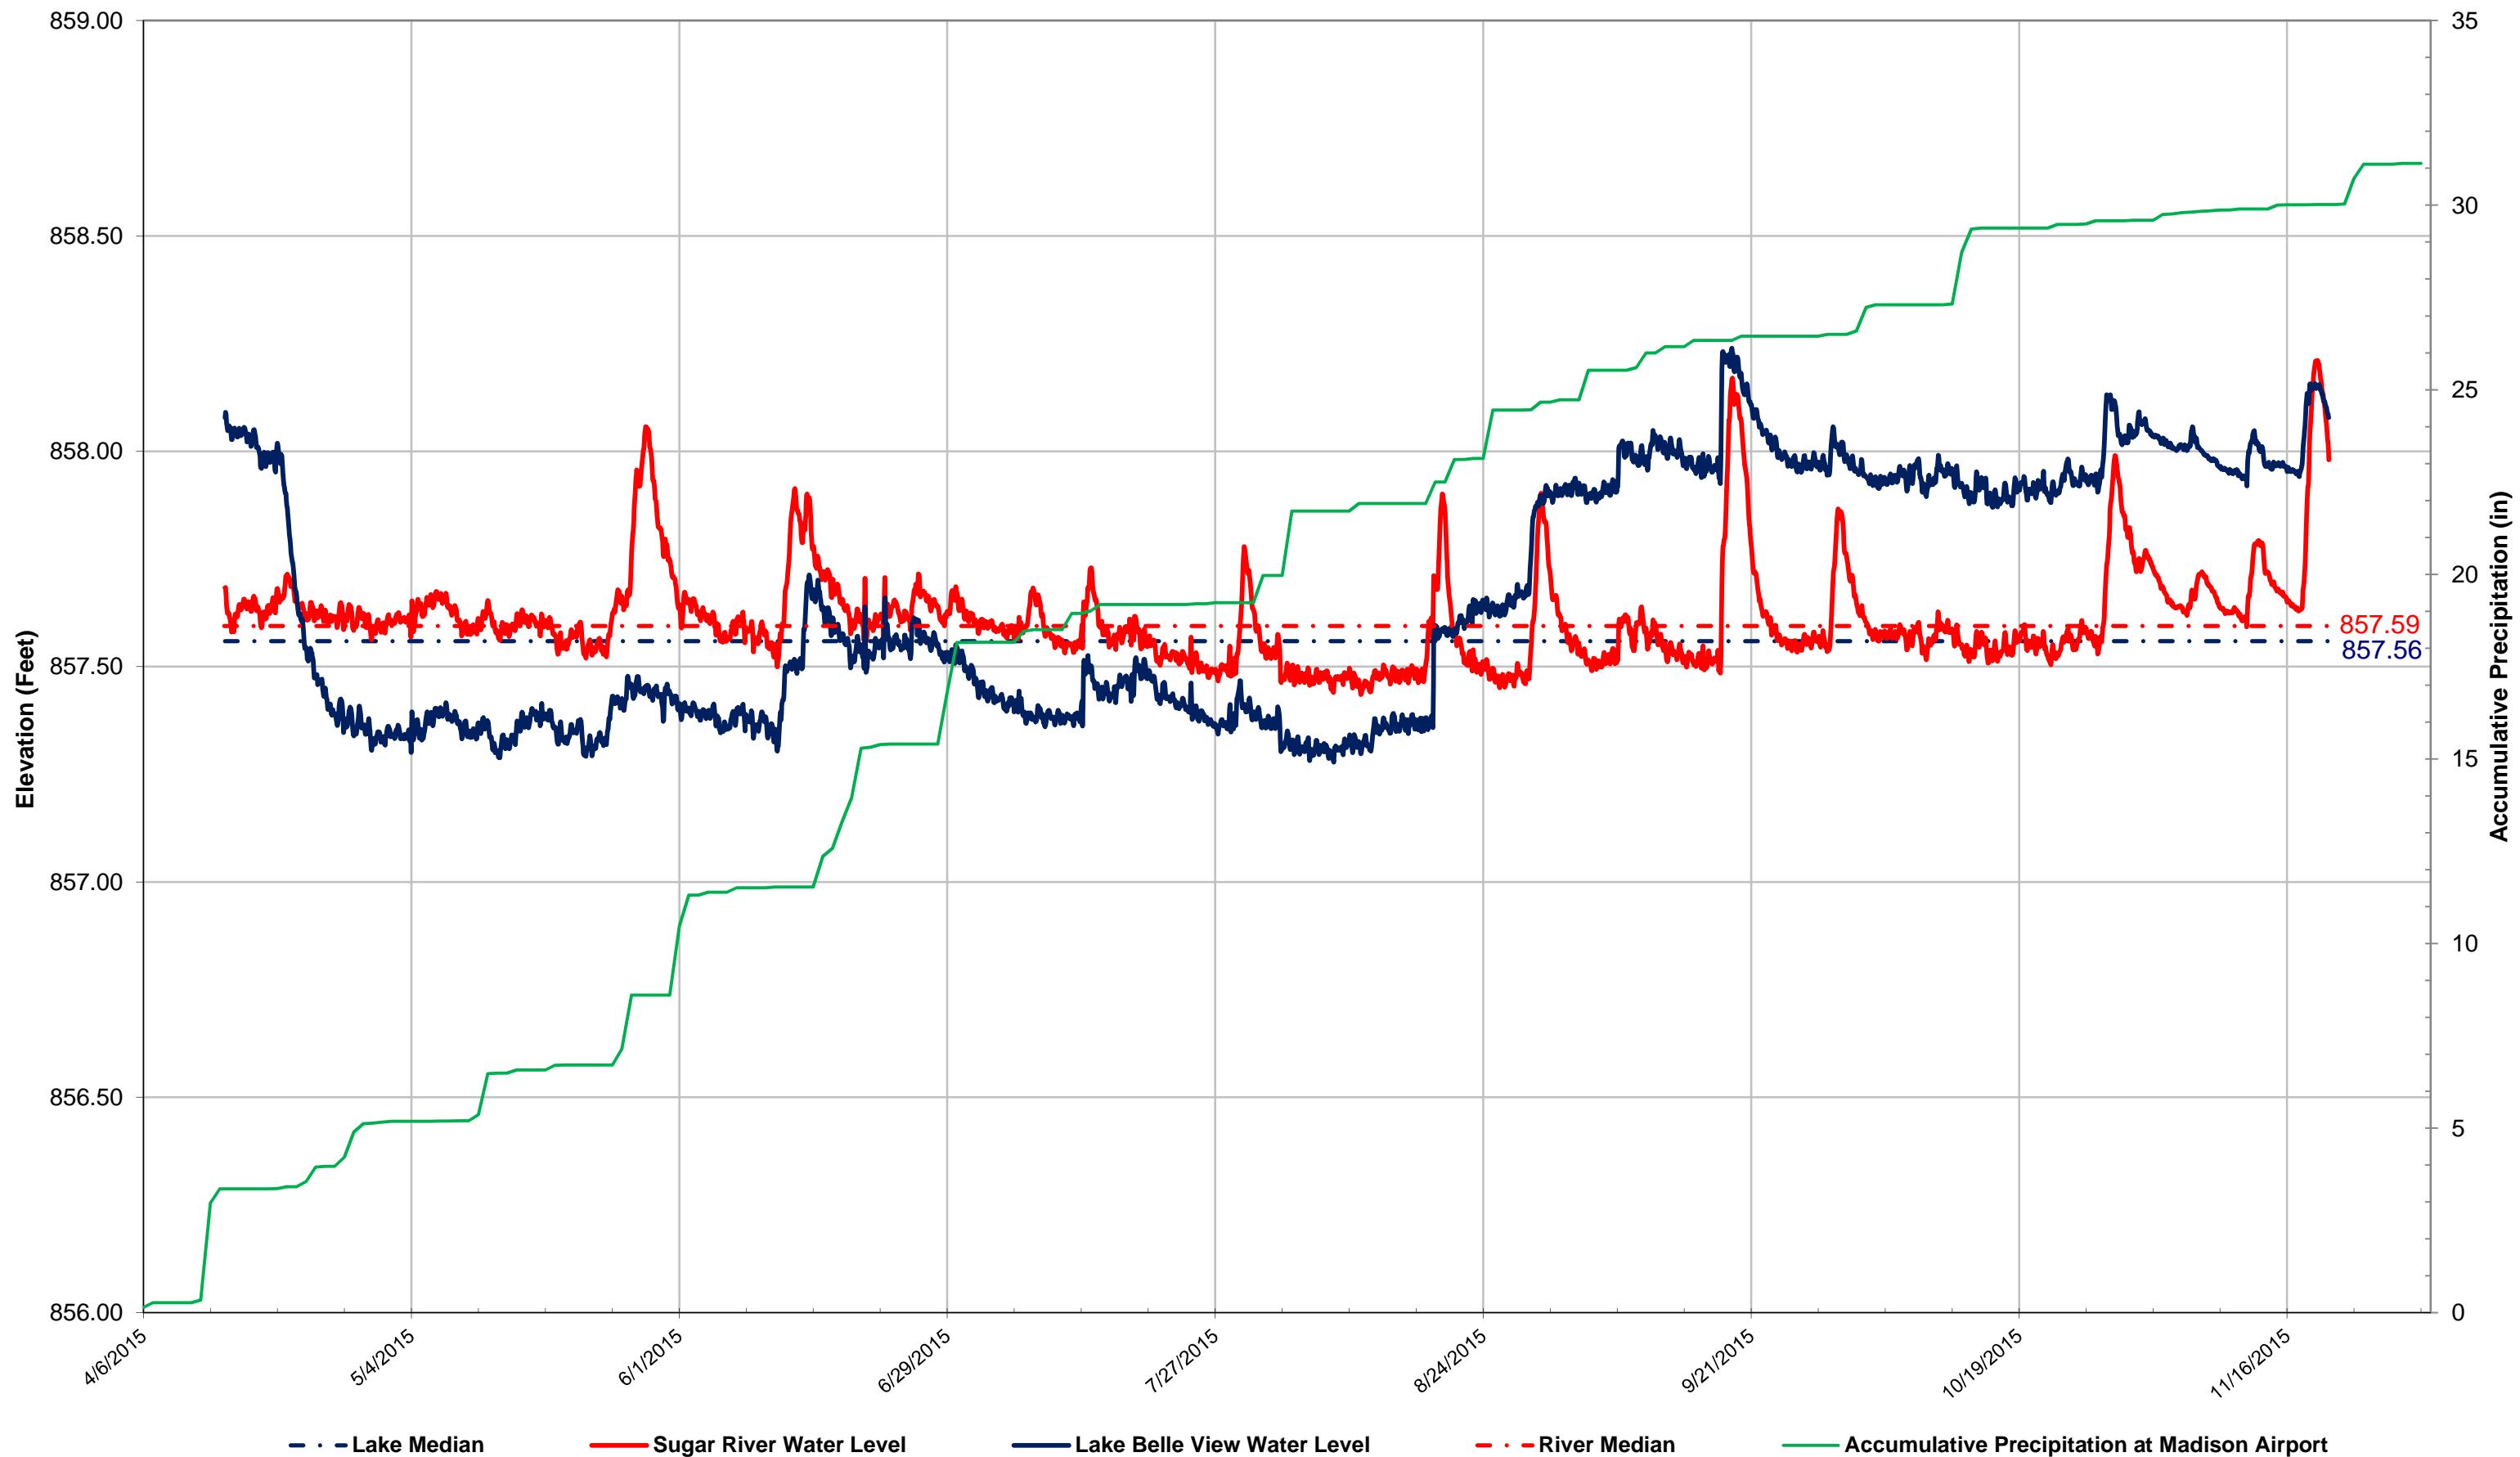
The graph shown in *Lake Belle View Restoration Project, 2015 Lake Water Levels – Continuous Monitoring* shows 2015 lake levels for Lake Belle View for the year 2015. The weir gate in the control structure was lowered 0.5 feet from 858' to 857.5' in late April 2015, to accommodate prairie burning and seeding activities. The gate was raised to 858' in August of 2015. Overall, the median level of the lake was 857.66' for the year 2015, which is within the requirement of $858' \pm 0.5'$ and within $\pm 0.5'$ of the median stage of the Sugar River at the dam (857.59') as stipulated in Special Condition #5 in the permit. Pending no foreseen issues related to vegetation burns or seeding activities, the lake level will be held at 858' through 2016.

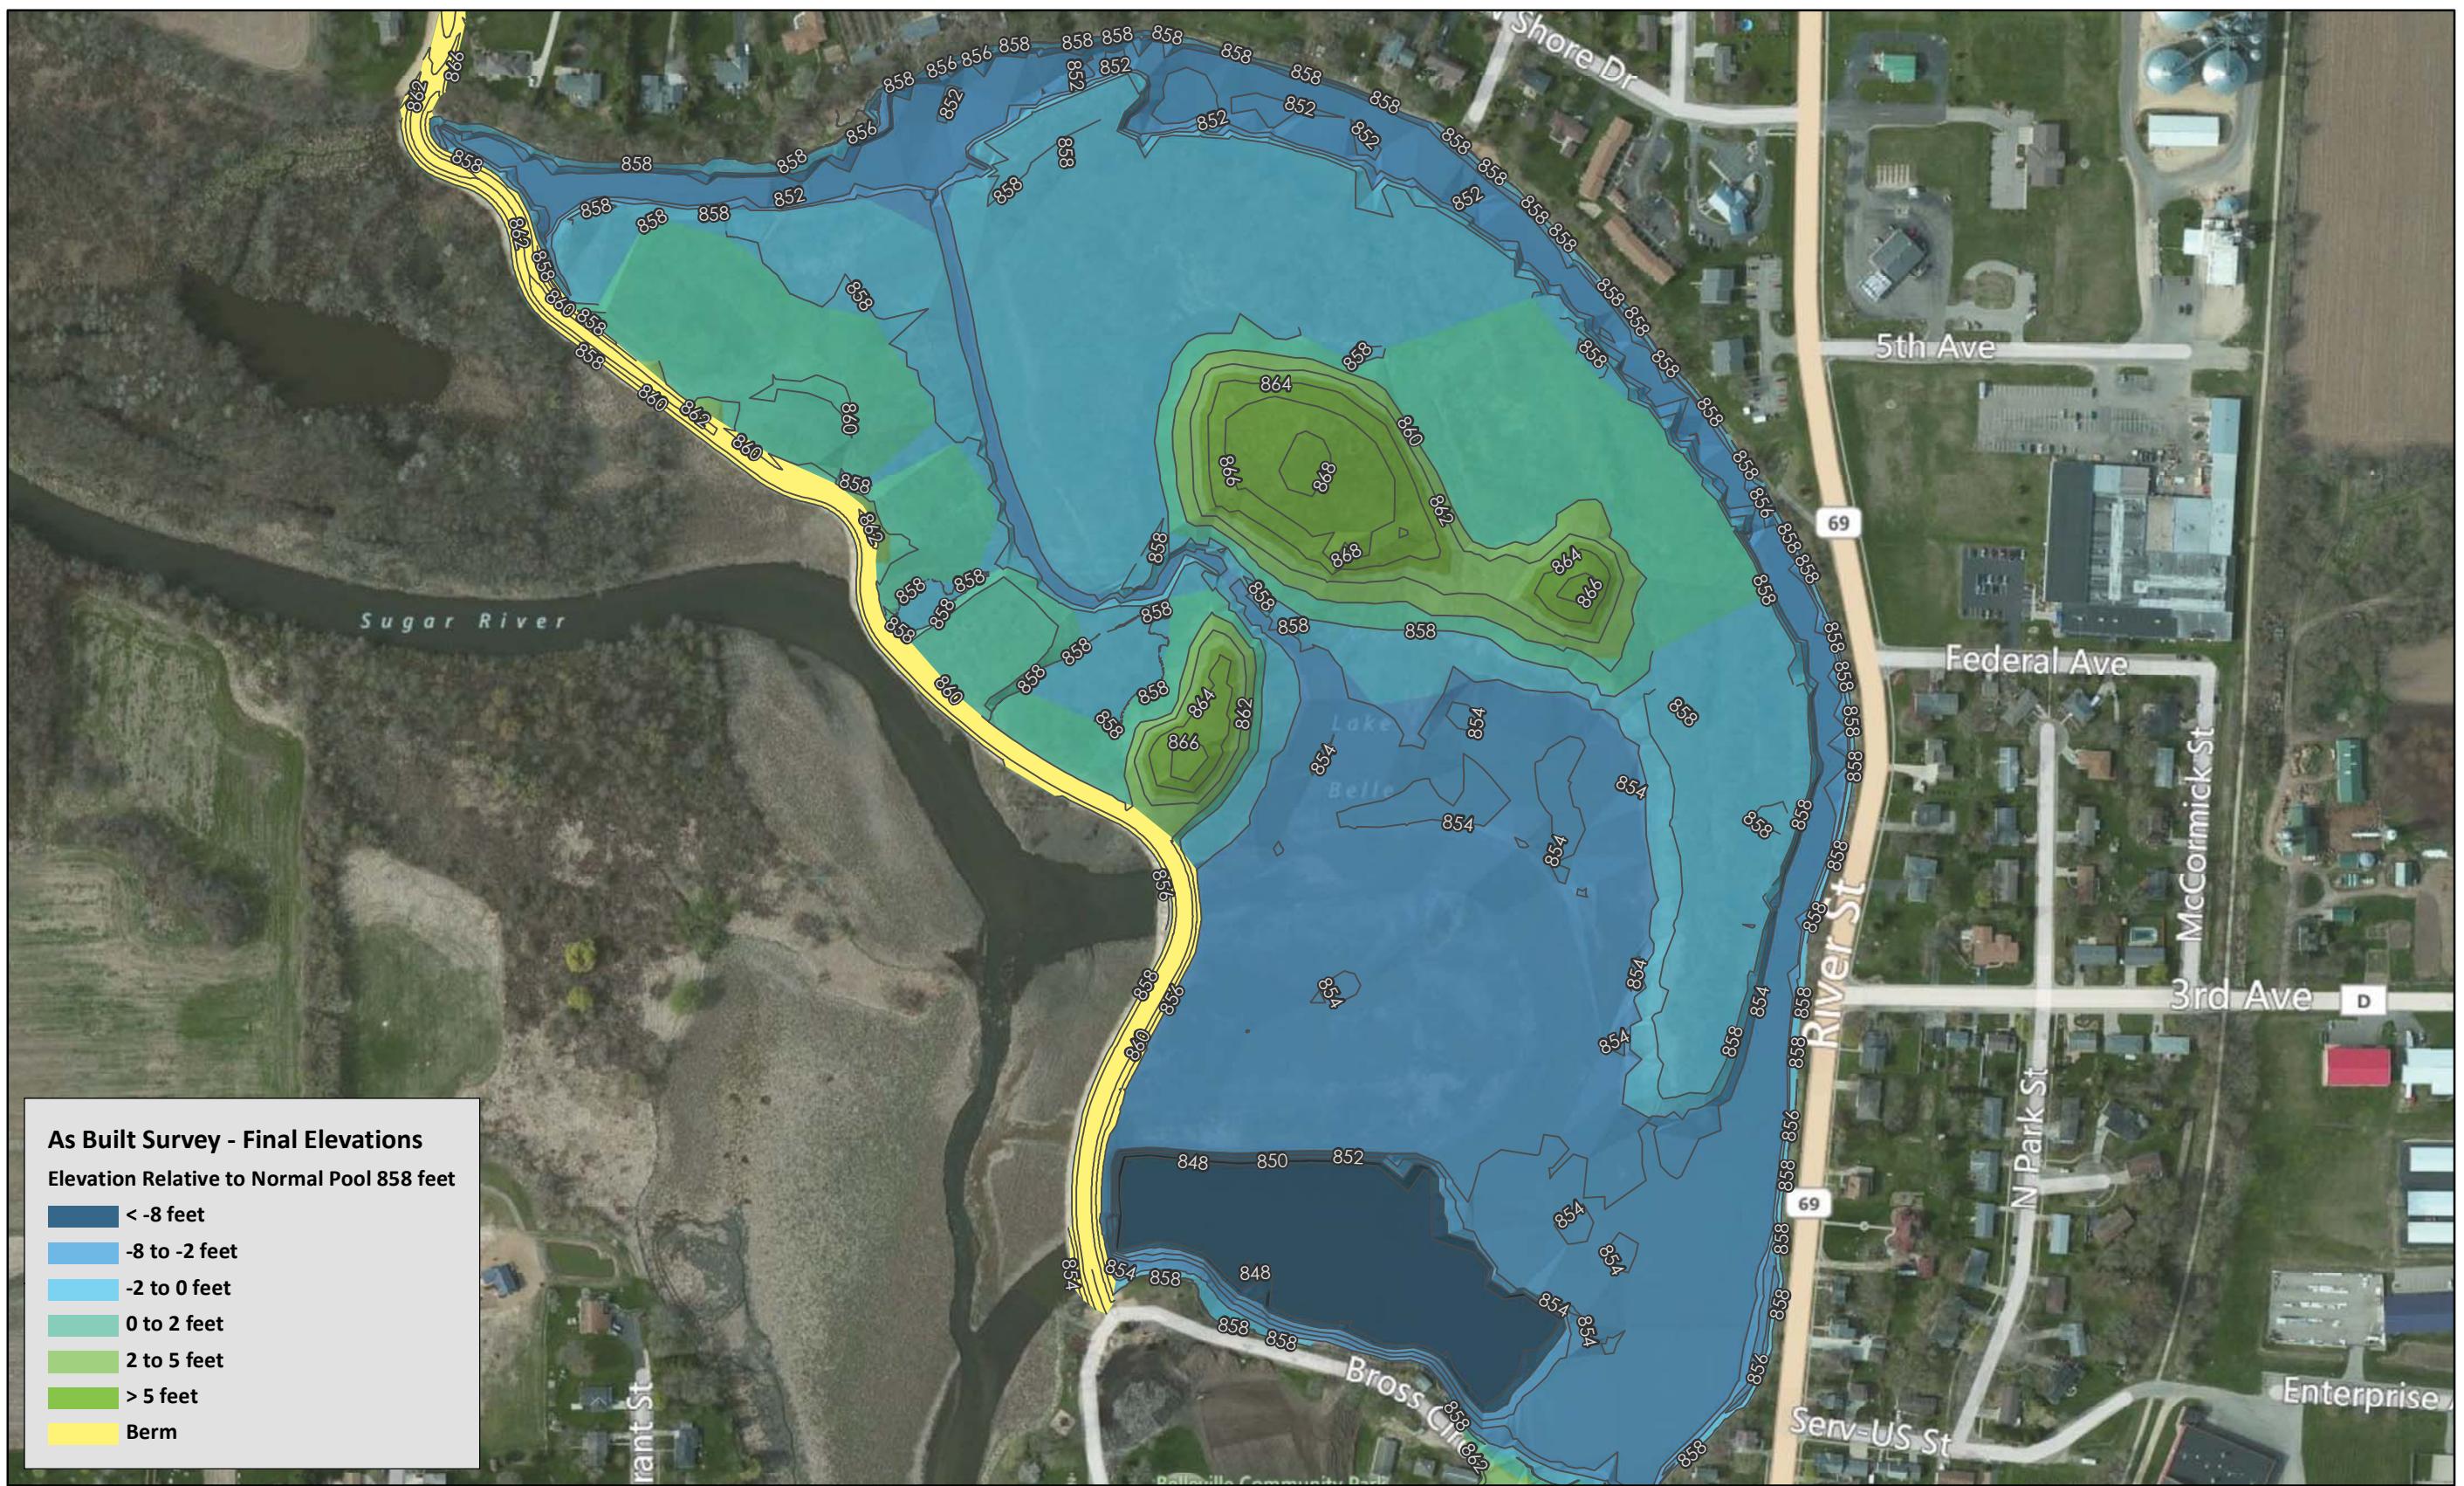
Figure 1

Eco-Resource Consulting, LLC (ERC), conducted a field investigation of the native plant community restoration around Lake Belle View on July 9, 2015. The areas surveyed included the emergent aquatic bed, an area from two feet below water level to the shoreline (-2 to 0 feet elevation), the wet meadow area from the shoreline to two feet of elevation above the shoreline (0 to + 2 feet elevation), the wet mesic prairie area from two feet to five feet elevation above the shoreline (+2 to + 5 feet elevation) and the mesic prairie area greater than five feet in elevation above the shoreline (> 5 feet elevation). The original plan called for the emergent aquatic bed to occupy 9.4 acres of shallow water, the wet meadow, 11.1 acres of wetland, the wet prairie, 4.1 acres, and the mesic prairie 3.9 acres of upland (Figure 1).

AS BUILT ELEVATIONS HABITAT ZONES Lake Belle View Lake Restoration Village of Belleville Dane County, WI

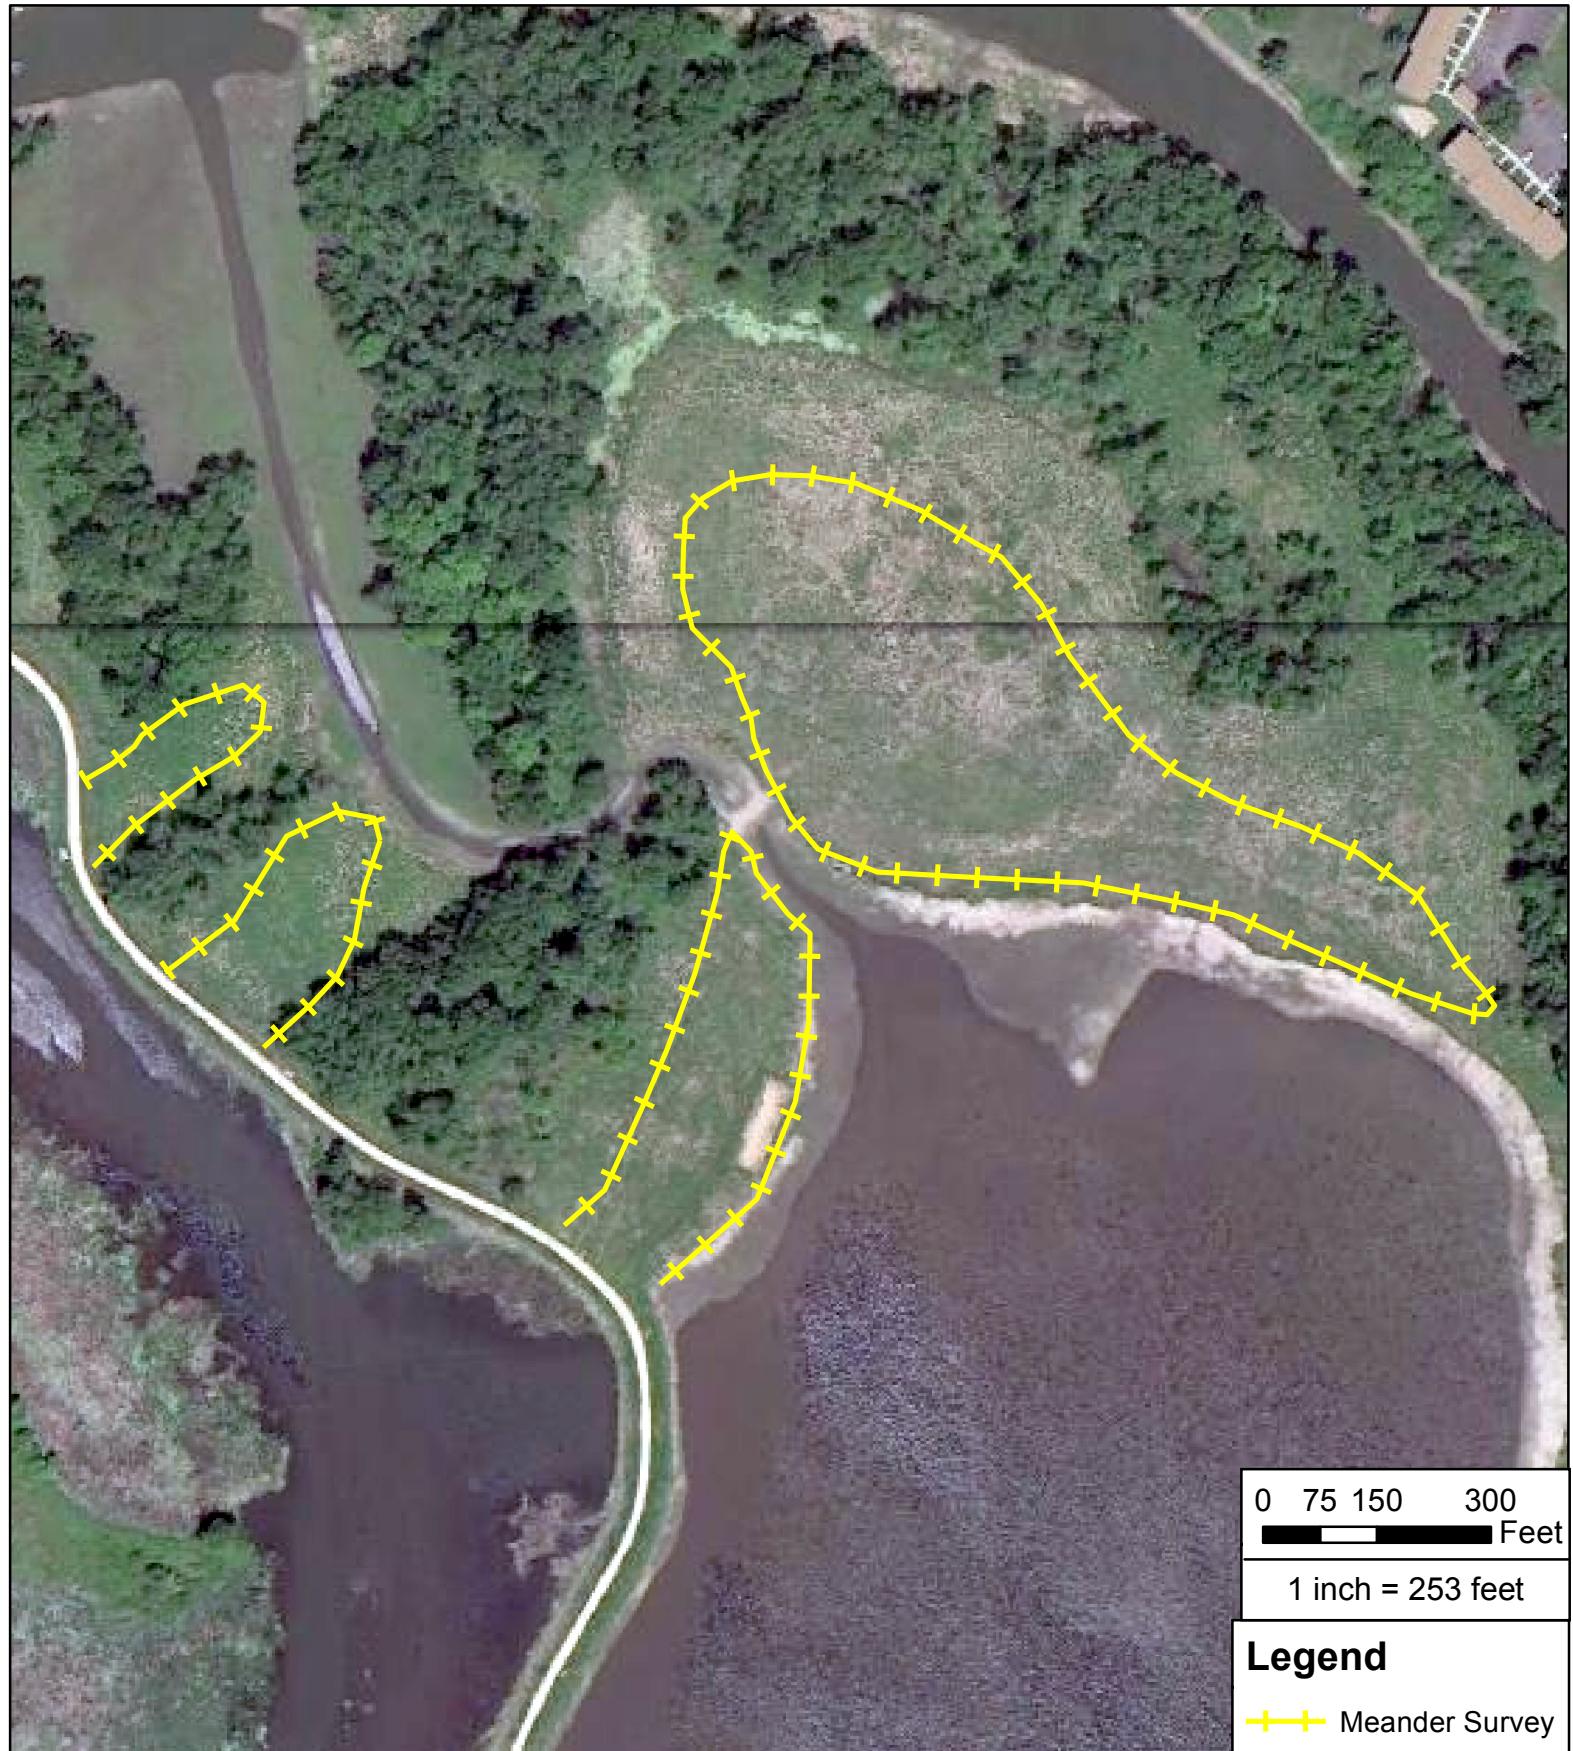
Drawn By: Daniel Fuhs
Date: 7/16/2015
Project Number: 11006
Figure 2

To assess the vegetation, a meander survey of the entire restoration area was conducted on July 9, 2015. Two field personnel traveled along the meander survey path(s) (Figure 2), and recorded all species encountered. Although the meander path was continuous, it was conducted so all habitat types are included. Each species encountered was assigned a vegetative cover class within each habitat type.

2015 Meander Survey
Lake Belle View Lake Restoration
Village of Belleville
Dane County, Wisconsin

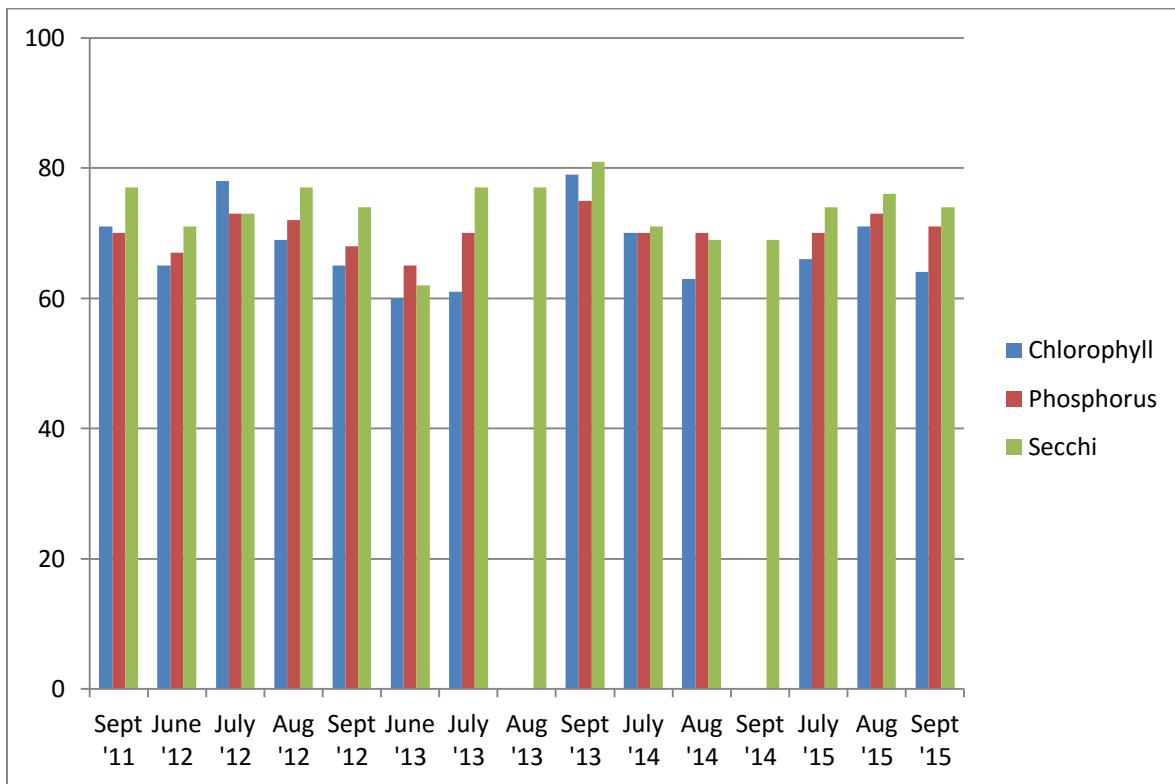
Figure 1: Lake Belle View Trophic State Index 2011 – 2015

Eutrophic conditions in Lake Belle View continued through the 2015 growing season. Trophic State Index values in Figure 1 demonstrate that a significant water quality change did not occur after the carp removal in 2014. These conditions indicated that common carp numbers in the lake remain high enough to maintain the turbid conditions. However, lake users reported that lake conditions are generally favorable since Cyanobacteria blooms have not occurred for the last two summers. In Figure 2, high turbidity measurements continued in 2014 and 2015.

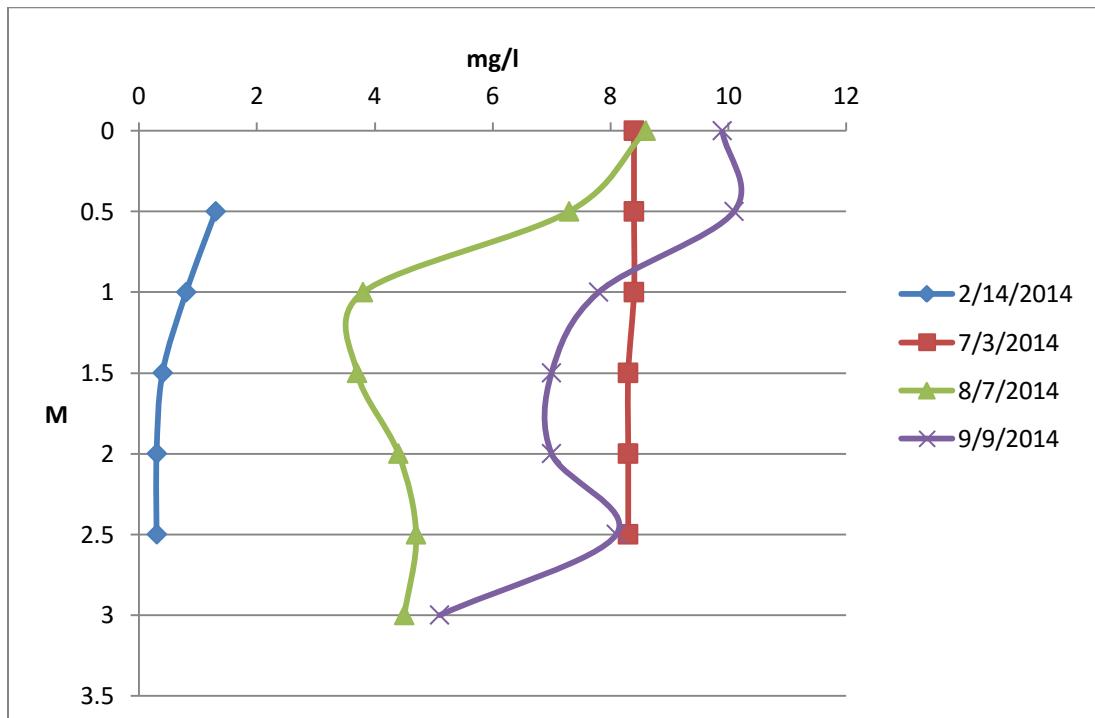
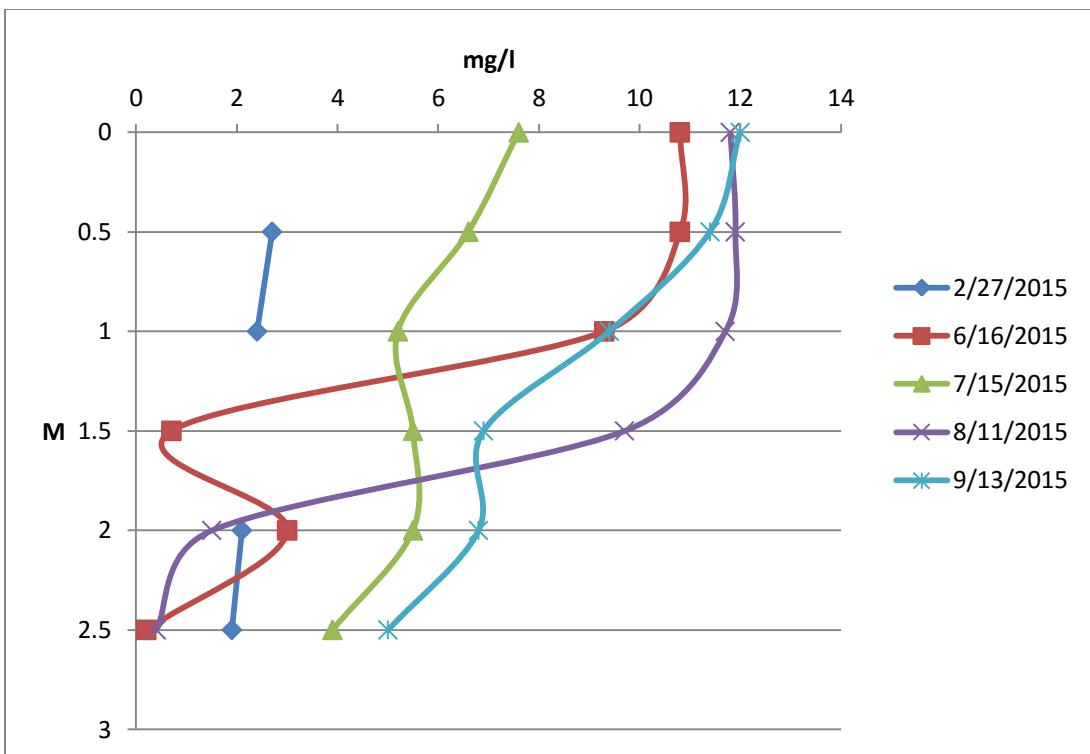
Figure 3: 2014 and 2015 Lake Belle View Dissolved Oxygen Profiles

A partial winterkill occurred in early 2014 and the resulting environmental stress had potential to benefit common carp at the expense of native fish populations. Deep hole dissolved oxygen profiles in Figure 3 demonstrate low dissolved oxygen levels measured during the winters of 2014 and 2015. The 2014 winterkill occurred due to very low dissolved oxygen concentrations that dropped below 1 mg/l throughout the water column. However, the loss of walleyes and some other large gamefish 2014 did not affect high numbers of panfish that may have overwintered in spring seeps elsewhere in the lake. Figures 4 displays nearshore fish shocking surveys in 2014 and 2015. In September 2014, two young of year common carp were collected and demonstrated recruitment for the first time in the lake. As part of citizen outreach and efforts to encourage carp removal from the lake, carp fishing contests were organized as part of the 2014 and 2015 Lakefest events. Results demonstrated that common carp were still abundant in the lake following commercial harvests and additional carp removal efforts should continue. Figure 5 displays the length frequency distribution from the carp fishing contests. Comparing the 2014 and 2015 data, carp recruitment occurred after the lake was constructed and some growth had occurred in 2015. In Figure 6, the catch and harvest rates did not change significantly comparing the 2014 and 2015 contests. Vertical temperature and conductivity

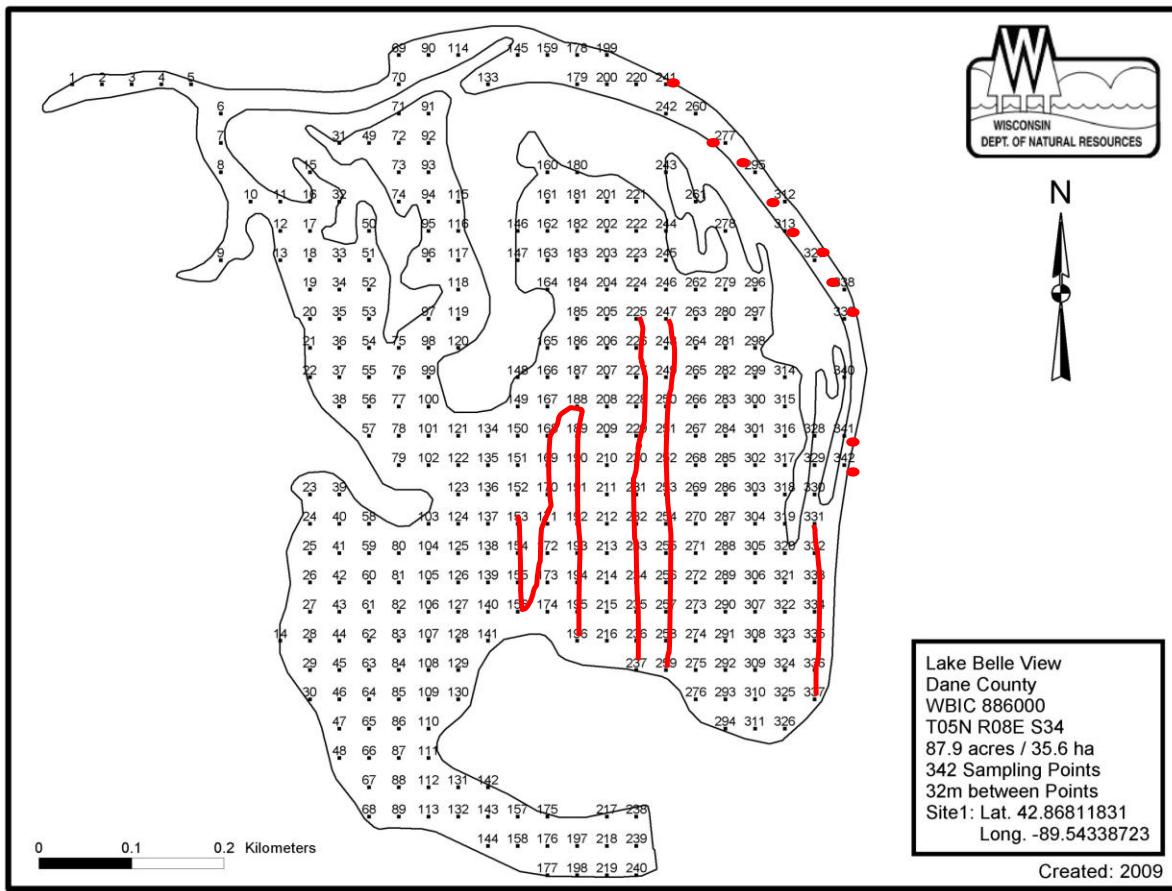
Figure 9: Lake Belle View (former millpond) Point Intercept Map and Sampled Areas Highlighted

Establishing diverse submersed and floating leaf aquatic plants was identified as an important goal of the oxbow lake restoration. However, the relatively short initial drawdown and common carp refuge undermined that effort. On June 16, 2015 we conducted a modified point intercept aquatic plant survey based on an earlier map of the old millpond. We sampled a subset of survey points that lie within the new lake boundaries but many other points now occur in the much reduced millpond, separation berm and newly expanded floodplain forest (Figure 9). Our data demonstrate the scarcity of both submersed and floating leaf pondweeds even though numerous white water lily and wild celery propagules were planted in the lake. Table 1 summarizes the aquatic plant survey results. Aquatic plant species collected or observed during the survey included coontail, Sago pondweed, curly-leaf pondweed, white water lily, small duckweed, large duckweed and long-leaf pondweed.
