Bullhead Lake

Manitowoc County, Wisconsin

Comprehensive Management Plan

January 2019

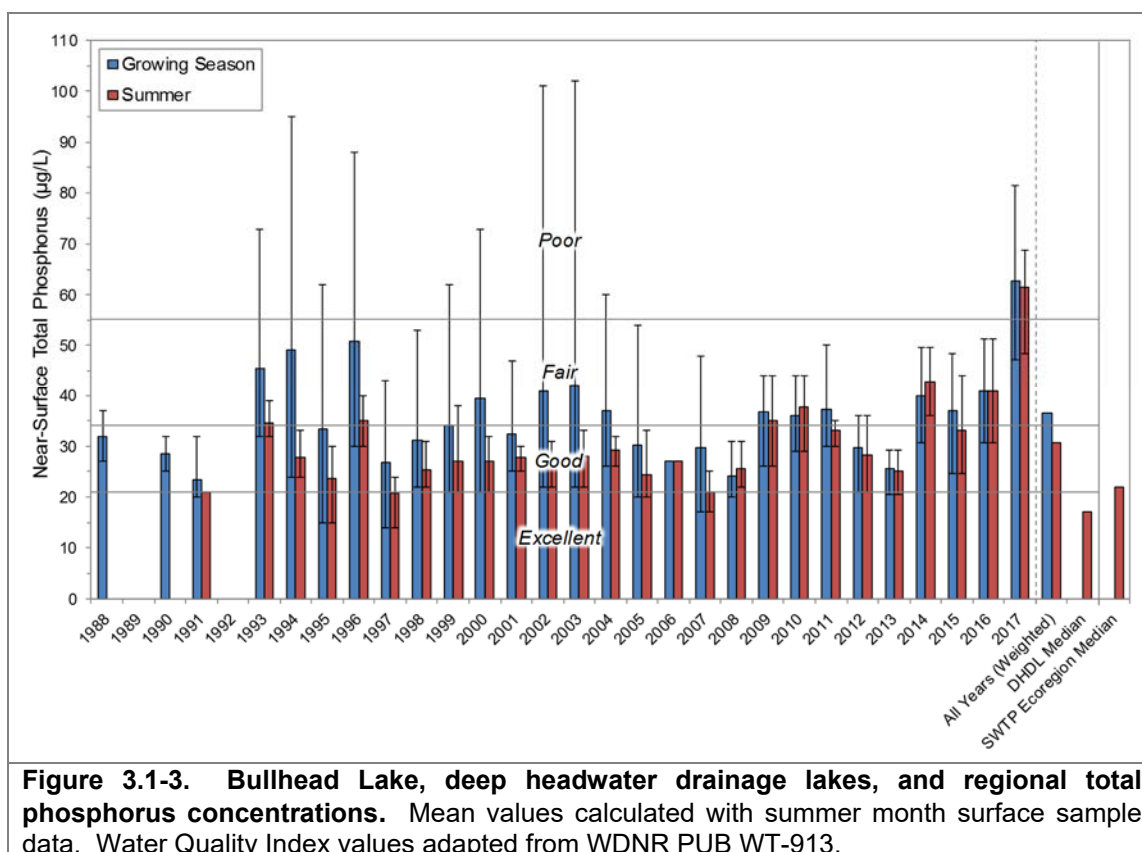
Figure 3.1-3. Bullhead Lake, deep headwater drainage lakes, and regional total phosphorus concentrations. Mean values calculated with summer month surface sample data. Water Quality Index values adapted from WDNR PUB WT-913.

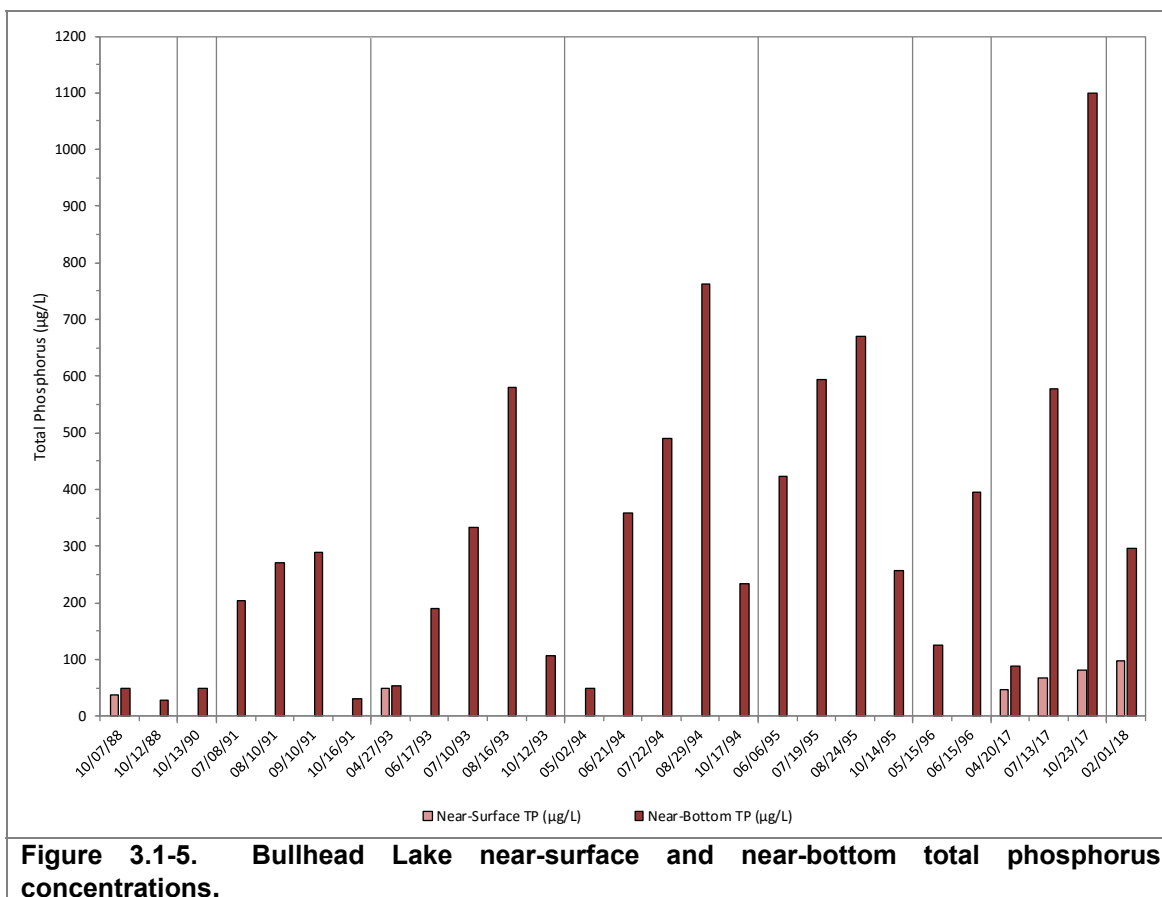
Figure 3.1-5. Bullhead Lake near-surface and near-bottom total phosphorus concentrations.

As seen in Figure 3.1-5, near-bottom phosphorus concentrations were similar to near-surface concentrations until 1990. If alum is applied in high enough doses, it is effective for a number of years. It appears that either not enough alum was added to the lake or enough phosphorus was delivered to Bullhead Lake for the alum treatment to only be effective for a few years. Internal nutrient loading began again in 1991 and continues at the present time with the highest measured phosphorus concentrations in the bottom waters occurring in 2017.

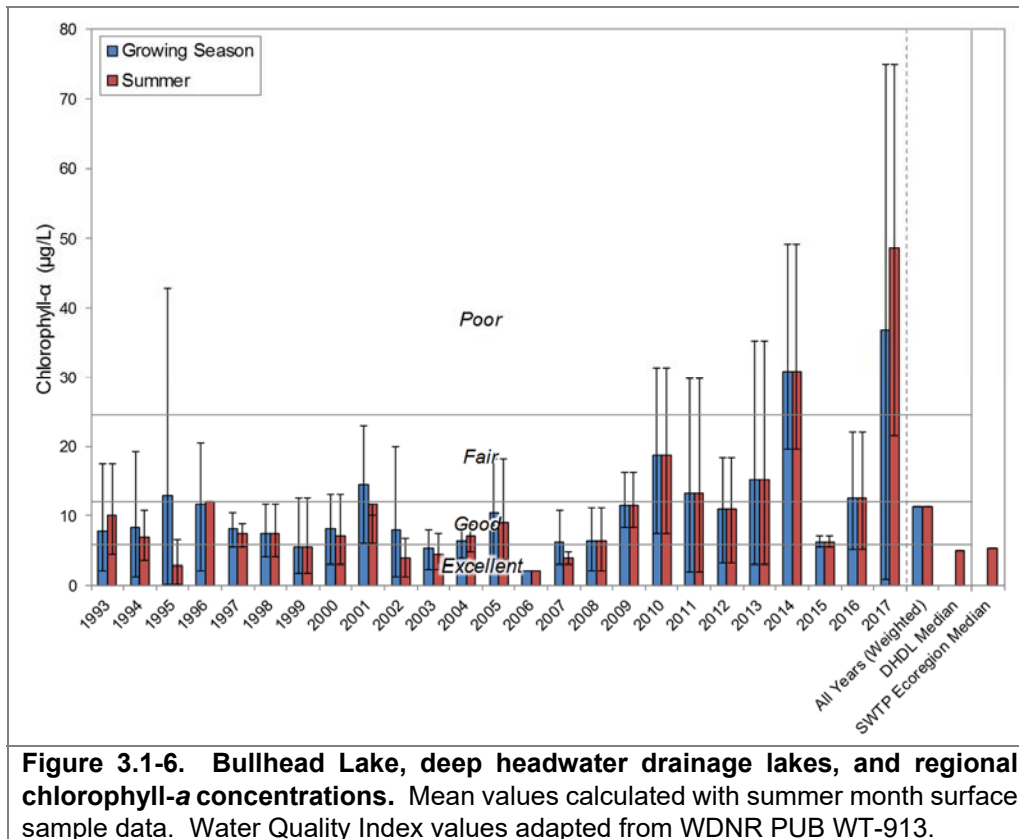
Chlorophyll-*a* concentration data are available annually from 1993 to 2017 (Figure 3.1-6). Average summer chlorophyll-*a* concentrations ranged from 2 µg/L in 2006 to 49 µg/L in 2017. It should be noted that only one summer chlorophyll-*a* sample was collected in 2006 and it may not be representative of the 2006 summer average chlorophyll-*a* concentration. The weighted summer chlorophyll-*a* concentration is 11 µg/L and falls into the *fair* category for chlorophyll-*a* concentrations in Wisconsin's deep headwater drainage lakes. Bullhead Lake's chlorophyll-*a* concentrations are approximately three times higher than the median values for deep headwater drainage lakes in the state and are approximately two times higher than the median values for all lake types within the SWTP ecoregion. Algal levels are considered to be a nuisance when the chlorophyll-*a* concentrations exceed 20 µg/L. Prior to 2010 this level was only exceeded 3 times out of 65 samples. Starting in 2010 this value has been exceeded at least 9 times with a

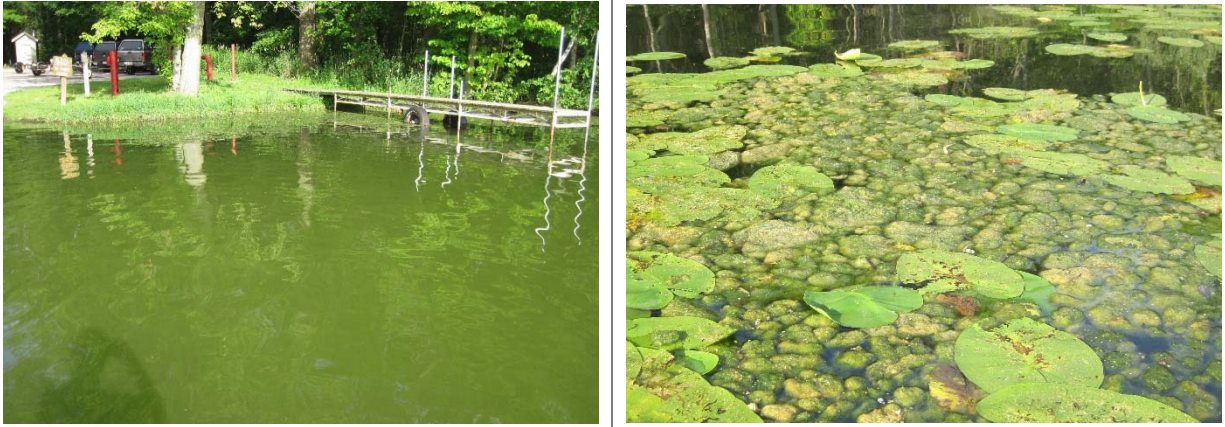
Photograph 3.1-2. Algal bloom (left) and surface-matting *Cladophora* spp. (right) in Bullhead Lake in 2017. Photo credit Onterra.

The 2017 average summer chlorophyll-*a* concentration was over four times higher than the lake's long-term weighted average, with an average concentration of 49 µg/L. Onterra crews noted an algal bloom and surface-matted *Cladophora* spp., filamentous algae or periphyton, in Bullhead Lake during the whole-lake aquatic vegetation surveys completed in July 2017 (Photograph 3.1-2). High nutrient conditions, as seen on Bullhead Lake in 2017, can result in extensive growth of *Cladophora* spp. (Bellinger and Sigeo 2010). *Cladophora* spp. can grow in dense communities among vegetation in shallow water, which can break off and form floating mats. In July 2017, mats of filamentous algae were noted along the shoreline in Bullhead Lake, especially within floating-leaf vegetation, as seen in Photograph 3.1-2.

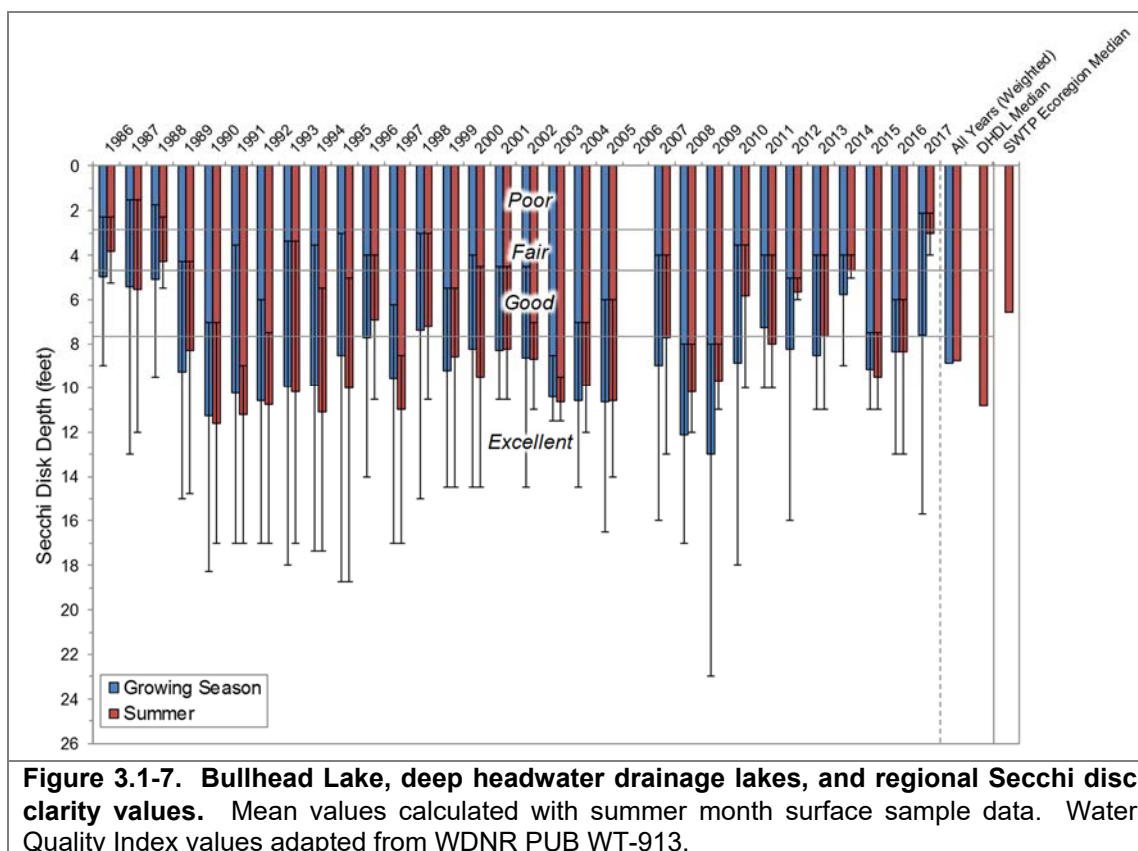
The improvement in water clarity following the 1988 alum treatment is apparent in Figure 3.1-7. The summer Secchi disc transparency during the three years prior to the treatment were approximately 5 feet but it increased to 11 feet in the years following the treatment. The 2017 average summer Secchi disc depth was almost three times shallower than the lake's weighted average, with an average summer Secchi disc depth of 3 feet.

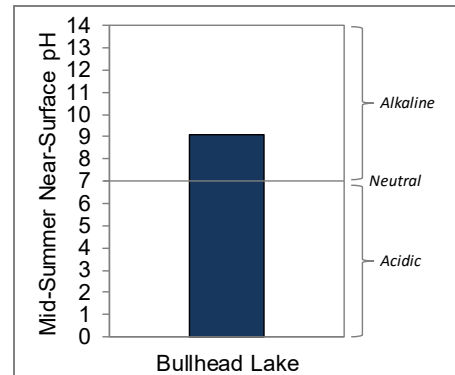
Figure 3.1-15. Bullhead Lake mid-summer near-surface pH value.

The pH scale ranges from 0 to 14 and indicates the concentration of hydrogen ions (H^+) within the lake's water and is an index of the lake's acidity. Water with a pH value of 7 has equal amounts of hydrogen ions and hydroxide ions (OH^-), and is considered to be neutral. Water with a pH of less than 7 has higher concentrations of hydrogen ions and is considered to be acidic, while values greater than 7 have lower hydrogen ion concentrations and are considered basic or alkaline. The pH scale is logarithmic; meaning that for every 1.0 pH unit the hydrogen ion concentration changes tenfold. The normal range for lake water pH in Wisconsin is about 5.2 to 8.4, though values lower than 5.2 can be observed in some acid bog lakes and higher than 8.4 in some marl lakes. In lakes with a pH of 6.5 and lower, the spawning of certain fish species such as walleye becomes inhibited (Shaw and Nimphius 1985). The pH of the water in Bullhead Lake was found to be alkaline with a value of 9.1, and falls outside the normal range for Wisconsin lakes (Figure 3.1-15).

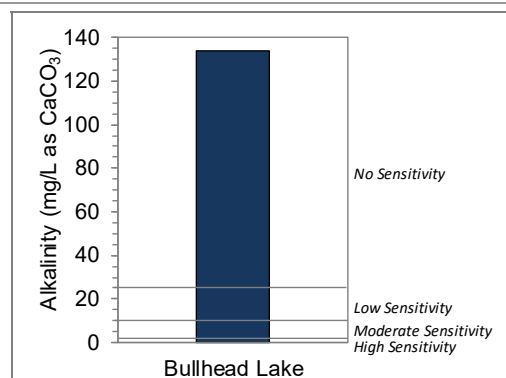
Figure 3.1-16. Bullhead Lake average growing season total alkalinity and sensitivity to acid rain. Samples collected from the near-surface.

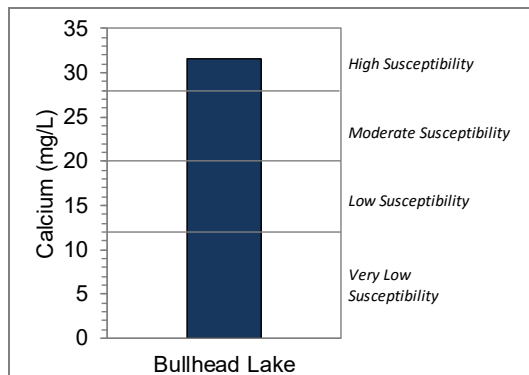
Figure 3.1-17. Bullhead Lake spring calcium concentration and zebra mussel susceptibility. Samples collected from the near-surface.

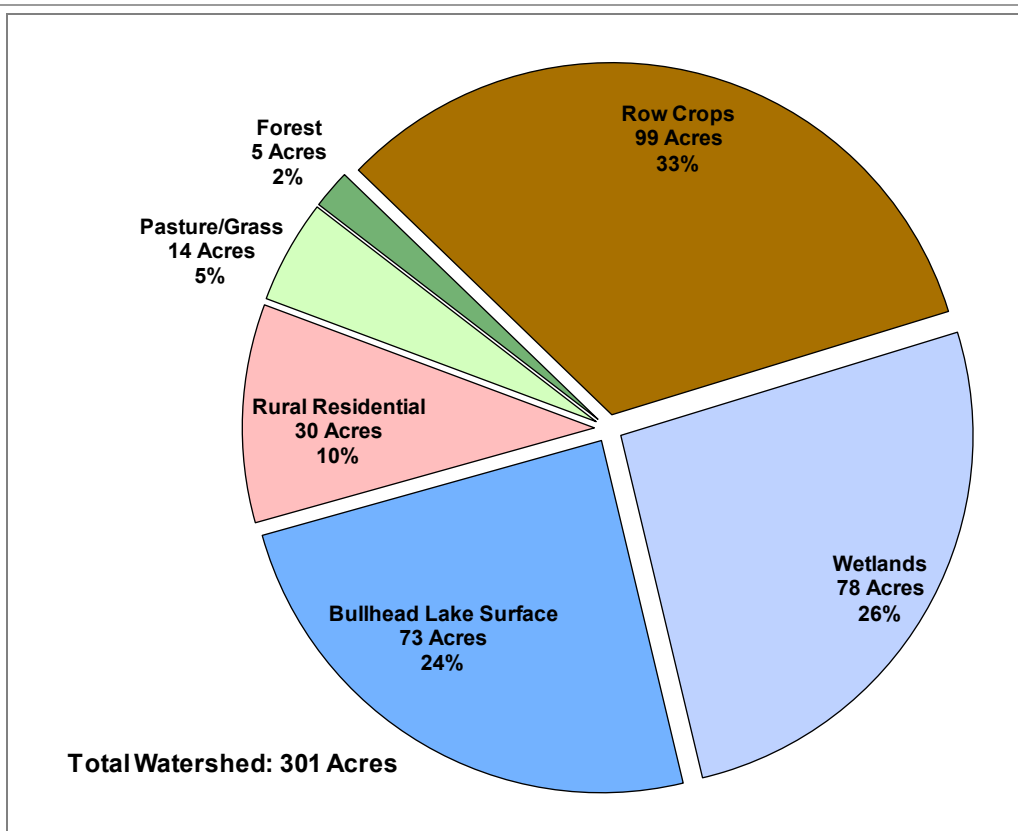
Figure 3.2-1. Bullhead Lake watershed land cover types in acres. Based upon National Land Cover Database (NLCD – Fry et. al 2011).

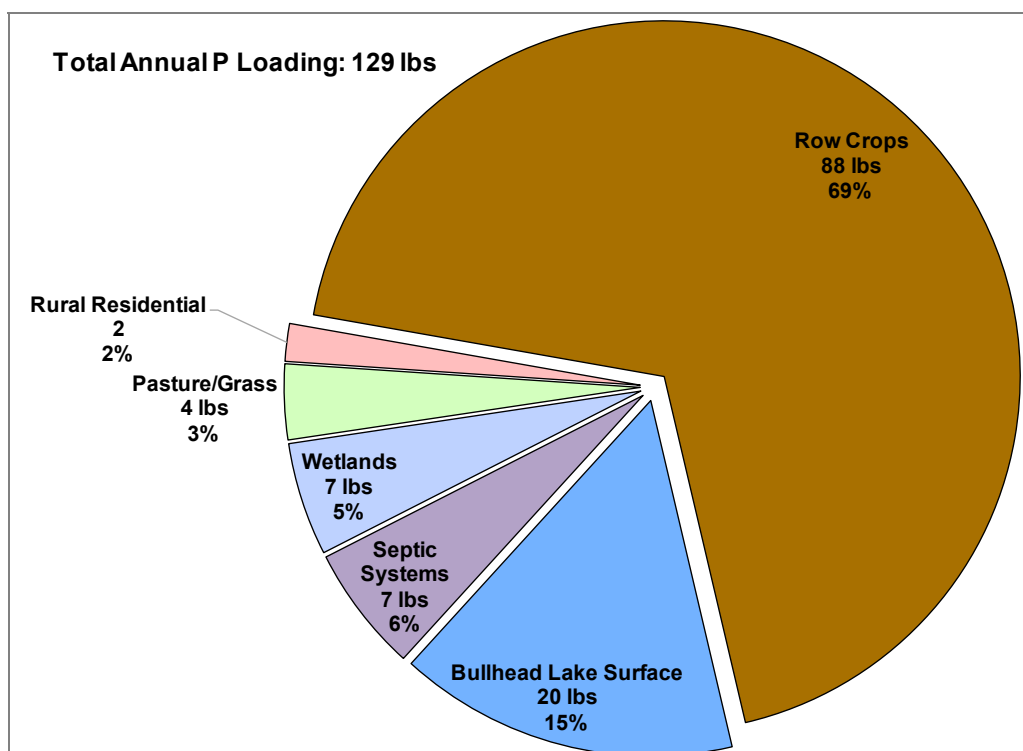
Figure 3.2-2. Bullhead Lake watershed phosphorus loading in pounds. Based upon Wisconsin Lake Modeling Suite (WiLMS) estimates.

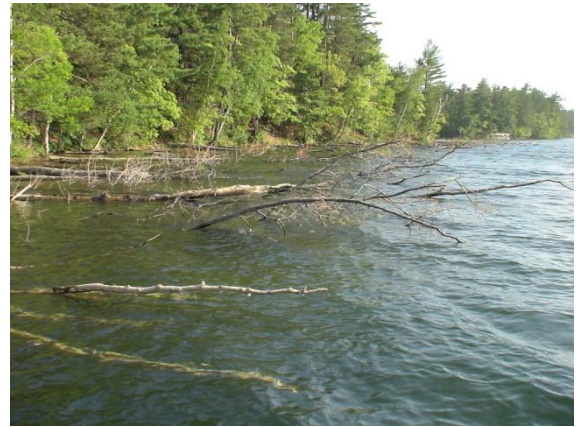
Photograph 3.3-1. Example of coarse woody habitat in a lake.

Coarse woody habitat has shown to be advantageous for fisheries in terms of providing refuge, foraging area, as well as spawning habitat (Hanchin et al 2003). In one study, researchers observed 16 different species occupying coarse woody habitat areas in a Wisconsin lake (Newbrey et al. 2005). Bluegill and bass species in particular are attracted to this habitat type; largemouth bass stalk bluegill in these areas while the bluegill hide amongst the debris and often feed upon many macroinvertebrates found in these areas, who themselves are feeding upon algae and periphyton growing on the wood surface. Newbrey et al. (2005) found that some fish species prefer different complexity of branching on coarse woody habitat, though in general some degree of branching is preferred over coarse woody habitat that has no branching.

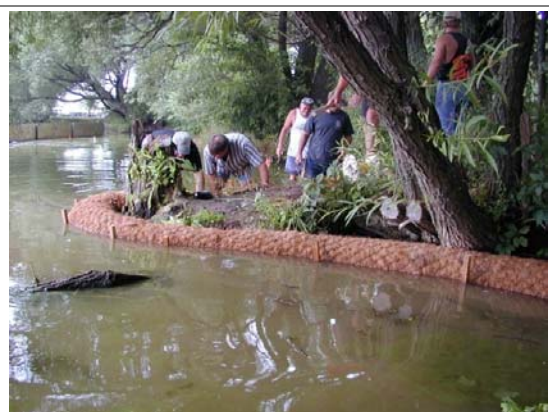
Photograph 3.3-2. Example of a biologic restoration site.

In recent years, many lakefront property owners have realized increased aesthetics, fisheries, property values, and water quality by restoring portions of their shoreland to mimic its unaltered state. An area of shore restored to its natural condition, both in the water and on shore, is commonly called a shoreland buffer zone. The shoreland buffer zone creates or restores the ecological habitat and benefits lost by traditional suburban landscaping. Simply not mowing within the buffer zone does wonders to restore some of the shoreland’s natural function.

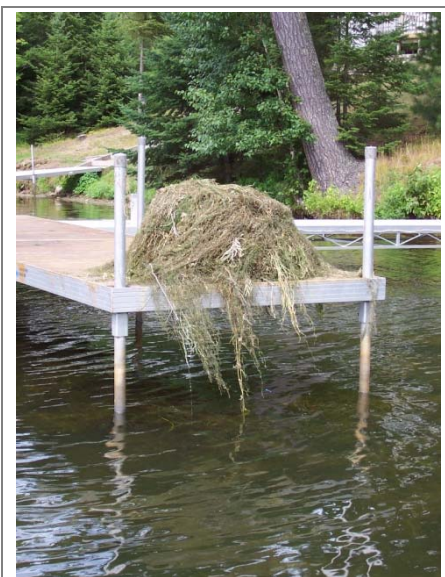
Photograph 3.4-2. Example of aquatic plants that have been removed manually.

Manual removal methods include hand-pulling, raking, and hand-cutting. Hand-pulling involves the manual removal of whole plants, including roots, from the area of concern and disposing them out of the waterbody. Raking entails the removal of partial and whole plants from the lake by dragging a rake with a rope tied to it through plant beds. Specially designed rakes are available from commercial sources or an asphalt rake can be used. Hand-cutting differs from the other two manual methods because the entire plant is not removed, rather the plants are cut similar to mowing a lawn; however Wisconsin law states that all plant fragments must be removed. One manual cutting technique involves throwing a specialized “V” shaped cutter into the plant bed and retrieving it with a rope. The raking method entails the use of a two-sided straight blade on a telescoping pole that is swiped back and forth at the base of the undesired plants.

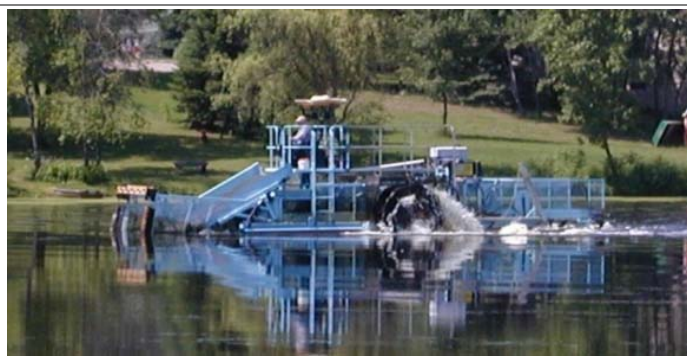
Photograph 3.4-3. Mechanical harvester.

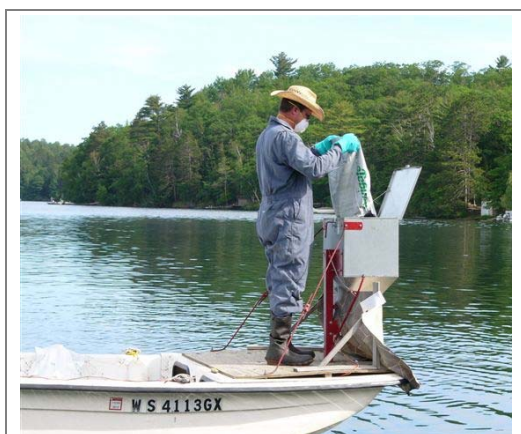
Photograph 3.4-4. Granular herbicide application.

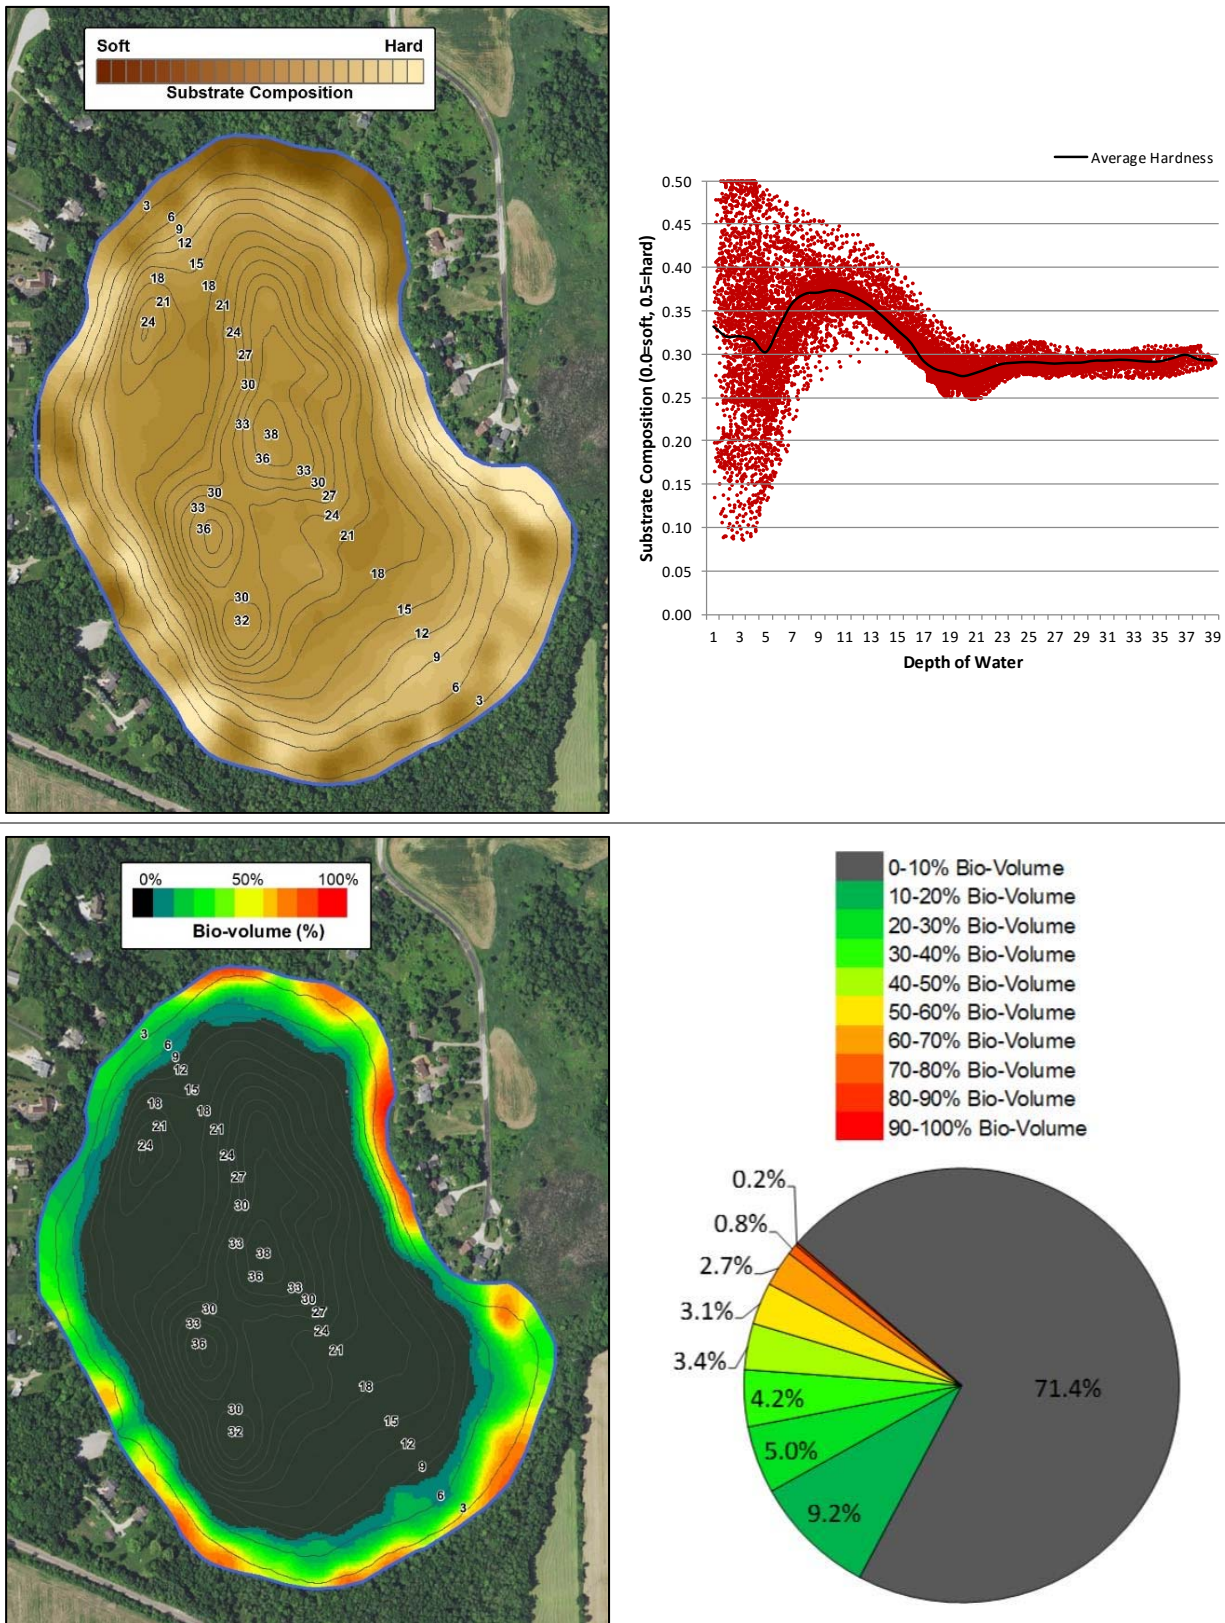
Figure 3.4-2. Bullhead Lake 2017 substrate hardness (top) and aquatic plant bio-volume (bottom). Created using data from August 2017 acoustic survey.

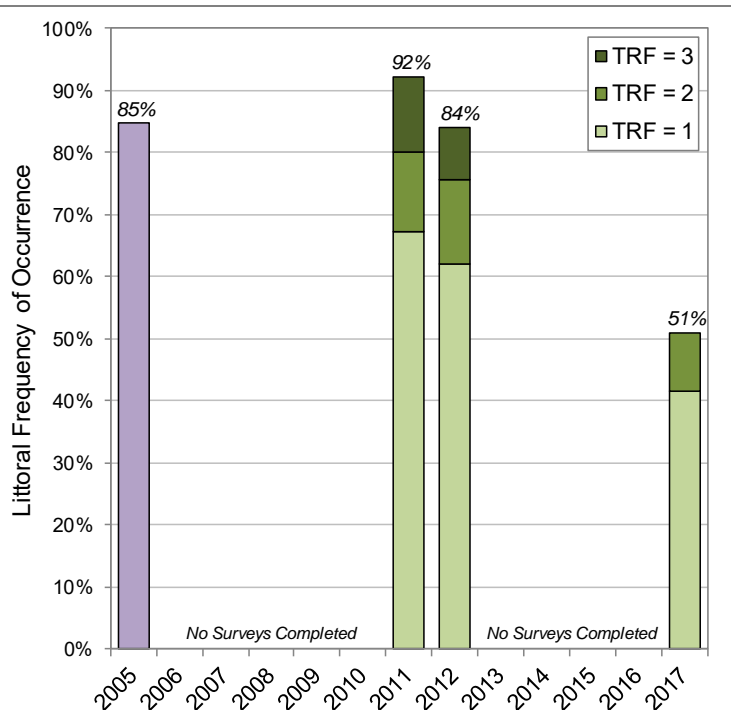
Figure 3.4-3. Aquatic plant frequency of occurrence and total rake fullness (TRF) ratings in Bullhead Lake from the 2005, 2011, 2012, and 2017 surveys. Total rake fullness ratings were not recorded in 2005. Littoral occurrence of vegetation in 2017 was statistically different from 2005, 2011, and 2012 (Chi-square $\alpha = 0.05$).

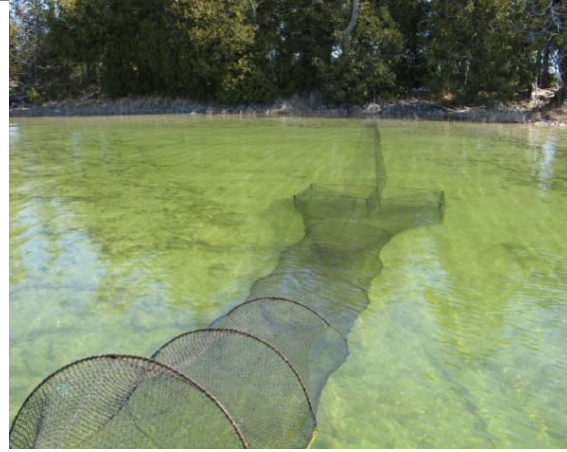
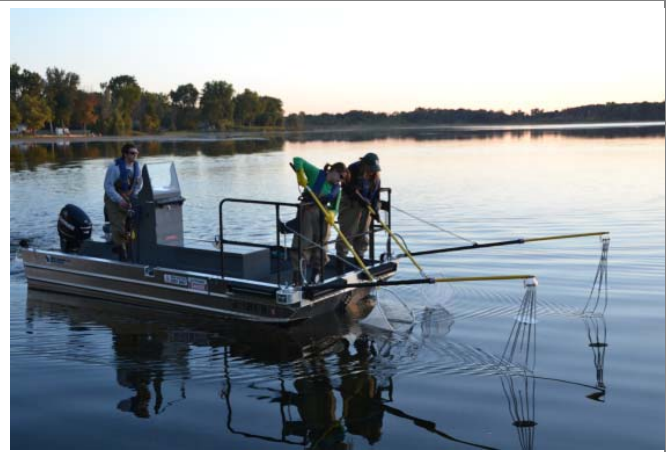
Photograph 3.6-1. Fyke net positioned in the littoral zone of a Wisconsin lake (left) and an electroshocking boat (right).

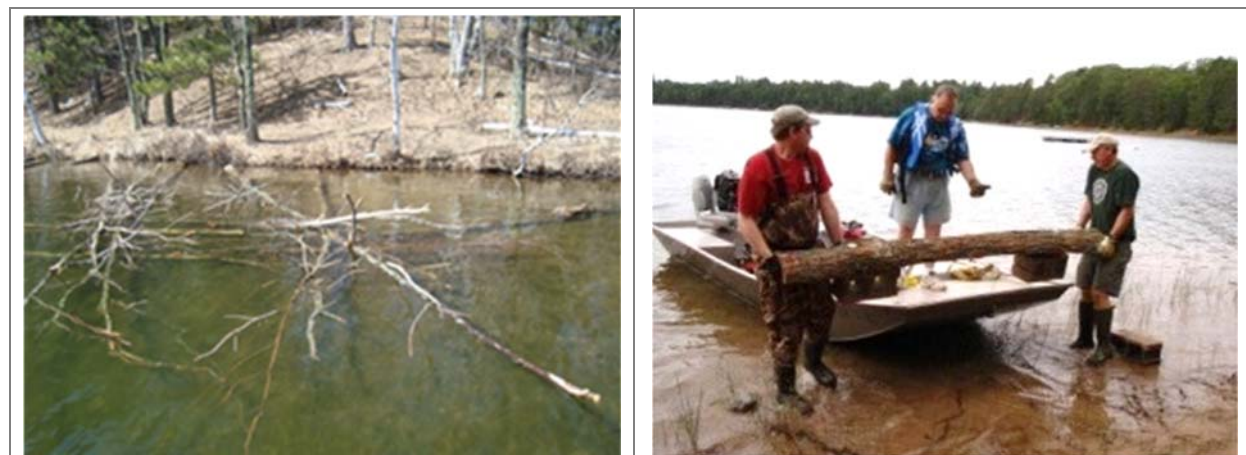
Photograph 3.6-3. Examples of fish sticks (left) and half-log habitat structures. (Photos by WDNR)

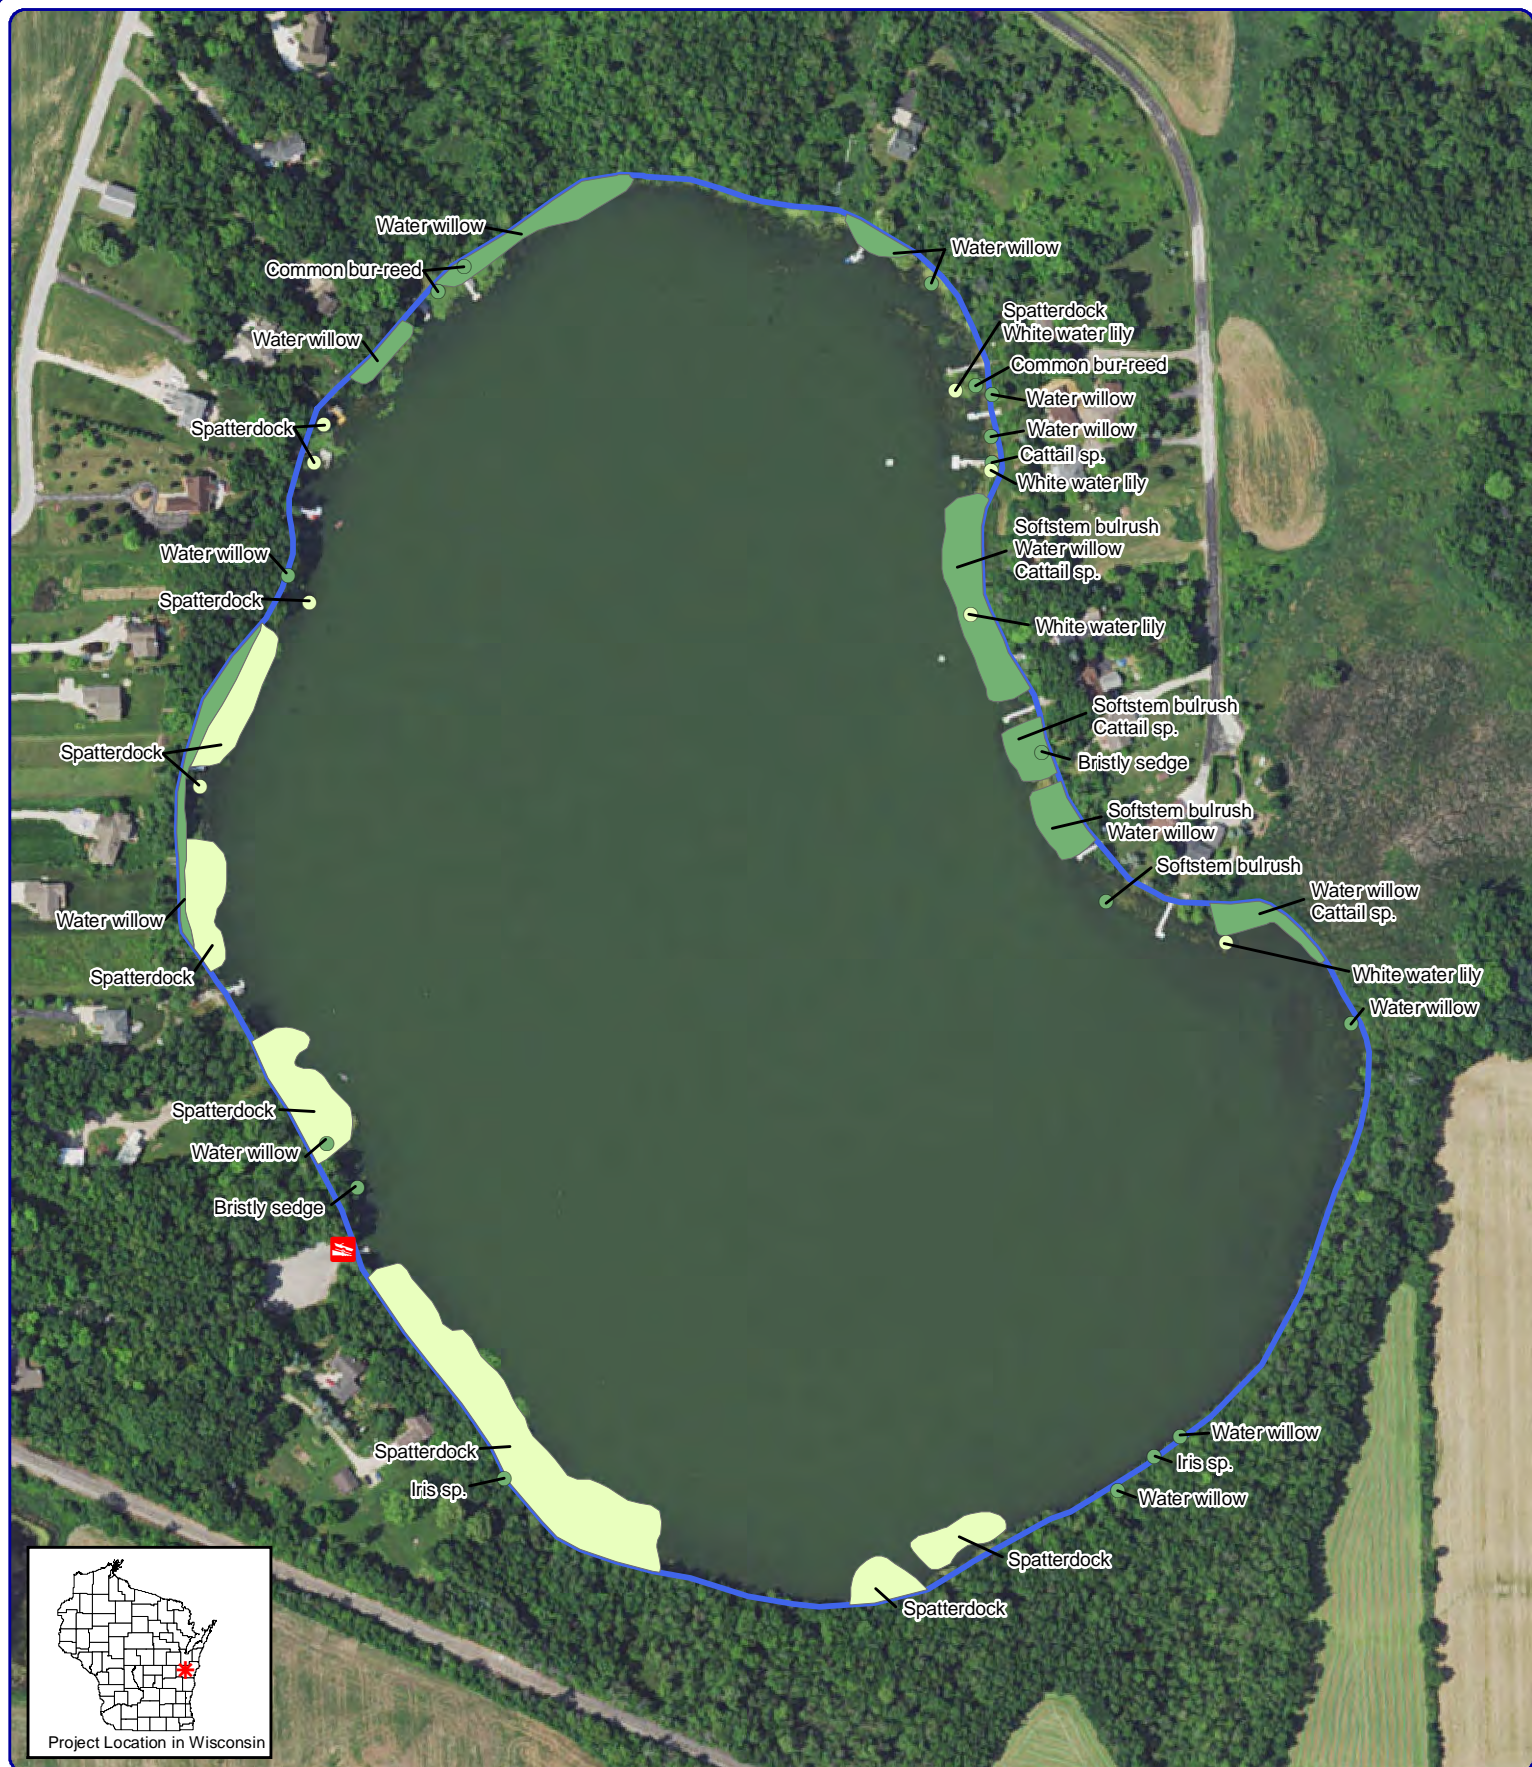
Map 5
 Bullhead Lake
 Manitowoc County, Wisconsin
**2017 Bio-Acoustic
 Survey Results -
 Substrate Hardness**
