2019 Purple Loosestrife Monitoring Report

White River (P-2444), Superior Falls (P-2587), Hayward (P-2417), Big Falls

(P-2390-01), and Thornapple (P-2475)

2019 Purple Loosestrife Monitoring Report for:

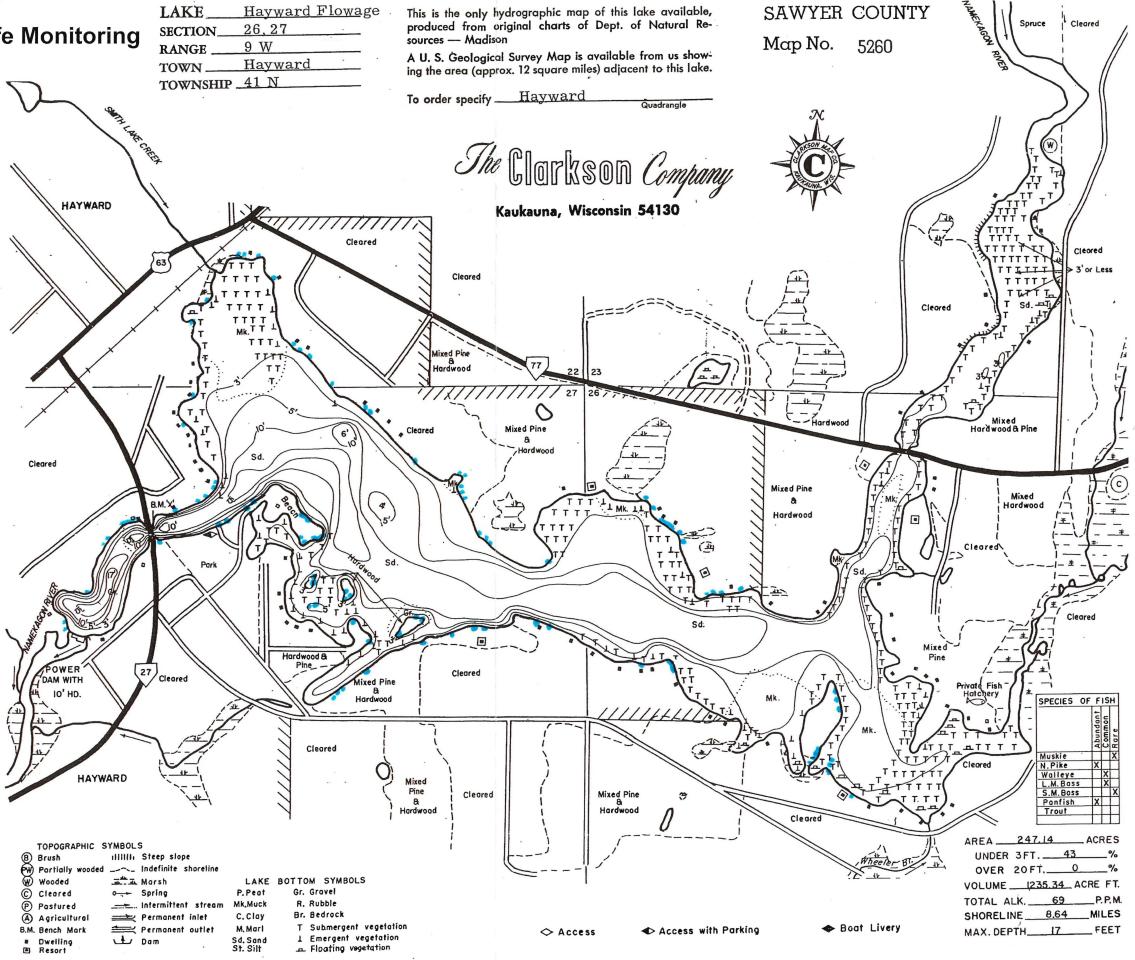
Annual Purple Loosestrife Monitoring August 15, 2019

Areas of loosestrife present or common

$\frac{7.2 \text{ CLICKS}}{1 \text{ MILE}} = \frac{4.3 \text{ CLICKS}}{X}$

X = 0.60 MILES = 3153 FT.

OR 6.9% OF SHORELINE

Areas of loosestrife abundant

OFT.

3.3 <u>Lake Hayward</u>. The presence of purple loosestrife on Lake Hayward has been relatively stable over the last several years. Appendix A includes a map of Lake Hayward depicting this year's loosestrife coverage which remained essentially unchanged from last year. There were no areas classified as abundant this year.

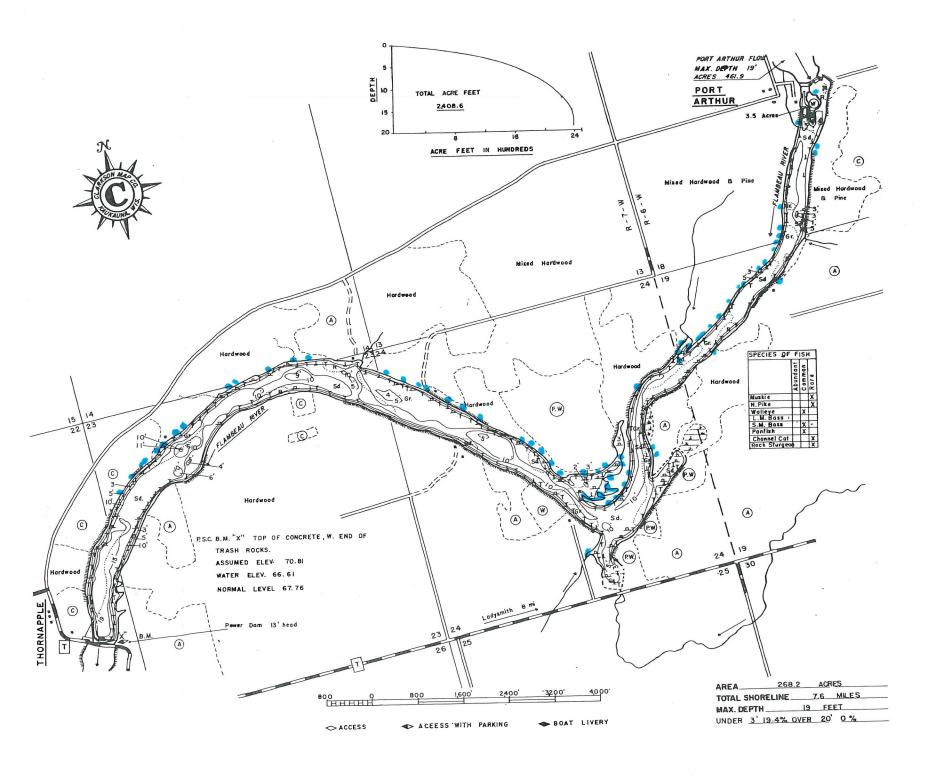
LAKE Thornapple Flow SECTION 18, 19, 22, 23, 24

Areas of Loosestrife Common

$\frac{2.5 \text{ CLICKS}}{4000 \text{ FT.}} = \frac{3.5 \text{ CLICKS}}{X \text{ FT.}}$ X = 5600 FT. = 1.06 MILES 0R 14.0 % OF SHORELINE

Areas of Loosestrife Abundant

O FT.

monitoring first began. Purple loosestrife was found to be present or common along 1.06 miles of shoreline compared to 0.79 miles in 2018. There were no areas classified as abundant this year. The wetland areas near the middle of the flowage continue to account for the greatest concentration of loosestrife plants. See Appendix A for a survey map of Thornapple Flowage depicting the results of this year's monitoring.
