***Bond Falls Hydroelectric Project***

***Article 411: Nuisance Plant Control Plan Monitoring Report***

### **Monitoring the Bergland Dam Project (Lake Gogebic) for Purple Loosestrife and Eurasian Watermilfoil Part of the Bond Falls Hydroelectric Project (FERC No. 01864)**

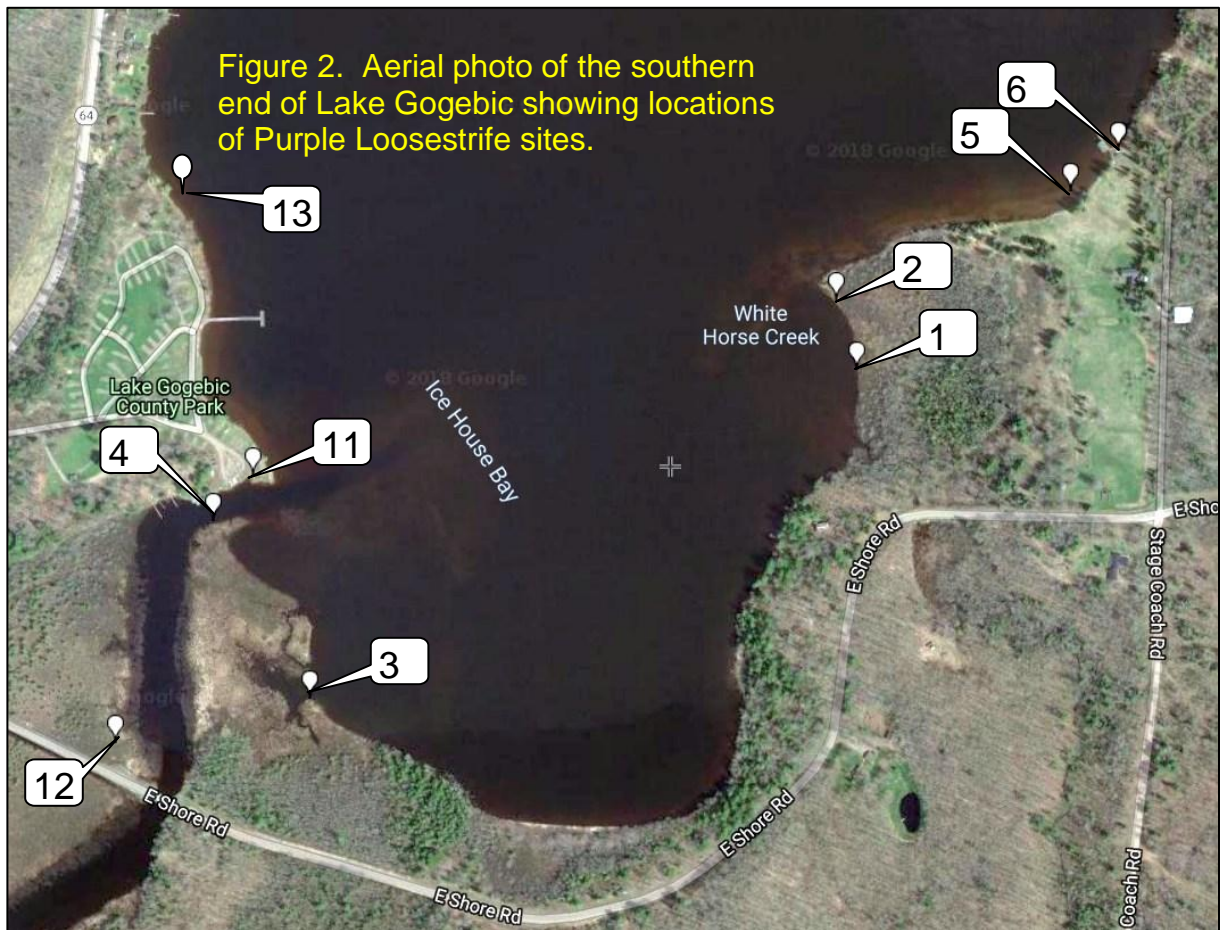
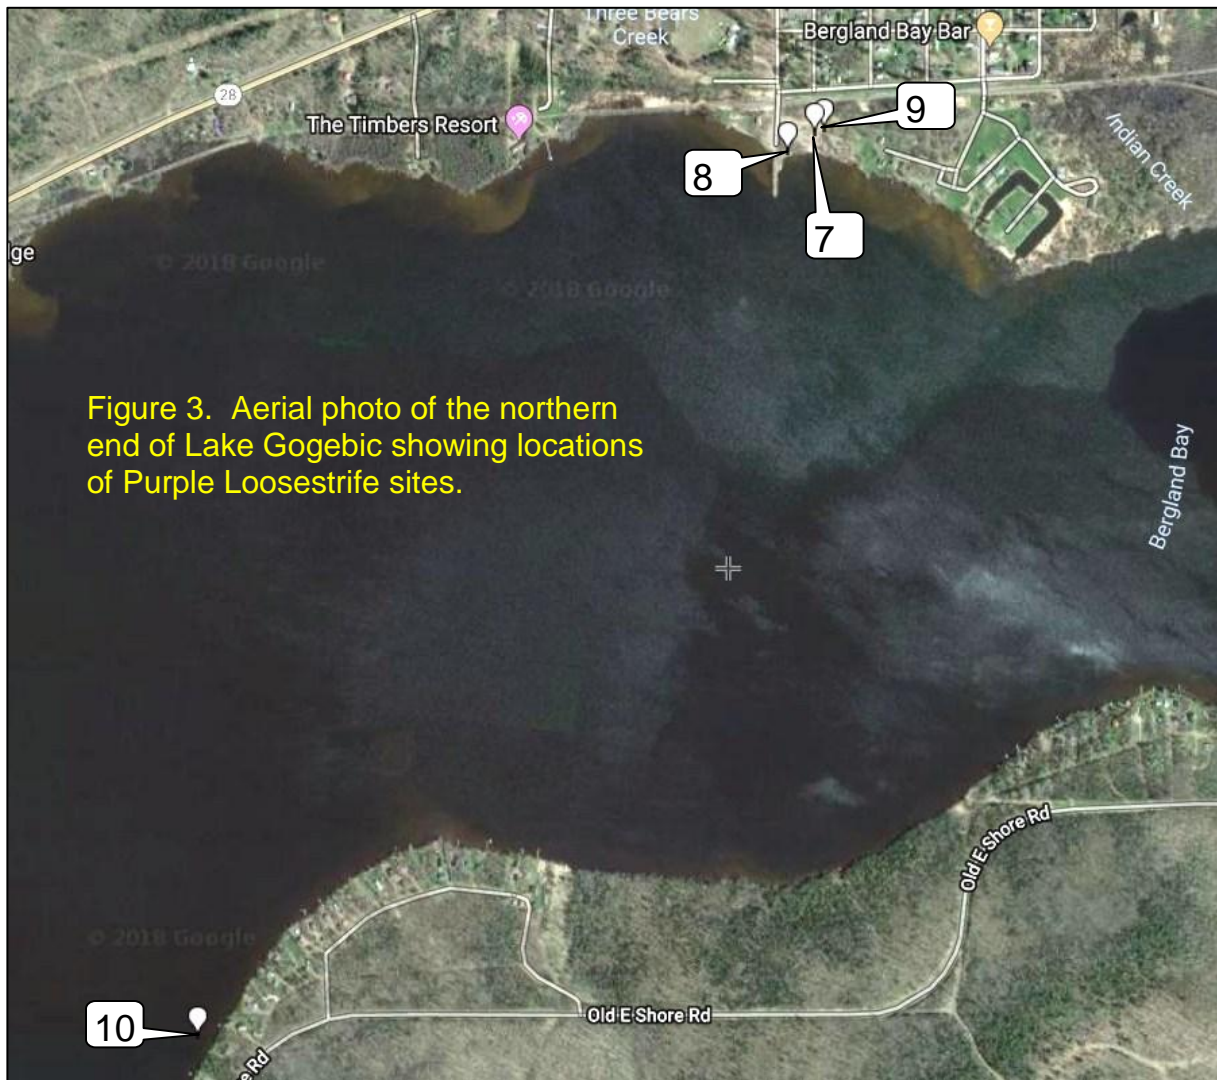
Figure 3. Aerial photo of the northern end of Lake Gogebic showing locations of Purple Loosestrife sites.

A total of eleven sites were found to contain Purple Loosestrife on Lake Gogebic in 2019. The locations of these sites are shown on Figures 1, 2, and 3. The sites were clustered at the north and south portions of Lake Gogebic. Table 1 provides information regarding geographic location (latitude and longitude coordinates), colony size (*small* at 1-5 plants, *medium* at 6-50 plants, and *dense* for any site with greater than 50 plants), and whether any management action was taken at the time of the monitoring activity.

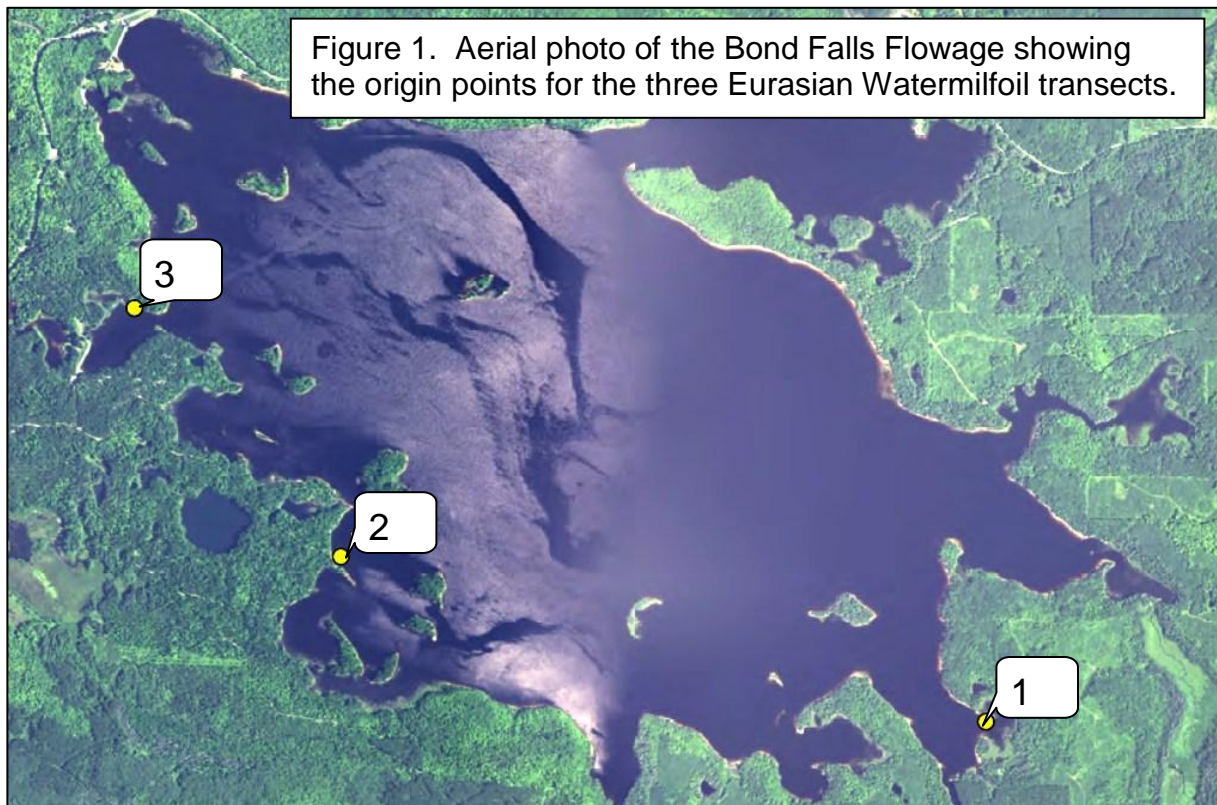
Figure 1 shows an aerial photo of the project area with the origin points for the three transects used for monitoring for Eurasian Watermilfoil.

Table 2 provides sampling results from each of the transects sampled at the Bond Falls Flowage. Each transect had three circular plots from which samples were collected in four depth quadrants. If a depth was not represented in the circular plot, “NA” (not applicable) was entered. No Eurasian Watermilfoil was found on transects or at boat landings in 2019.
