Comprehensive Management Plan

White River and Neshkoro Millpond Marquette County, Wisconsin

Cason & Associates, LLC

December 2009

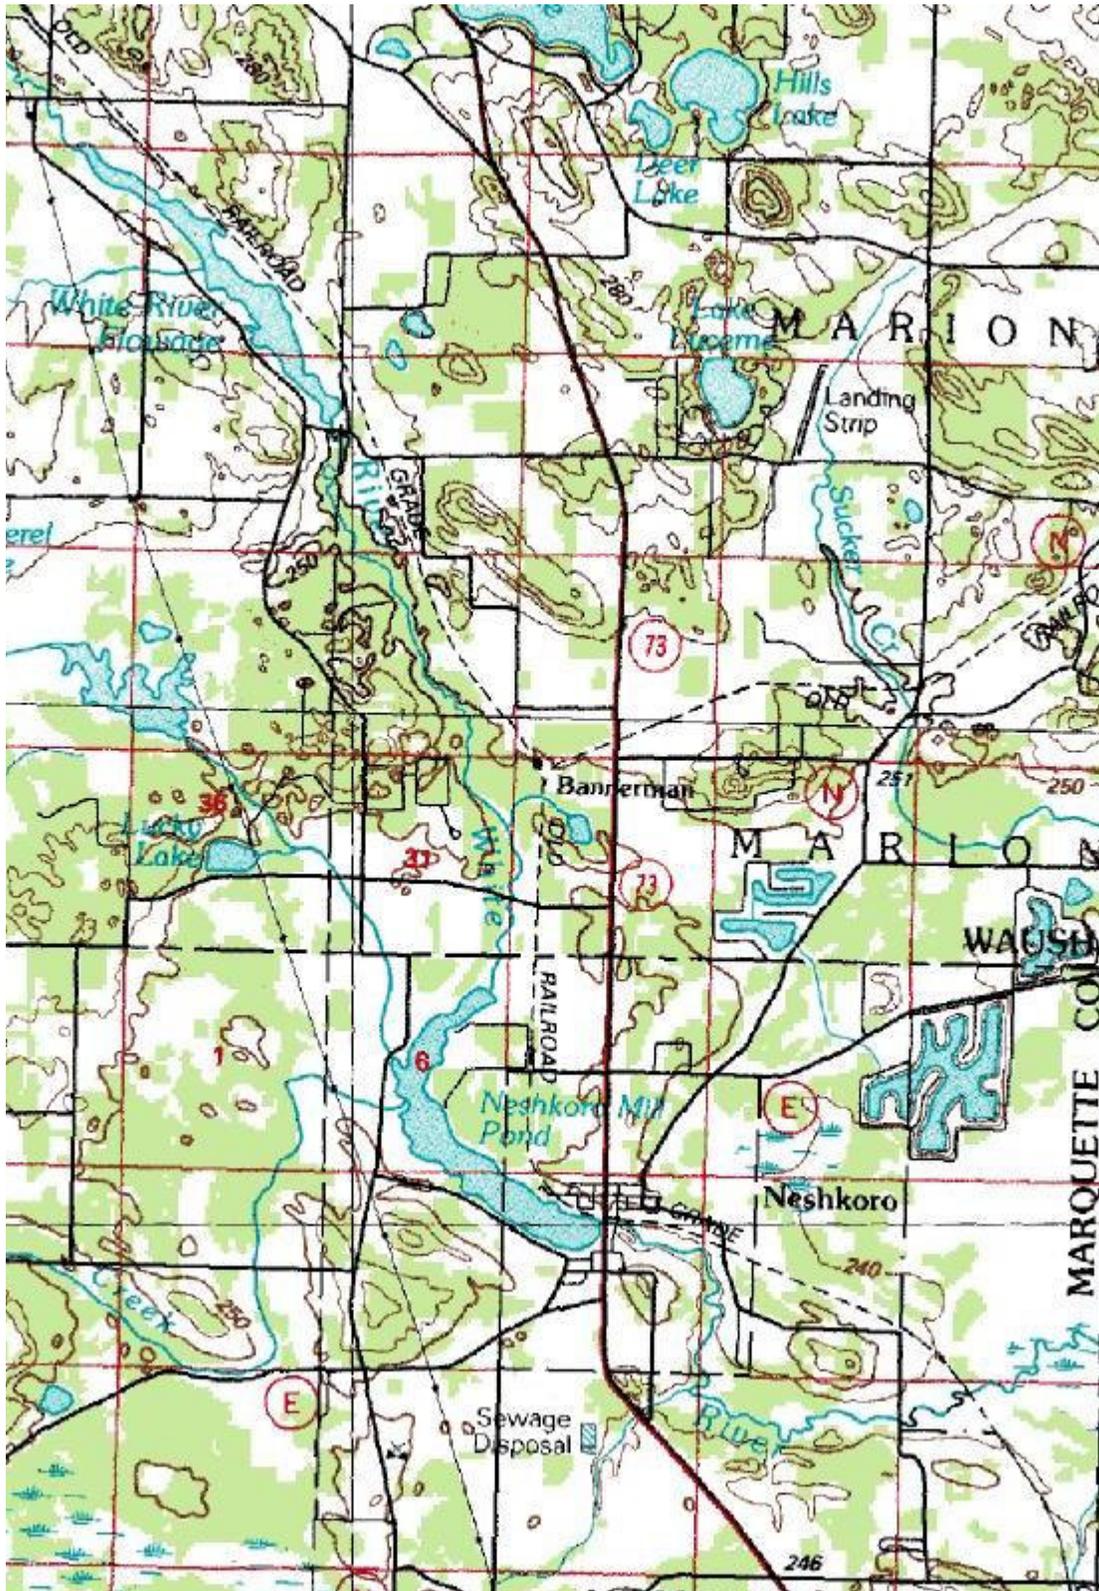
Figure 1. Area surrounding Neshkoro Millpond in Marquette County, Wisconsin

The project area for this study includes the Lower White River below the North American Hydro dam on County YY (this dam creates the White River Flowage), the Neshkoro Millpond, and the Lower White River below a second North American Hydro dam at the south end of the Neshkoro Millpond up to the White River Marsh wildlife habitat and public hunting zone (**Figure 1**). The millpond is located in Marquette County (**Figure 2**).

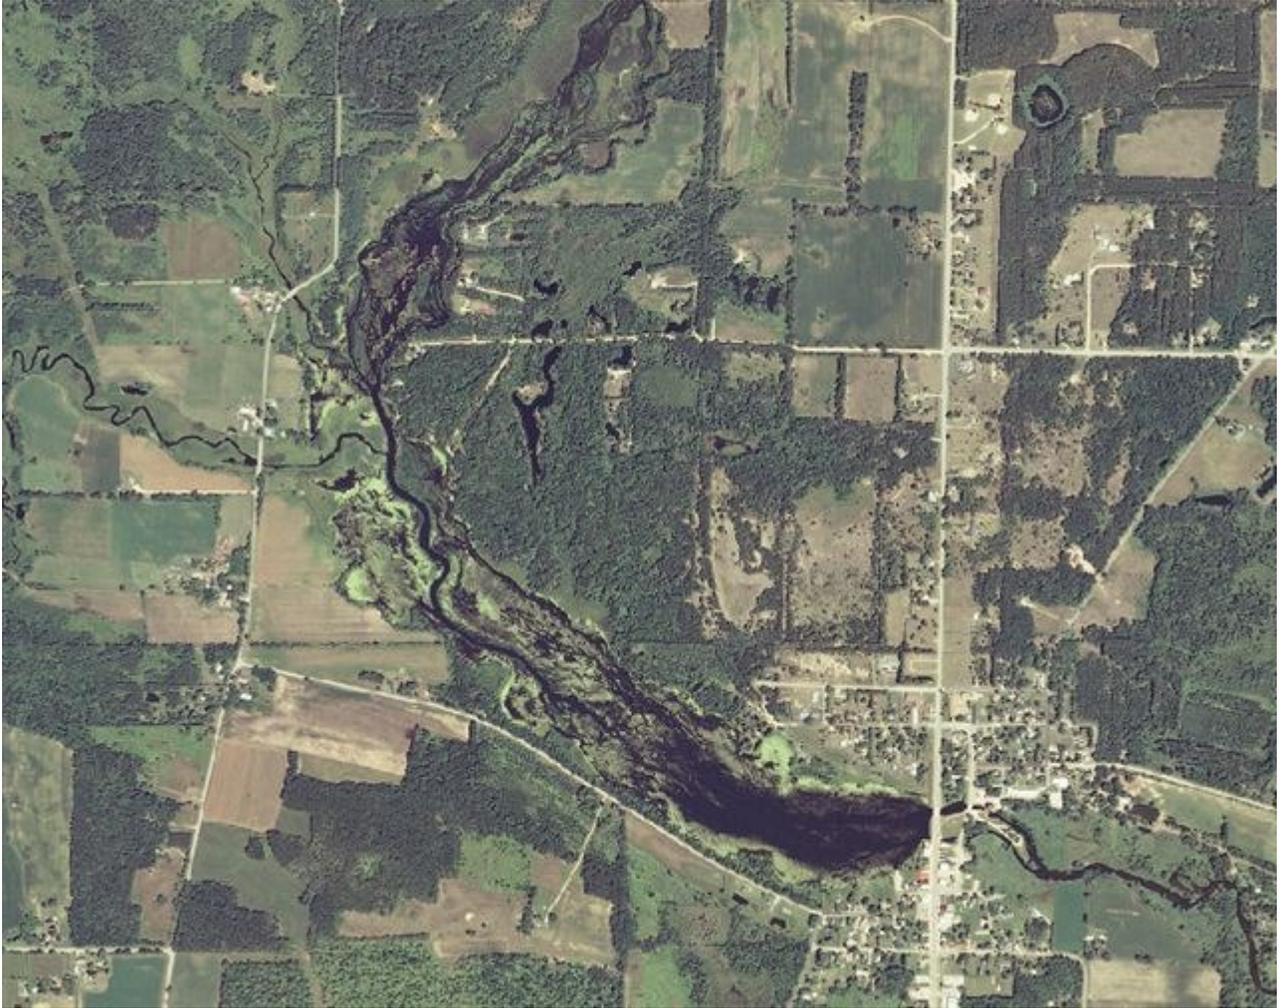
Figure 17. August 2008 aerial photo of the Neshkoro Millpond, Marquette County, WI.

Figure 17 helps illustrate the issue of wild rice growth and shallow water. This photo was taken in August 2008. The deepest area of the lake near the Town of Neshkoro is clearly visible. Also visible is the large shallow portion of the lake. Unfortunately it is difficult to specifically identify wild rice. However, the issue of navigability is evident particularly when the distribution of wild rice documented onsite is overlaid onto this map (**Figure 18**). Other aerial photos dating back to 1981 were obtained from the US Geological Survey office in Westfield, WI. They can be found in **Appendix D**. These images were taken for agricultural purposes. As a result, they were all taken in the late summer when crops were actively growing. These photos show shallow conditions dating back nearly 30 years. However, the quality of the images is not high enough to make effective comparisons from year to year. Many are copied from slides which are discolored or do not show the entire millpond. The clearest images from the 1980s appear to show shallow water and dense plant and algae growth in the upper portions of the millpond.
