## 8.12 Sturgeon Lake

### *An Introduction to Sturgeon Lake*

Sturgeon Lake, Vilas County, is a deep lowland drainage lake with a maximum depth of 18 feet, a mean depth of 5 feet, and a surface area of approximately 32 acres. Sturgeon Lake is considered to be mesotrophic and its watershed encompasses approximately 147,704 acres. In 2017, 41 native aquatic plant species were found in the lake, of which slender naiad (*Najas flexilis*) is the most common. No non-native plants were found during surveys.

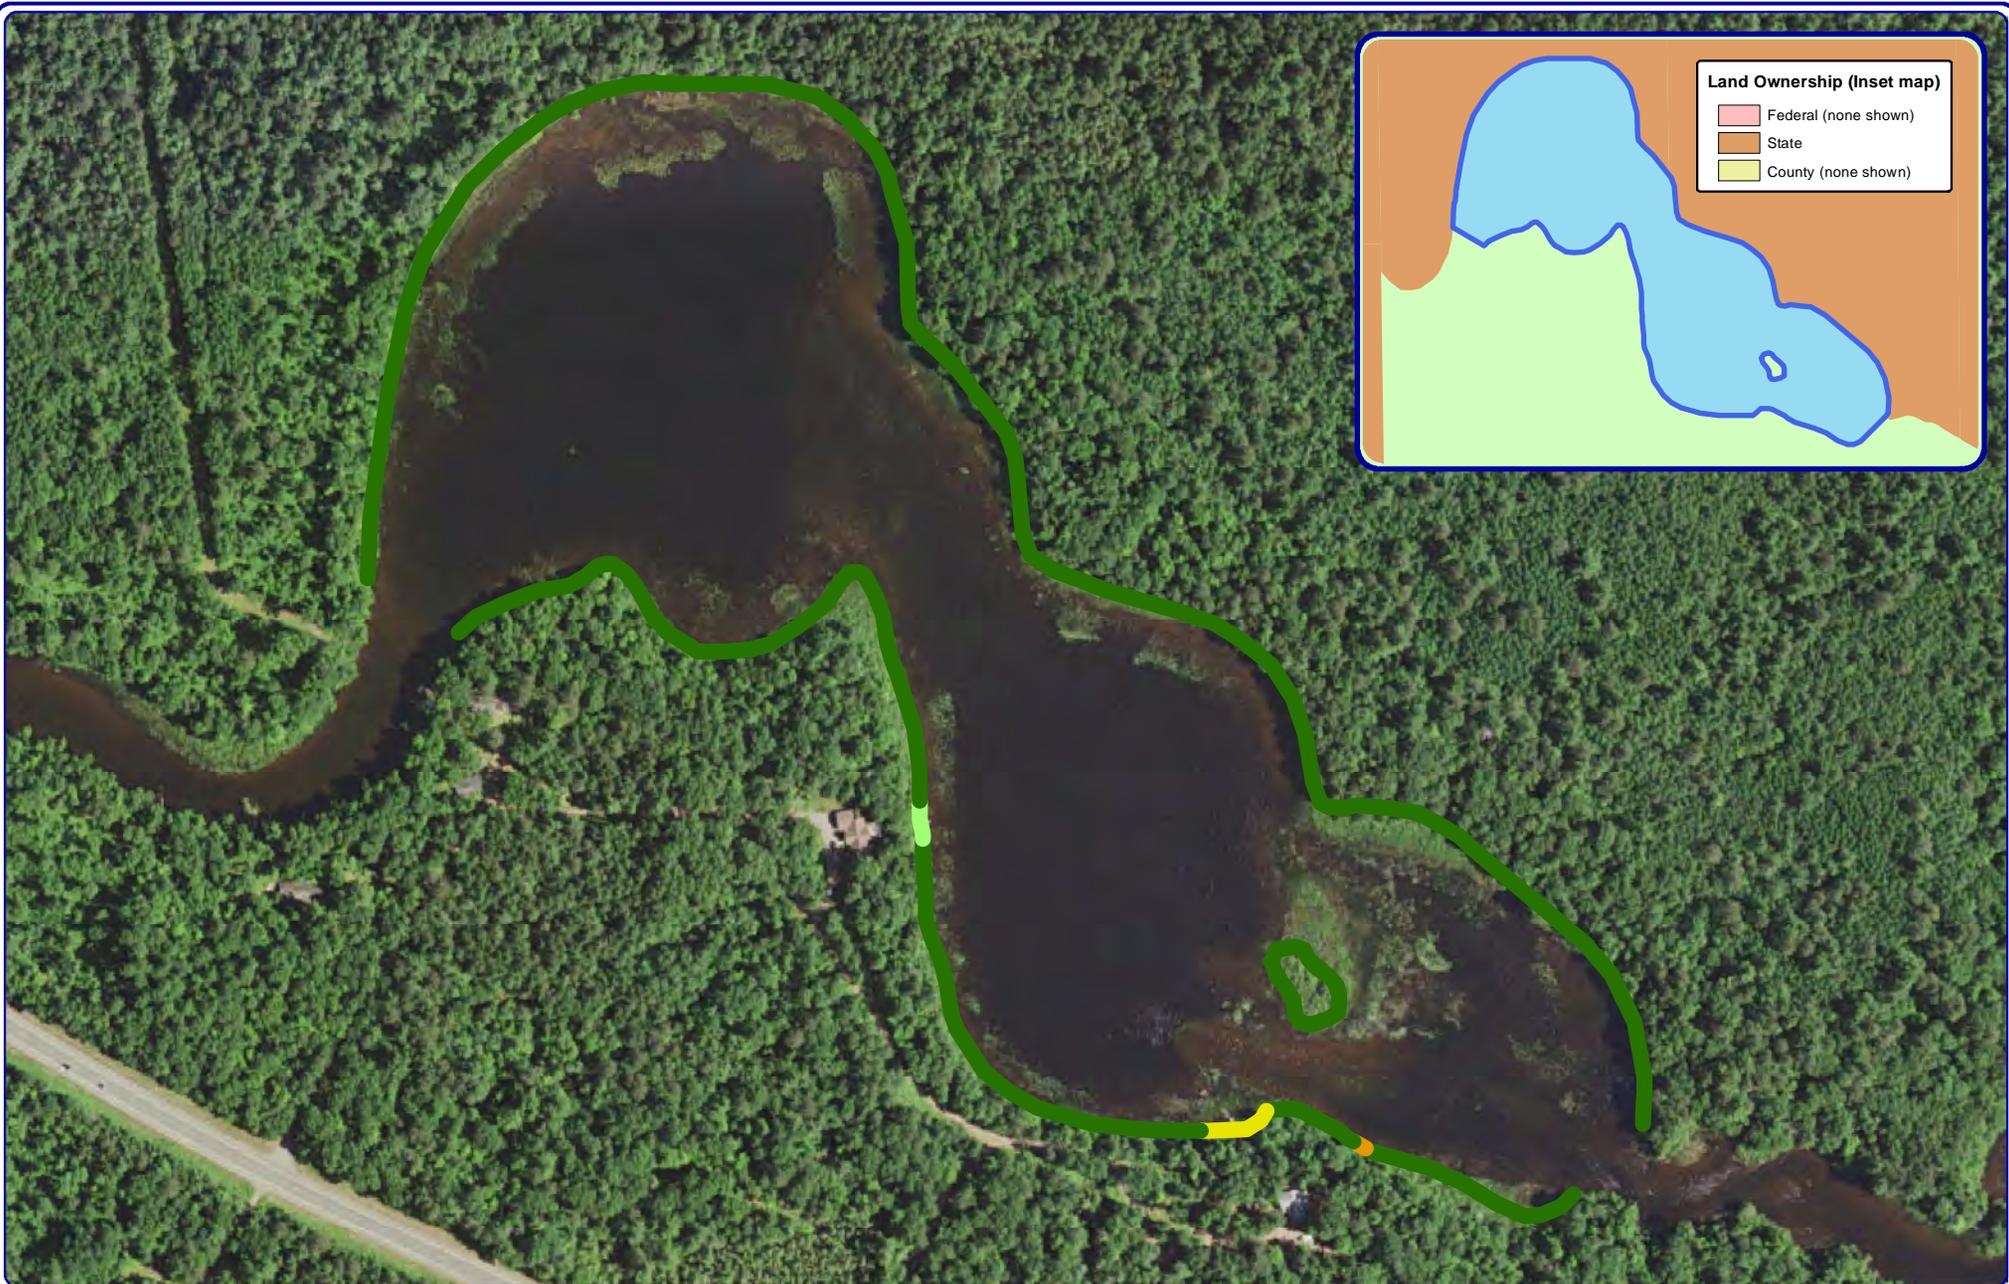
Map 1  
 Sturgeon Lake  
 Vilas County, Wisconsin  
**2017 Shoreland  
 Condition**

- Natural/Undeveloped
- Developed-Natural
- Developed-Semi-Natural
- Developed-Unnatural
- Urbanized

As mentioned previously in the Chain-wide Shoreland Condition Section, one of the most sensitive areas of the watershed is the immediate shoreland area. This area of land is the last source of protection for a lake against surface water runoff, and is also a critical area for wildlife habitat. In fall of 2017, Sturgeon Lake's immediate shoreline was assessed in terms of its development. Sturgeon Lake has stretches of shoreland that fit four of the five shoreland assessment categories. In all, 1.2 miles of natural/undeveloped and developed-natural shoreline were observed during the survey (Figure 8.12.3-1). This constitutes about 97.9% of Sturgeon Lake's shoreline. These shoreland types provide the most benefit to the lake and should be left in their natural state if at all possible. During the survey, less than one tenth of a mile of developed-unnatural shoreline (0.3%) was observed. If restoration of the Sturgeon Lake shoreline is to occur, primary focus should be placed on these shoreland areas as they currently provide little benefit to, and actually may harm, the lake ecosystem. Sturgeon Lake Map 1 displays the location of these shoreline lengths around the entire lake.

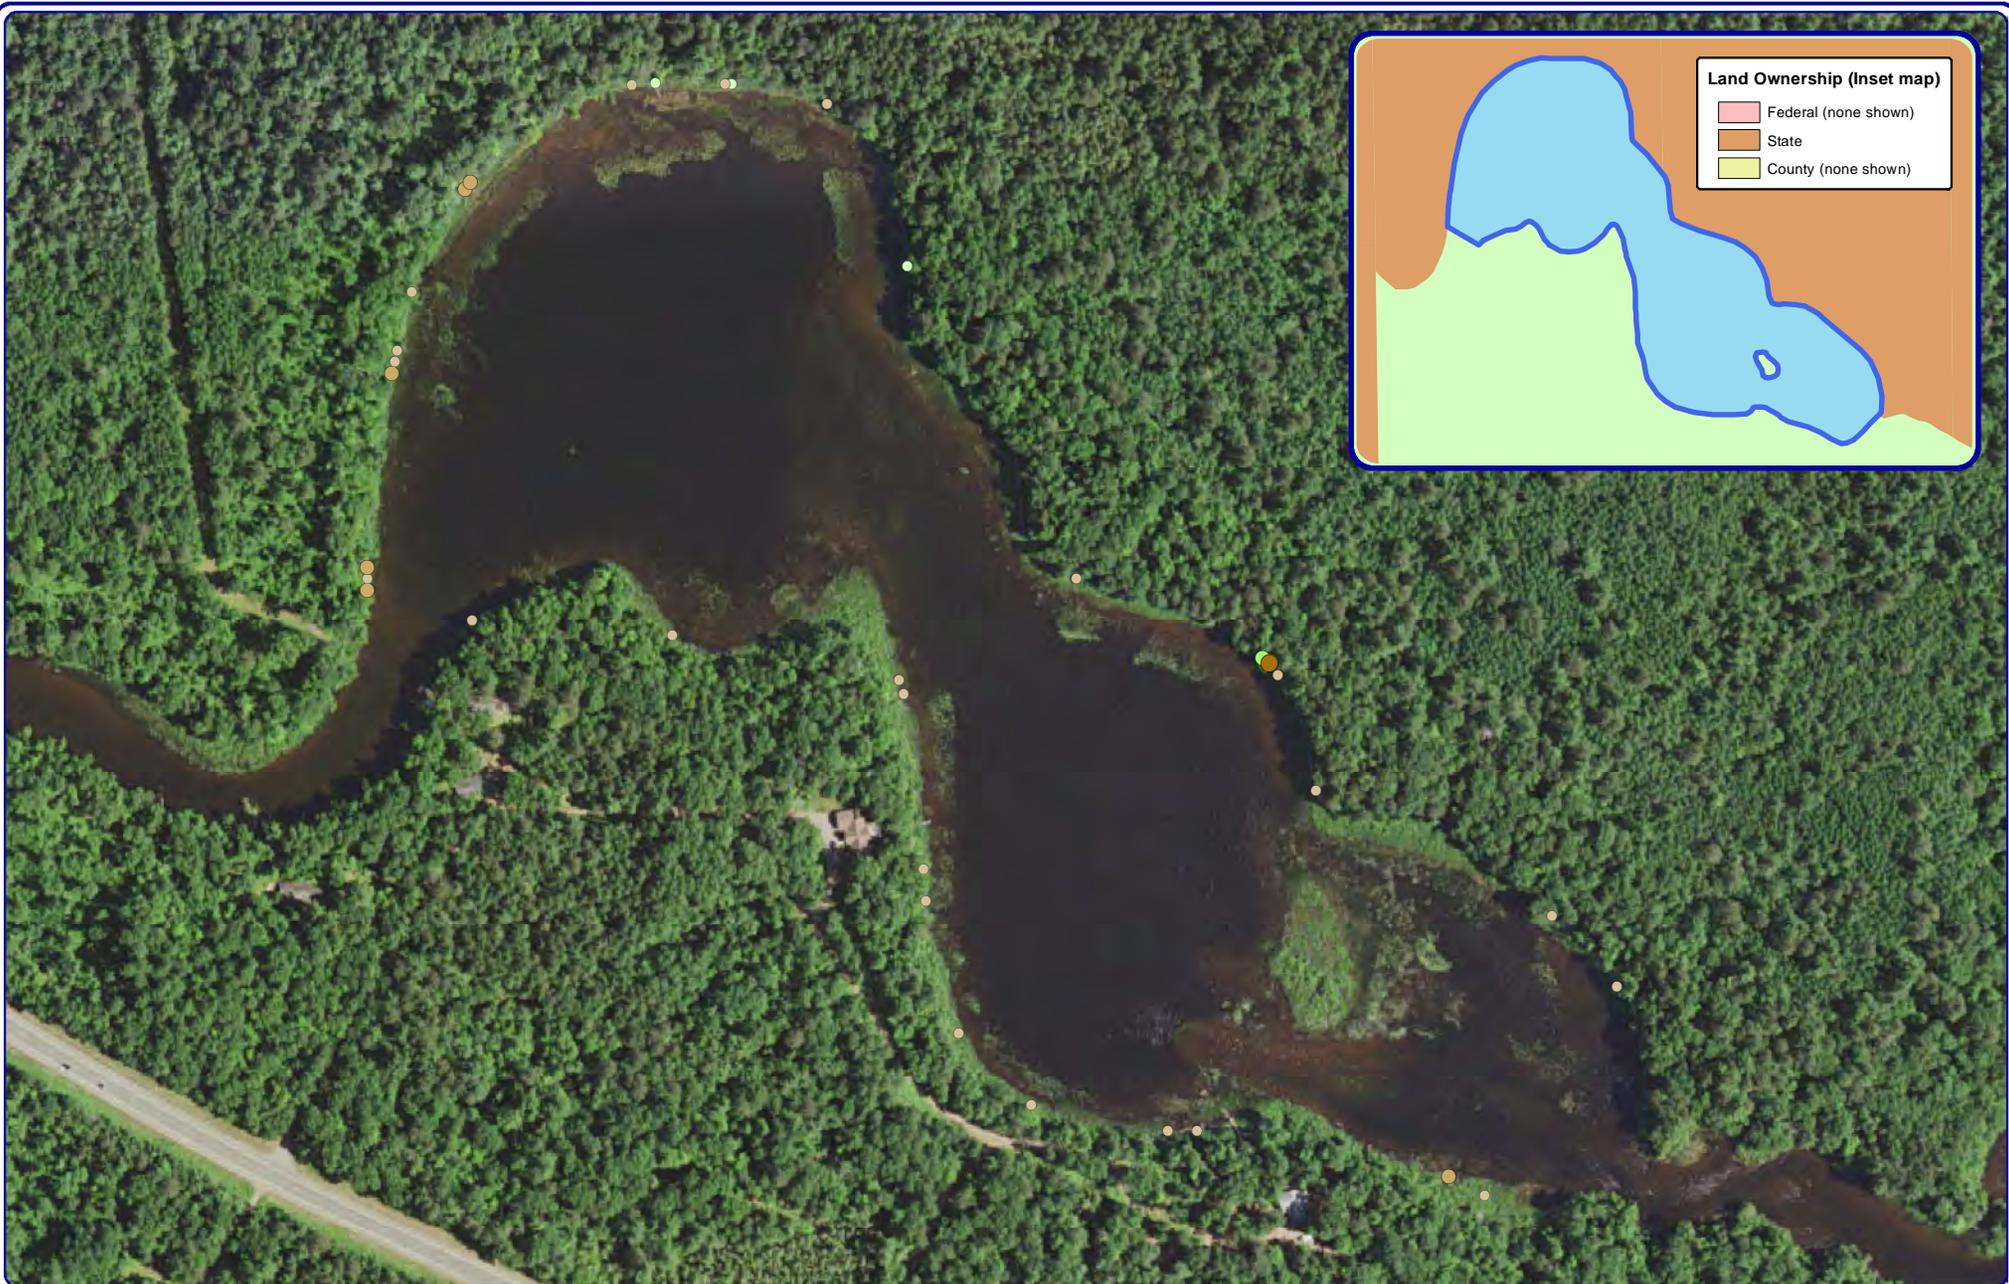
Map 2  
 Sturgeon Lake  
 Vilas County, Wisconsin  
**Coarse Woody  
 Habitat**

- No Branches
- Minimal Branches
- Moderate Branches
- Full Canopy (none)

- No Branches
- Minimal Branches
- Moderate Branches (none)
- Full Canopy (none)

During this survey, 34 total pieces of coarse woody habitat were observed along 1.2 miles of shoreline (Sturgeon Lake Map 2), which gives Sturgeon Lake a coarse woody habitat to shoreline mile ratio of 28:1 (Figure 3.3-3). Only instances where emergent coarse woody habitat extended from shore into the water were recorded during the survey. Thirty pieces of 2-8 inches in diameter pieces of coarse woody habitat were found, four pieces of 8+ inches in diameter pieces of coarse woody habitat were found, and no instances of clusters of coarse woody habitat were found.

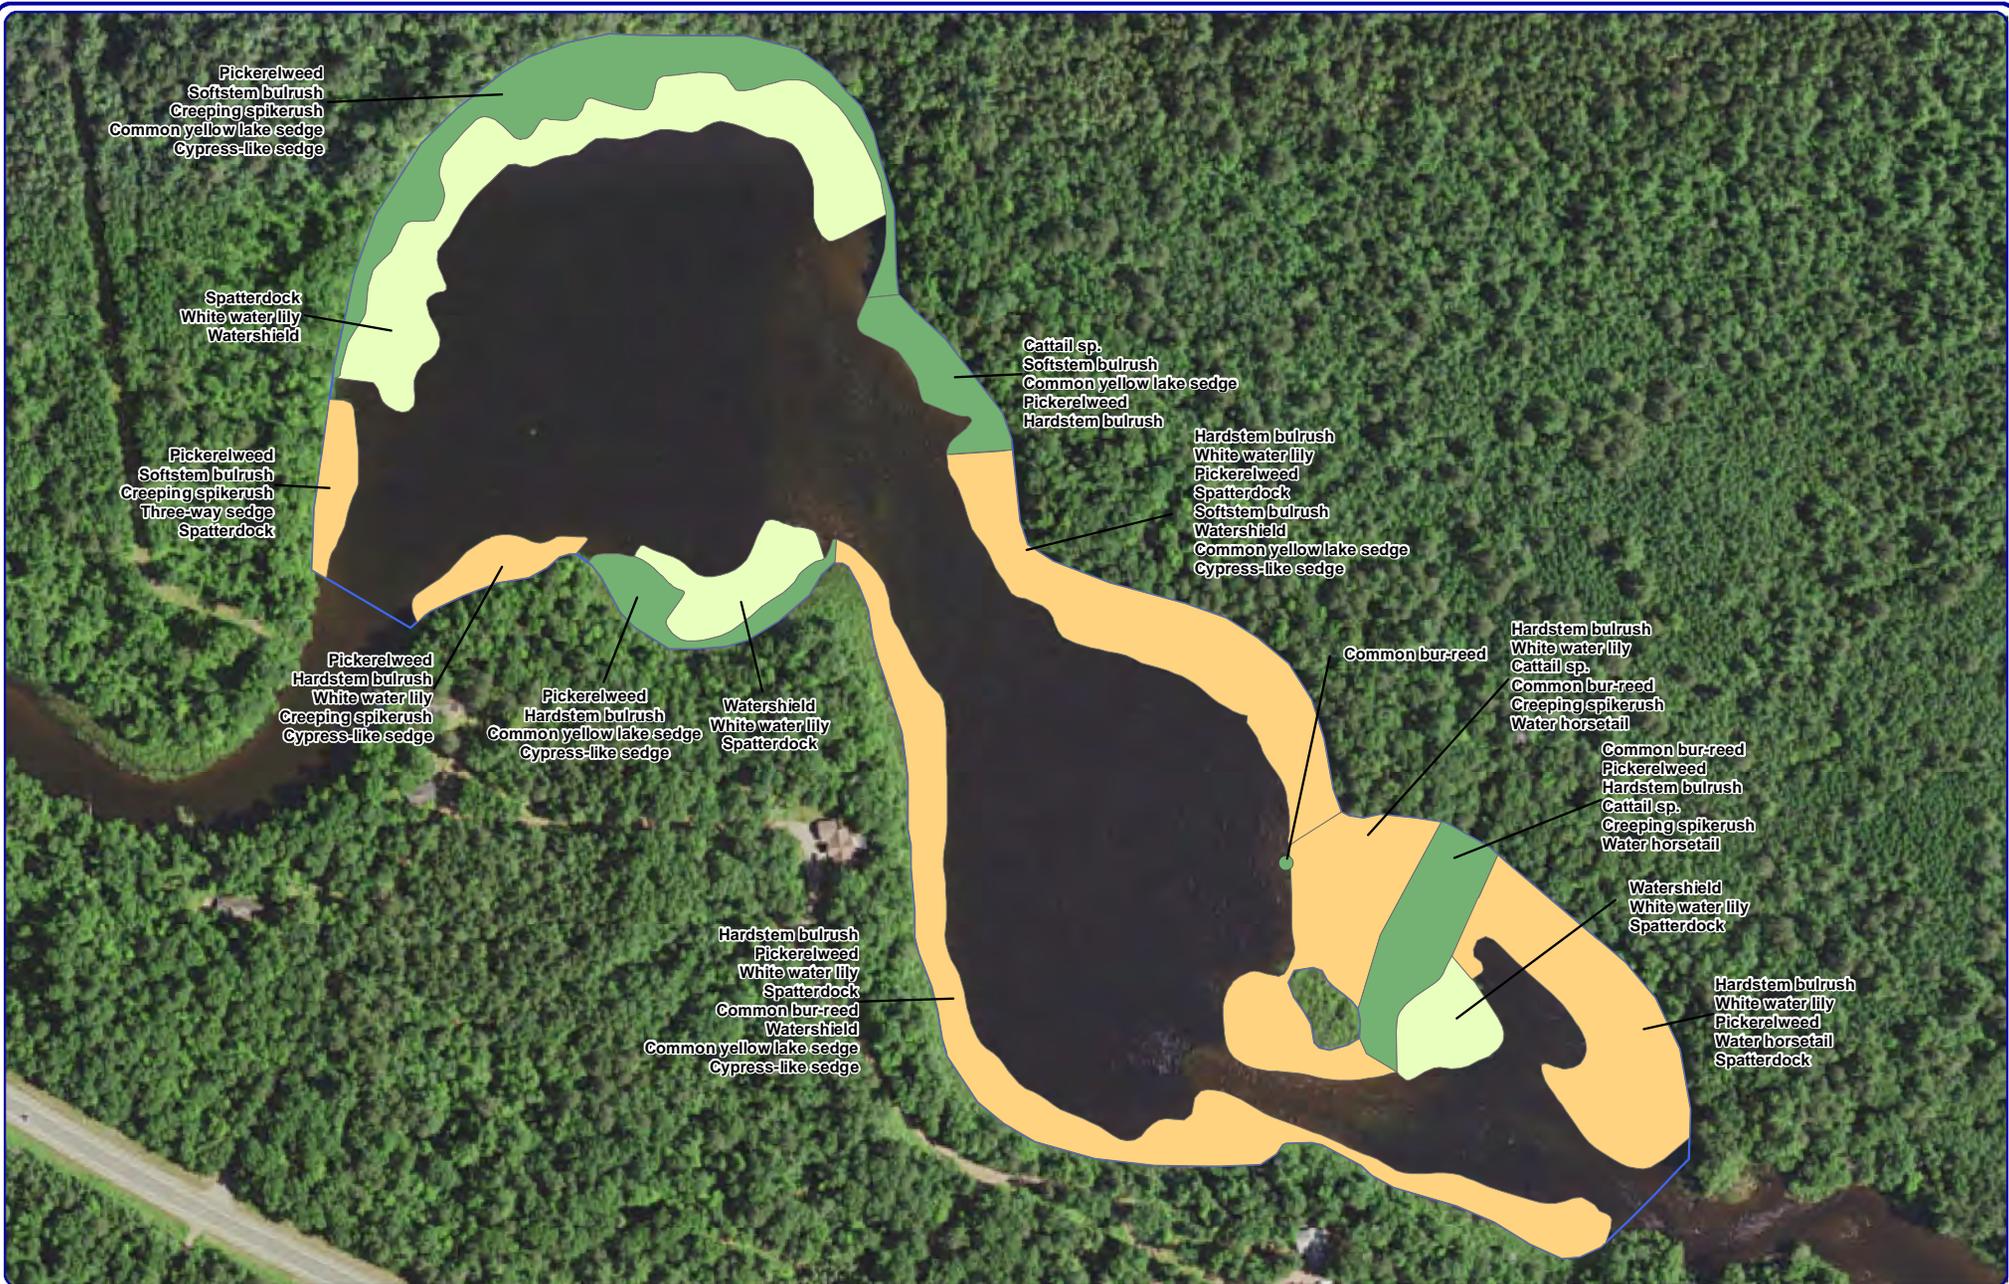
**Map 4**

**Emergent & Floating-leaf  
 Aquatic Plant Communities**

The 2017 community map indicates that approximately 12.6 acres of the lake contains these types of plant communities (Sturgeon Lake Map 4, Table 8.12.4-2). Fourteen floating-leaf and emergent species were located on Sturgeon Lake (Table 8.12.4-1), all of which provide valuable wildlife habitat.
