RED CEDAR LAKES, BARRON & WASHBURN COUNTIES

BALSAM (2112800),
MUD, BASS (1833100),
RED CEDAR (2109600),
AND HEMLOCK
(2109800) LAKES

2020-2024 Aquatic Plant Management Plan

Prepared by: Dave Blumer, Lake
Educator & Heather Wood, Lake
Management Assistant

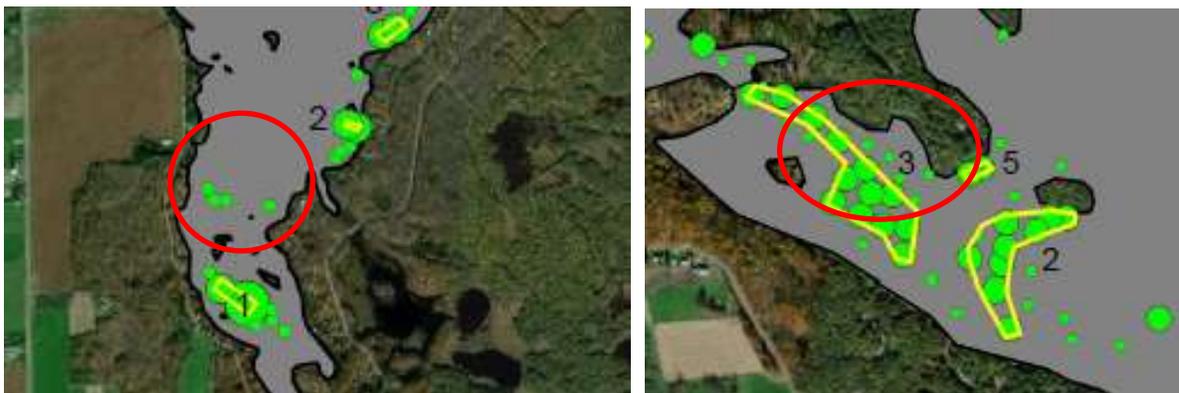
Figure 4: 2018 CLP survey results in the Red Cedar 3-yr CLP treatment area (left) and the Hemlock 3-yr CLP treatment area (right)

This occurrence was again supported by the spring 2018 CLP delineation completed by FFS. After three years of management, the density in those areas was reduced such that when the 2018 CLP survey was completed 3 years later, only a handful of plants were found (Figure 4).

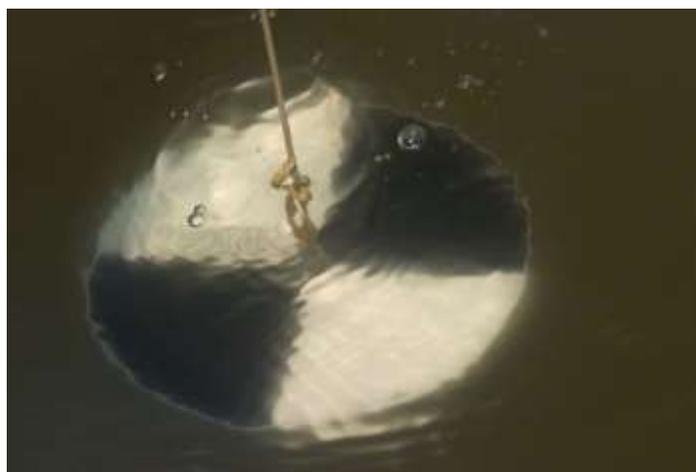
Figure 20: Black and white Secchi disk

Water clarity is a measurement of how deep sunlight can penetrate into the waters of a lake. It can be measured in a number of ways, the most common being an 8” disk divided into four sections, two black and two white, lowered into the lake water from the surface by a rope marked in measurable increments (Figure 20). The water clarity reading is the point at which the Secchi disk when lowered into the water can no longer be seen from the surface of the lake. Water color (like dark water stained by tannins from nearby bogs and wetlands), particles suspended in the water column (like sediment or algae), and weather conditions (cloudy, windy, or sunlight) can impact how far a Secchi disk can be seen down in the water. Some lakes have Secchi disk readings of water clarity of just a few inches, while other lakes have conditions that allow the Secchi disk to be seen for dozens of feet before it disappears from view.

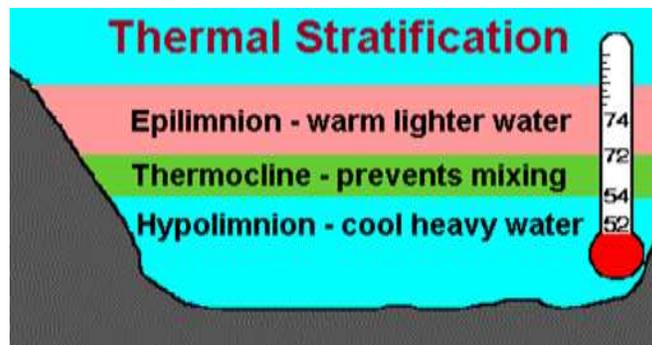
Figure 31: Summer thermal stratification

Temperature and dissolved oxygen are important factors that influence aquatic organisms and nutrient availability in lakes. As temperature increases during the summer in deeper lakes, the colder water sinks to the bottom and the lake develops three distinct layers as shown in Figure 31. This process, called stratification, prevents mixing between the layers due to density differences which limits the transport of nutrients and dissolved oxygen between the upper and lower layers. In most lakes in Wisconsin that undergo stratification, the whole lake mixes in the spring and fall when the water temperature is between 53 and 66°F, a process called overturn. Overturn begins when the surface water temperatures become colder and therefore denser causing that water to sink or fall through the water column. Below about 39°F, colder water becomes less dense and begins to rise through the water column. Water at the freezing point is the least dense which is why ice floats and warmer water is near the bottom (called inverse stratification) throughout the winter.

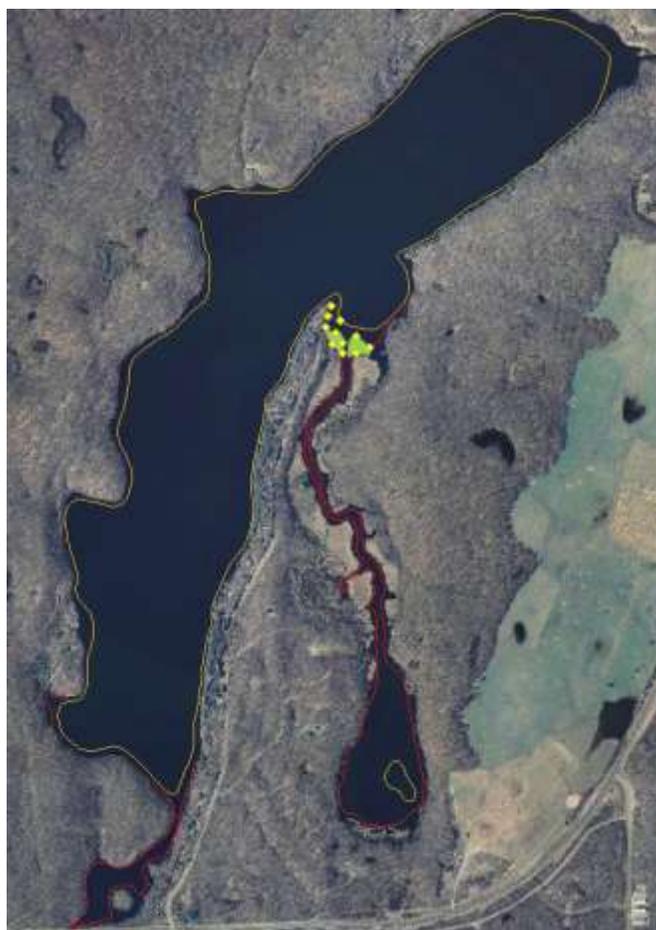
Figure 36: 2012 Wild Rice in Balsam Lake (RCLA-SEH)

Wild rice is an aquatic grass which grows in shallow water in lakes and slow flowing streams. This grass produces a seed which is a nutritious source of food for wildlife and people. The seed matures in August and September with the ripe seed dropping into the sediment, unless harvested by wildlife or people. It is a highly protected and valued natural resource in Wisconsin. Only Wisconsin residents may harvest wild rice in the state. According to the WDNR, Balsam Lake (of which Mud Lake is considered to be a part of) and Red Cedar Lake are wild rice waters while Hemlock Lake is not considered to be wild rice waters. A 2012 survey completed by RCLA volunteers found wild rice and the head waters of Mud Lake into Balsam Lake (Figure 36). The 2018 aquatic plant surveys confirmed the presence of wild rice in both Balsam and Mud Lakes. In Balsam Lake, wild rice was found at 4 of the 410 points sampled. In Mud Lake, wild rice was visually spotted by the surveyors while on the lake, but was not present at any of the points sampled. No other wild rice was found in the system.

Balsam Lake and the attached Mud Lake is also the one known location of wild rice in the entire system. Last mapped in 2019 by RCLA volunteers, wild rice has been identified at the mouth of the Mud Lake channel into Balsam Lake and in the Mud Lake channel itself. In total, 1.5 acres of wild rice was mapped in this area in 2019 (Figure 53). All of Mud Lake, including the channel is considered “sensitive area” for aquatic plant and wildlife (Figure 16). No management of CLP except by physical removal has ever been proposed in Mud Lake, the channel, or the mouth of the channel to Balsam Lake because of the wild rice. This will continue to be the case through the duration of this new plan.

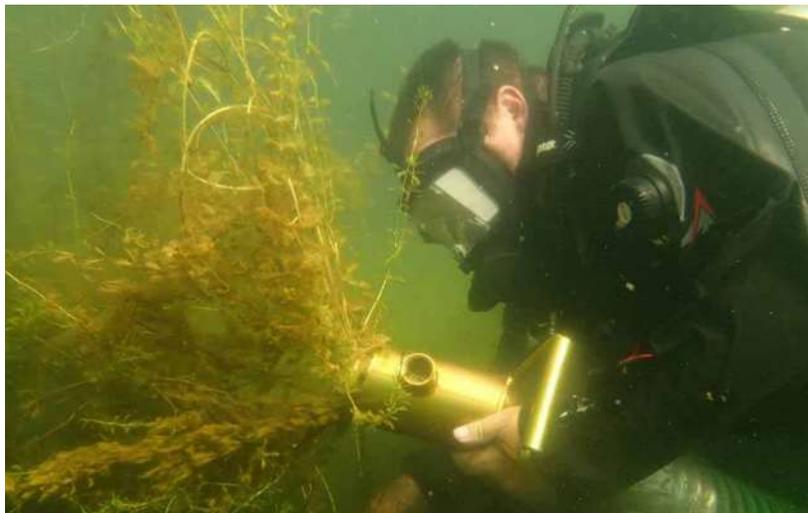
Figure 48: DASH - Diver Assisted Suction Harvesting (Chuck Druckery, 2016 Wisconsin Lakes Convention Presentation)

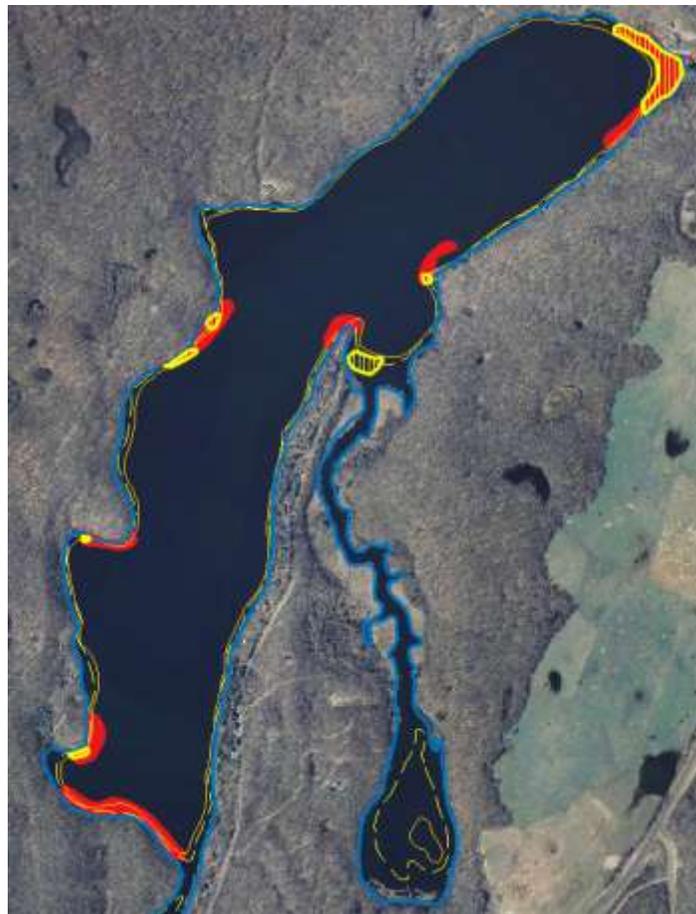
Figure 52: 2017 CLP beds (yellow) overlapped with 1992 walleye spawning areas (red)

The north end of Balsam Lake at the inlet from Birch Lake is also listed as a “sensitive area” for walleye spawning. Several other areas of Balsam Lake are also listed as walleye spawning areas totaling 15.5 acres. CLP mapping in 2017 identified CLP in 7.2 acres of that total area with more than 4 of the 7.2 acres being moderate to dense growth CLP which could reduce the effectiveness of walleye spawning in this area (Figure 52).

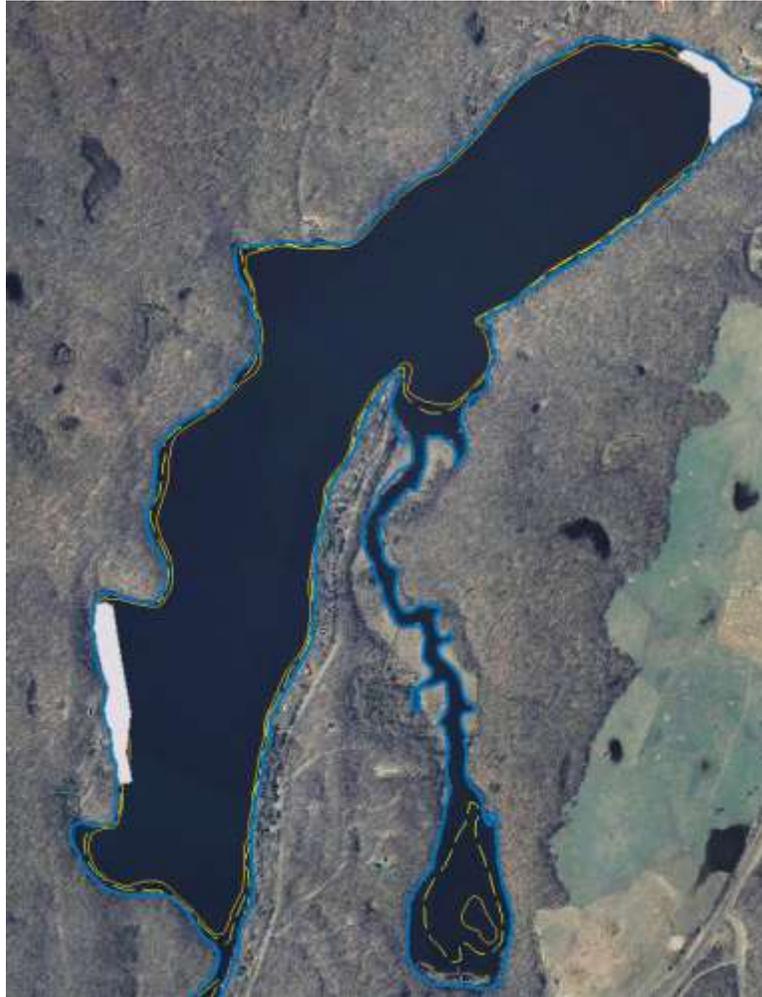
Figure 54: 2017 moderate to dense growth CLP near developed shoreline in Balsam Lake

Much of the shoreline around Balsam Lake is undeveloped particularly along the west and northeast shores of the lake. There are several developed lots around Mud Lake, but none along its channel to Balsam Lake. In 2017, two areas of CLP were mapped in Balsam Lake that were adjacent to developed property (Figure 54). These were located at the north end of the lake and along a portion of the west shore. Both of these areas were considered moderate to dense growth CLP in 2017, and to a lesser degree, again in 2018. These areas could be considered a nuisance and hamper navigation in years when growing conditions are good for CLP.
