Total Maximum Daily Load: Little Willow Creek Richland County, WI

Sediment Total Maximum Daily Load for Little Willow Creek

Little Willow Creek Sediment TMDL, Final July 30, 2008

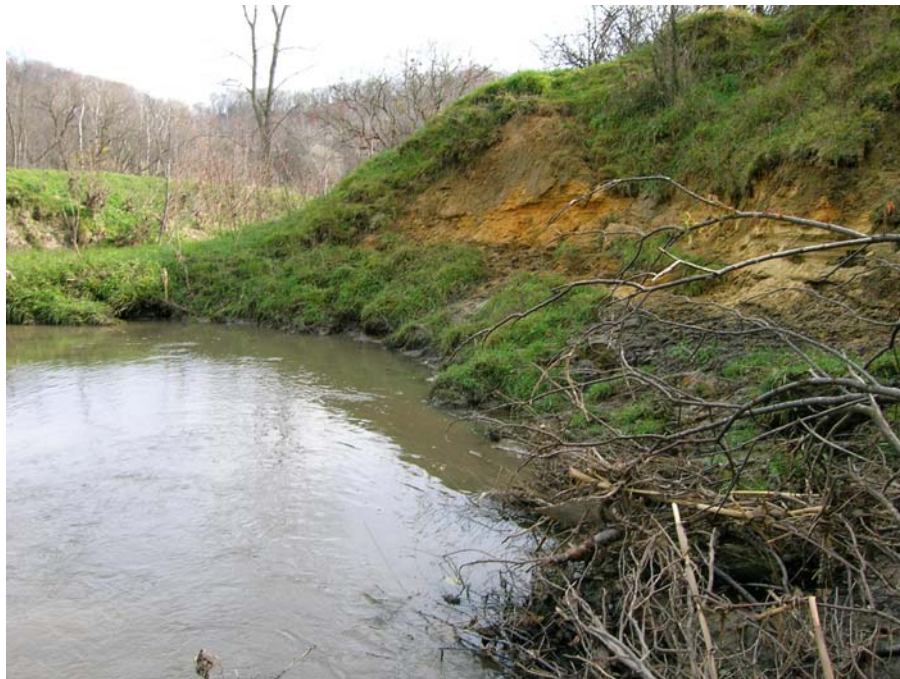
Figure E-1. Typical bank erosion along Little Willow Creek downstream of Spiral Road

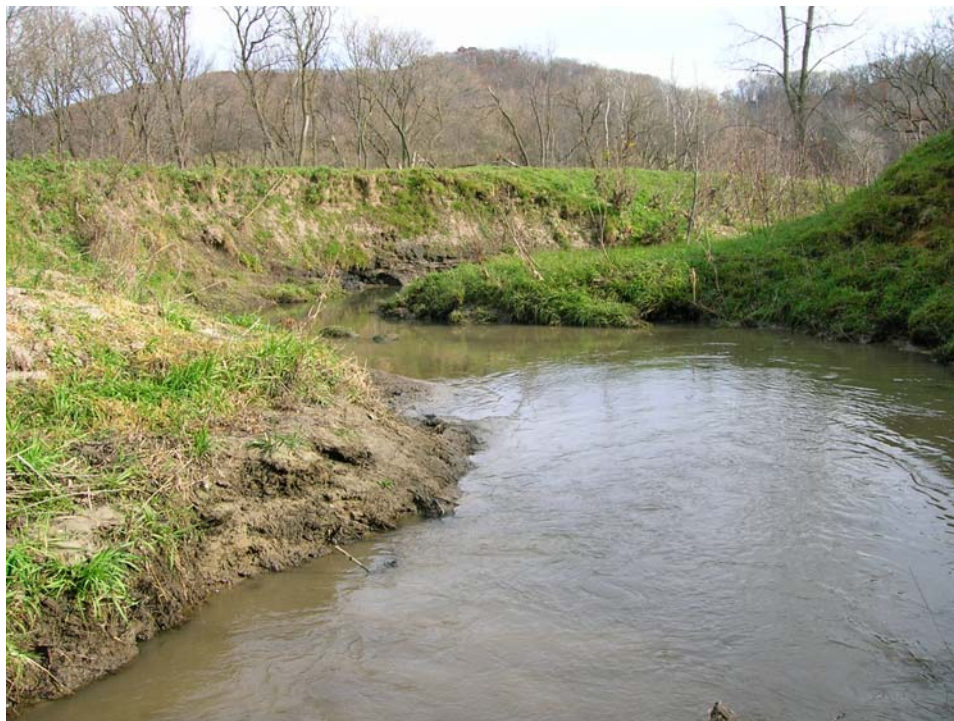
Figure E-2. Typical bank erosion along Little Willow Creek downstream of Spiral Road

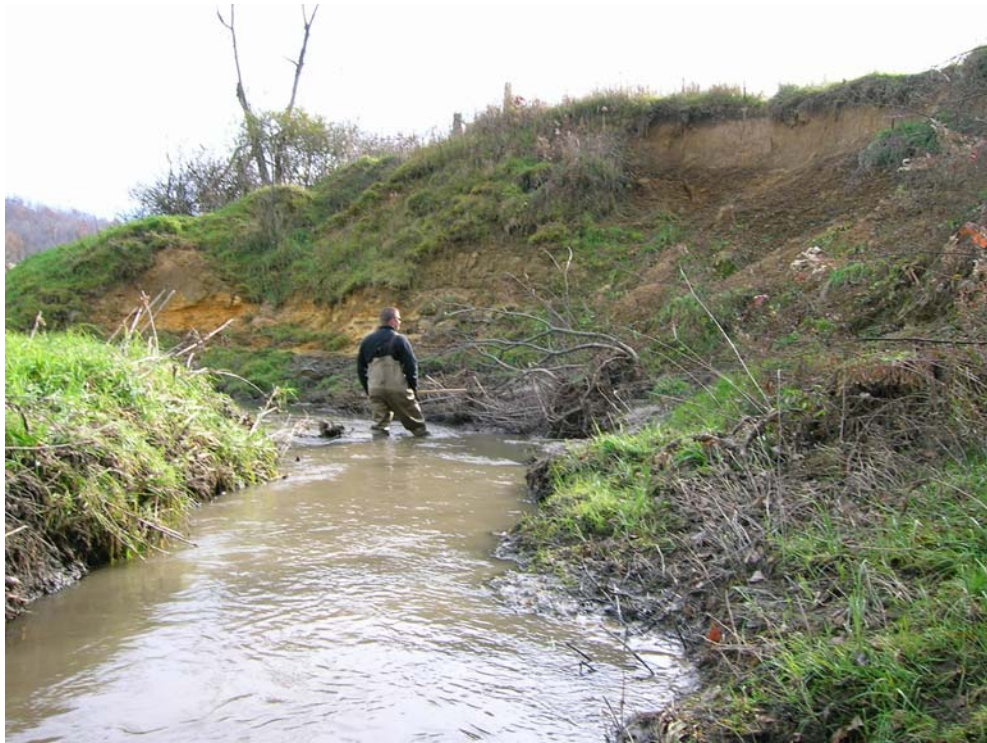
Figure E-3. Typical bank erosion along Little Willow Creek downstream of Spiral Road

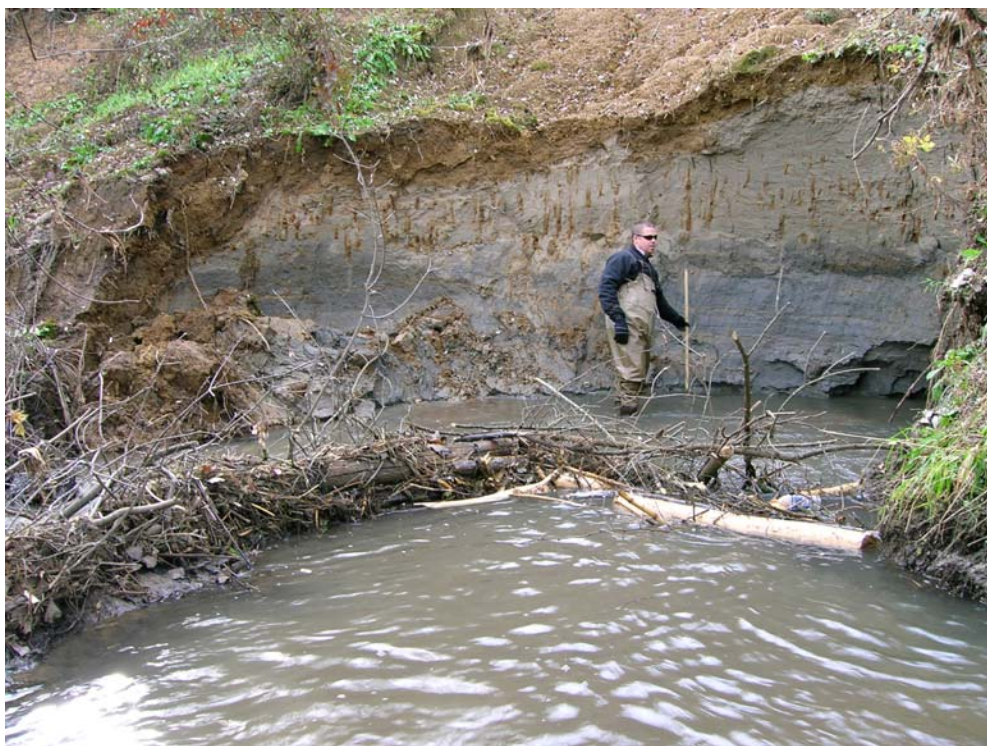
Figure E-4. A section of the stream bank was carved out as a result of the August 2007 flooding.

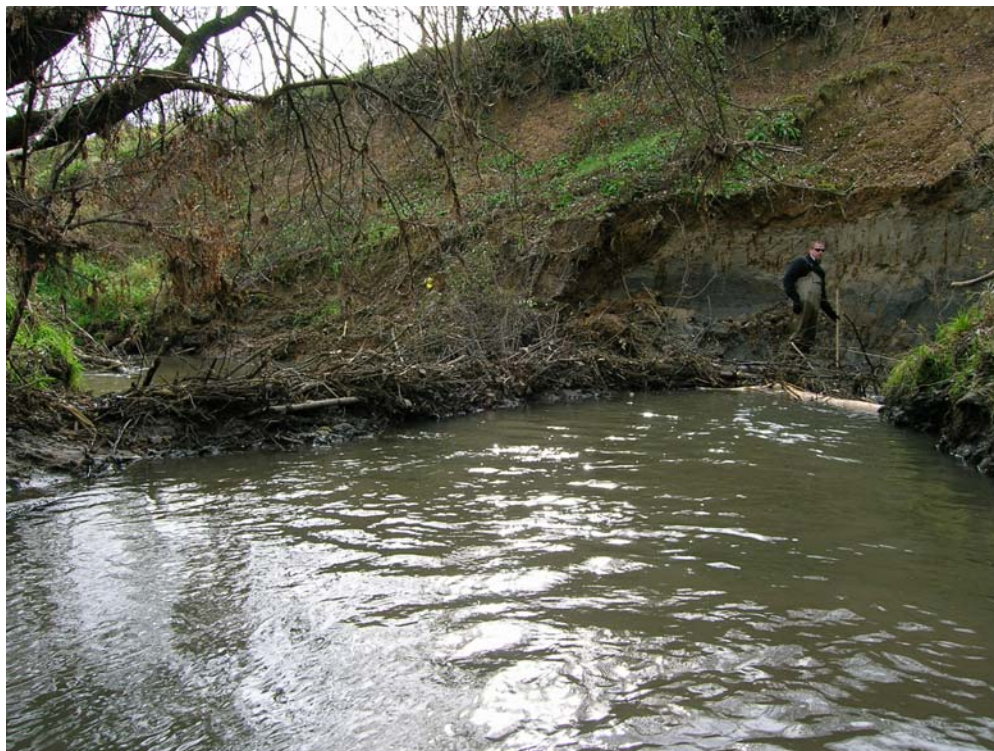
Figure E-5. A section of the stream bank was carved out as a result of the August 2007 flooding.

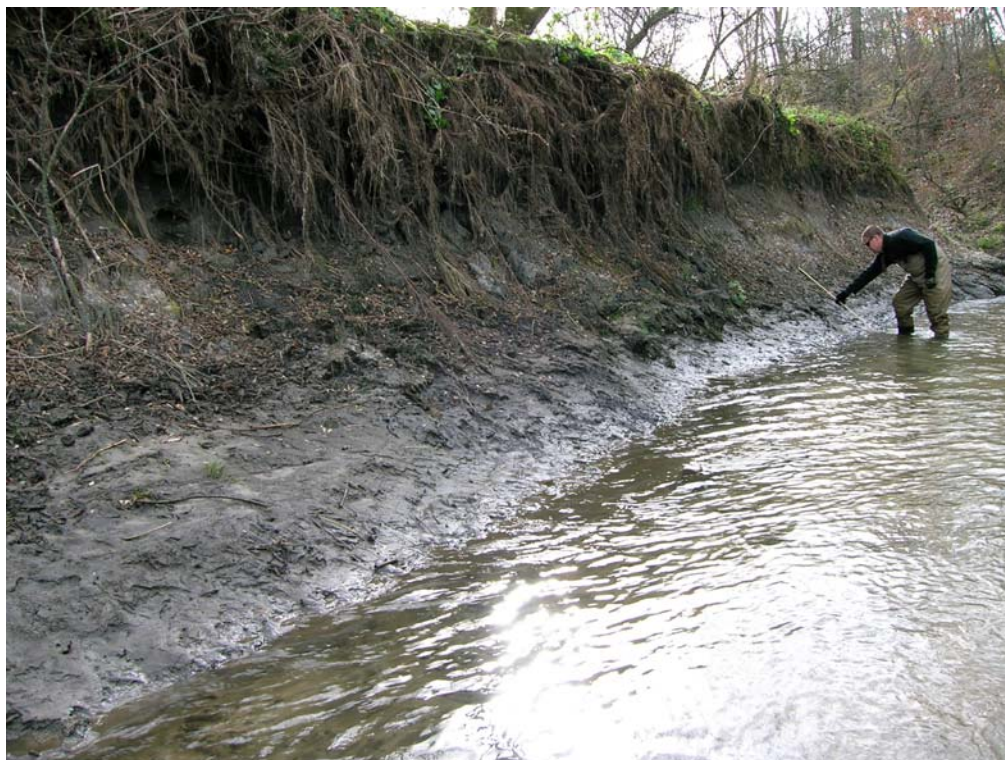
Figure E-6. Typical bank erosion along Little Willow Creek downstream of Spiral Road

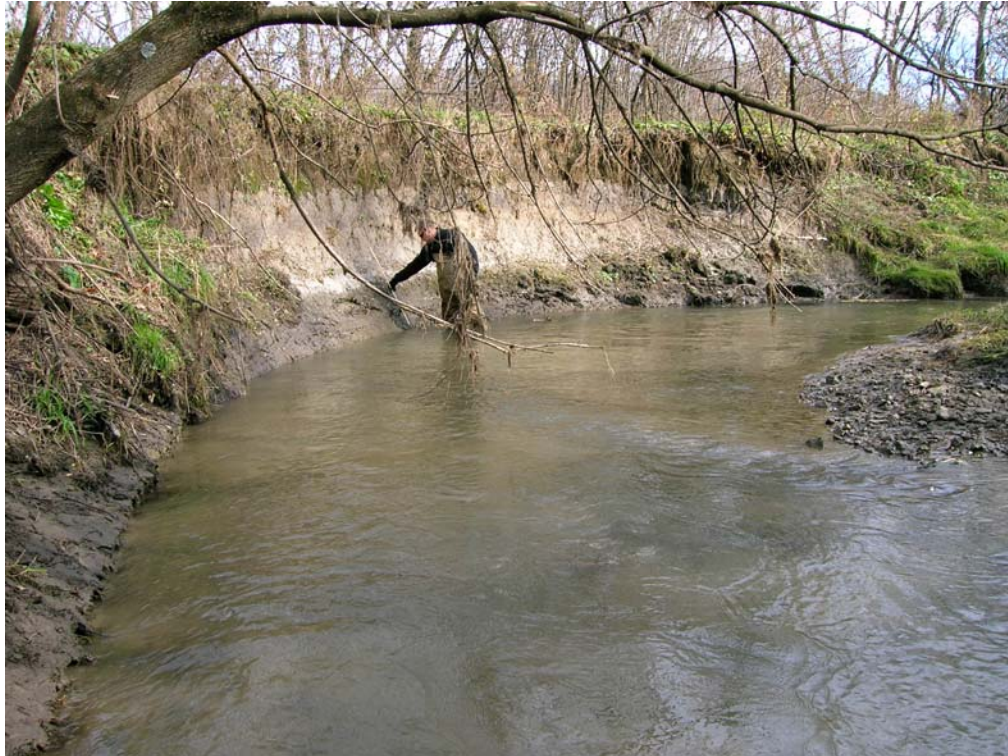
Figure E-7. Typical bank erosion along Little Willow Creek downstream of Spiral Road
