Pioneer Lake

2019 Lake Assessment

Report

Prepared by
Vilas County Land &
Water Conservation

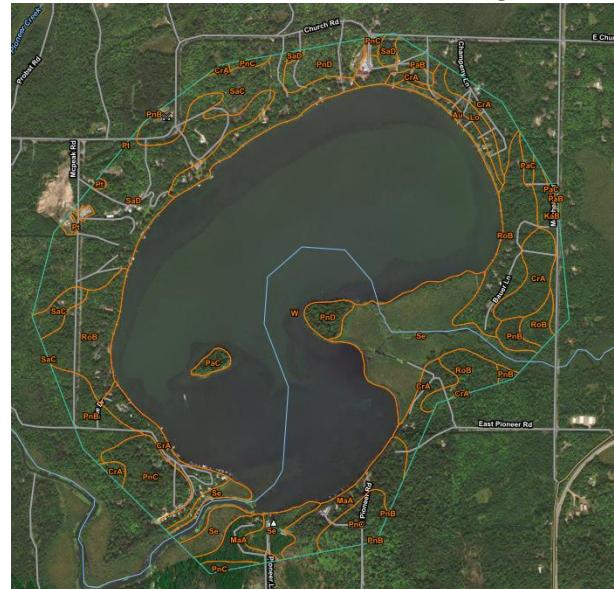
Figure 3. Soils of Pioneer Lake. Seelyeville and Markey mucks (Se), Sayner-Rubicon complex (SaC & SaD), Rubicon sand (RoB), Croswell sand (CrA), and predominates the riparian area. Courtesy Soil Web Survey, NRCS.

Apart from the boat launch area, there is no public land on the lakeshore and most parcels are developed. The ground cover is primarily forests and wetland. Seelyeville and Markey mucks predominate the inlet and outlet areas and are indicative of wetlands. Other predominant surrounding soils are sandy soils with slopes ranging from 0-35%: primarily Sayner-Rubicon Complex (SaC & SaD), Rubicon Sand (RoB), and Croswell sand CrA. The steeper soils (SaC and SaD) are located on the northwest side of the lake (*Web Soil Survey*).

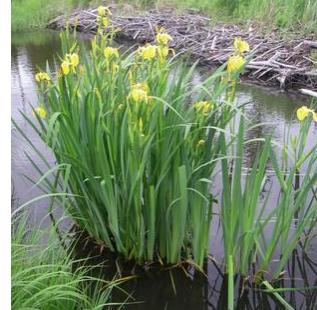
Figure 5. Example photo of invasive yellow iris. This plant is suspected but not verified on Pioneer Lake. Photo courtesy of Oneida County Land & Water Conservation.

Invasive yellow iris is suspected but not verified on Pioneer Lake. A flower is needed to differentiate invasive yellow iris from native blue flag iris. It would be recommended for residents of Pioneer Lake to be watchful of Yellow Iris on their shorelines during late May to early June when blooms – see Figure 5.

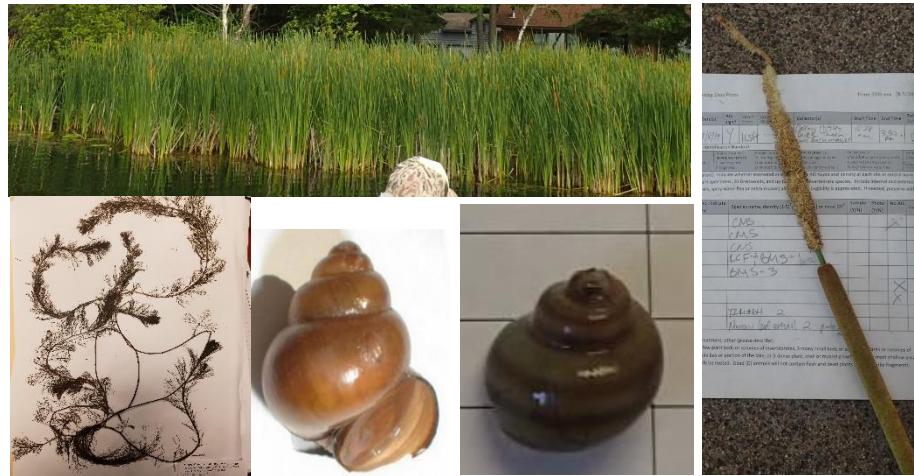
Figure 6. Verified invasives of Pioneer Lake and nearby Twin River (clockwise from top left): narrow leaf cattail area on Pioneer Lake; narrow-leaf cattail flower; Chinese mystery snail photo courtesy of Amy Benson; USGS, Banded mystery snail; and Eurasian watermilfoil found on the Twin River-Monheim Rd. crossing.

- **Create an AIS monitoring group:**
 - Invasive Eurasian water milfoil was found in the Twin River at the Monheim Rd. crossing, and yellow iris is suspected but not yet confirmed. Monitoring for Eurasian water-milfoil and other AIS will be helpful so the association can respond in a timely manner if desired. Contact Cathy Higley from Vilas County Land & Water Conservation 715-479-3738 or cahigl@vilascountywi.gov for training and guidance on forming a group.

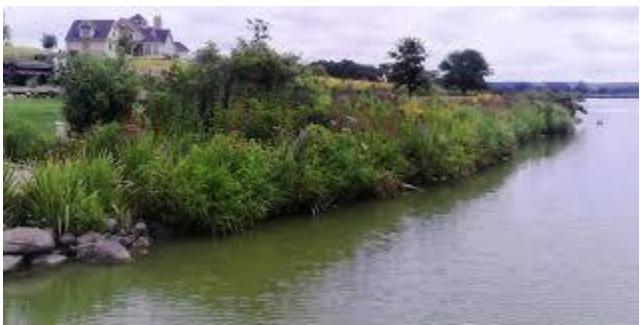
Figure 9. Landowners experiencing minor-moderate erosion issues may find that Healthy Lakes practices such as native plantings are enough to reduce runoff. Contact Land & Water Conservation for an assessment. Photo courtesy of Healthy lakes WI.

- **Address runoff and erosion concerns:**
 - Areas of bare soil in the riparian zone and bank erosion should be restored as they can add extra phosphorus into the water. Staff from Vilas County Land & Water Conservation are able to do site visits, recommend solutions, and in certain instances offer grant fund reimbursement for installing best practices. Contact Cathy Higley from Vilas County Land & Water Conservation 715-479-3738 or cahigl@vilascountywi.gov for assistance, questions, or possible funding.

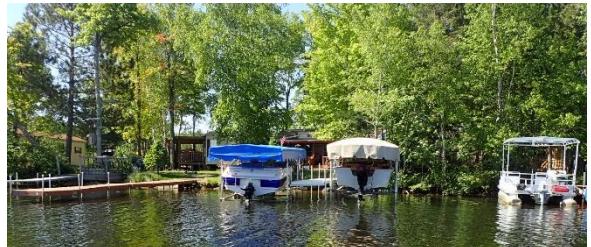
Figure 8. Dock density on Pioneer Lake was fairly high at 25.20 docks/mile. Having a lake-wide dock density greater than 16 docks/mile has been shown to have negative effects on fish diversity (Jacobsen et.al).

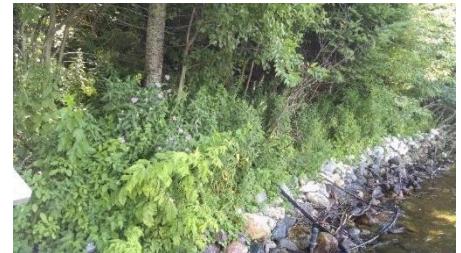
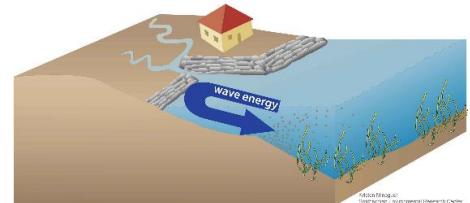
Riprap

Waves bounce back from the surface with higher energy, stirring up mud and clouding the water.

Figure 10. Top: Rock riprap photo. Bottom: Wave energy is “bounced” or transferred from riprap to adjacent shoreline and lake bottom. While the armored section is protected, the adjacent shoreline and lake bottom are now the target of higher wave energy, making them further susceptible to erosion. Kristen Minogue, Smithsonian Environmental Research Center.

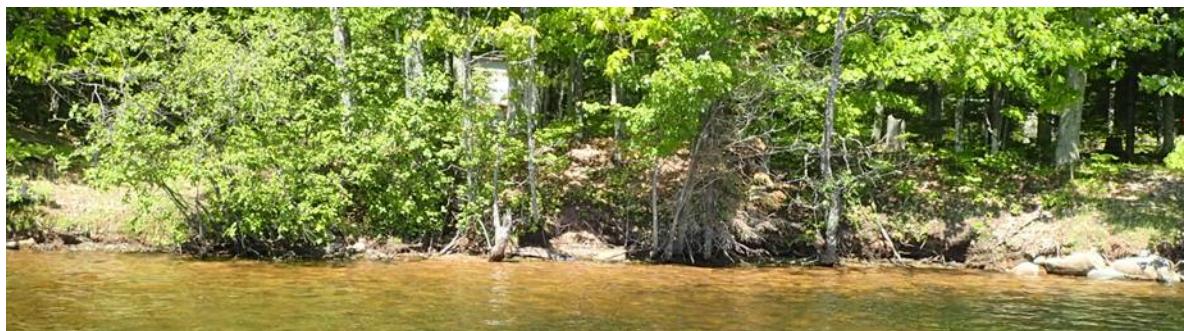
Figure 11. Bank erosion on Pioneer Lake likely caused by flank erosion from the adjacent riprapped area.

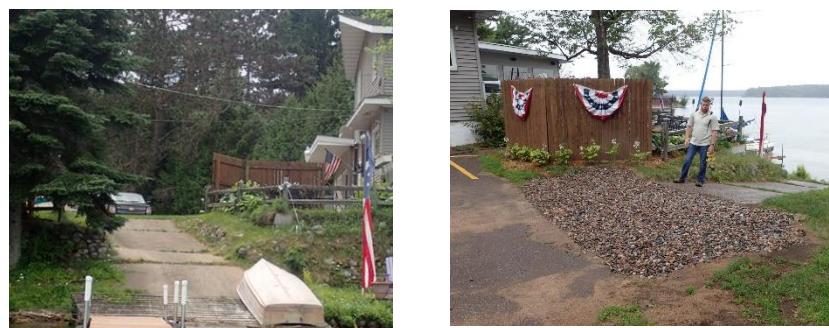
Figure 15. Impervious surfaces and straight trail/road access allow runoff to speed up and brings phosphorus laden sediments to the lake. This site (not on Pioneer Lake) was augmented with a water infiltration pit to minimize runoff going into the lake.

- Where lake access trails/driveways slope down to the lake, encourage riparian owners to curve their access trails across the slope rather than going straight down to the lake. This switchback approach will allow stormwater to infiltrate into the soil (vs. becoming runoff) better than a straight trail would. Landowners should be mindful when curving or meandering an access path to comply with Zoning regulations on allowable access area width. See Figure 14 as an example. For assistance with properly placing this type of lake access with the viewing corridor contact the Vilas County Zoning at 715-479-3620.

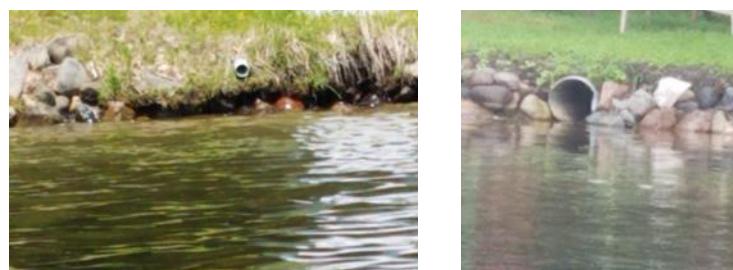
Figure 16. Point source pipes were found on Pioneer Lake.

- **Address point source sites:**
 - Follow up on the two point source discharges found for potential pollutants. If necessary/appropriate, encourage landowners to consider alternate ways to deal with their storm/waste water. Contact Melissa Yarrington of the WI DNR for assistance at 715-359-0192 or Melissa.yarrington@wisconsin.gov.

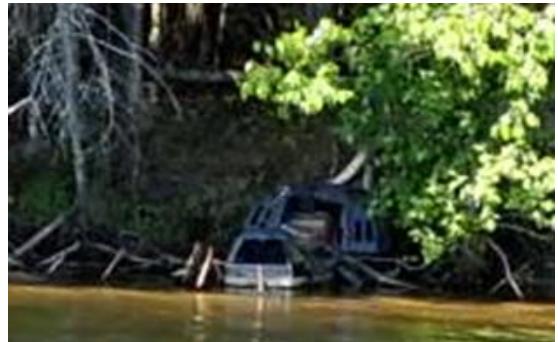
And old snowmobile was found sunk into the lake’s shoreland area. Residents indicate this had been there since the 1980’s.

Figure 18. An old snowmobile has been reported to have been sunk into the shoreline since the 1980's.

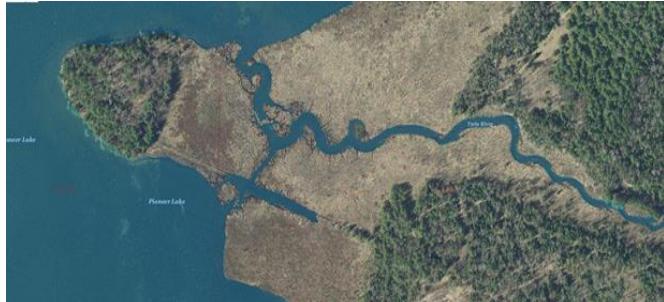
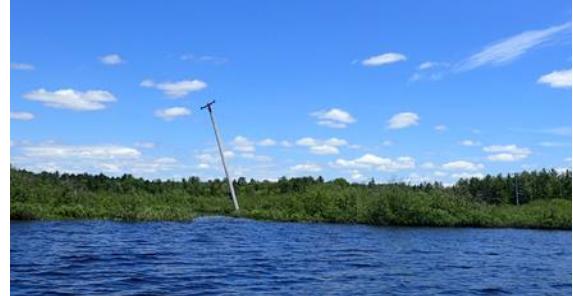
Residents reported that historically, a landowner of the peninsula area near the Twin River outlet had attempted to upgrade the log road to a gravel road. Upon adding the heavy gravel, a whole section of the road and underlying wetland sunk into the lake. The utility poles around this area also seem a bit unstable. See Figure 19.

Figure 19. Air photo of the “sunken land” described by lake residents and photo of a leaning utility pole in same area.

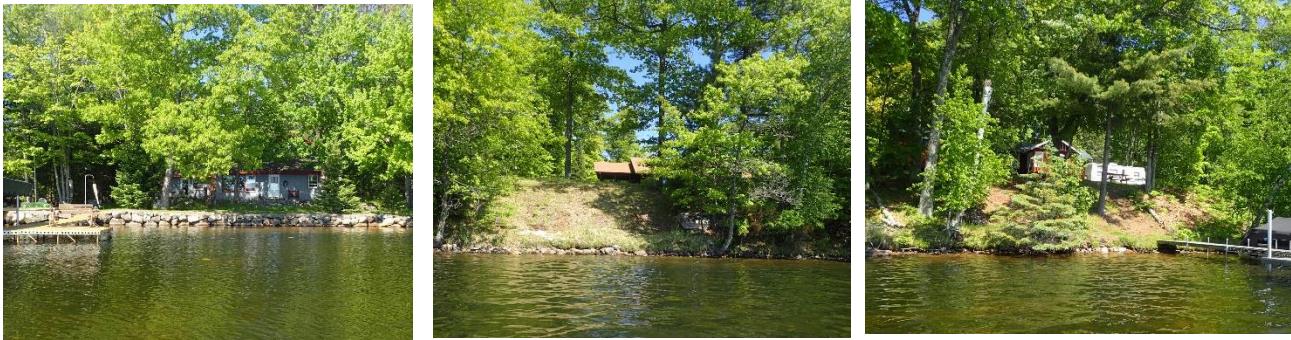
The majority of the parcels on Pioneer Lake did not have steep banks. However there were some areas that were steep. Sandy dry soil in these areas are quite prone to erosion, and can be difficult to get vegetation established.

Figure 21. The photo on the left show the gentle grade of the majority of Pioneer Lake's parcels. The middle and right photos show steeper slopes. Runoff and erosion are more of a concern on steeper areas that occur primarily on the northwest side of the lake.

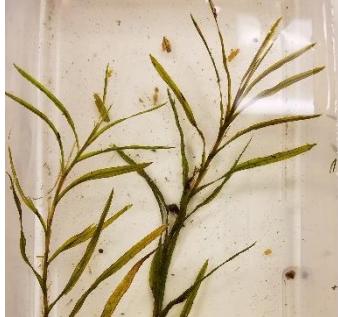
Figure 25. Fern pondweed (*Potamogeton robbinsii*) was found in Pioneer Lake 2019 point-intercept survey. This plant occurred in over 47% of littoral sites surveyed.

Of the plant species found, Fern pondweed (*Potamogeton robbinsii*), Water celery (*Vallisneria americana*), Flat-stem pondweed (*Potamogeton zosteriformis*), and Small pondweed (*Potamogeton pusillus*) were the most prevalent. See Table 2.

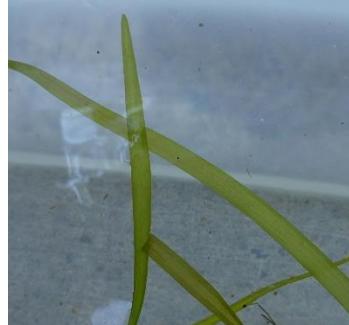
Figure 26. Water celery was found in the Pioneer Lake 2019 point-intercept survey. This plant occurred in over 34% of littoral sites surveyed.

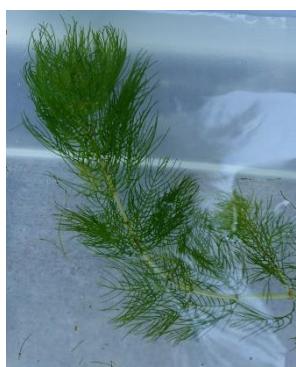
Figure 28. Northern water-milfoil (*Myriophyllum sibiricum*) was found in the Pioneer Lake 2019 point-intercept survey. This plant occurred in over 16% of littoral sites surveyed.

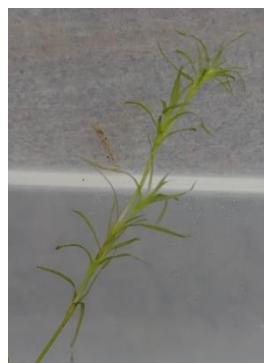
Figure 29. Slender naiad (*Najas flexilis*) was found in the Pioneer Lake 2019 point-intercept survey. This plant occurred in over 18% of littoral sites surveyed.

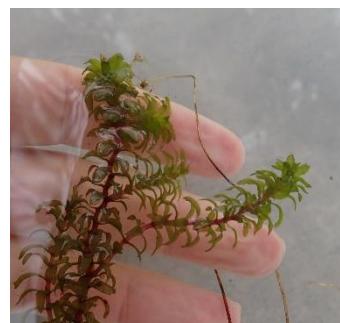
Figure 30. Common water weed (*Elodea canadensis*) was found in the Pioneer Lake 2019 point-intercept survey. This plant occurred in over 15% of littoral sites surveyed.

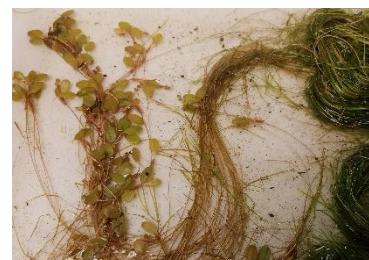
A *Potamogeton* species was found that could not be Identified to species, but is either *Potamogeton diversifolius* (water-thread pondweed) or *Potamogeton vaseyi* (Vasey's pondweed) (Freckmann). Both are considered rare plants and are listed as Special Concern by DNR Natural Heritage Inventory (*Wisconsin's Rare Plants*). To identify this to species, another specimen is needed. See Appendix 3 for photos of highlighted plants.

Figure 33. Special concern pondweed species, either water-thread pondweed or Vasey's pondweed (*Potamogeton diversifolius* or *vaseyi*) found in Pioneer Lake.

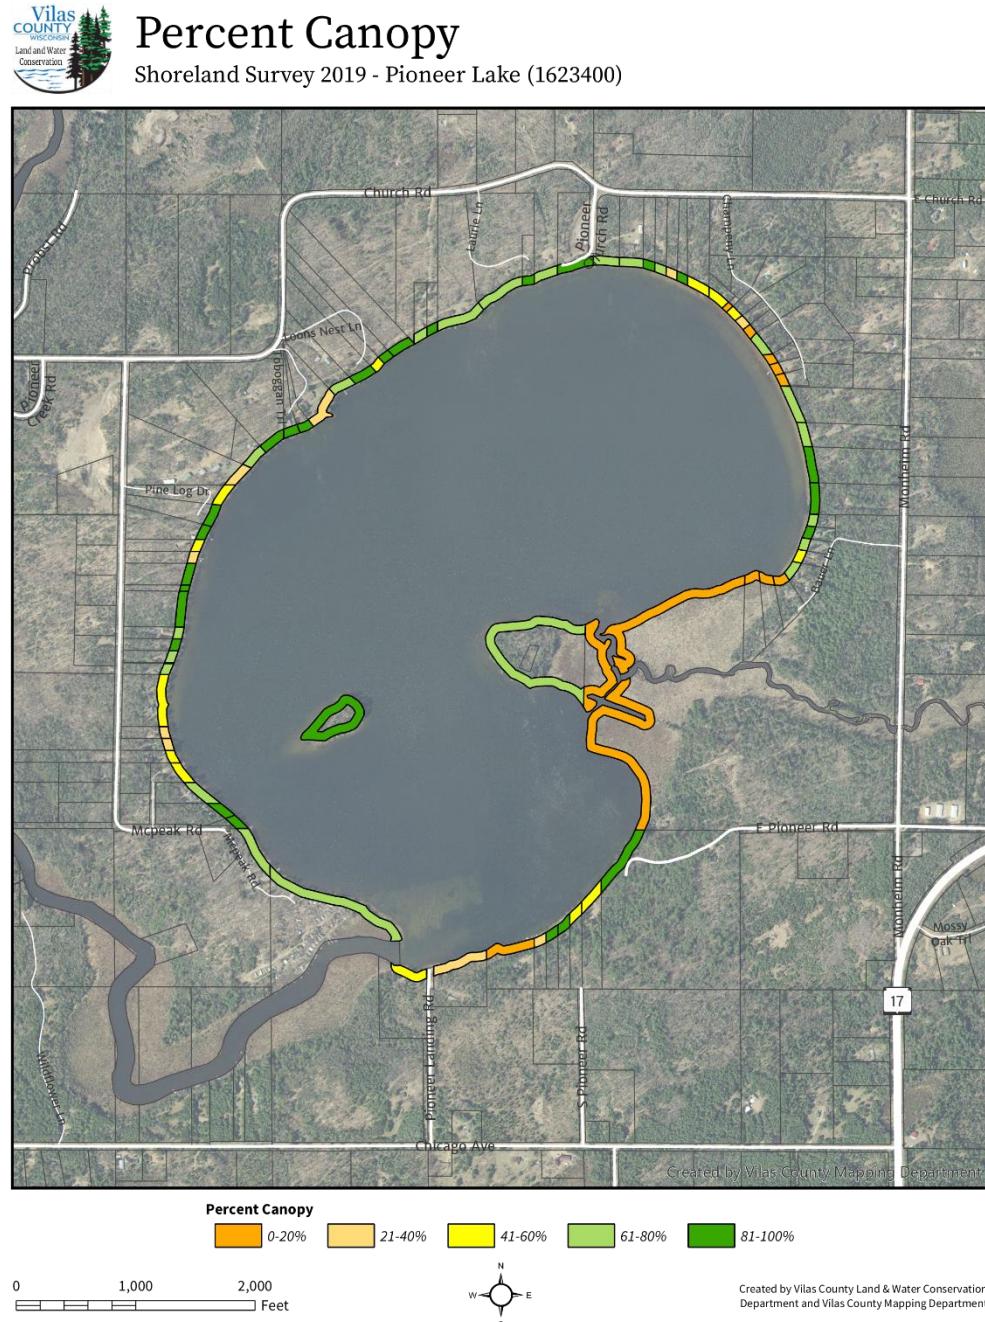
Figure 37. Canopy cover percent per parcel within 35 ft buffer area on Pioneer Lake 2019.

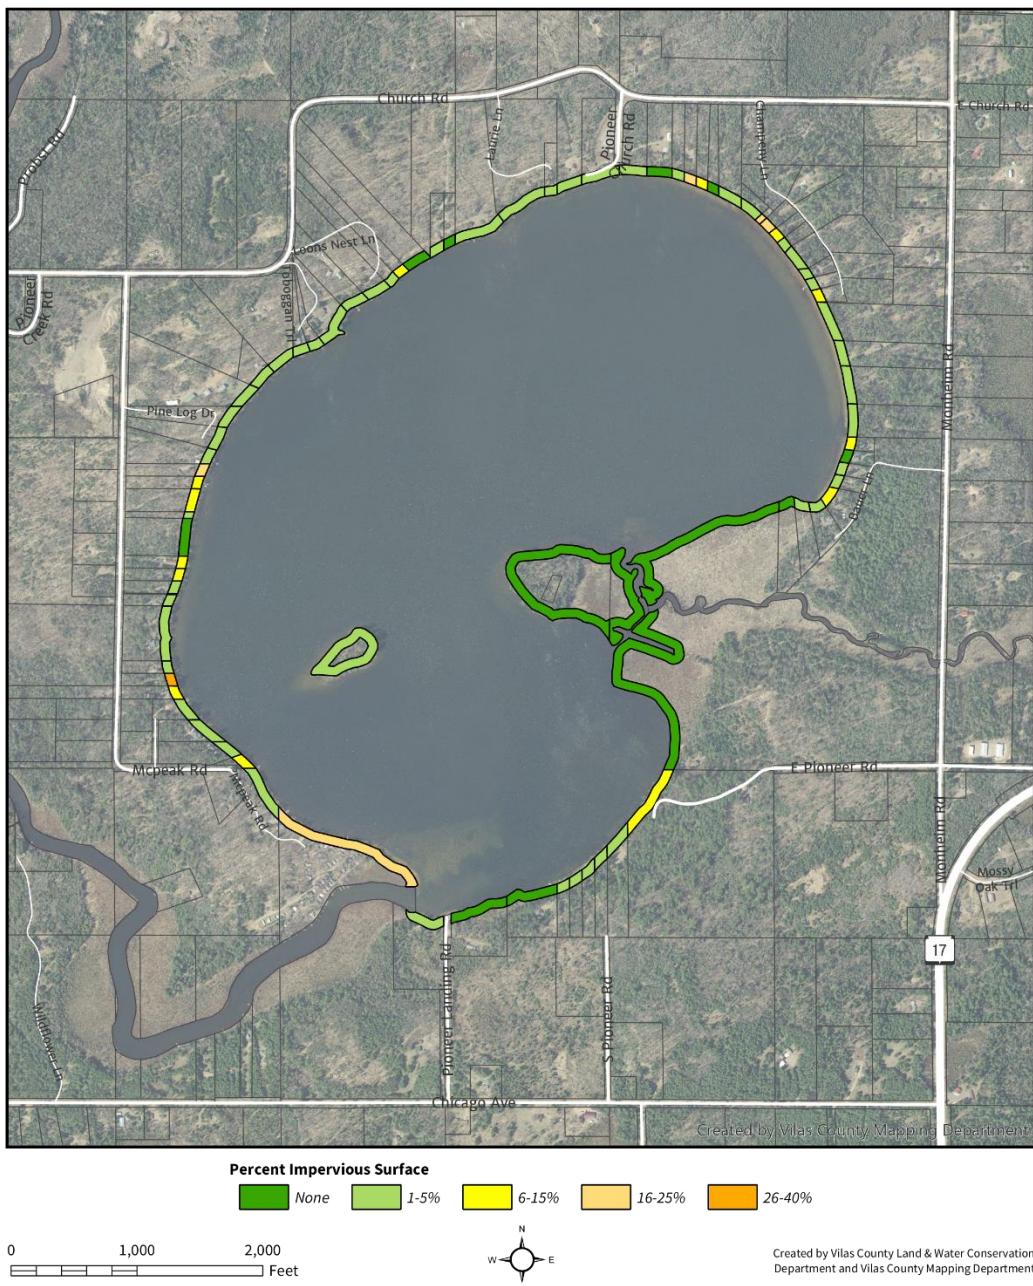
Percent Impervious Surface

Figure 40. Percent impervious surfaces within 35 ft. riparian buffer zone per parcel on Pioneer Lake 2019.

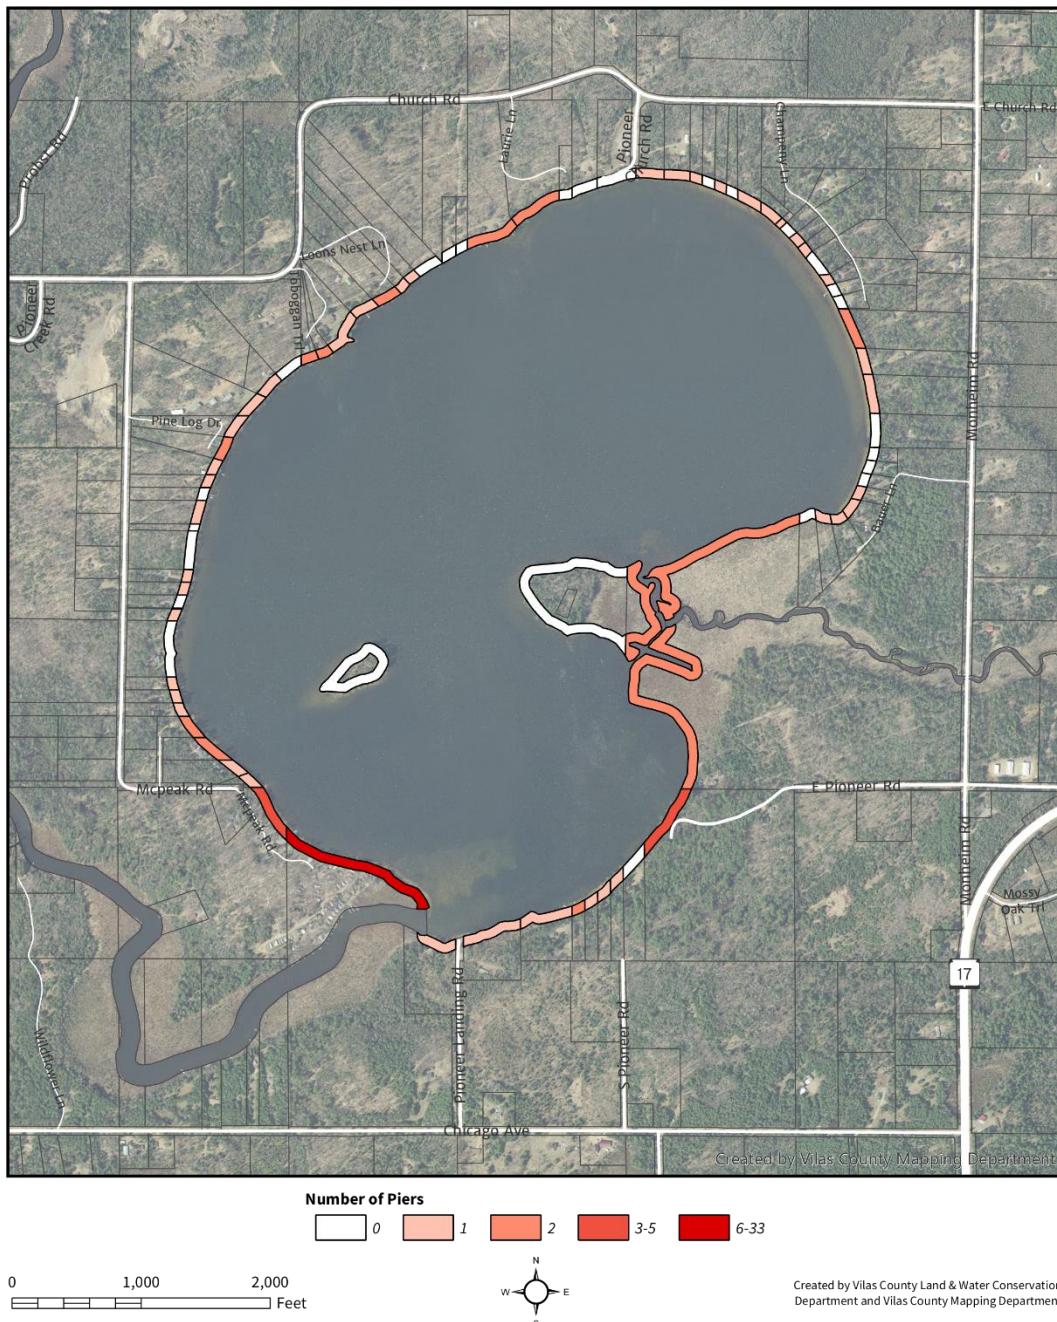
Figure 41. Piers per parcel on Pioneer Lake 2019.

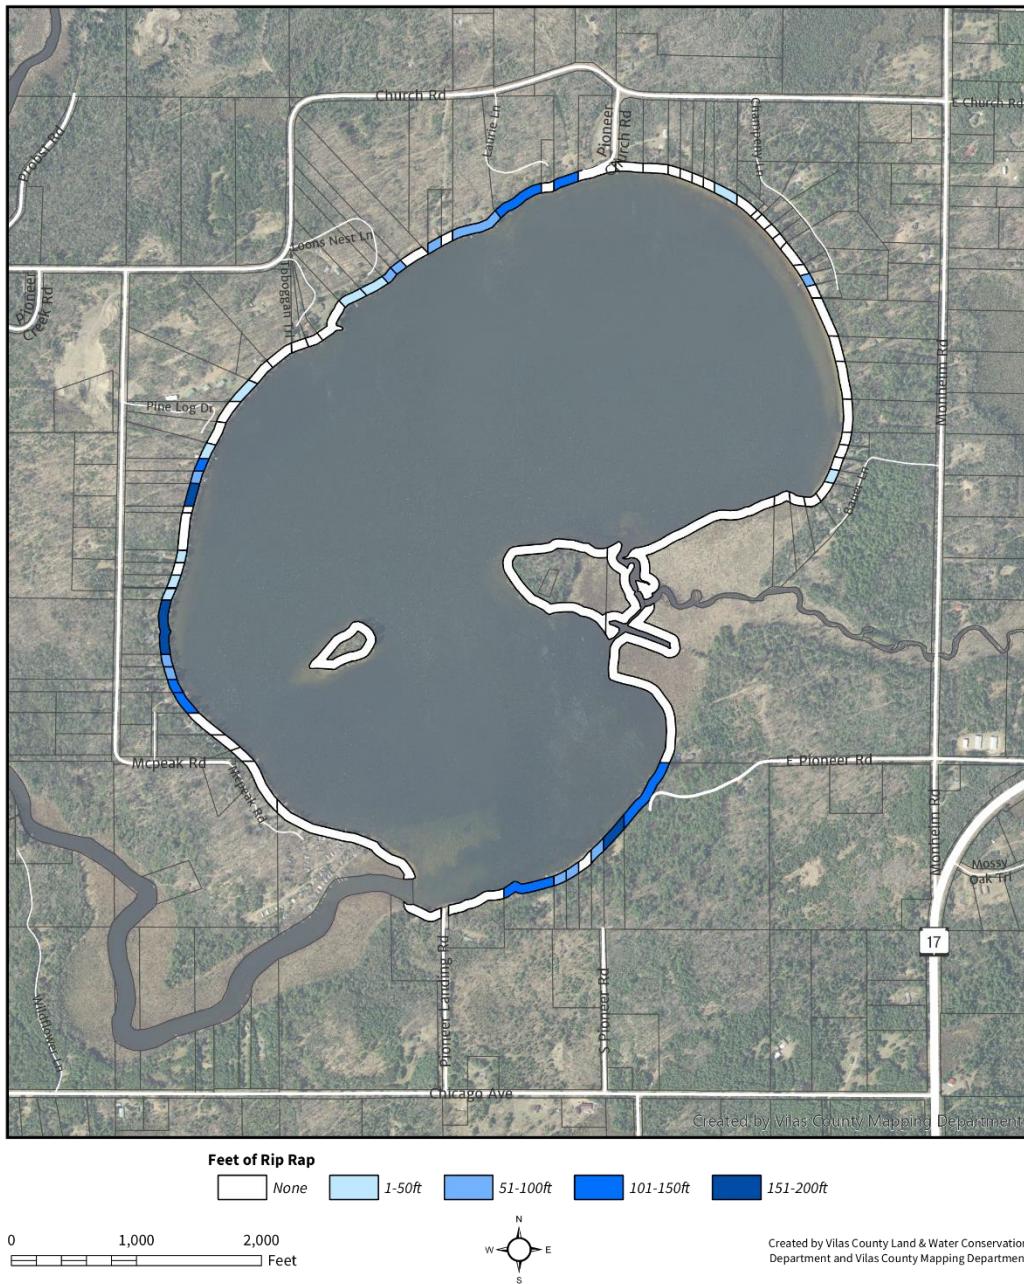
Figure 42. Feet of riprap per parcel on Pioneer Lake 2019. Over 12% of the shoreline was riprapped.

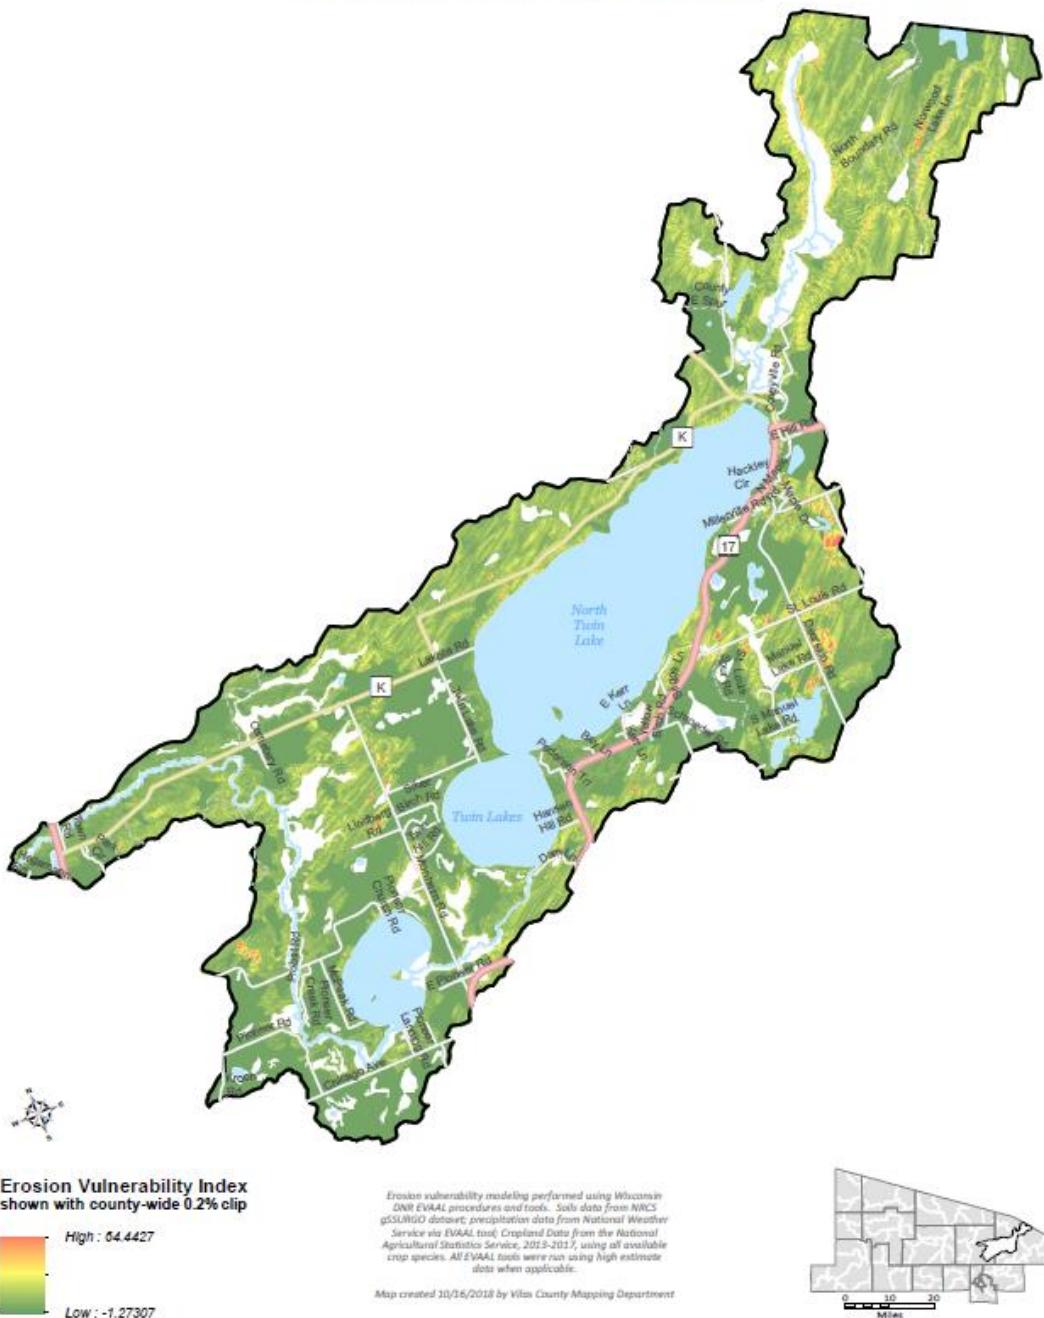
Figure 49. Areas susceptible to erosion in the Pioneer Creek subwatershed.

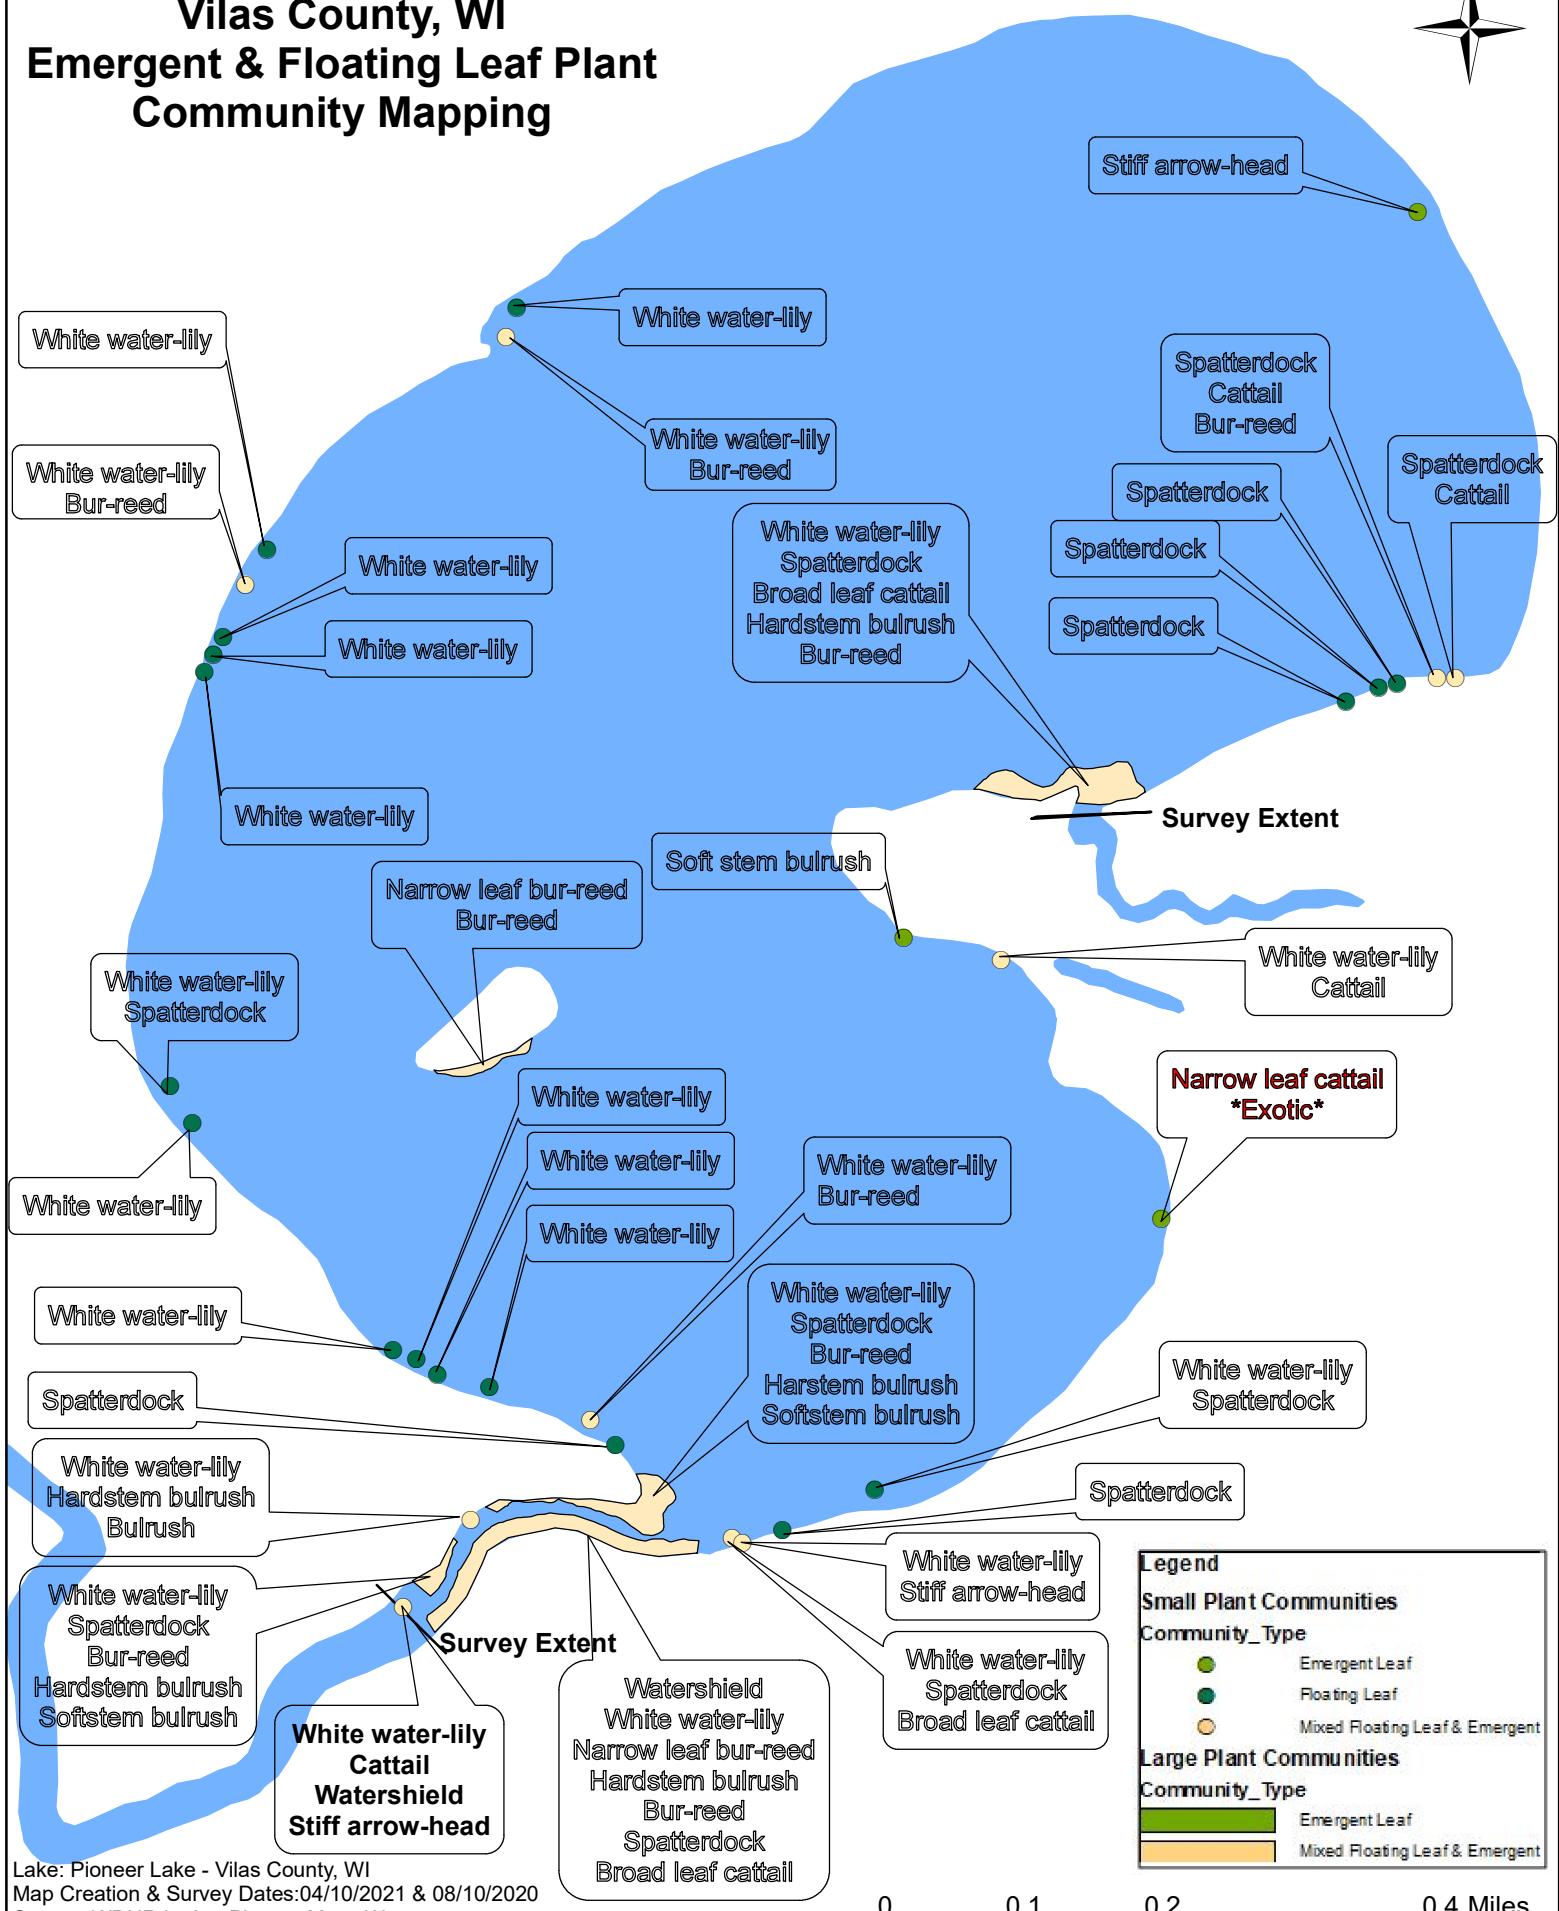
Emergent & Floating Leaf Plant Community Mapping
