# **Little Crooked Lake 2020 Lake Assessment Report**

Prepared by  
Vilas County Land & Water Conservation

May 23, 2021

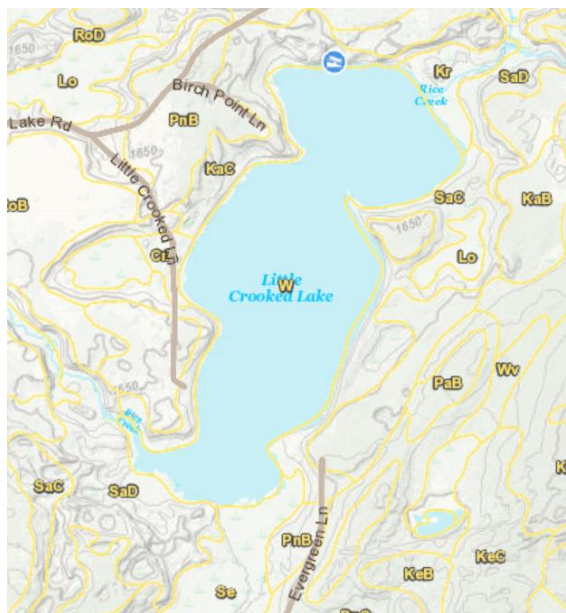
The ground cover is primarily forests and wetland at the inlet and outlet, as well as near Evergreen Rd. Seelyeville and Markey mucks as well as Kinross muck occur at the inlets and outlets and are indicative of wetlands. Other predominant surrounding soils are sandy soils with slopes ranging from 0-35%: primarily Sayner-Rubicon Complex (SaC & SaD), Karlin loamy fine sand (KaB & KaC), Pence sandy loam (PnB) and Croswell sand (CrB). (*Web Soil Survey*).

Figure 3. Soils of Little Crooked Lake. Sayner-Rubicon complex (SaC & SaD), Karlin loamy fine sand (KaB & KaC), Pence sandy loam (PnB), and Croswell sand (CrA) predominate the riparian area. Courtesy Vilas County Mapping.

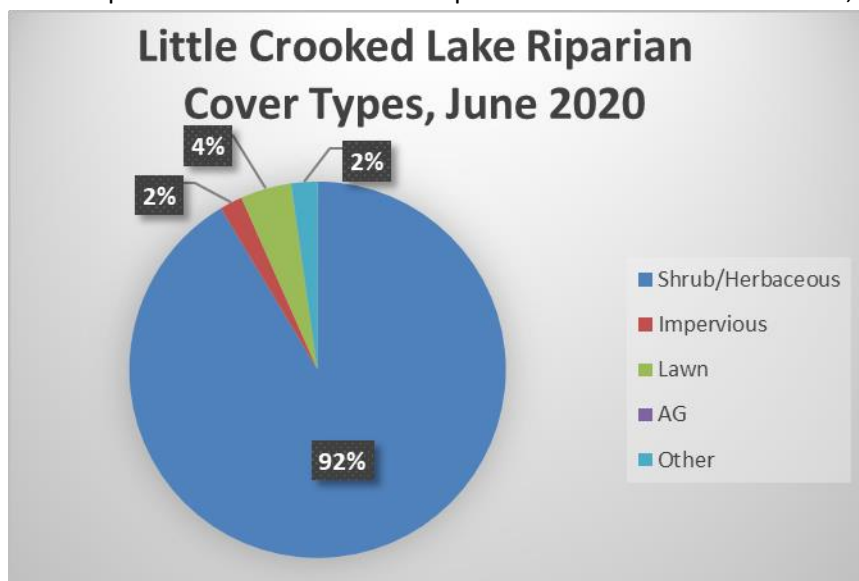
Figure 6. Ground cover type in Riparian Buffer Area (35 ft. inland from shore) on Little Crooked Lake, 2020.

canopy (trees taller than 16 ft.). In many cases, parcels with lower canopy percentages correlated with higher percentages of lawn, however; the wetland areas encountered naturally have very little canopy. See Figure 34 for a map of percent canopy cover.

Lake-wide, 92% of the riparian area (35 ft. inland from ordinary high water mark) was covered by a shrub-herbaceous layer. Lawn made up 4% of the riparian area, and impervious surfaces made up 2%. See Appendix 5 for Riparian Buffer Zone Cover Types.

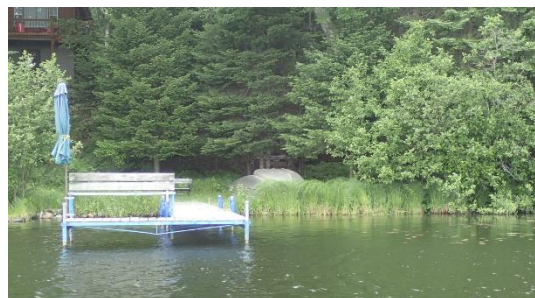
Figure 7. Dock density on Little Crooked Lake was low at 6.52 docks/mile. Having a lake-wide dock density greater than 16 docks/mile has been shown to have negative effects on fish diversity (Jacobsen et.al).

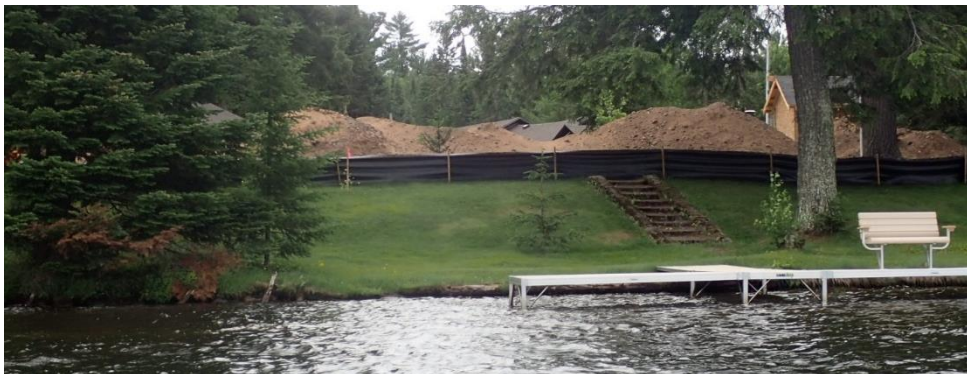
Figure 9. There was some major construction adjacent to Little Crooked Lake in 2020. Silt fences appeared to be properly placed.

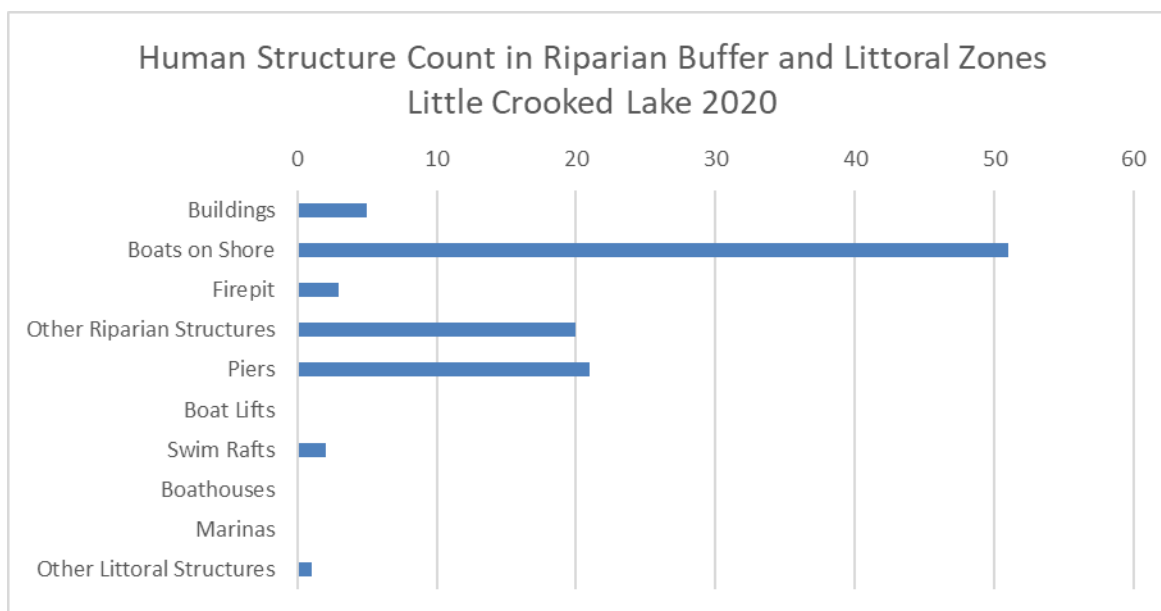
to modify or place new structures in these areas. In Little Crooked Lake, boats on shore were the most common structure (15.84 boats on shore/mile of shoreline). Ten docks or less per kilometer (16 docks/mile) of shoreline, as a reflection of shoreline development, has been shown to be a threshold of maintaining high quality fish diversity in Minnesota (Jacobsen et. al). Little Crooked Lake's pier density was 6.52 docks/mile of shoreline. Other riparian structures encountered were predominantly chairs, benches, and dock sections on shore (6.21/mile).

Figure 10. Number and density per mile of shoreline of human structures documented in the Riparian Buffer and Littoral Zones on Little Crooked Lake 2020.

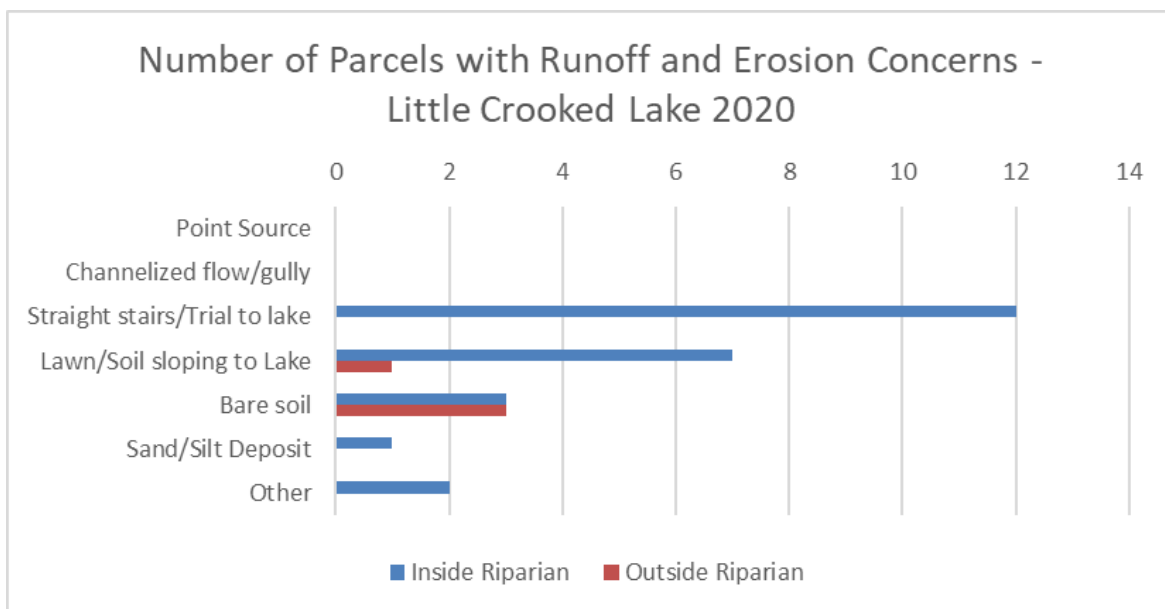
Figure 11. Number of parcels with runoff and erosion concerns in Riparian Zone and Outside Riparian Zone on Little Crooked Lake 2020. Of the 28 parcels, 18 had erosion or runoff concerns (64%).

- **Address runoff and erosion concerns:**
  - Areas of bare soil in the riparian zone and bank erosion should be restored as they can add extra phosphorus into the water. Staff from Vilas County Land & Water Conservation are able to do site visits, recommend solutions, and in certain instances offer grant fund reimbursement for installing best practices. Contact Cathy Higley from Vilas County Land & Water Conservation 715-479-3738 or [cahigl@vilascountywi.gov](mailto:cahigl@vilascountywi.gov) for assistance, questions, or possible funding.

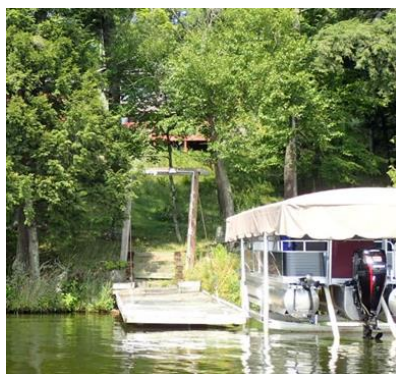
Figure 12. Minimizing impervious surfaces in the buffer zone, including on the access paths, maintaining vegetation, and curving the trail across the slope keeps shoreland erosion in check. Landowners should be mindful when curving or meandering an access path to comply with Zoning regulations on allowable access area width. Diagram courtesy of the US Forest Service.

- Where lake access trails/driveways slope down to the lake, encourage riparian owners to curve their access trails across the slope rather than going straight down to the lake. This switchback approach will allow stormwater to infiltrate into the soil (vs. becoming runoff) better than a straight trail would. Landowners should be mindful when curving or meandering an access path to comply with Zoning regulations on allowable access area width. See Figure 14 as an example. For assistance with properly placing this type of lake access with the viewing corridor contact the Vilas County Zoning at 715-479-3620.

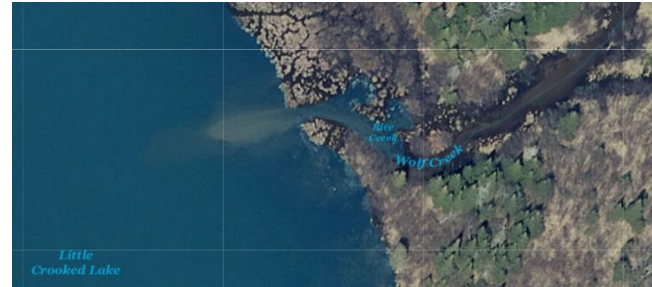
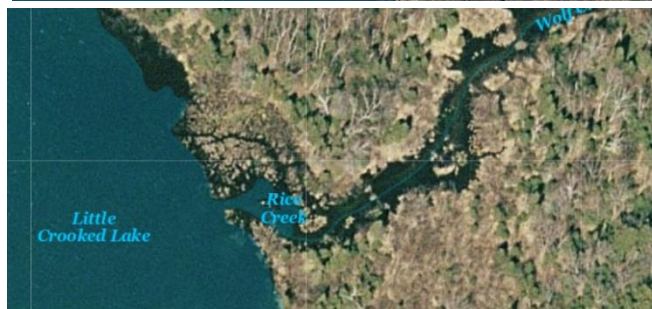
Figure 16. The 2020 air photo (top) show the sediment deposition from Wolf Creek into Little Crooked Lake. The air photo from 2005 does not show the same kind of deposition, however this may be due to photo quality. Maps courtesy of Vilas County Mapping.

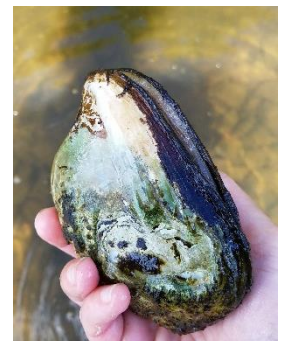
These were identified as Pocketbook mussels (*Lampsilis cardium*) (Kitchel 2021). However, the outer covering of their shells (the periostricum) of those found is missing. Anecdotally, it seemed that most of the large mussels encountered while snorkeling were in this condition. It is uncertain why the outler layer of shell is missing.

Figure 18. Pocketbook mussels found on July 15 and Aug 17, 2020 on Little Crooked Lake with eroded outer shell layers.

- **Consider a mussel monitoring initiative:**
  - The mussels in Little Crooked Lake were large, some were identified as Pocketbook mussels. These Pocketbook mussels seemed to be having the out layer of their shells missing or compromised. Additional data collection may help guide answers of why the mussels are doing poorly. See <https://wiatri.net/inventory/mussels/> for Wisconsin's Mussel Monitoring Program. Lisie Kitchel of WI DNR [lisie.kitchel@wisconsin.gov](mailto:lisie.kitchel@wisconsin.gov) can help train and set up a volunteer mussel monitoring programming.
