SUBJECT: School District of Superior (WPDES Permit 0035866) and Unnamed Tributary to Copper Creek (WBIC 3000143)

### **Overview of issue**

## Site overview maps

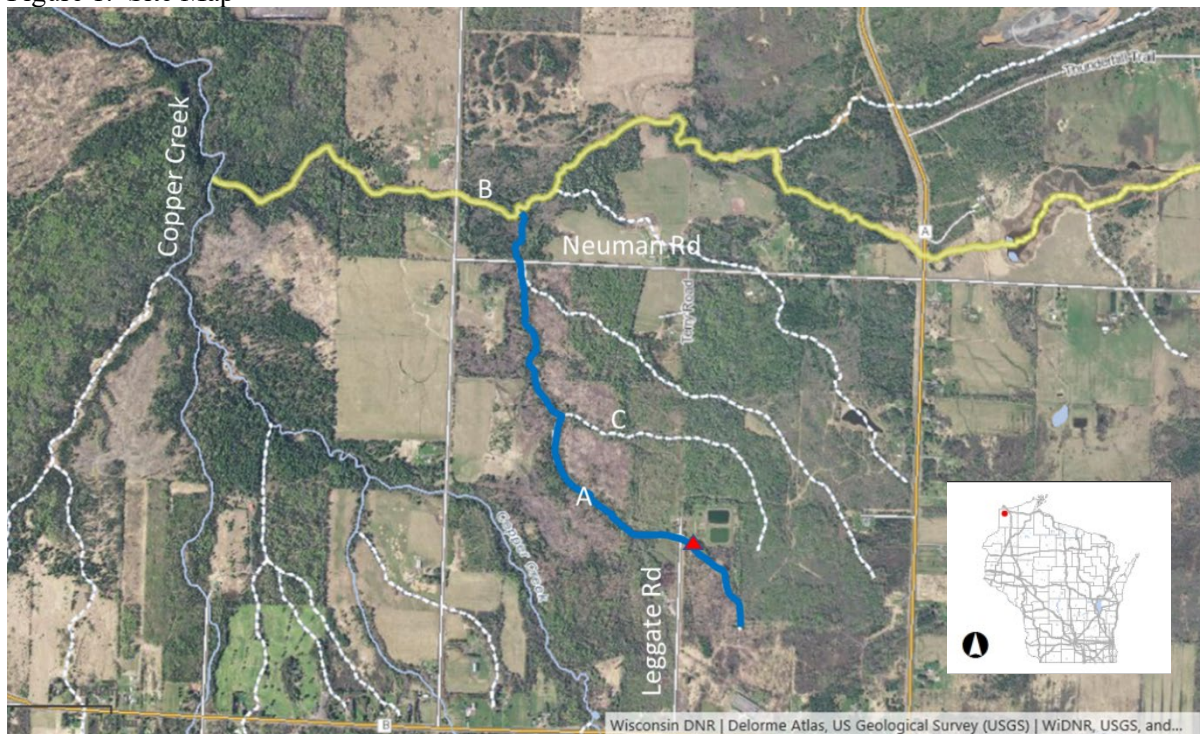
Figure 1. Site Map

The WWTP is on the East side of Leggate Road. The red triangle is the location of the outfall. The effluent is discharged through a pipe to Stream A (shown in dark blue). Stream A flows under Leggate Road through a concrete culvert down a natural channel toward Neuman Road. A concrete culvert allows the tributary to flow under Neuman Road to Stream B (shown in yellow) that then flows to Copper Creek.

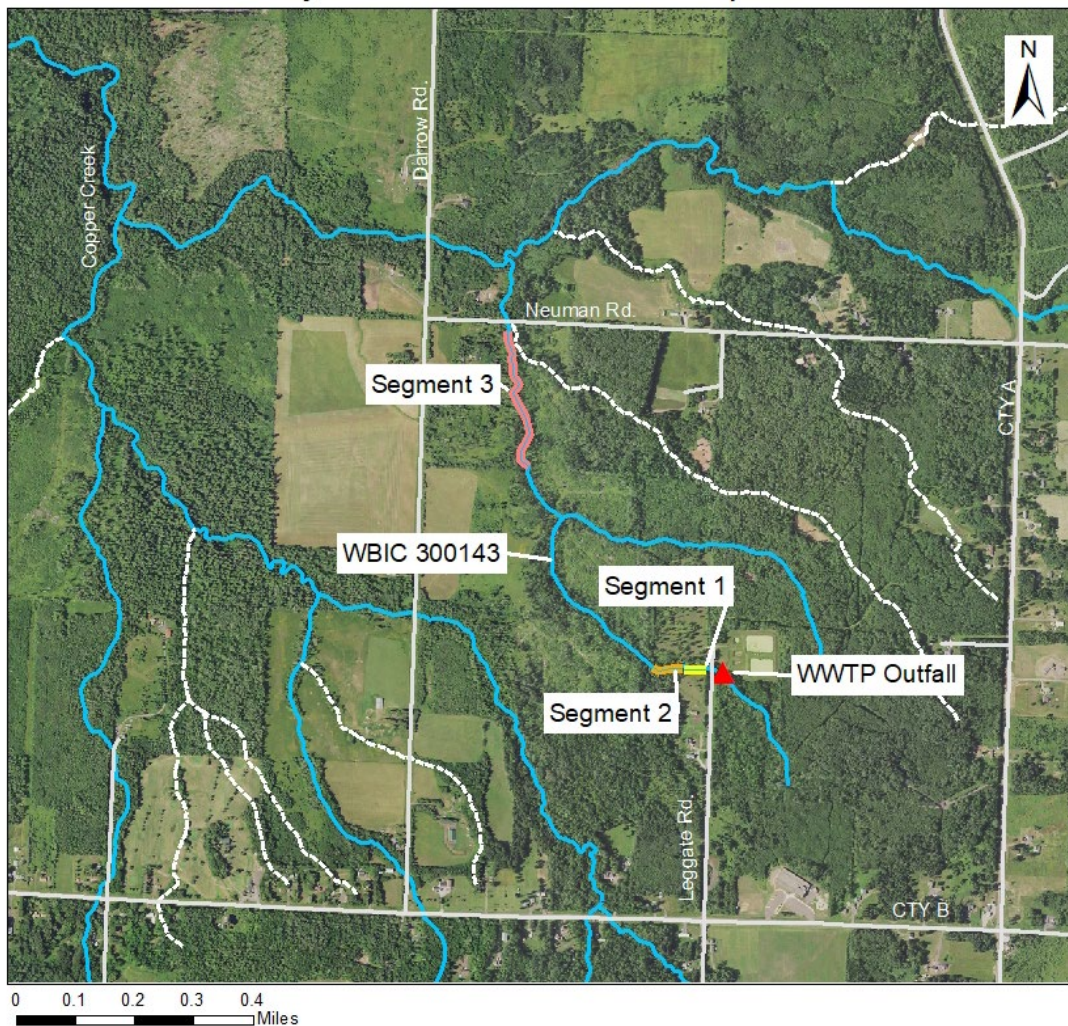
Figure 2. Stream A Survey sites. Stream A (WBIC 3000143) was assessed at 2 access points and broken into 3 stream segments based on changes in flow. The yellow stream section is the location of segment 1. The first fish survey was downstream of Leggate road in segment 2 (orange stream section). The second fish survey was upstream of Neuman Road in segment 3 (pink stream section).

The purpose of this site visit was to determine whether the direct receiving water is appropriately considered an ephemeral/diffuse surface water and to characterize the downstream waters. Two sites were evaluated on Stream A to achieve this goal: downstream of Leggate Road (segments 1 and 2) and upstream of Neuman Road (segment 3). Downstream of Leggate Road, Stream A changes flow characteristics so the stream was evaluated as two different segments (Figure 2-3). Details of each segment are listed below.

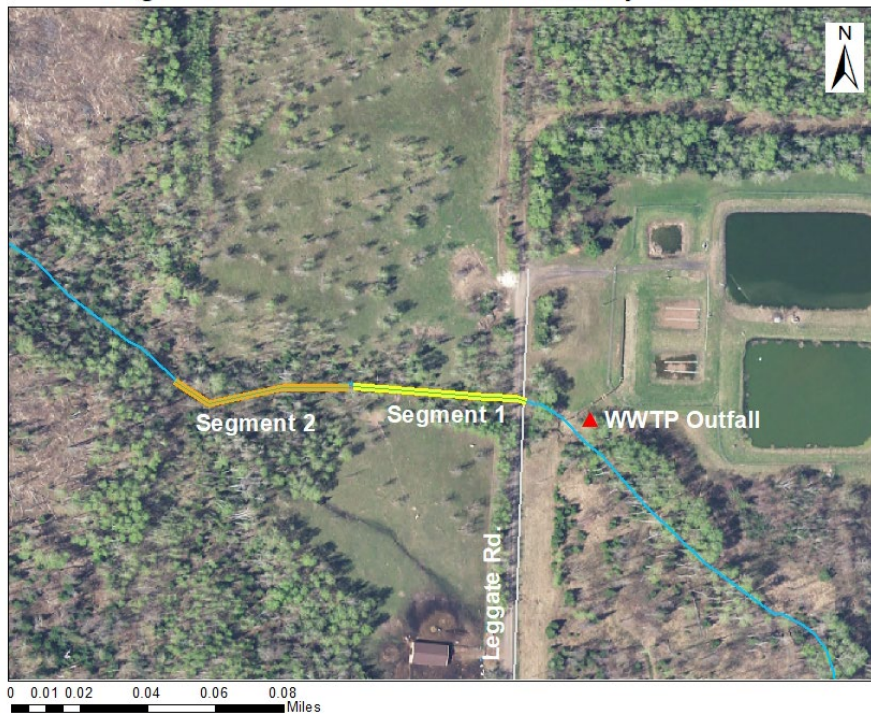
Figure 3. Segment 1 & 2 of Stream A. Segment 1 is shown in yellow. Segment 2 is in orange. The red triangle east of Leggate Rd is the WWTP outfall.

- Segment 1 (most upstream): **Headwaters to ~140 m downstream of Leggate Road**
  - This segment flows through a horse pasture (Figure 3). At the road crossing, the streambed was dry and there was no discharge when the site was visited. The tributary continued as a dry stream channel for approximately 140 m downstream of Leggate Rd (Photo 1). There was a defined channel that could be easily followed. While not measured during the survey, the channel width ranged from approximately 0.5 to 1 m. The channel depth to top of bank was around 0.3 m and up to around 0.5 m. The stream through this segment likely flows only during rain events, snow melt, or during discharge from the WWTP.

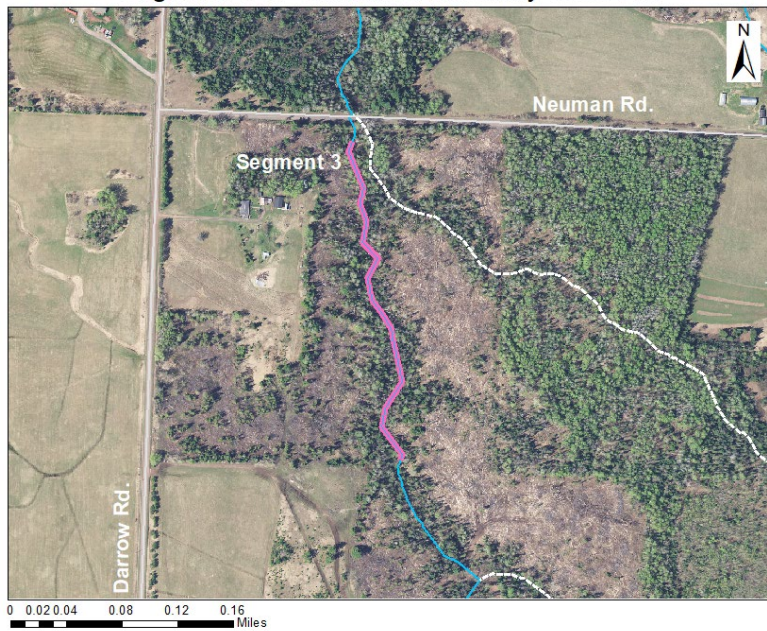
Figure 4. Segment 3 of Stream A. Segment 3 is shown in pink.

- Segment 3: **Upstream of Neuman Road**
  - The stream channel was well defined through this reach and flowed through a mix of forest and agricultural lands (Figure 4). We did not measure the stream width, but a reasonable estimate is 1 to 1.5 m in width and a depth of 0.5 m or maybe a little more in the pools (Photos 4, 5). There was observable flow throughout the reach. There were well defined riffles, runs, and pools and several bends or meanders. The segment had good water depth and habitat to support fish. Spring activity entering the stream was observed near the end of the fish survey.

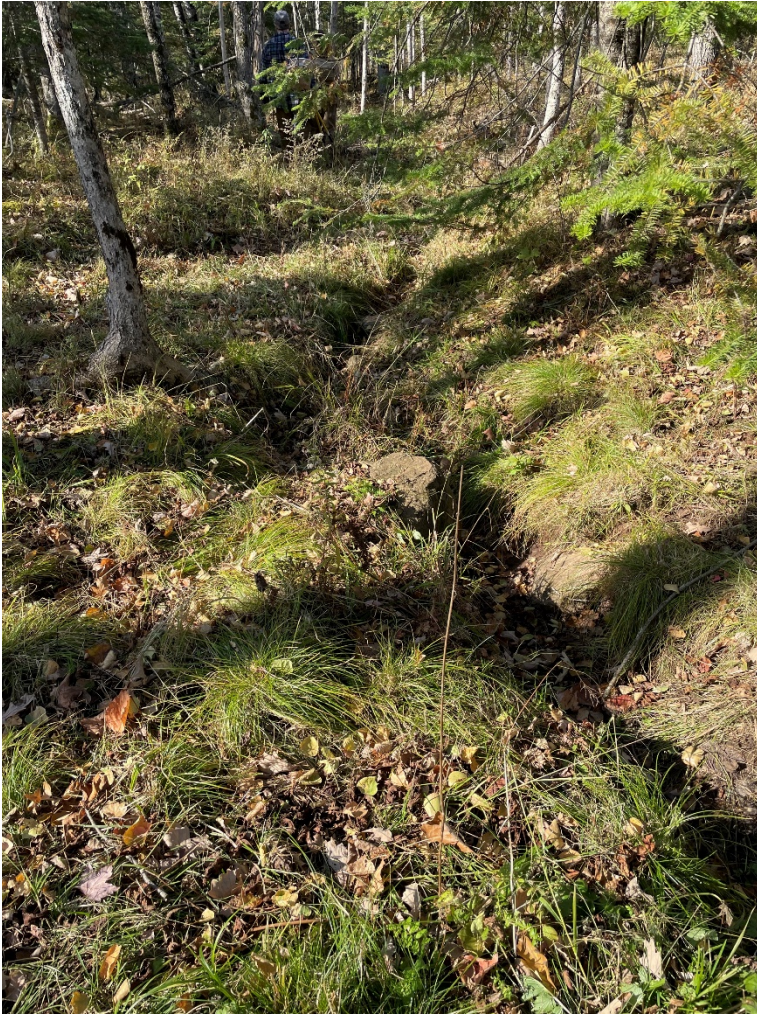
Photo 1. Downstream view of dry stream bed of segment 1.

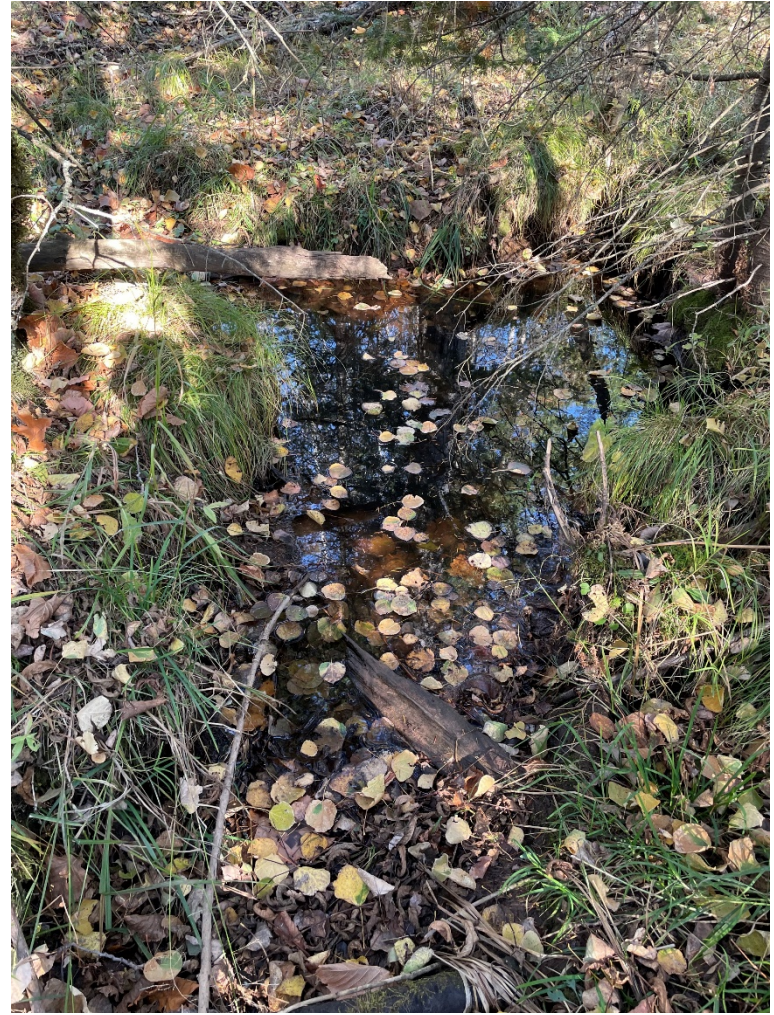
Photo 2. End of segment 2 fish survey looking upstream.

- Segment 2: **Headwater Wetland Stream 140 m downstream of Leggate Road**
  - After an estimated 140 m, the tributary entered a headwater wetland area in the horse pasture (Photo 2). At this point water was observed in the stream channel and the wetland soils were saturated to the surface. The channel braided a bit and had some flow from groundwater discharge (Photo 3). Iron floc bacteria, which are indicative of groundwater discharge, were also observed in the stream channel. The channel widths were slightly wider through this area when compared to the upstream segment and the gradient slightly less. Water Resources staff did not have permission to enter the next property downstream, however the channel was easily visible in the open woods. Downstream of the property line, the stream quickly changed into a more clearly defined, wider and deeper channel. The channel widths were probably a meter or more and water was visible in the channel. The stream began to meander. This change in channel dimensions matches a change in elevation on the 7.5 minute USGS topo maps in this area.

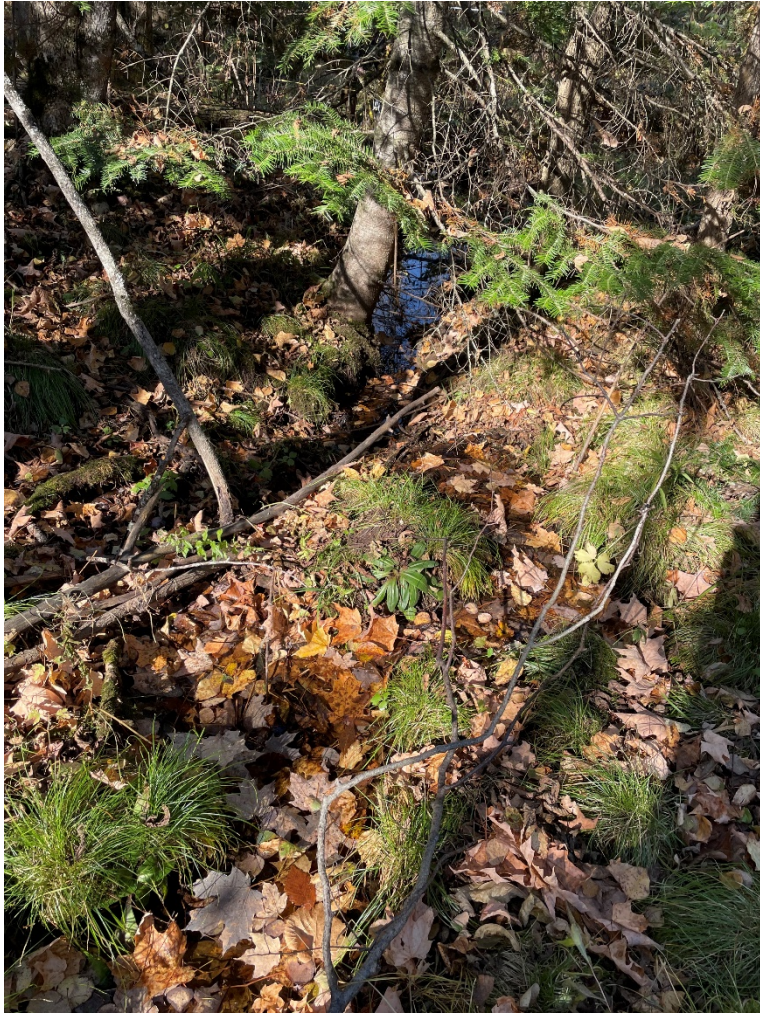
Photo 3. Upstream of the start of segment 2 fish survey looking downstream.

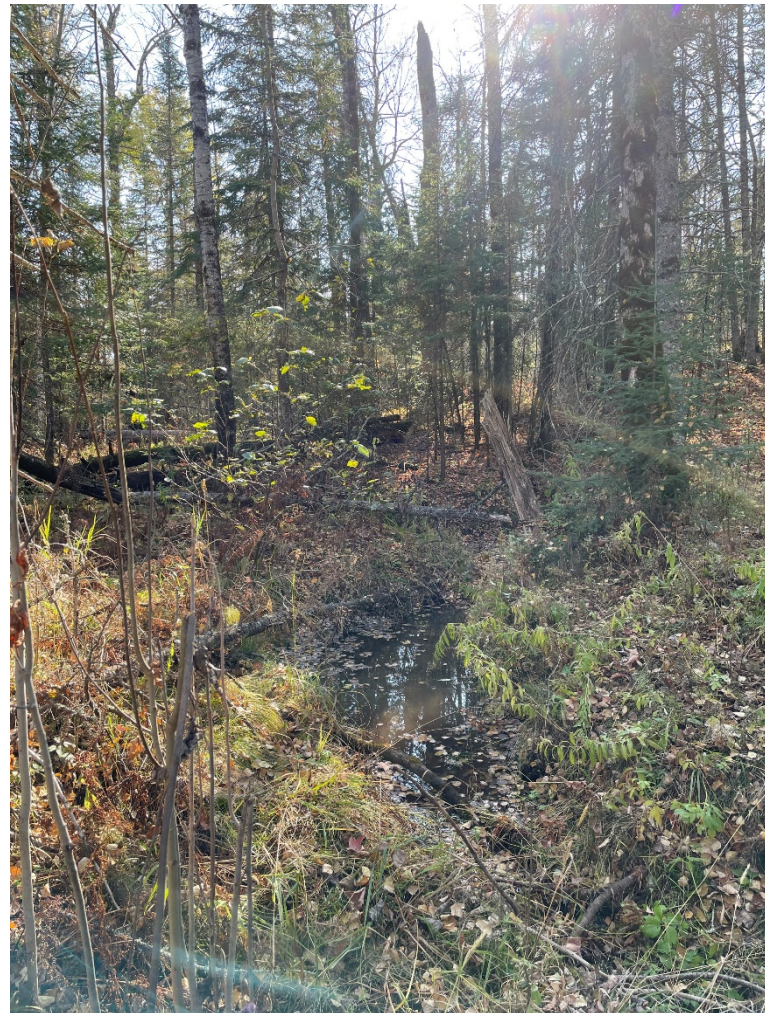
Photo 4. Near the end of the segment 3 fish survey looking downstream. Spring activity was noted in this area.

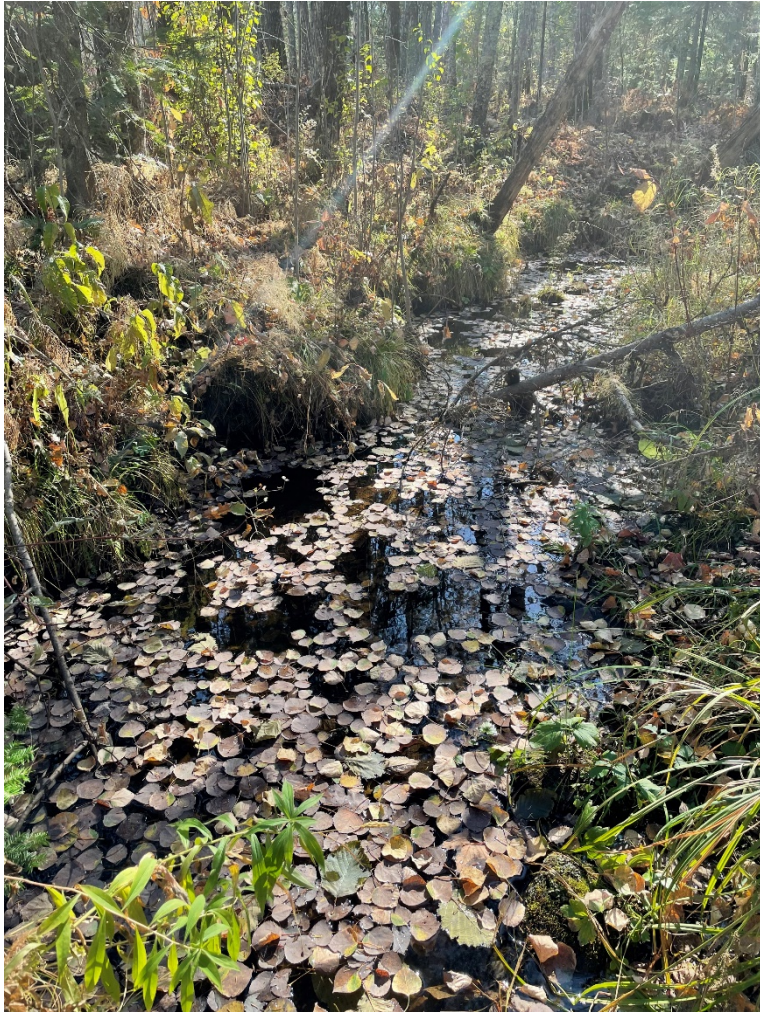
Photo 5. Start of segment 3 fish survey looking upstream.

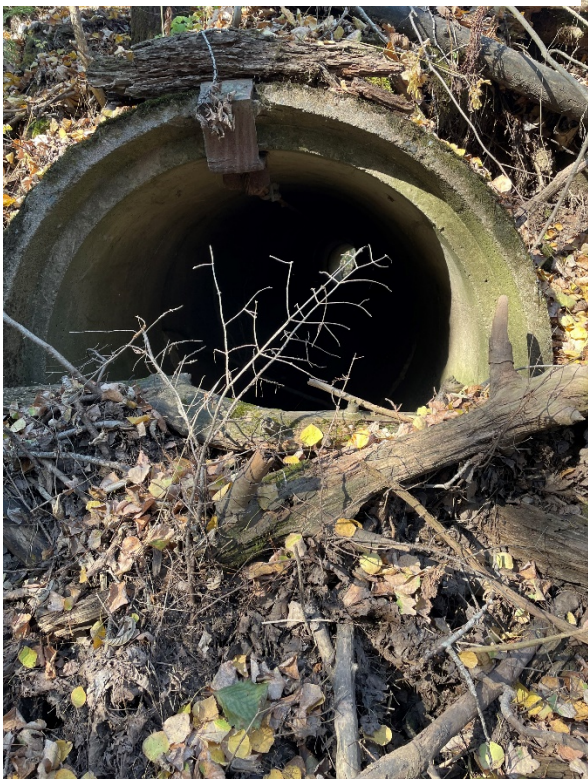
- A perched concrete culvert on Neuman Road was observed. This culvert was in very poor condition and held together with a couple rusty clamps and cables (Photos 6-8). It was cracked and twisted with water flowing outside the culvert through the cracks with none of the flow reaching the end of the pipe. It is a complete barrier to fish movement upstream.

Photo 6. (Left) Upstream end of Neuman Road culvert. Large debris barrier was present.

- While more fish species were not observed in Stream A upstream of Neuman Road, the stream could support a more diverse fish community if the culvert on Neuman road was not a barrier to fish moving upstream. The capture of other fish species downstream of Neuman road demonstrates that other species are present in the system and do survive in the stream. In its current state it supports a limited forage fish community, but if the culvert were appropriately replaced with one that allows fish passage, it would be expected to support a more well-balanced community upstream to a point where there is continuous water in the stream channel (segments 2 and 3). Further monitoring would be needed to determine the thermal regime given the presence of groundwater inputs in these segments.

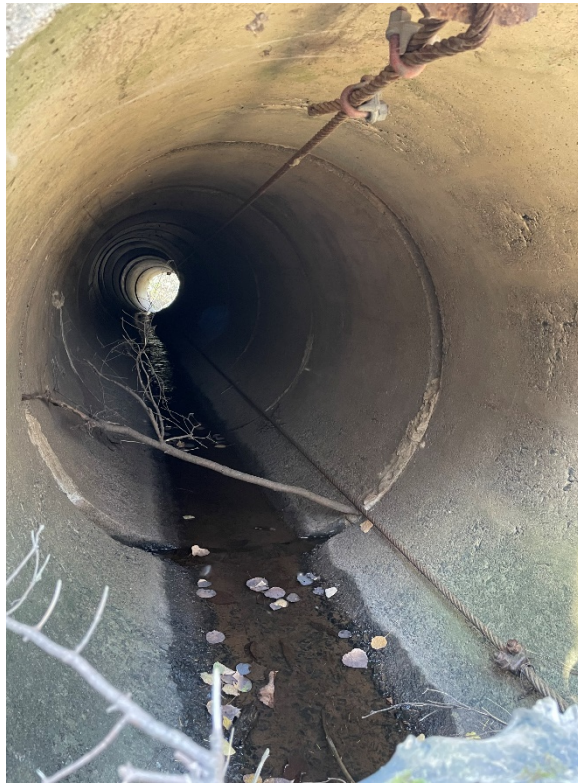
Photo 7. (Center) Inside of Neuman Road culvert viewed from the upstream end. There is a rise and bend in the culvert.

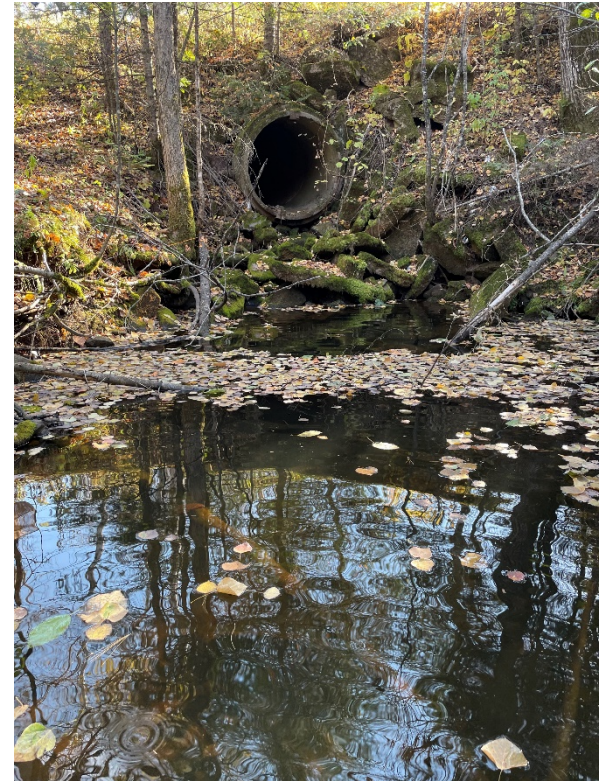
Photo 8. (Right) Downstream end of Neuman Road culvert. Rock pile at the mouth of the culvert is about 1m high.
