VOYAGEUR LAKE SUMMARY AND CONCLUSIONS

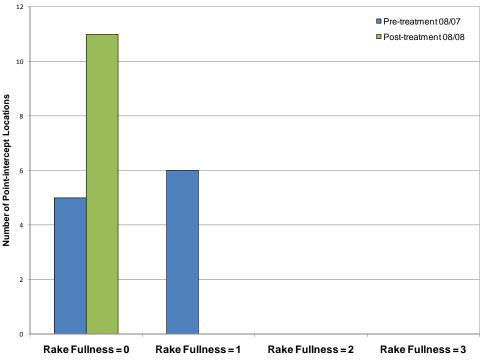
Figure 12. EWM rake fullness distribution within treated areas on Voyageur Lake.

The treatment on Voyageur Lake was very successful. No EWM was found at three of the four sites after the treatment (Maps 3 & 13). Figure 12 shows that of the six locations that contained EWM before the treatment, none of the rake tows had EWM after the treatment (Figure 12). Based upon the qualitative method of evaluating success, the 2008 treatments were shown to be effective on Voyageur Lake (Table 4). Quantitative methods of evaluating success are not applicable due to insufficient sample sizes in the small treatment areas (Table 4). One site remains for treatment in 2009, but has decreased in size (Voy-A-09, Map 13).
