End of Project Summary

Poskin Lake Phase 2 - Watershed Evaluation, Paleocore, Plant Survey, and Shoreland Inventory

Barron County, Wisconsin

Grant No. LPL-1271-09 SEH No. POSKI 106161

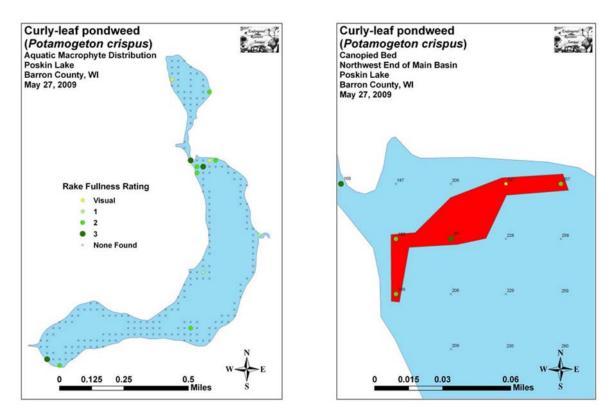
Figure 1 – May CLP Density and Bed Map

(*Potamogeton crispus*) density and bed mapping survey was completed. On July 13 a warm water point-intercept survey of all aquatic macrophytes was completed. The early season survey found CLP at 11 points throughout the lake (Figure 1). Of these locations, nine points rated a 2 or a 3 indicating that just over 2% of the lake's surface had a sizable infestation.

In the spring of 2010, local landowners complained about a significant bed of CLP in the southwest corner of the lake. This bed has been mapped and will be considered in the aquatic plant management plan.

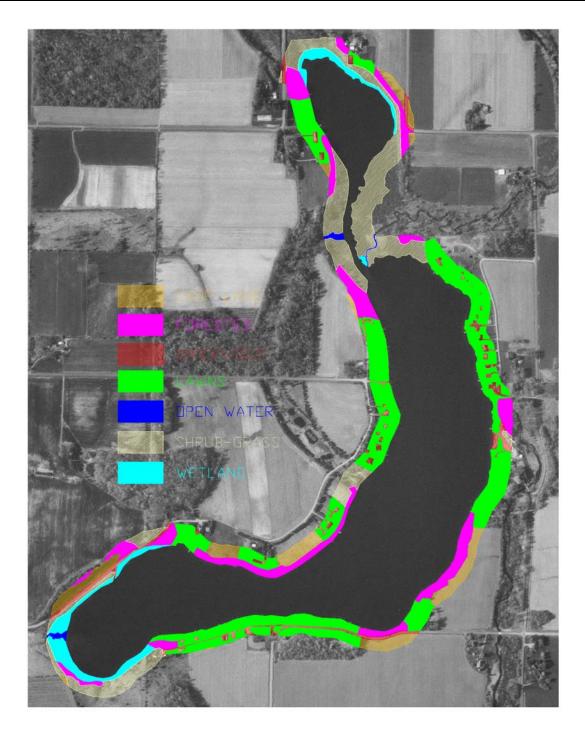
Figure 2 – Aerial Photo Land Cover Assessment

A shoreline inventory using high resolution aerial photography and ArcMap operations was completed in 2009. Shore land cover was assessed within a band 200-ft wide all the way around Poskin and Little Poskin Lakes. A total of 102 acres were mapped for the following types of disturbed land cover: cropland, lawn, and impervious surfaces; and the following types of undisturbed land cover: forests, shrub/grass, wetlands, and open water. Table 3 shows the results of this aerial mapping. Figure 2 shows the results of the aerial shoreland cover assessment.

Land Cover	Total Acreage		
Natural			
Forest	16.2 (16%)		
Shrub/grass	7.5 (7%)		
Wetland	23.7 (23%)		
Open water	0.7 (1%)		
Disturbed			
Cropland	10.2 (10%)		
Lawn	36.2 (35%)		
Impervious surface	7.5 (7%)

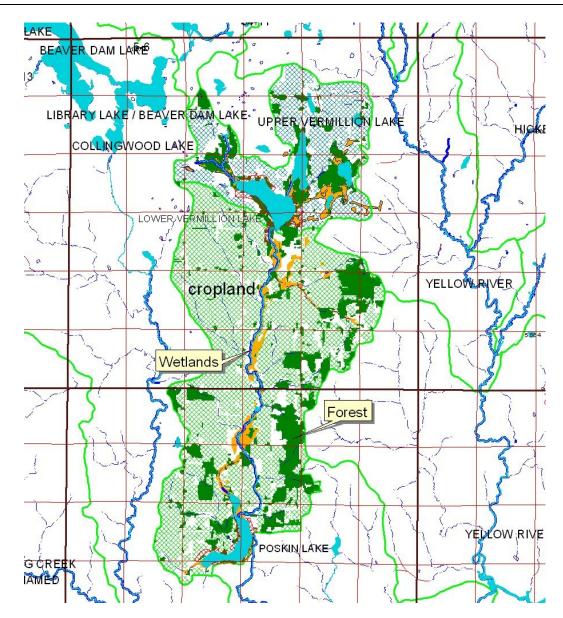
Figure 3 – Poskin Lake and Vermillion River Watersheds (Barron County SWCD, 2010)

The Barron County Soil and Water Conservation Department was partnered with to provide an assessment of the entire Poskin Lake and Vermillion River Watershed. Land use within the watershed, including significant farming operations was evaluated. The entire watershed is approximately 12,817 acres or approximately 20 square miles in size. The immediate watershed around Poskin Lake accounts for 9,735 acres or about 76% of the overall watershed. The Vermillion River watershed, beginning at the outlet of Lower Vermillion Lake accounts for the remaining 24% (Figure 3). Table 5 summarizes land use in the watershed.

Land Use	Poskin Lake Watershed (acres)	Vermillion River Watershed (acres)
Cropland	6192	1745
Residential	68	15
Wetland	585	380
Lake/River surface area	166	34
Forest	1867	590
Pasture, roads, brush, farmsteads	893	282
TOTAL	9771	3046
Source: Barron County SWCD, 2010

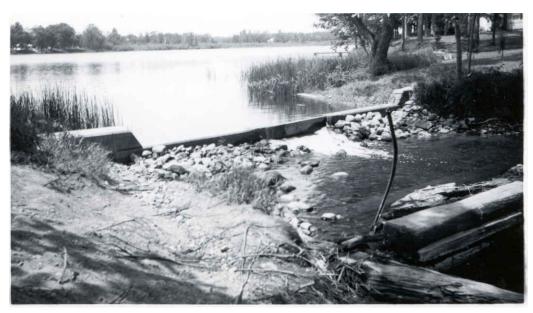
Figure 4 – Vermillion River Dam on Poskin Lake

As with many lakes, there is a great deal of discussion about the fluctuating water levels in Poskin Lake. Because the Vermillion River passes through the lake, it is subject to frequent and often significant water level fluctuations. There is a low dam (3-ft high with a 2-ft hydraulic height) at the outlet of the Vermillion River on the east shore of the lake (Figure 4). It is considered a small dam with a low hazard potential. It is currently listed as being owned by the Barron County Property Committee, and according to the WDNR, it was last inspected in 1969 (Appendix C).

It is not known when this photo was taken, but the dam does not look like this anymore. A steel structure was placed on top of the 12-ft wide concrete structure to allow a gate to be opened and closed to either hold back or release water (Figure 5). The gate structure is currently left open so that the lake level is maintained at the level of the concrete structure. The issue most discussed is the fact that the steel structure reduces the linear feet that the lake water can flow over by half, thus reducing the amount of water that can flow through and out after a large rainfall event.
