# Cloverleaf Lakes Shoreland Restoration Demonstration Project

WDNR Lake Planning Grants: LPL-1246-09 & LPL-1247-09

## Cloverleaf Lakes Protective Association

January 2011

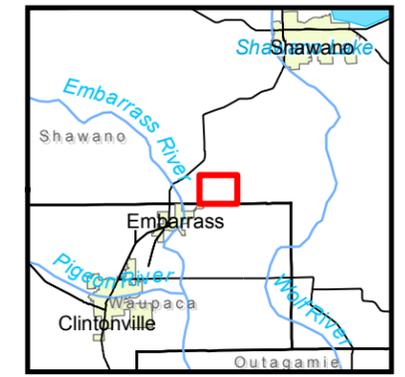
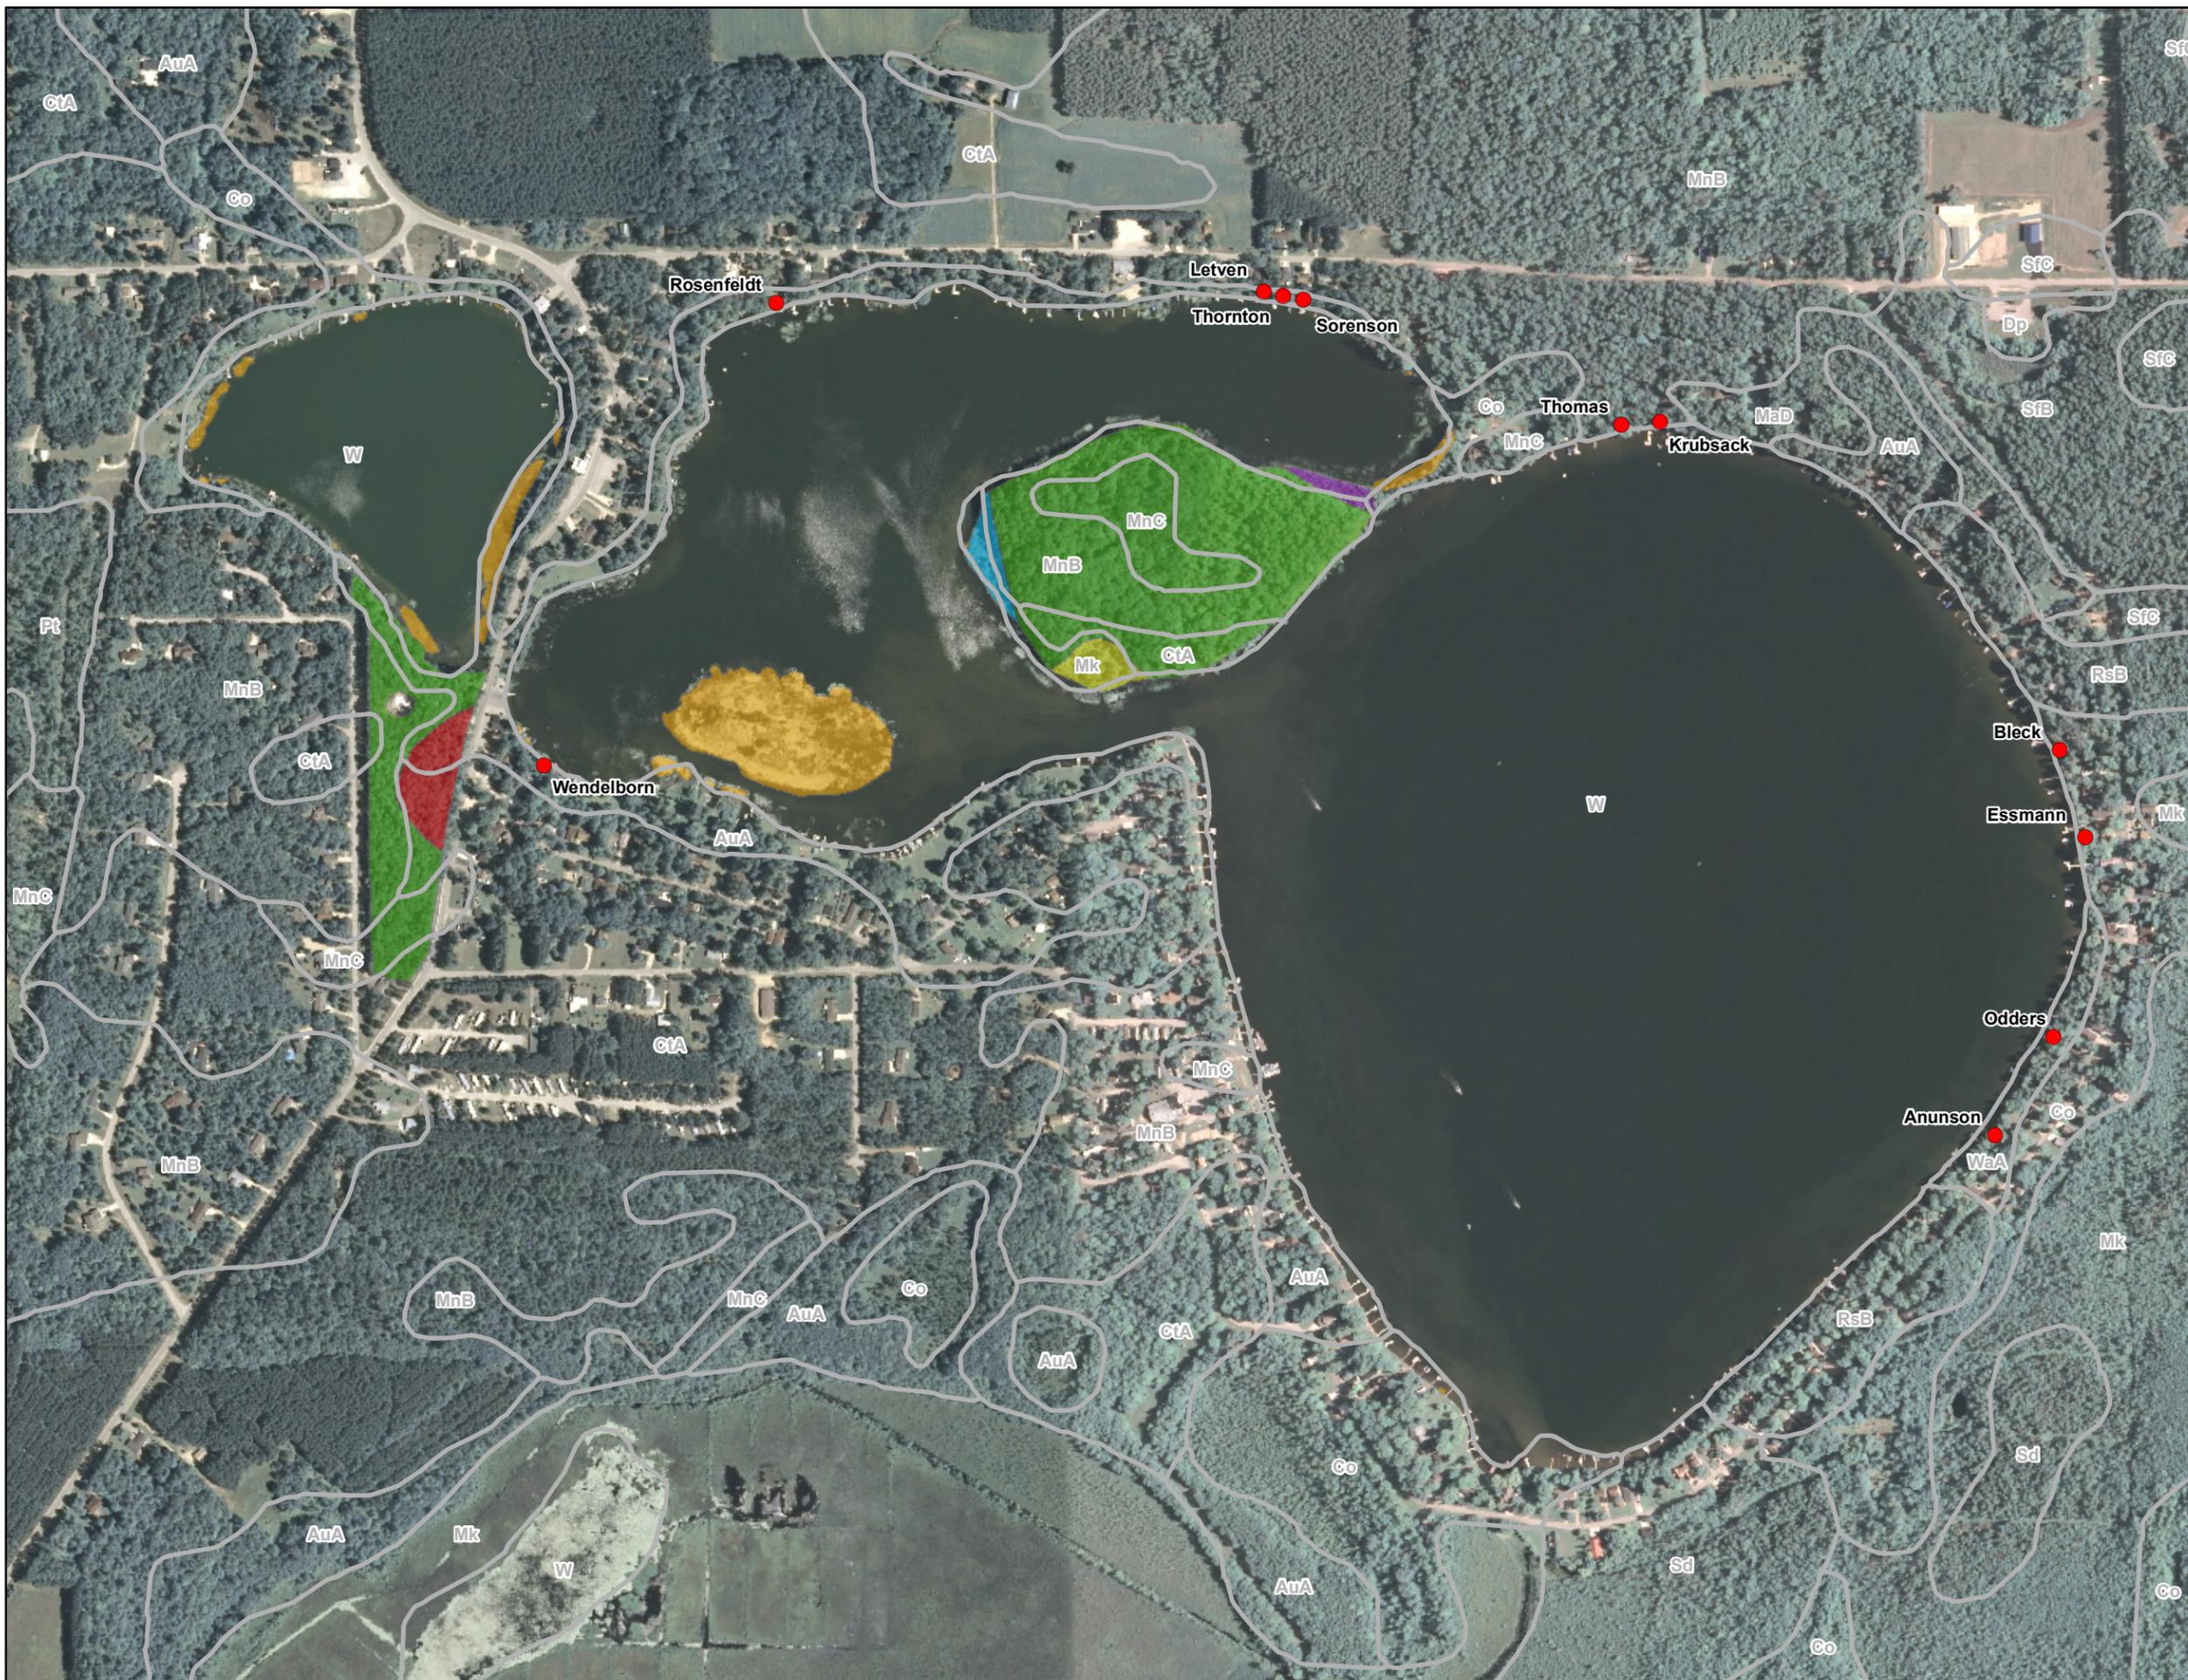
**Figure 1**  
**Restoration Areas, Soils and**  
**Native Vegetation**  
**Cloverleaf Lakes**  
**Protection Association**  
**Project No. 14747002**  
**Town of Belle Plaine,**  
**Shawano County, Wisconsin**

According to the main vegetation species identified within a portion of the two intact and relatively undisturbed forested communities (Gibson Island and the southern portion of Round Lake)(Figure 1), found around the lakes, the dominant terrestrial community type is Northern Dry-Mesic Forest (Curtis 1959). Site conditions within this community generally include well drained, loam-sand soils with filtered sun (< 4 hours). Natural openings within the forest canopy or edges could receive additional sunlight. Although much of the understory has been removed from shorelines around the lakes, the dominant tree species that remain indicate that most of Cloverleaf Lake's terrestrial shoreline was historically a Northern Dry-Mesic Forest.

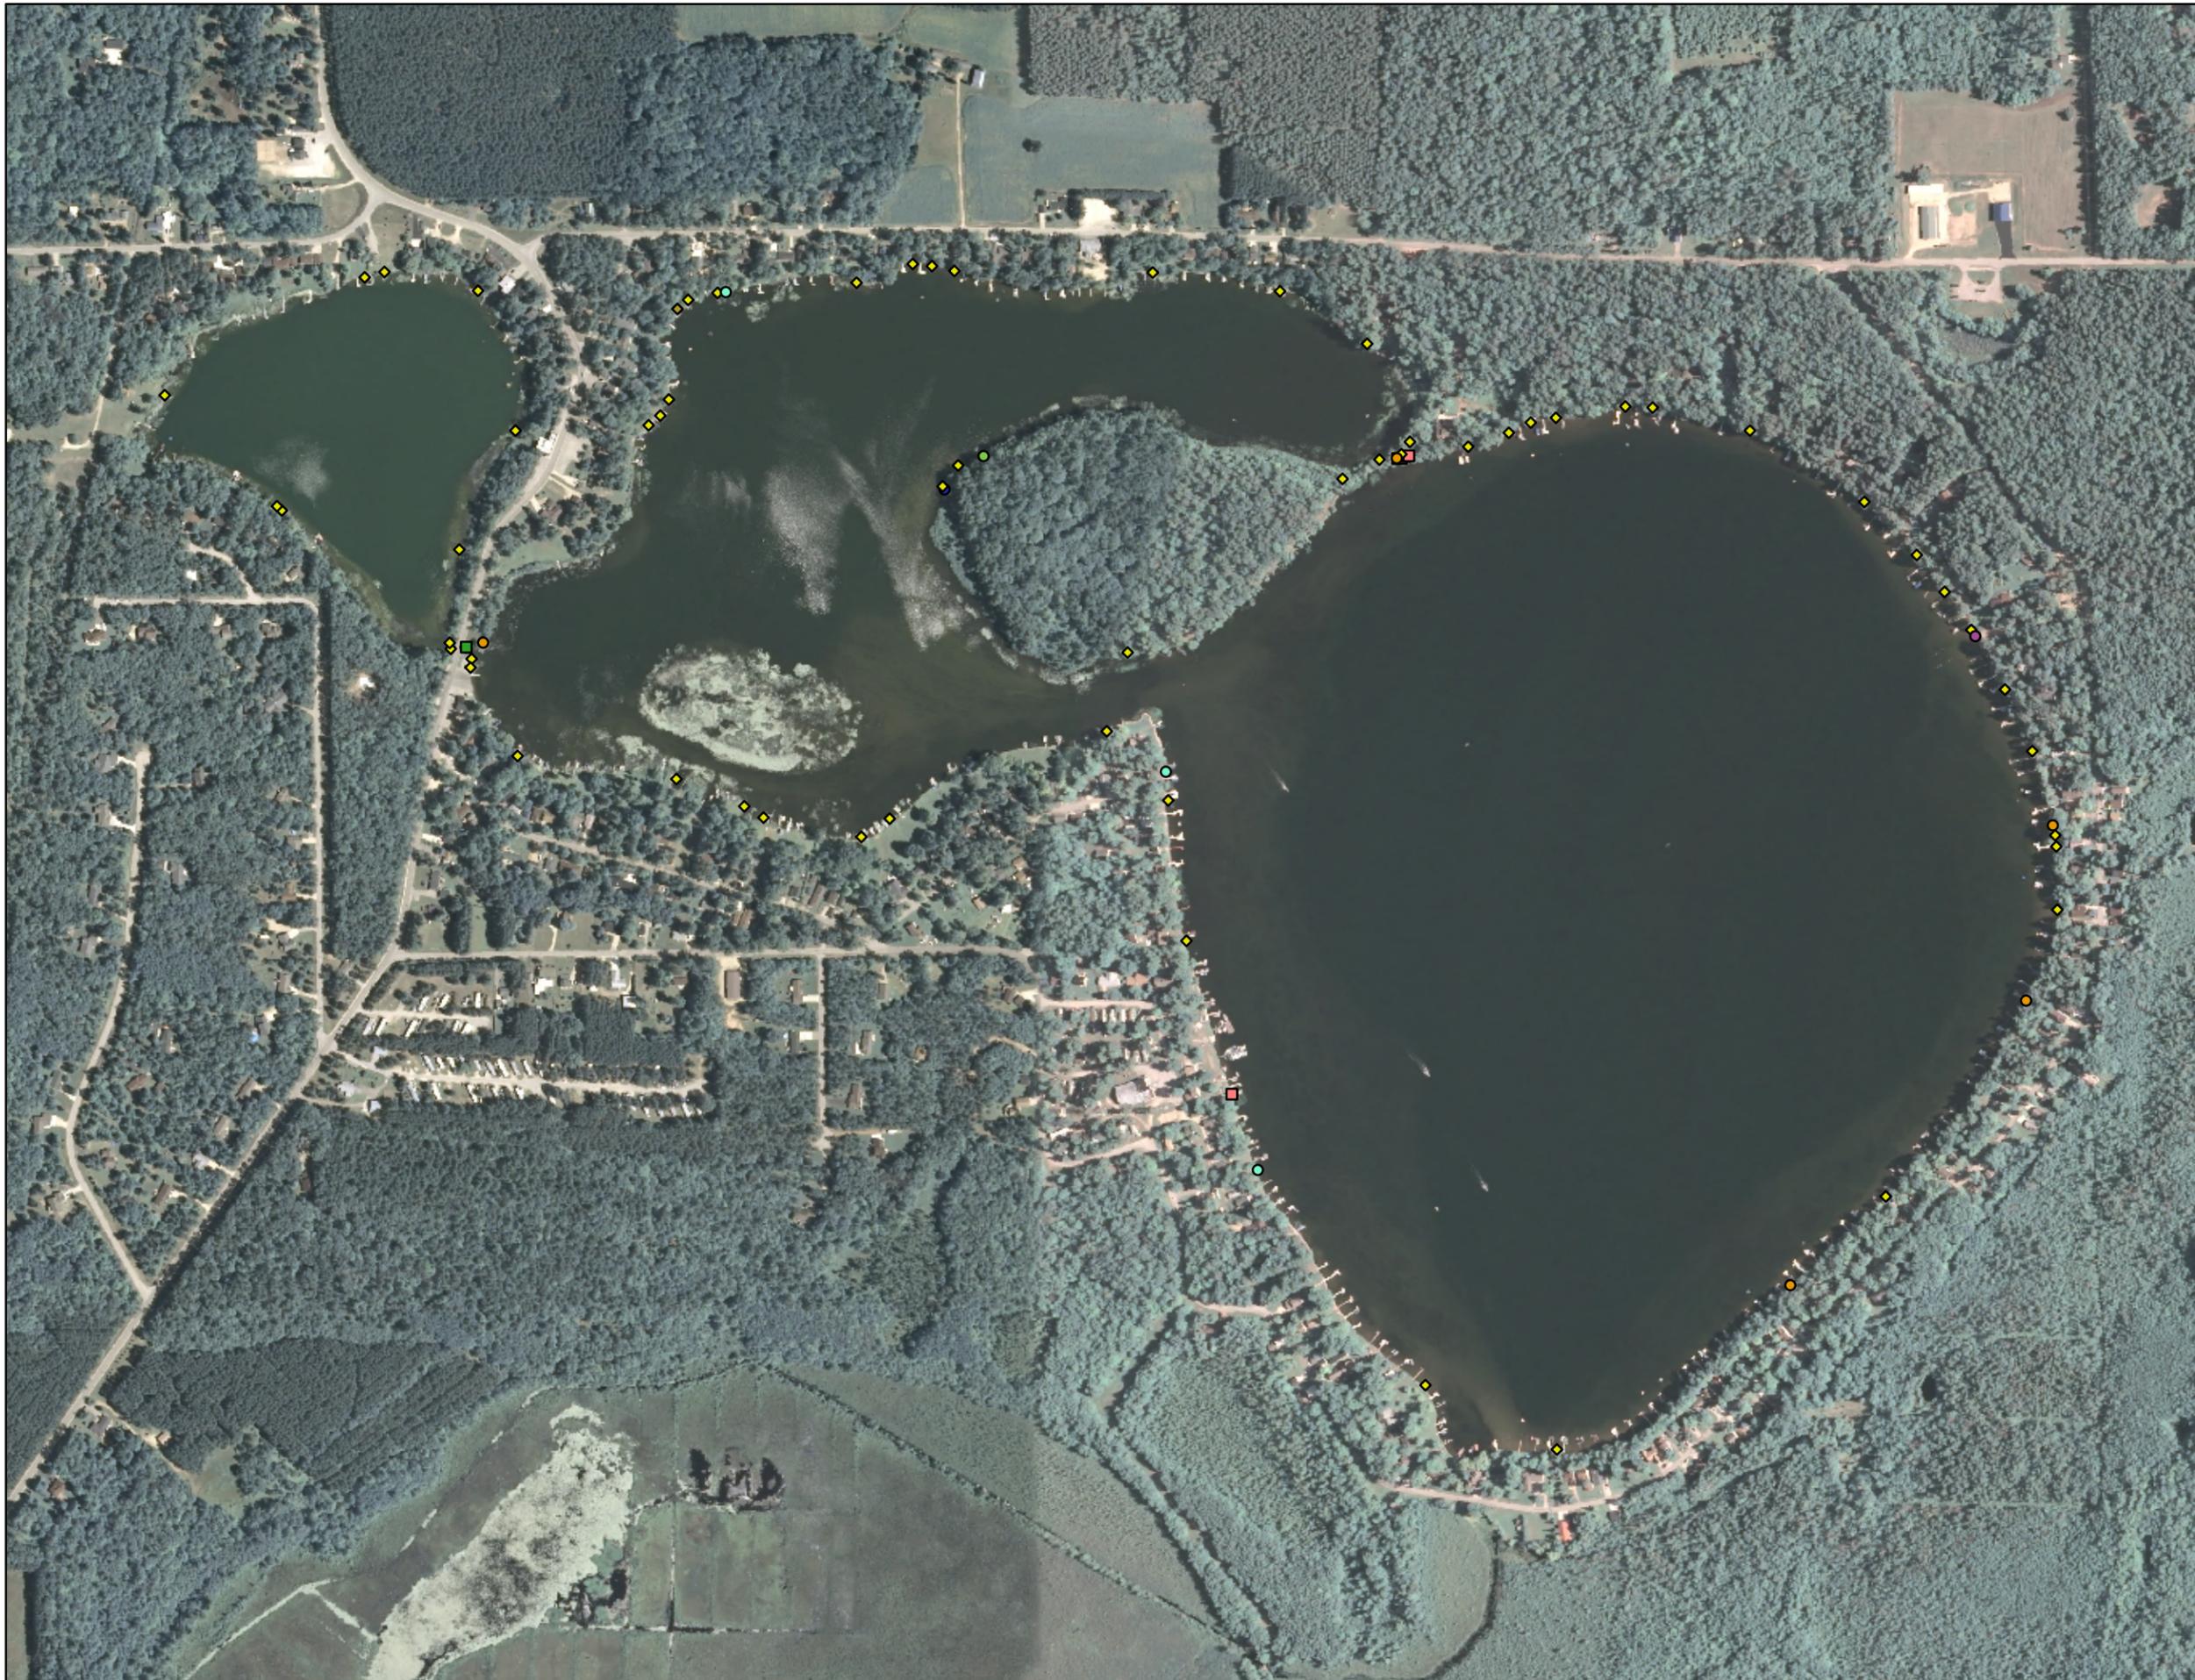
**Figure 2  
Invasive Species Locations**

NES conducted a plant survey on the three lakes to determine dominant species found within terrestrial and aquatic (wetland/emergent) zones. A list of the plant species recorded along with their dominance, exotic/invasive status and community association can be found in Appendix A. Invasive species of greatest concern were located with a GPS and are identified on Figure 2. As can be seen from the map, reed canary grass (*Phalaris arundinacea*), is the most common invasive species found around the lakes.

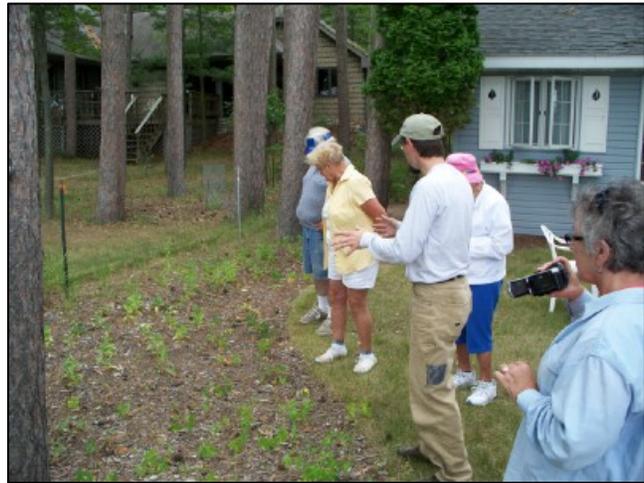
Photo 2

Mr. Bleck is by profession an architect so he designed the landscape plan found in Appendix B. Two rain gardens were designed to intersect on-site runoff and let it infiltrate before it reaches the lake. An upper rain garden is located where runoff from the adjacent property and runoff from the roof of a cottage on-site collects. This rain garden is separated from the lower swale and rain garden by a low berm. The lower swale and rain garden collects water from the main cottage on-site. In the summer of 2008, Dan and his family constructed the rain gardens (Photo 2) and installed the native plants, which were scattered planted within each zone.

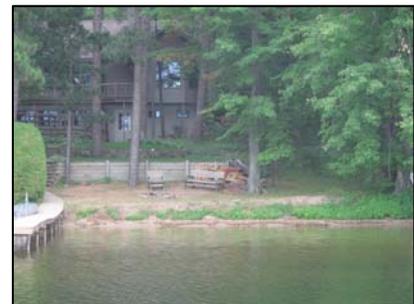
Photo 3

NES ecologists met with Joy and Dennis Krubsack to assess existing site conditions on their Pine Lake property (Figure 1). During this site visit we noted the presence of a small ice ridge that had exposed soil along the shoreline (Photo 3). Except for the lack of vegetation, the shoreline appeared to be in good shape because the sand ridge was left natural; however, the exposed soils were prone to erosion. We suggested installing native plants along the shoreline to help stabilize the area. Both Dennis and Joy agreed, but they had concerns about continued use of the area for recreation and how plant height would impact their view. After much

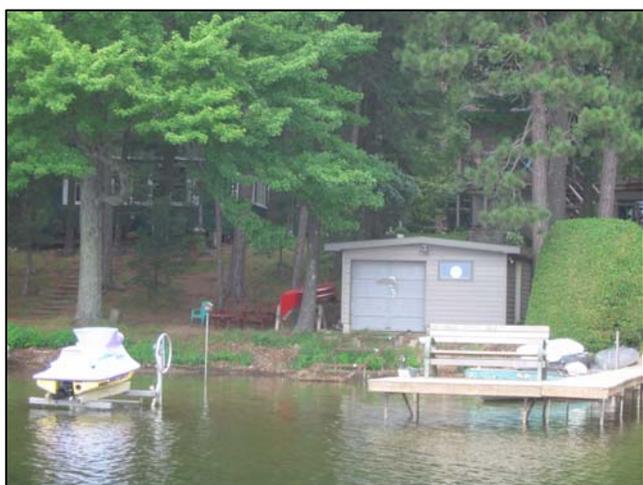
Photo 4

discussion, they decided to confine restoration activities to an area in front of the boathouse (Photo 4) and the east side of their lot (right side of Photo 4). To ensure they had walking access to the lake they decided to incorporate a walking path between areas within their eastern planting zone. Based on their final decision, NES collected the above site condition data for the two areas and drew a preliminary sketch of the restoration site. Using the above conditions and taking into consideration the Krubsack’s concerns regarding plant height, NES generated a suitable plant list and added them to the sketch (Appendix B). Upland shoreline plants chosen for the site do not generally exceed three feet in height, while those selected for the wet meadow zone grow 2-5’ in height. This particular zone is lower in elevation than the upland zone; therefore, species that grow a little taller could be utilized.

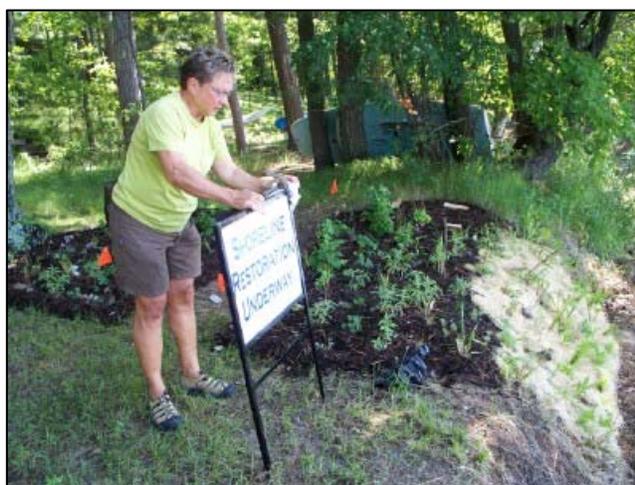
Photo 5

In the summer of 2008, Joy and Dennis installed the native plants, which were scattered planted within each zone and mulch added (Photo 5). The combination of upland and wetland planting allowed the Krubsack’s to increase floral diversity and stabilize their shoreline.

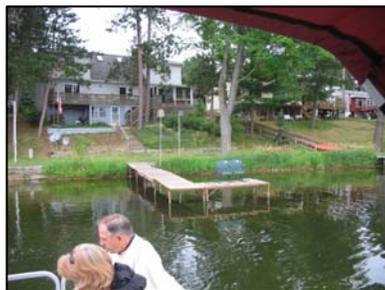
Photo 6

site conditions on the lowest terrace, which was being maintained as lawn (Photo 6). During this site visit we did not notice erosion issues either on the steep slope or along the shoreline; however, we did note the presence of reed canary grass growing within the rock located along the water’s edge (Photo 6). The Thornton’s wanted a more natural looking shoreline so they were allowing the vegetation to grow not knowing it was a very aggressive, non-native species. Although Dennis was focused on restoring the lower terrace, he was open to suggestions regarding the shoreline area; therefore, NES collected site condition data within the terrace area and along the shoreline. For this particular site neither NES nor the Thornton’s created a

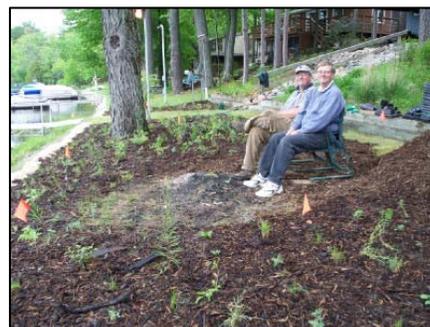
Photo 7

base map. Dennis marked the desired planting areas with flags and we measured them so the number of plants required could be calculated. Since height was not a concern for the planting area, NES chose the below species to add floral diversity, texture, color and wildlife value. The plants were scattered throughout the zone to provide a more natural appearance. Except for a small area for the fire pit and two narrow paths to the pit and pier, the entire terrace was planted. In the summer of 2008 restoration activities were completed by the Thornton’s. Dennis applied herbicide to the grass and then convinced his brother, who was visiting from Oregon, to help him install the plants and add shredded hardwood bark mulch (Photo 7).

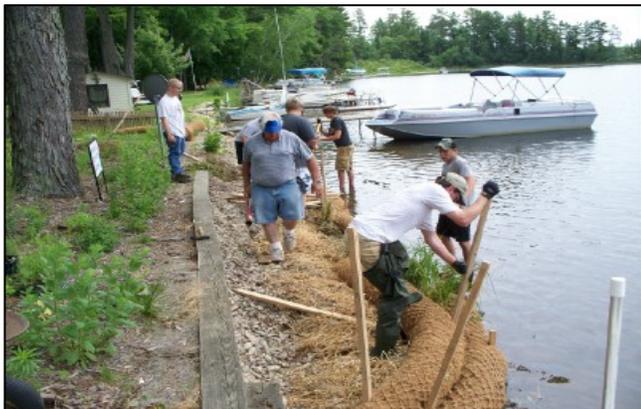
Photo 8

water's edge (Photo 8). The Thornton's location on Grass Lake limits wave energy; therefore, 2" wooden stakes were used to secure the materials. Once secured, the biologs were backfilled with topsoil, creating a terraced slope from the waterline to the top of the existing shoreline (Photo 7). The biologs and slope were then planted with a mixture of sedges, grasses and wildflowers suited for each of the growing conditions present, see above table. A list of species for each zone can be found below.

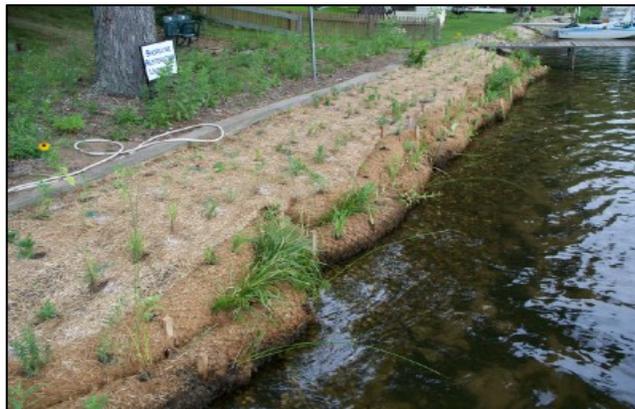
Photo 9

Although Dennis conducted the site preparation work, much of the installation work was performed by students and neighbors that participated in the "Shoreland Restoration Day" (Photos 8 and 9). The educational hands-on event was held by the Cloverleaf Lakes Association to give landowners and individuals an opportunity to see and participate in shoreline restoration techniques including site preparation, material installation and planting. On the Thornton project, participants learned proper biolog installation, use of *erosion control blankets* and the installation of live plants. In addition to planting plugs, a *cover crop* of oats was hand seeded prior to staking the erosion blanket into place.

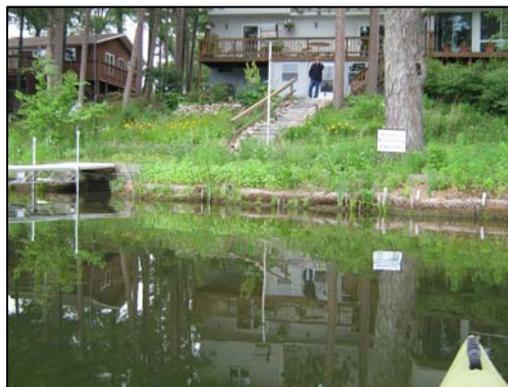
Photo 10

Aside from occasional weed pulling, the Thornton's report very little maintenance is required to keep up the planting. They have also noticed an increase in birds, bees and butterflies and enjoy the aesthetic beauty of the wildflowers and grasses. Negative aspects of the planting that were incurred include the expense of implementing the restoration (cost of materials and plants) and the loss of time spent waiting for the plants to mature. This project is a good example of how a landowner can use natural building materials to reshape their shoreline to match in with existing bulkheads or retaining walls, and also demonstrates how using both upland and shoreline areas can increase floral diversity and aesthetic value (Photo 10).

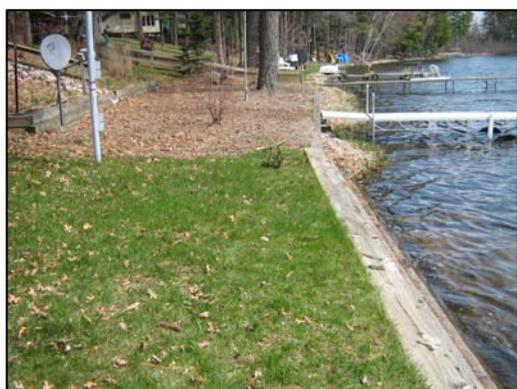
**Photo 12**

The Letvens were also interested in improving their shoreline. A review of the area indicated the presence of maintained lawn up to a timber retaining wall (Photo 12). Except for a lack of native vegetation, the shoreline appeared to be in good shape because the timbers were preventing shoreline erosion. We suggested replacing the timber wall with a series of biologs similar to the Thornton property to provide a more natural buffer between the water’s edge and the shoreline. Our staff also recommended installing native plants in the lawn area behind the wall to improve aesthetics, plant diversity, and wildlife habitat. Both Marv and Esther agreed that they did not want to tackle the removal of the retaining wall at this time, but they liked the idea of replacing some of the lawn. They had concerns about

continued use of their shoreline for recreation; therefore, they decided to confine restoration activities to an area directly adjacent to the Thornton restoration (top portion of Photo 12). Based on their final decision, NES collected the above site condition data for the area and created a design of the restoration site. Using the above conditions and taking into consideration the Letven’s desire to have a landscaped feel to the planting, NES generated a suitable plant list and arranged them on the design (Appendix B).

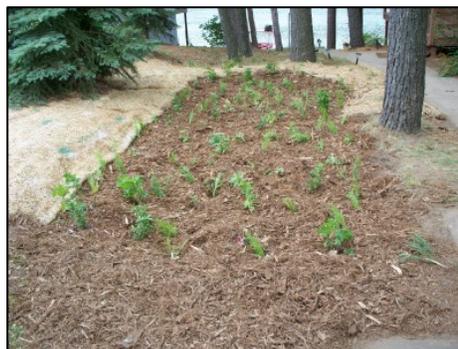
Photo 13

Site preparation of the lawn included a herbicide application, which was conducted by the Letven’s neighbor, Dennis Thornton. Although Dennis conducted the site preparation work, much of the installation work was performed by NES, students and neighbors that participated in the “Shoreland Restoration Day”. The educational hands-on event was held by the Cloverleaf Lakes Association to give landowners and individuals an opportunity to see and participate in shoreline restoration techniques including site preparation, material installation and planting. On the Letven project, participants learned how to construct a rain garden, use of erosion control blankets, and the installation of live plants (Photo 13).

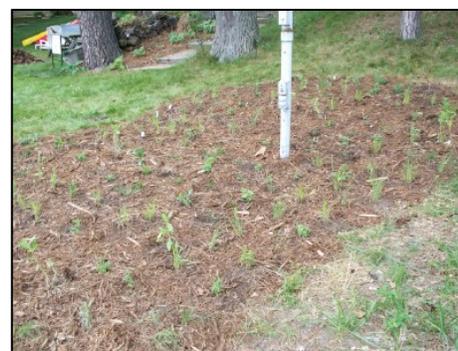
Photo 14

This project, along with Thornton’s was a great example of how well supervised volunteers can greatly decrease the time and workload needed to complete a project. Stand-alone gardens (Photo 14), like the upland garden planted at Letven’s, are a great way to add diversity to a property even when shoreline restoration or stormwater control is not necessary.

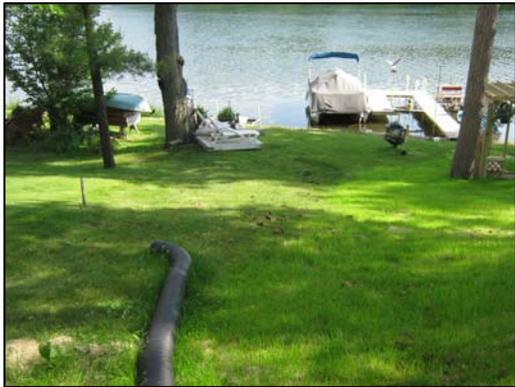
**Photo 15**

rain garden to capture surface water run-off currently discharging from a pipe that was connected to one of the house’s downspouts (Photo 15). They liked the idea of controlling the run-off and installing another plant bed on their property. Based on their final decision, NES collected the above site condition data for the area where the rain garden was to be constructed. In addition to this information, NES calculated the roof dimension so we knew the approximate amount of surface water that would discharge to the rain garden. Due to the desired location of the pipe’s outfall, the garden would need to be constructed on a steep slope, which can create erosion problems if it is not properly designed. For this reason, elevations were surveyed on the slope leading down to the lake. Our engineers then utilized stormwater modeling to

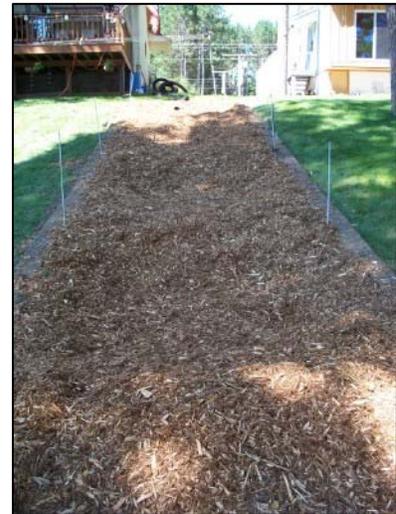
**Photo 16**

In the summer of 2010, the Sorenson’s used the plans and constructed the terraced rain gardens. Although Photograph 16 does not show the installed plants, the Sorenson’s planted the native species recommended for the site. Extra plants from the terrace project were used to create a small rain garden below their sidewalk. Aside from minor movement of the mulch after a heavy rain, the landowners are very pleased with their terraced rain gardens. This project is a great example of how stormwater runoff can be collected and treated even on steep slopes before it reaches a waterbody.

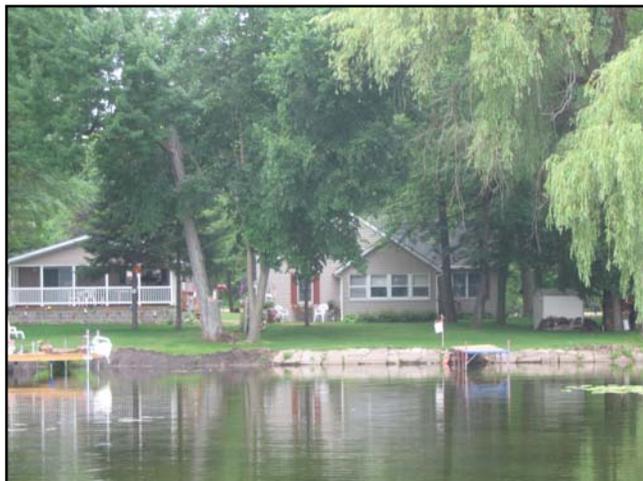
Photo 17

Donald and Laverne Wendelborn were interested in increasing the aesthetic quality of their shoreline and attracting butterflies and other insects and wildlife to their property. The area available to restore was constrained by an access easement, therefore they were limited in the size and scope of design options. The initial site assessment conducted by NES ecologists found that the site was maintained as lawn up to a rip-rap border that continued into the lake (Photo 17). Soils were very poorly drained, loam-silt loam and contained gravel backfill from the rip-rap.

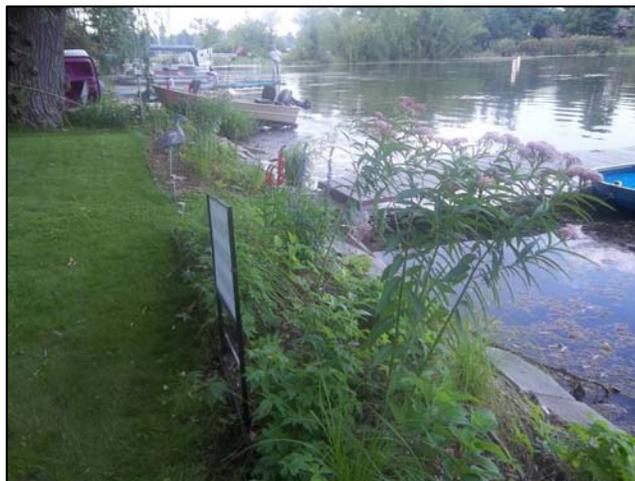
Photo 18

Above normal precipitation and lake level in 2010 greatly increased the growth of the plants and allowed them to increase their coverage of the shoreline buffer (Photo 18). The southern section is approximately 75% covered by planted species, while the northern section is lagging behind with approximately 50% coverage. In addition, several plants were buried in the northern section by woodchips from the pruning of a neighboring tree. The buried plants were replaced by new stock. Additional stock will be planted in 2011 if coverage does not increase in the buffer. A side benefit to the increased plant density and height was the increased reluctance of Canadian geese to use the shoreline, which had become a problem in recent years. They have also noticed an increase in hummingbird activity along the lakeshore and have identified monarch butterfly caterpillars feeding on the vegetation.

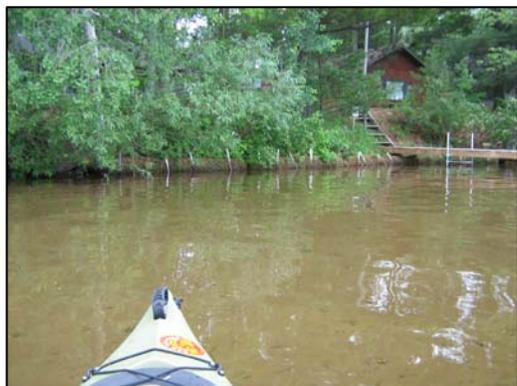
Photo 20

Anunson’s was the second of three properties along the east shore of Pine Lake to be restored due to wave induced erosion. It is the smallest of the three properties restored and contained the most natural shoreline, which had led to a very successful restoration (Photo 20).

then installed the biologs, topsoil, erosion blanket and live plants according to the proposed design. Due to the concern of potential impacts by large waves and ice, the biologs were secured with duckbill anchors and 2” wooden stakes. The biologs create a reinforced shoreline capable of withstanding the constant waves produced by the wind and watercraft on Pine Lake. The added protection will allow both the planted and existing vegetation to become established to help stabilize the soils.

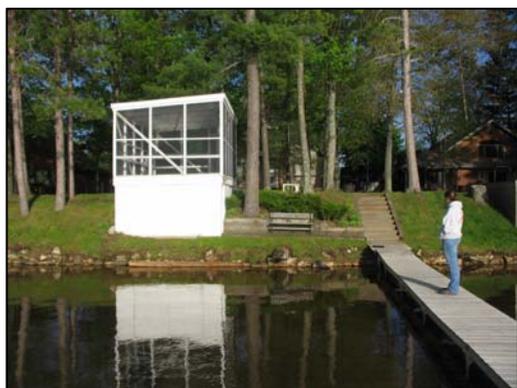
Photo 21

We then reviewed the north side of the boathouse and discovered a gully that had formed due to a concentration of water that was running off the pitched boathouse roof (Photo 21). Our suggestion was to first install a gutter and downspout on the north side of the roof so water could be directed to an upslope area. Water run-off could then be captured and infiltrated within a rain garden prior to reaching the steep slope, thus eliminating erosion potential. Following our site visit, the Odders' had a gutter and downspout installed, which discharges to a level area on the northeast side of the boathouse. Although any size garden could have been constructed, the goal was to reduce surface water run-off that was causing soil erosion along the building's foundation; therefore, NES calculated the roof dimension so we knew the amount of surface water that would discharge to the rain garden. Based on the roof surface area on the soil(s) present we determined that a 50 ft<sup>2</sup> rain garden approximately five inches in depth with 2-3" berms was needed to adequately capture and infiltrate the roof run-off (Appendix B). During the site visit the above data were also collected so a native plant list could be generated for the rain garden.

In addition to recommending the biolog installation at the water's edge, our staff also suggested installing native plants on the steep slope behind the biologs to improve slope stability, aesthetics, plant diversity, and wildlife habitat. A review of the area indicated the presence of maintained lawn up to the water's edge (Photo 21). Both Dick and Mary Lee liked the idea of replacing the lawn on the steep slope because mowing that section of lawn was a safety hazard; however, they had concerns about continued use of their boathouse. Traffic into and out of the building was infrequent; therefore, we suggested the installation of ScourStop, a durable plastic product, in front of the boathouse. The material provides extra stability while still allowing vegetation to grow through. Based on their final decision, NES collected the above site condition data for the area and created a design of the restoration site. Using the above conditions and taking into consideration the Odders' desire to restrict plant height, especially in Zone 3 which is located in front of a bench (Photo 21), and attract birds, NES generated a suitable plant list for the various zones (Appendix B).

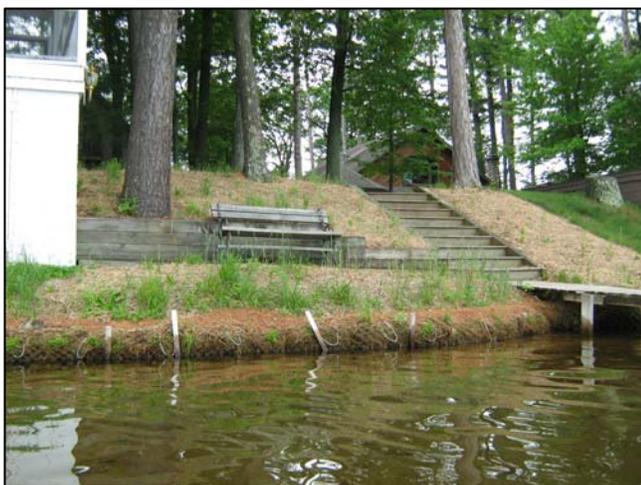
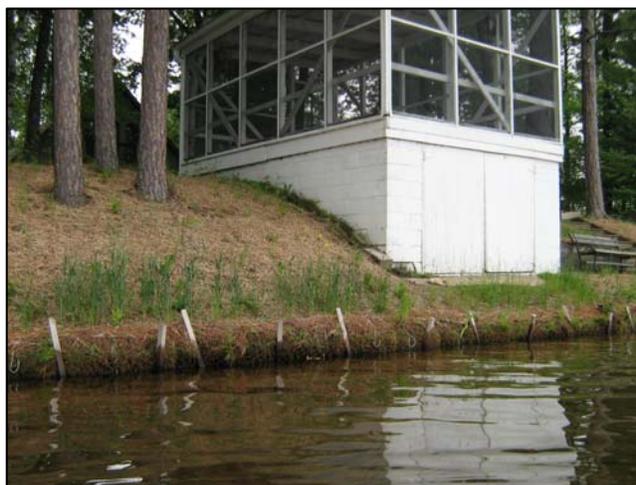
While weather could have played a role in some planting problems, the inexperience of the students led to a significant number of plants having to be replanted by the Odders'. Although not part of the "Shoreland Restoration Day", the students learned and participated in shoreline restoration techniques including site preparation, material installation and planting. Aside from issues with the planting, the project was successfully installed and is growing well after its first growing season (Photos 24 & 25).

High water levels (6"-10" above normal) in Pine Lake, however, caused some issues along the shoreline. Wave action created a situation where water was routinely breaking over the biologs and caused some soil settling and erosion. Although the plants were present, they did not have enough time to become fully established to dissipate the wave energy and fully stabilize the bank. Due to these circumstances, NES installed EnviroLok™ bags in the fall of 2010 along the back side of the biologs. EnviroLok bags are filled with topsoil and can be planted with vegetation. Installation of the bags stopped the erosion and NES will return in the spring of 2011 to plant the bags with native vegetation.

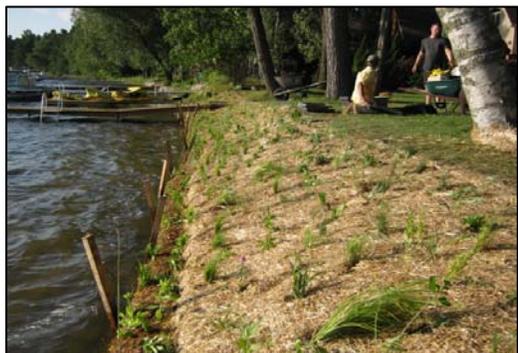
**Photo 28**

with topsoil to create a more gentle slope from the waterline to the top of an existing timber per the design details (Photo 28). Live plants were then installed on the slope and in the biolog. To ease plant installation into the biologs, the Essmann’s chose to pay a little more money and have the manufacturer pre-drill holes based on NES’ recommended plant spacing.

NES staff met with Howard and his daughter in July of 2010 and recommended an herbicide application to the vegetation present along the shoreline. Shortly after the meeting, Howard carefully sprayed the area. Prior to conducting any on-site activities, a bioengineering permit was secured from the WDNR by John. Once the permit was obtained in early August of 2010, our staff along with both John and Howard Essmann began by installing eight 10’ x 16” biologs that were secured into the lakebed and shoreline with both 2” wood stakes and duck-bill anchors due to the concern of potential impacts by large waves and ice (Photo 27). The existing ground was then contoured, erosion blanket installed to reduce surface erosion, and the biologs backfilled

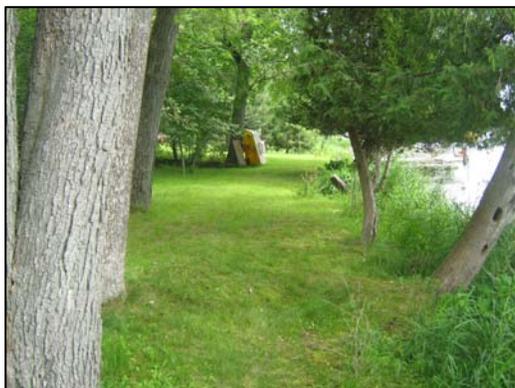
Photo 30

NES ecologists met with Dave and Sandy Rosenfeldt in the summer of 2009 to assess existing site conditions on their Grass Lake property (Figure 1). Except for the presence of an abundance of reed canary grass, the shoreline appeared to be in good shape (Photo 30). The Rosenfeldt’s were aware of the invasive grass and said they were already removing seed heads to prevent further spread. Our ecologists discussed additional removal/treatment options with them so they could eliminate the species if they chose to conduct the work.

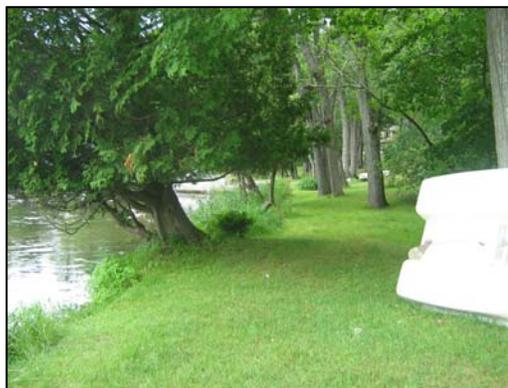
Photo 31

The remainder of the buffer was stable, but much of the area was being maintained as lawn (Photo 31). Our staff suggested installing native plants and controlling invasive species within several areas to improve the property's aesthetics, plant diversity, and wildlife habitat. The Rosenfeldts wanted to improve their property and were open to suggestions; therefore, NES collected the above site condition data for the chosen areas and designed a restoration plan for the property. Using the above conditions and native plants found on-site NES generated a suitable plant list and added the planting zones to the plan (Appendix B).

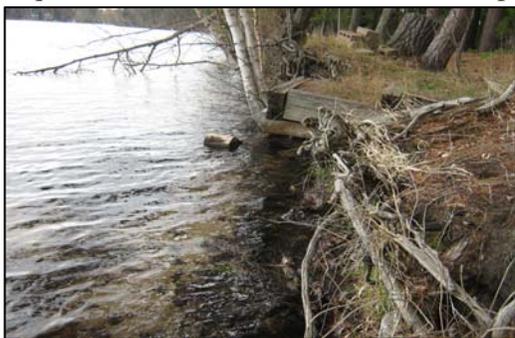
Photo 32

The property owned by brothers Mark and John Thomas has seen severe erosion due to wave action. Over the last 25 year, approximately 4-5 feet of shoreline has been lost. Site investigations found a natural forested shoreline that was helping stabilize the shoreline but was still being undercut due to frequent wave action (Photos 32 & 33). A topographic survey was completed to design a restoration plan; however, the owner's unwillingness to remove any trees and the inability to secure a permit from the WDNR to extend the shoreline into the water prevented the project from going forward; therefore, a full design and restoration plan was not completed. This site is an example of an area within the Cloverleaf Lakes chain that may have been eligible to use more than just biostabilization methods, but shoreline contouring and the loss of trees would have been required, which is sometimes difficult for property owners.
