IMPROVING WATERSHED WATER QUALITY:

EAGLE AND JOOS VALLEY CREEKS DEMONSTRATE THE EFFECTS OF BEST MANAGEMENT PRACTICES

BY JULIA RILEY

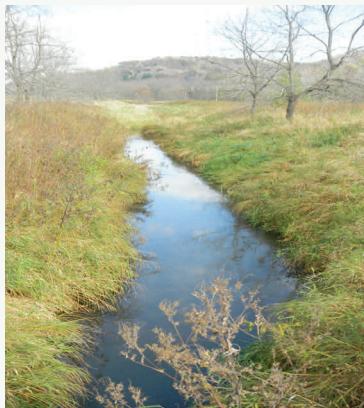
Joos Valley Creek after management practices.

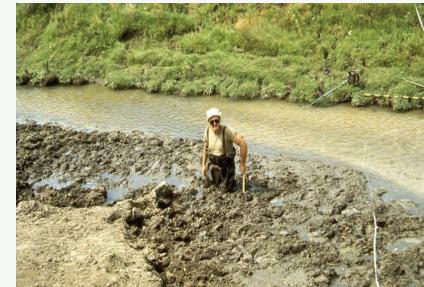
Mud Bank on Joos Valley Creek before management practices.

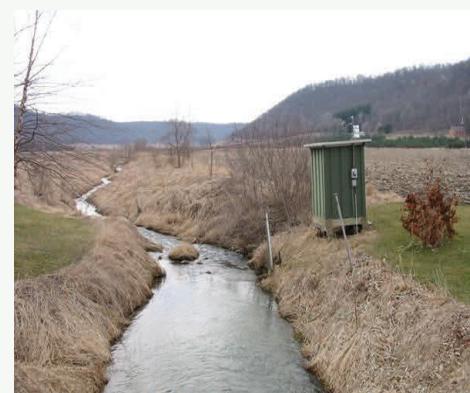
Joos Valley Creek sampling station,

Creeks in the Waumandee Creek Priority Watershed, Wisconsin, 1990-2007" is slated for final publication. The study monitored the amount of suspended solids, ammonia nitrogen and phosphorus in Eagle and Joos Valley creeks before watershed best management practices (BMPs) were installed, during the installation phase, and for seven years after the majority of management practices were installed.

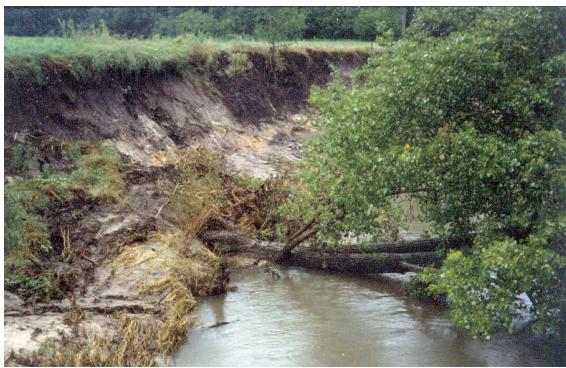
Streambank erosion before restoration

"Once the cows weren't trampling the streambanks, we began shaping and rip-rapping areas of the creeks to help stabilize the banks and prevent streambank erosion. Volunteers from the rod and gun clubs also helped with the installation of hundreds of lunker structures in the creeks to improve fisheries. We also did quite a bit of stream restoration work. When box elder trees take over areas of the streambank, they create shade, then you don't have undergrowth vegetation to stabilize the soil. You can get quite a bit of soil erosion along those parts of the creek. We targeted about 30-40 areas in the watershed for stream restoration where we removed the box elders, sloped the stream banks approximately 6-1, and then planted cover vegetation that can be mowed to keep the box elders from growing back.

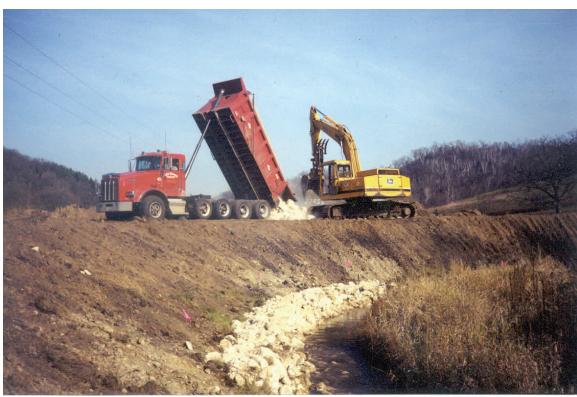
Installation of rip-rapping and stabilization of streambank.

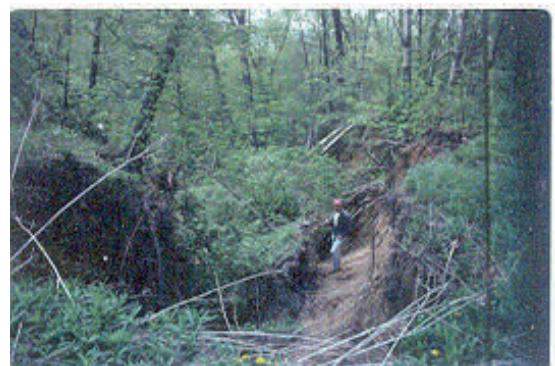
Gully erosion before stabilization.

"Another big effort was controlling soil erosion from rainfall events. We had some fairly substantial highly eroded gullies – some 10-20 feet deep – coming down in the smaller ravines from the bluffs. In those areas we built earthen erosion control structure dams with underdrain piping. The smaller dams on the tops of the ridges ran about \$5,000 per installation. The larger 15 to 20-foot dams ran about \$12,000 per installation and many of them now have a permanent pool behind the dam. With money from the state's Priority Watershed Program, we were able to cost-share 70% with the landowner for the installation costs of the dams. Most landowners saw the benefit of removing these gullies from their land and wanted to put in the dams.

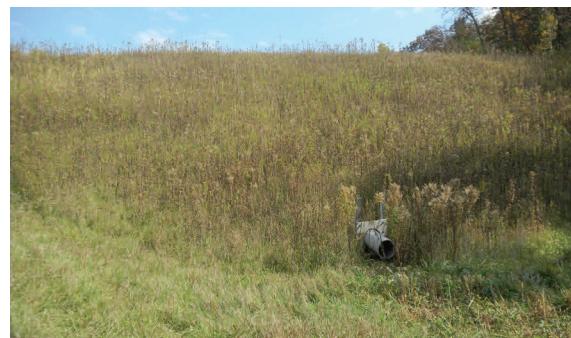
Erosion control structure with underdrain.

"The dam underdrains let out a controlled amount of water from the 6-8 inch drain pipes into grassed swales. These structures have really helped reduce soil erosion throughout the watershed. Another advantage of the dams is their use in flood control. In the summer of 2010, we had record rainfall of over 9 inches in a 24-hour period! There was water running over the emergency spillways in the erosion control dams, but they held back a considerable amount of water and helped prevent flooding downstream. I had people calling me telling me how the installation of all those

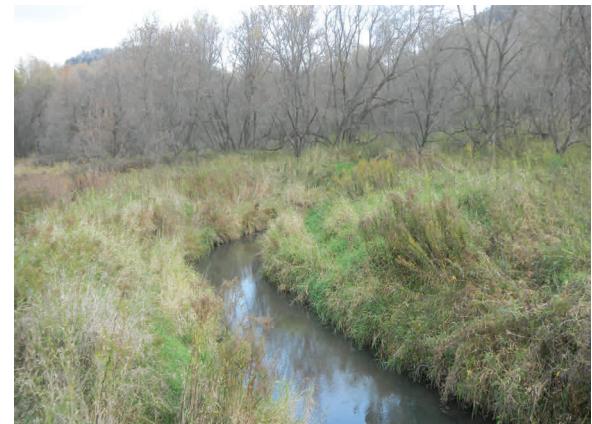
Lower Eagle Creek after restoration.
