# AIS Invasive Species Control Grant Kettle Moraine Lake ACEI-059-09

Kettle Moraine Lake 1/1/2013

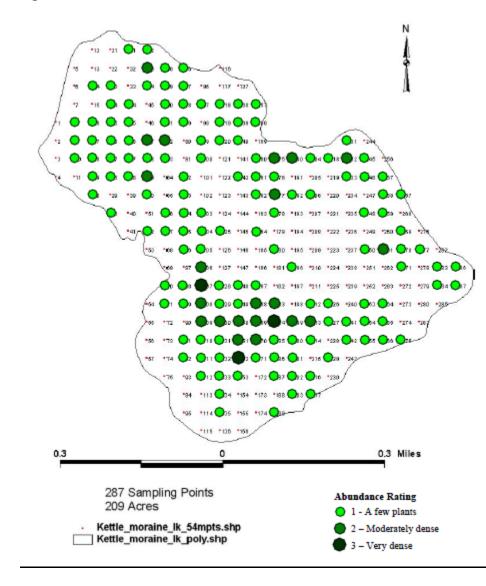
Figure 1. Eurasian Watermilfoil distribution on Kettle Moraine Lake on May 1, 2009

Maps showing May 09 distribution of Eurasian watermilfoil and curlyleaf pondweed were provided by the applicator (Figure 1 and Figure 2). According to the applicator the application was conducted on May 11. Seven sample sites were established to collect water samples for endothall and 2,4-D residual analysis (Figure 3). Site KM1 is meant to be in the deep hole, and sites KM6 and KM7 are meant to be at or near what appears to be water lily beds on the aerial photo. Water samples were collected by lake volunteers at mid depth for all locations at specified sample intervals (Table 1). Following completion of each sample interval, 2-3 drops of muriatic acid were added to the sample to fix the herbicide.

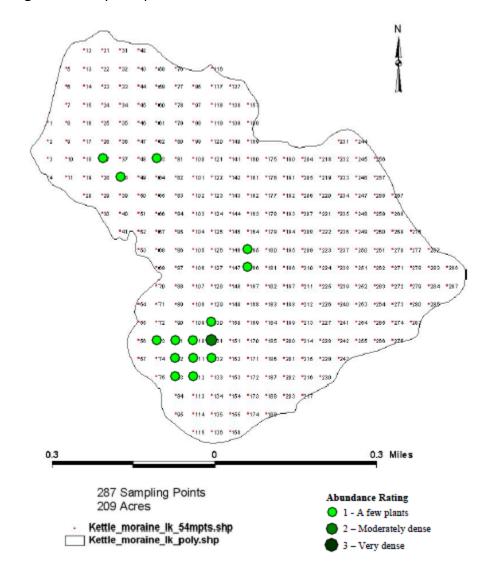
Figure 2. Curly-leaf pondweed distribution on Kettle Moraine Lake on May 1, 2009

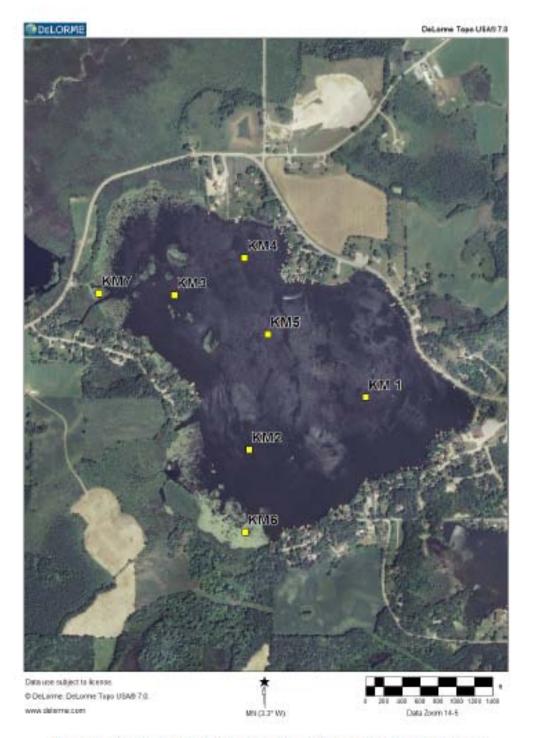
Figure 3. 2009 Kettle Moraine Lake herbicide residual sample locations

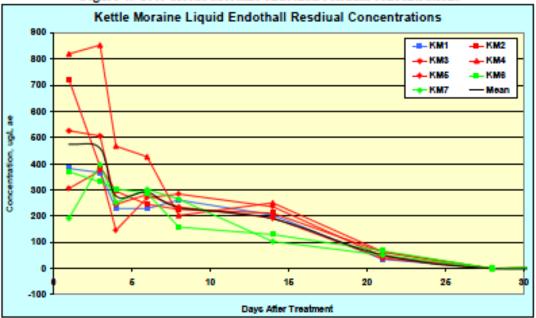
Figure 4. 2009 Kettle Moraine endothall residual concentrations

Endothall residual concentrations are presented (Figure 4). Application rates for endothall are based on active ingredient (ai) while residual concentrations are determined as acid equivalent (ae). A target concentration of 1000 ug/L ai is equivalent to 700 ug/L ae. The half live for endothall determined by a linear regress using log transformed data was 5.64 days. The half life seems short, however the data indicates that initial concentrations in probable target areas were between 500 and 900 ug/L ae. The herbicide was dissipated through the entire lake during the first 3 DAT, and then the herbicide degraded at a slower rate to 21 DAT.

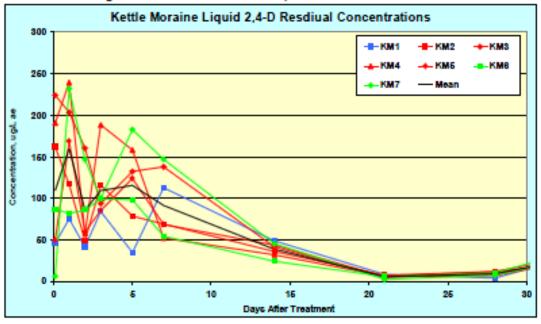
Figure 5. 2009 Kettle Moraine 2,4-D residual concentrations

Residual concentrations of 2,4-D are presented (Figure 5). Application rates and residual concentrations are all determined as ae. The average concentration for all stations ranged between 100 and 150 ug/L ae through 5 DAT and was below 100 ug/L ae at 7 DAT. The average half live computed from a linear regression using log transformed data was 14.65 days, longer than endothall.

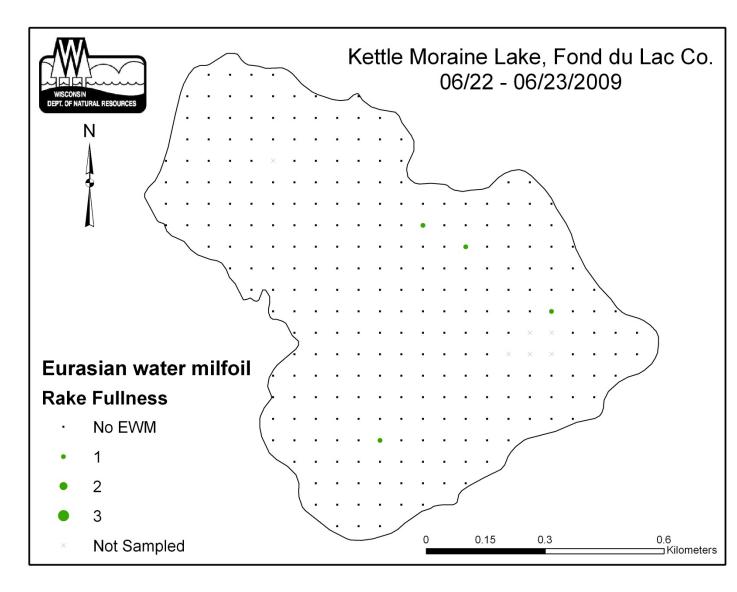
Figure 2: A map of the approximate location of Eurasian water milfoil.

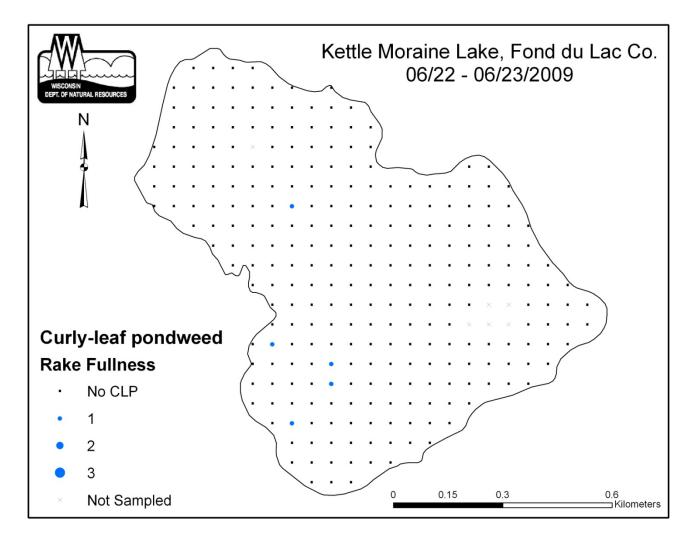
Figure 3: A map of the approximate location of Curly-leaf pondweed.

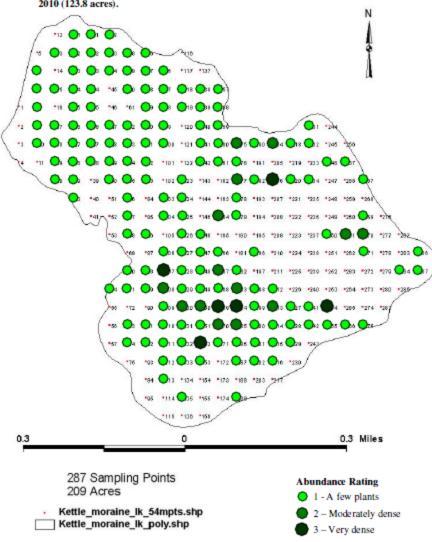
Figure 1. Eurasian watermilfoil distribution on Kettle Moraine Lake on April 20, 2010 (123.8 acres).

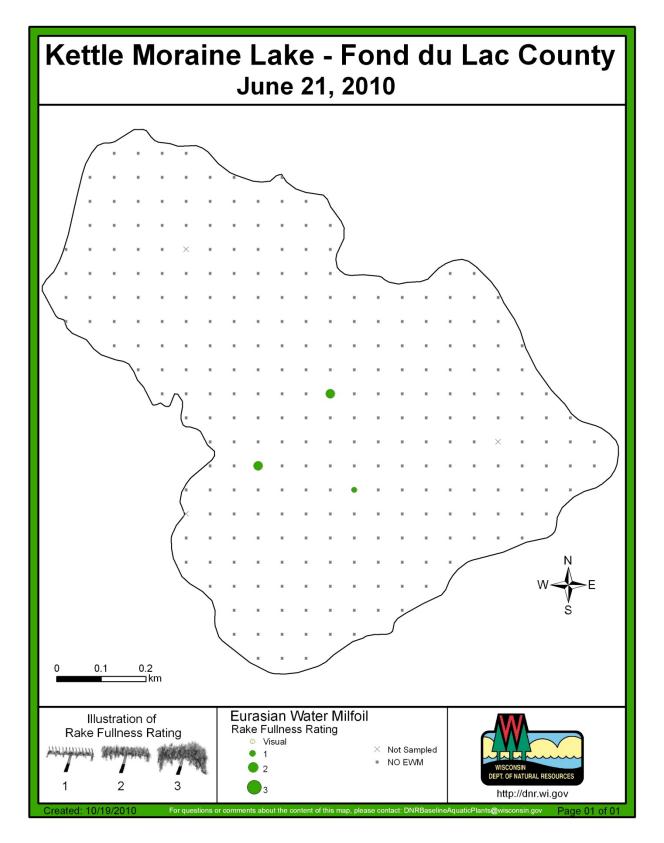
Figure 2. A map of the approximate location of Eurasian water milfoil.

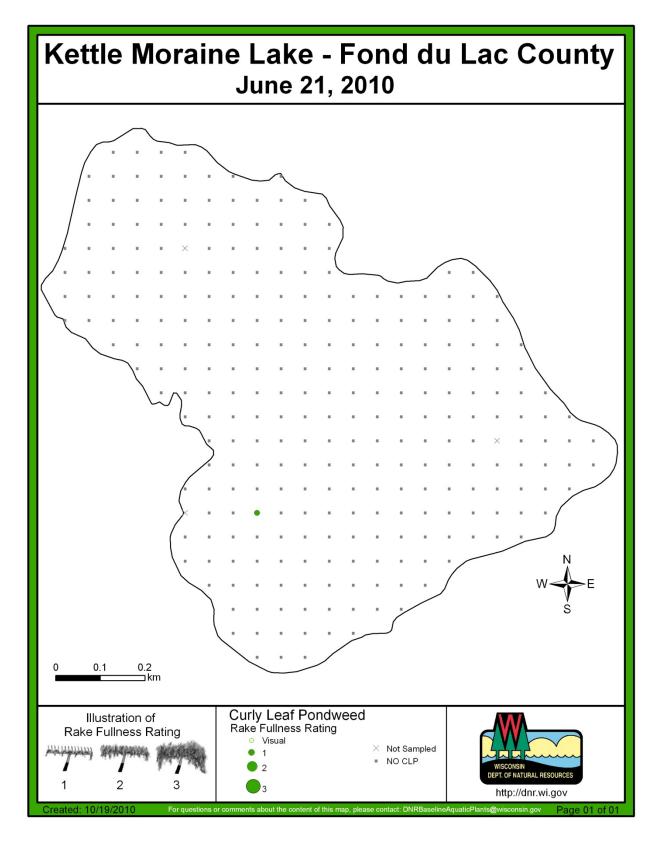
Figure 3. A map of the approximate location of curly-leaf pondweed.

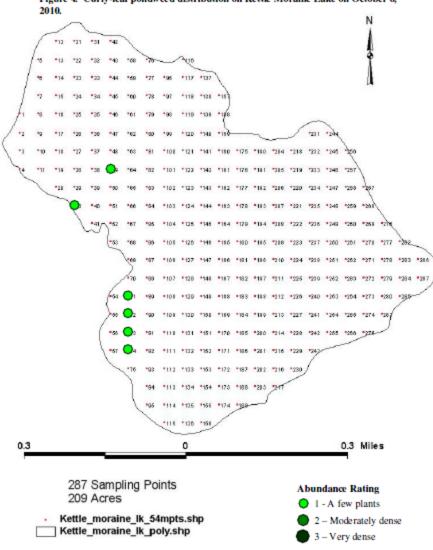
Figure 4. Curly-leaf pondweed distribution on Kettle Moraine Lake on October 6,

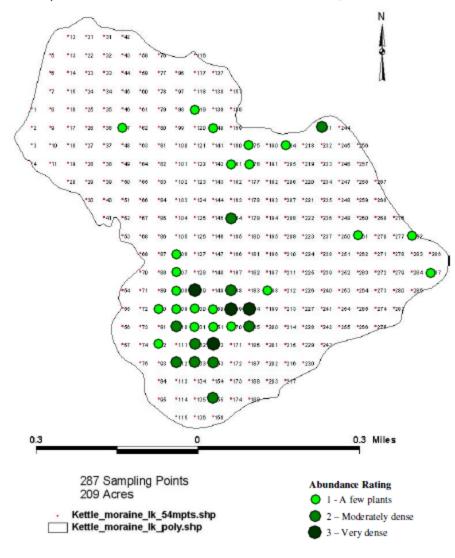
Eurasian watermilfoil distribution on Kettle Moraine Lake on May 10, 2011.

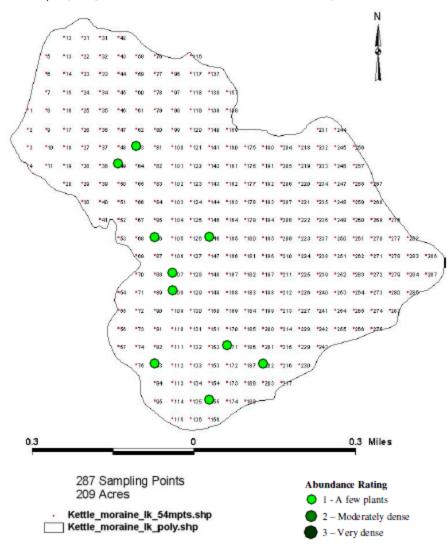
Curly-leaf pondweed distribution on Kettle Moraine Lake on May 10, 2011.

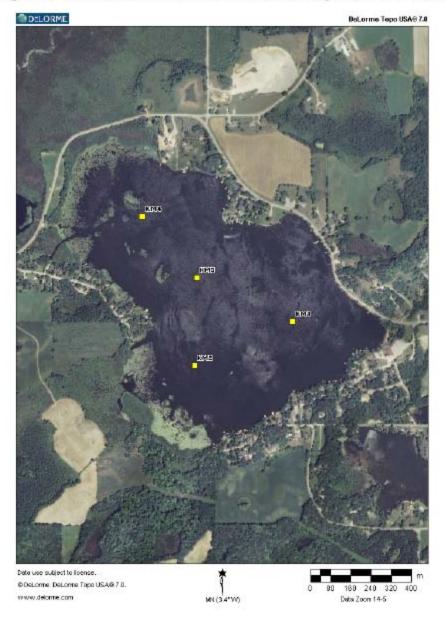
Figure 1. Kettle Moraine 2,4-D and Endothall Sample Locations, 2011

Kettle Moraine Lake was treated on May 10, 2011 with a liquid formulation of 2,4-D at a lake wide target application rate of 250 ug/L ae (2.5 mg/L ae) to control Eurasian milfoil. The lake was treated with a liquid formulation of endothall at a target concentration of 1000 ug/L ai (2129 ug/L ae) in specific target areas to control curly-leaf pondweed. Water sample sites were established at 4 sites to monitor herbicide concentration and exposure times (Figure 1).

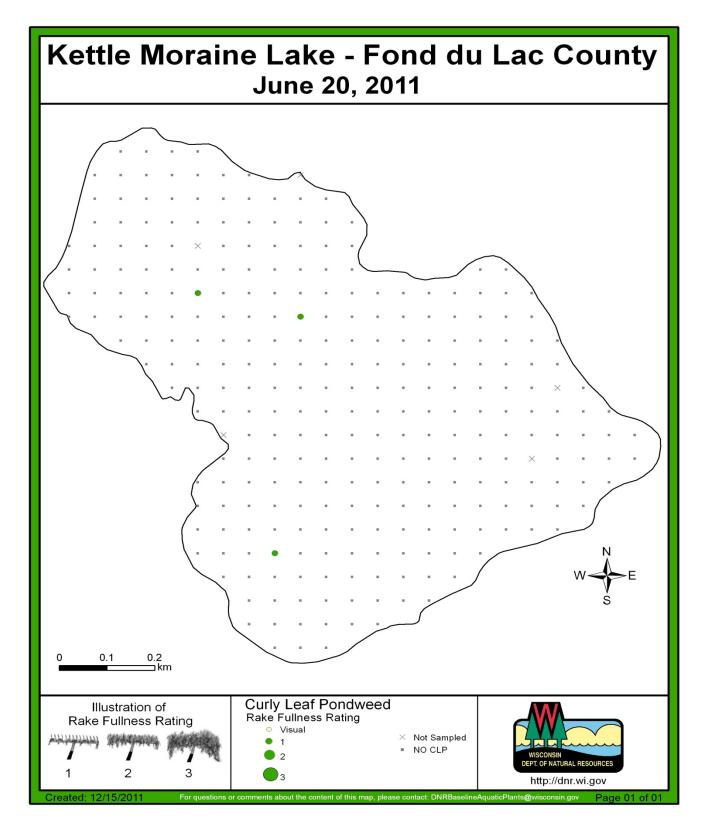
Figure 4: A map of the approximate location of Curly Leaf Pondweed.

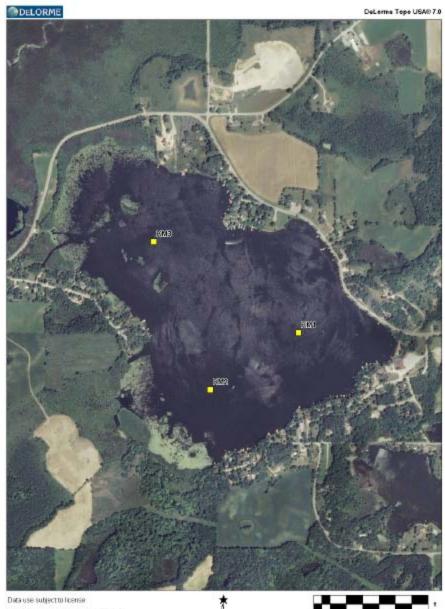
Figure 1. Kettle Moraine 2,4-D and Endothall Sample Locations, 2012
