CITY OF LODI, WI

Spring Creek Watershed Study & Urban Stormwater Plan

City of Lodi, WI Stormwater Quality Master Plan Spring Creek Watershed Assessment

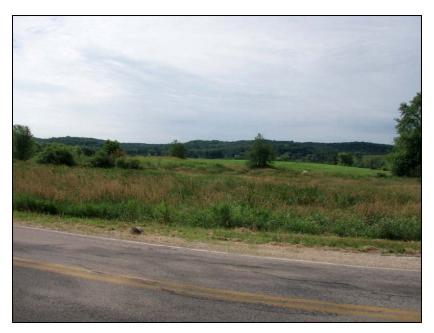
Observation Point 1 is an inundated area located in the west corner of the marsh where a tributary enters the marsh through a box culvert beneath CTH Any water entering the marsh at this location loses velocity because of the dense vegetation and the flat topography present. There was no visible channel present, so flow from the tributary

appears to spread out within the marsh. The vegetation present in this location is typical of seasonally inundated, emergent vegetation, such as Angelica, cattails, arrowhead, and reed canary grass.

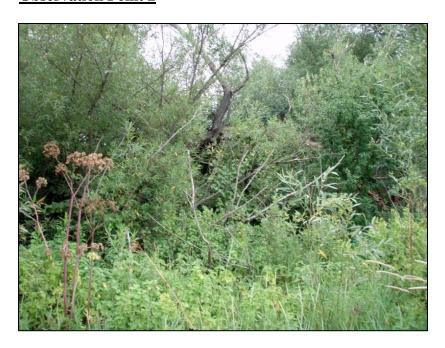
Observation Point 2 is a forested wetland area across from a farm field, which slopes down and towards a flat, wet sedge meadow. The herbaceous layer of the forested area has dense vegetation which appears capable of trapping sediment prior to the reaching the wet sedge meadow area.

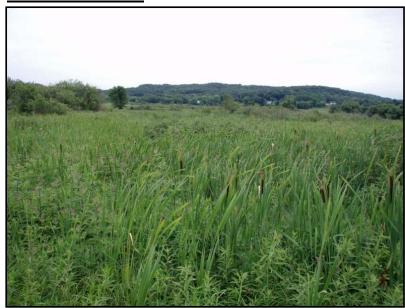
Observation Point 3 is located across from a farm field in a low area along CTH Y that inundated is or saturated in most areas. The area supports a mixture of an emergent marsh and sedge meadow habitat, dominated by cattails, sedges, Joe Pye-weed, and dogwood shrubs. The meadow appeared to provide an

approximately 1000 ft buffer between the road and the main channel of Spring Creek.

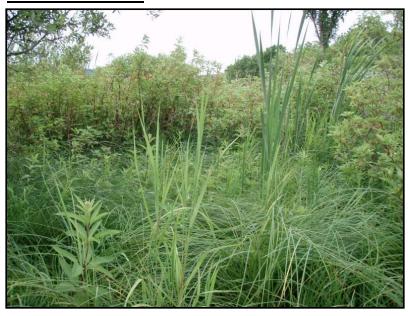
Observation Point 4 is a shrub habitat along CTH Y dominated by willow and dogwood shrubs, and a good mix of sedges, grasses and flowering plants in the herbaceous layer. The area was saturated to the surface. This area also appeared to provid an approximately 1000 ft buffer between the road and the main channel of Spring Creek.

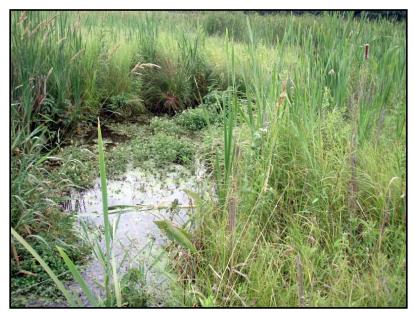
Observation Point 5 is open sedge meadow across from a forested sandstone hill. This area also contains spring which discharges to Spring Creek. The area had the highest diversity of plants, with a high density of vegetation. This area also had a buffer over 1,000 wide adjacent to the main channel of Spring Creek.

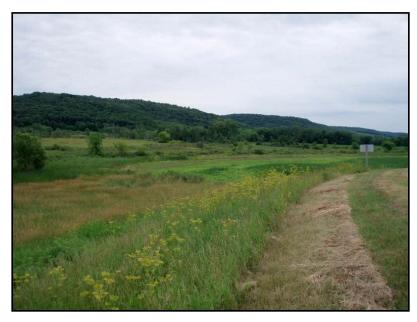
Observation Point 6 is a mosaic of forest, wet meadow dominated by reed canary grass, and farm land. It is located in the northeast portion of the marsh, just prior to where Spring Creek enters the City of Lodi. In location, this the marsh provides 1,000 to 1,400 feet wide buffer of dense vegetation between the farm field and creek channel.

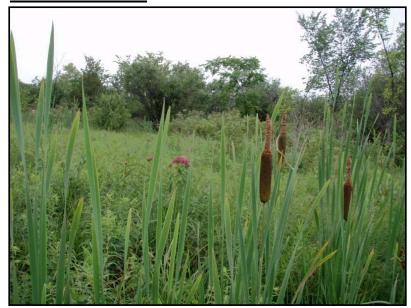
Observation Point 7 is located near the north parking area along Lodi Springfield Road, observed to saturated or inundated. This area is a mix of shrubs and wet/sedge meadow habitat, with a high density and diversity of vegetation, bordered by a moist undisturbed forest forested east of the road.

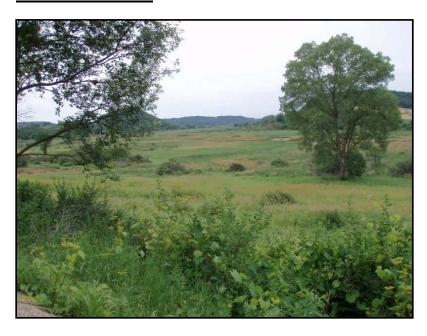
Observation Point 8 is a mosaic of mesic and wet meadow habitats, with areas dominated by reed canary grass.

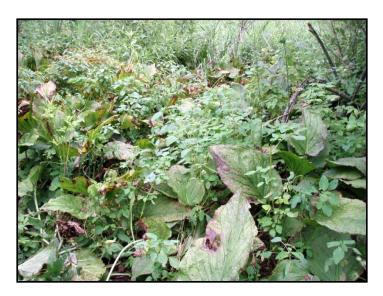
Observation Point 9 is a seepage area on a slope on the east side of the marsh that was dominated by skunk cabbage and jewelweed.

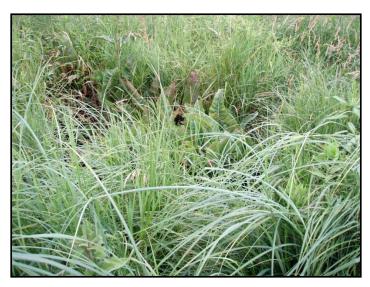
Observation Point 10 is a wet/sedge meadow with many small channels cutting through marsh that were fed by springs on the east side of the marsh.

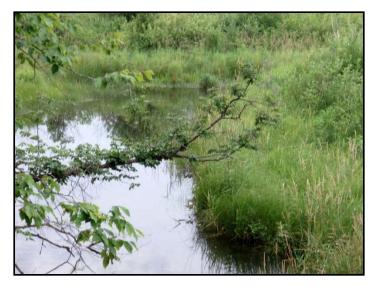
Observation Point 11 is a large spring and pond fed by the spring at the base of a sandstone hill.
