**Aquatic Macrophyte Survey for
Chetac Lake
Sawyer County, Wisconsin
WBIC: 2113300**

Project Initiated by:
Wisconsin Department of Natural Resources,
Big Chetac Chain Lake Association and
Short Elliott Hendrickson Inc.

Survey Conducted by and Report Prepared by:
Endangered Resource Services, LLC
Matthew S. Berg, Research Biologist
St. Croix Falls, Wisconsin
Summer 2008

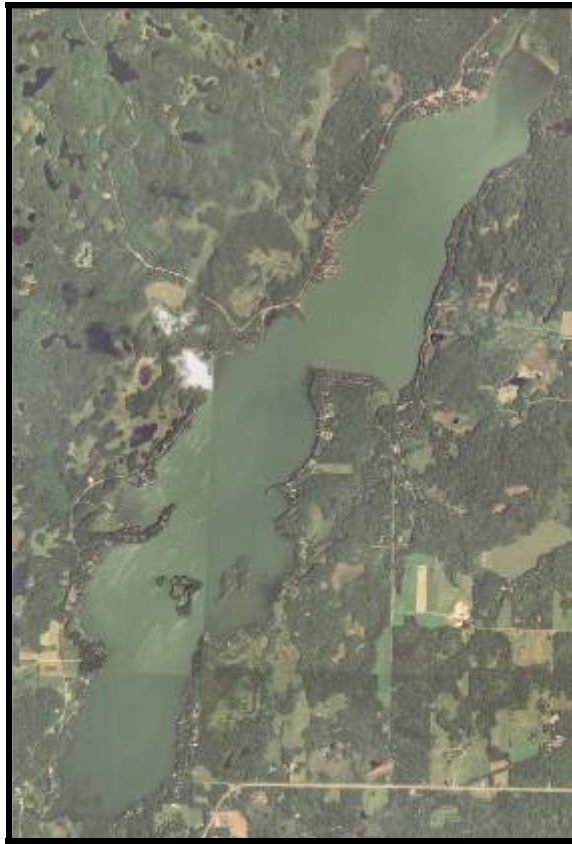
Figure 1: Chetac Lake Aerial Photo

Chetac Lake (WBIC 2113300) is a 1,920-acre stratified drainage lake in southwestern Sawyer County, Wisconsin in the Town of Edgewater (T37N R09W S19 NE NE). It achieves a maximum depth of 28ft in the narrows between the islands in the south basin, and has an average depth of approximately 14ft. Chetac Lake is eutrophic (nutrient rich) with poor to fair water clarity. Historical summer Secchi readings were unavailable, but we estimated a range from 5-7ft with a summer littoral zone extending to 12.5ft. The bottom substrate is predominately muck in the lake's side bays and throughout the north and south ends, and a mixture of sand and rock along exposed shorelines, the mid-lake narrows and around the southern islands.

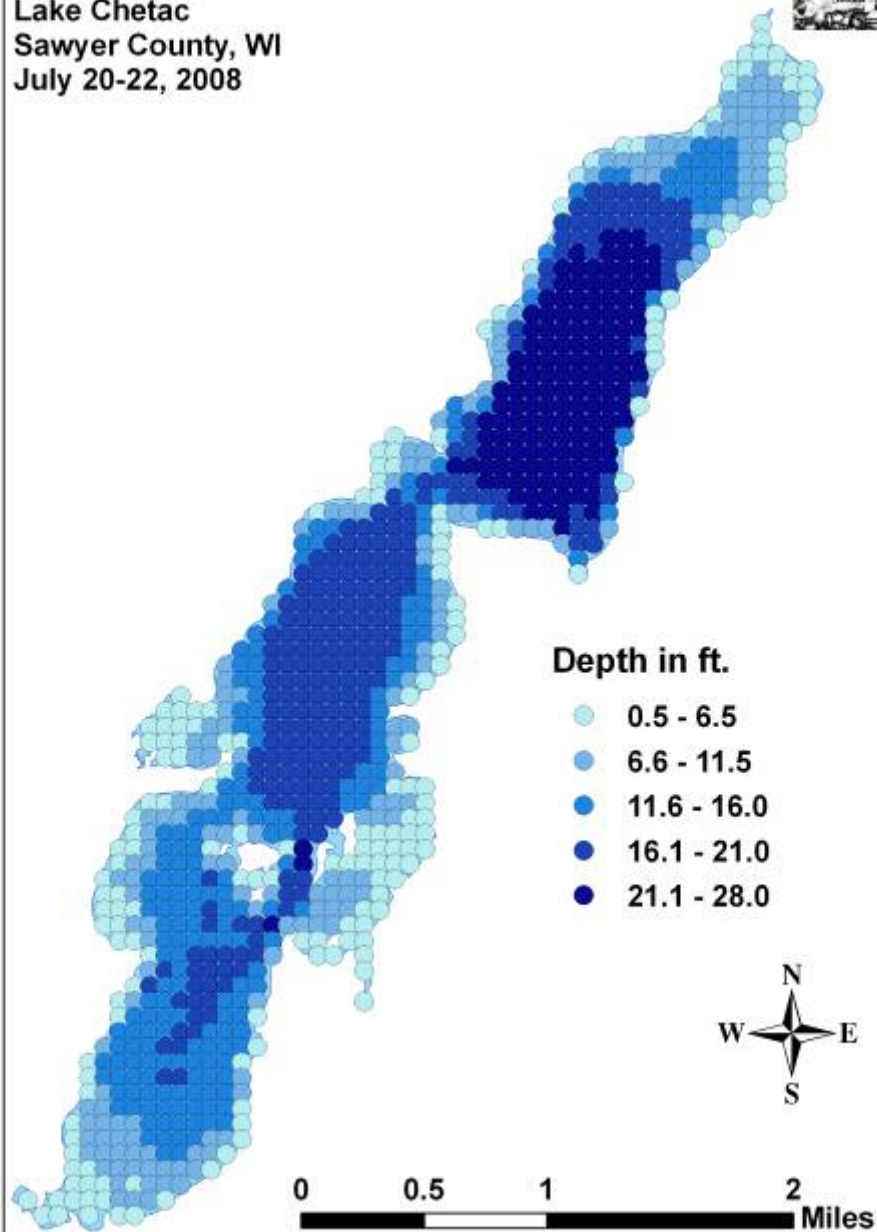
Lake Depth

Lake Chetac
Sawyer County, WI
July 20-22, 2008

Depth in ft.

- 0.5 - 6.5
- 6.6 - 11.5
- 11.6 - 16.0
- 16.1 - 21.0
- 21.1 - 28.0

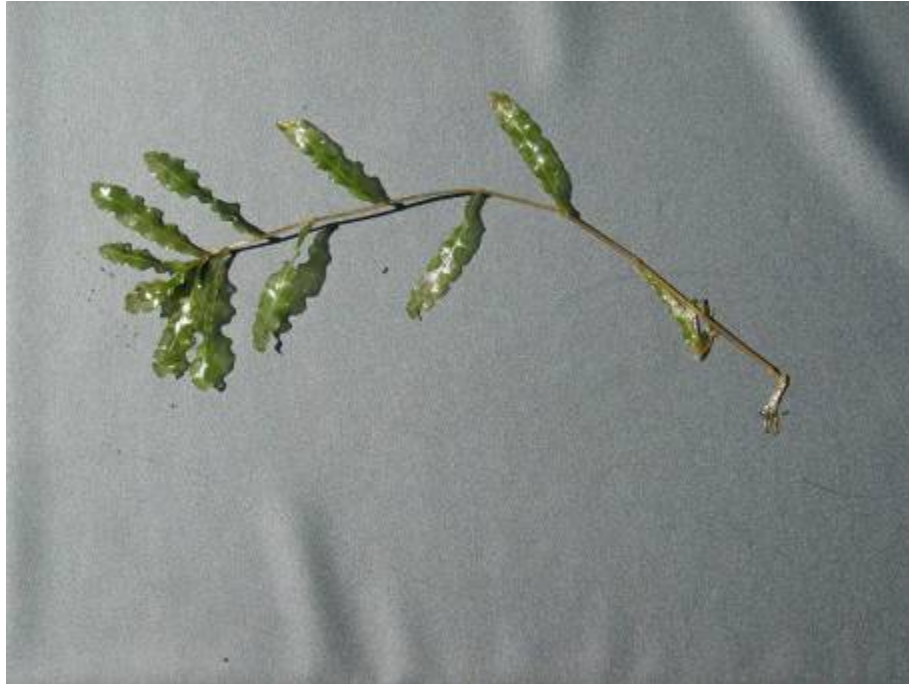
DESCRIPTION: Curly-leaf pondweed is an invasive aquatic perennial that is native to Eurasia, Africa, and Australia. It was accidentally introduced to United States waters in the mid-1880s by hobbyists who used it as an aquarium plant. The leaves are reddish-green, oblong, and about 3 inches long, with distinct wavy edges that are finely toothed. The stem of the plant is flat, reddish-brown and grows from 1 to 3 feet long. The plant usually drops to the lake bottom by early July

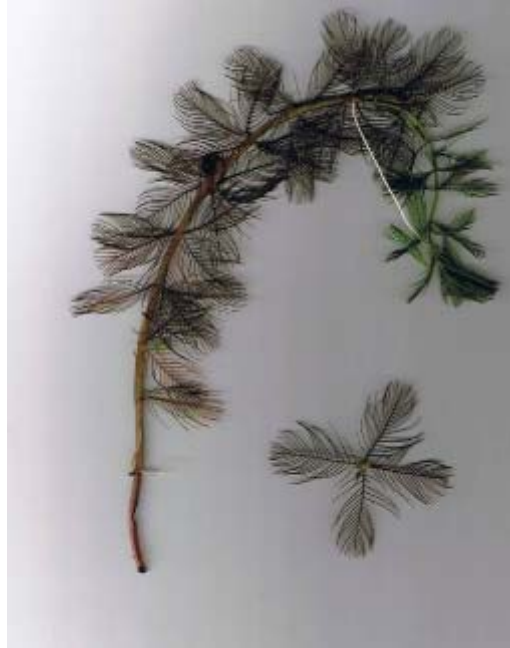
DESCRIPTION: Eurasian water milfoil is a submersed aquatic plant native to Europe, Asia, and northern Africa. It is the only non-native milfoil in Wisconsin. Like the native milfoils, the Eurasian variety has slender stems whorled by submersed feathery leaves and tiny flowers produced above the water surface. The flowers are located in the axils of the floral bracts, and are either four-petaled or without petals. The leaves are threadlike, typically uniform in diameter, and aggregated into a submersed terminal spike. The stem thickens below the inflorescence and doubles its width further down, often curving to lie parallel with the water surface. The fruits are four-jointed nut-like bodies. Without flowers or fruits, Eurasian water milfoil is nearly impossible to distinguish from Northern water milfoil. Eurasian water milfoil has 9-21 pairs of leaflets per leaf, while Northern milfoil typically has 7-11 pairs of leaflets. Coontail is often mistaken for the milfoils, but does not have individual leaflets.

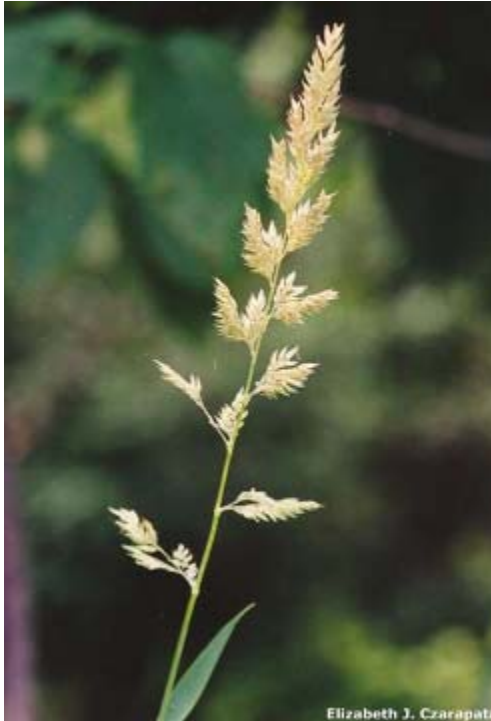
DESCRIPTION: Reed canary grass is a large, coarse grass that reaches 2 to 9 feet in height. It has an erect, hairless stem with gradually tapering leaf blades 3 1/2 to 10 inches long and 1/4 to 3/4 inch in width. Blades are flat and have a rough texture on both surfaces. The leaf ligule is membranous and long. The compact panicles are erect or slightly spreading (depending on the plant's reproductive stage), and range from 3 to 16 inches long with branches 2 to 12 inches in length. Single flowers occur in dense clusters in May to mid-June. They are green to purple at first and change to beige over time. This grass is one of the first to sprout in spring, and forms a thick rhizome system that dominates the subsurface soil. Seeds are shiny brown in color.

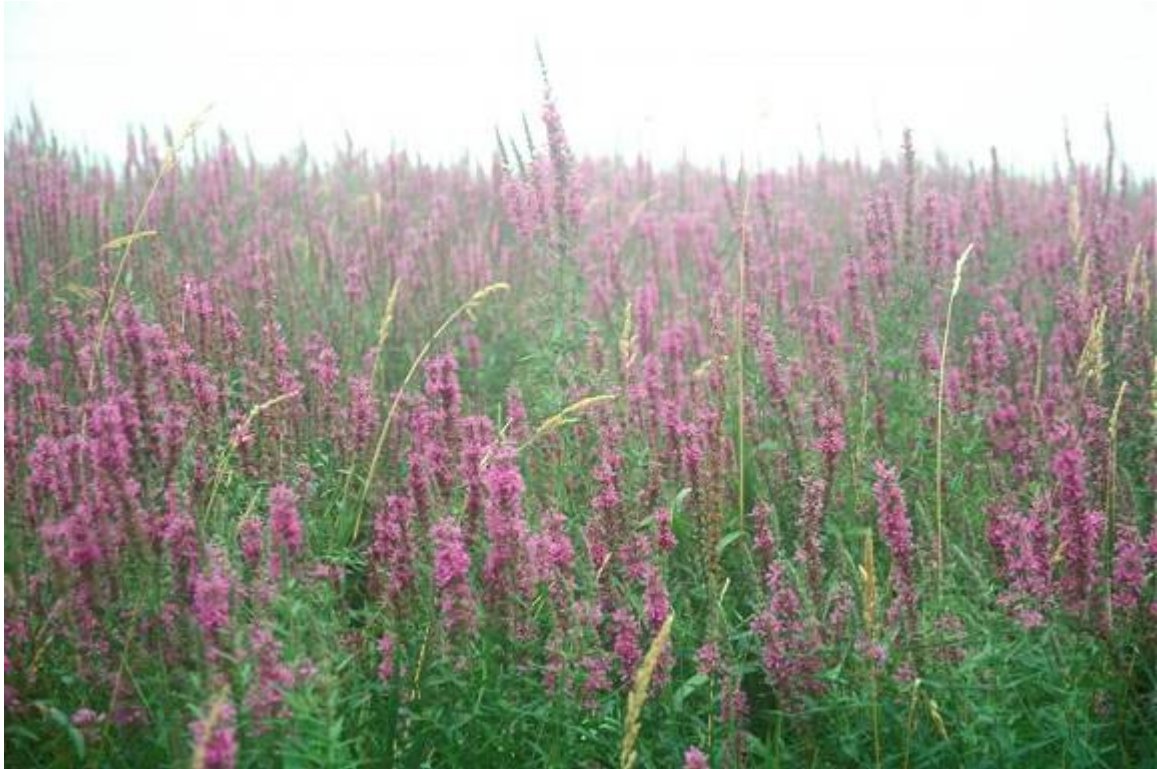
DESCRIPTION: Purple loosestrife is a perennial herb 3-7 feet tall with a dense bushy growth of 1-50 stems. The stems, which range from green to purple, die back each year. Showy flowers vary from purple to magenta, possess 5-6 petals aggregated into numerous long spikes, and bloom from July to September. Leaves are opposite, nearly linear, and attached to four-sided stems without stalks. It has a large, woody taproot with fibrous rhizomes that form a dense mat.
