Facility Name Haven Sanitary District

Receiving Water Sevanmilo Creek

STREAM: Seven mile Creek

WISCONSIN DEPARTMENT OF NATURAL RESOURCES  
STREAM CLASSIFICATION WORKSHEET

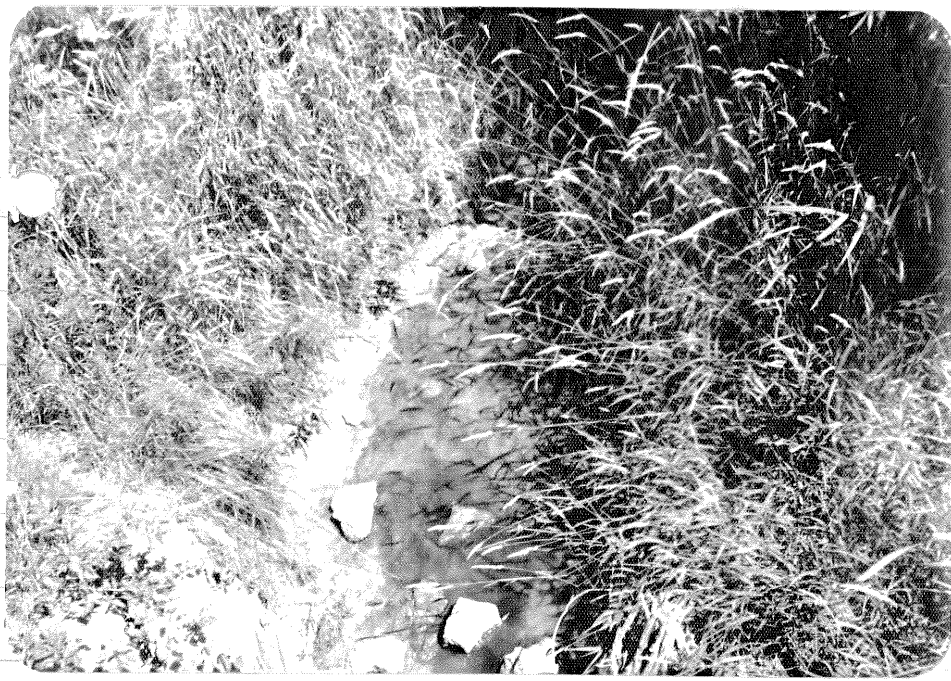
#1 Seven Mile Creek

The Village of Haven has no municipal sewage service. The Village experiences some problems with failing septic tanks. Seven Mile Creek is an intermittent stream with definite banks, a natural bed and many small pools. The stream flows beside a number of barnyards and may receive non-point source pollution. A biological examination revealed only sow bugs on the bottom. There were also minnows present.

- looking downstream
