Lincoln Creek

Segment 1

STREAM SYSTEM HABITAT RATING FORM  
Form 3200-68 1-85

Stream Lincoln Cr. Reach Location Tuckerton Ave upstream to 32<sup>nd</sup> Reach Score Rating 206  
 County MKE Date Aug 84 Evaluator W. Wawerzja Classification MAR-E  
NOV 84

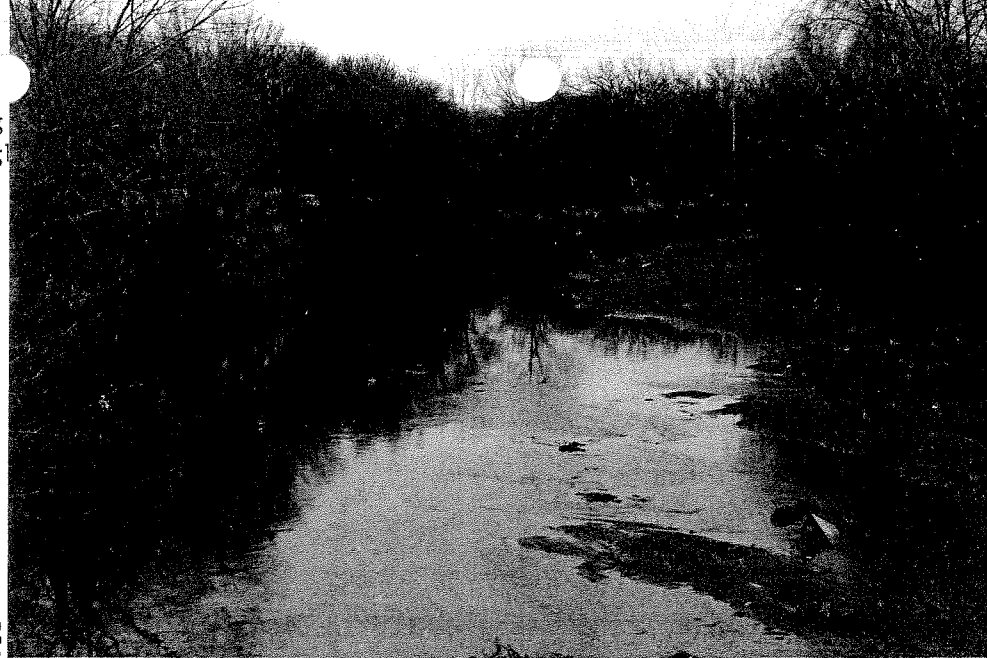
Looking downstream of bridge at Green Bay Ave. Steel retaining wall along short segment of right bank. Note bar formation and sedimentation. Channel along right bank is well scoured.

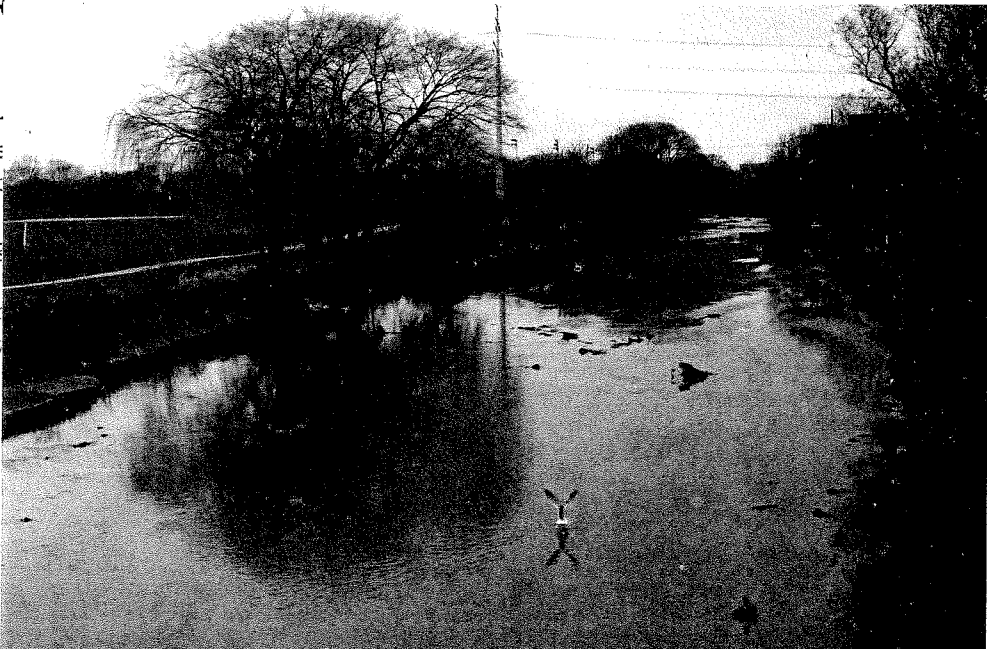
Looking upstream from Green Bay Ave. bridge following pool drawdown in September. Depth lowered by 3'. Sedimentation and bar formation evident. Substrate well sorted deposits of material ranging from silt to coarse gravel. Flow is often diffused across the mud flats following pool drawdown and scour and redeposited as a result of runoff events.
