**The City of Fitchburg**  
Urban Service Area Application

**Edgewood College**  
Athletic and Wellness Campus Development

Prepared by: Rettler Corporation  
Project Number: 18.083  
December 9, 2021

New Athletic and Wellness Campus  
Edgewood College  
Fitchburg, Wisconsin

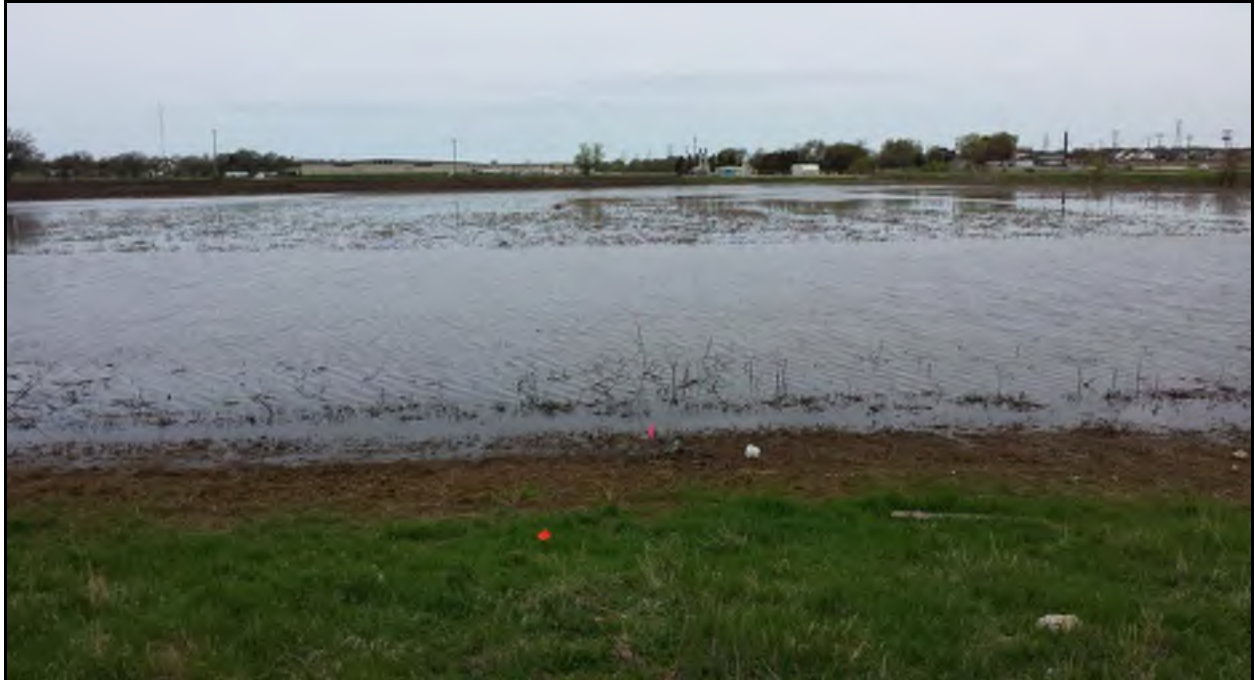
**Photo 1. Wetland 1, emergent/wet meadow, viewing north past Plot 3 toward Plot 4.**

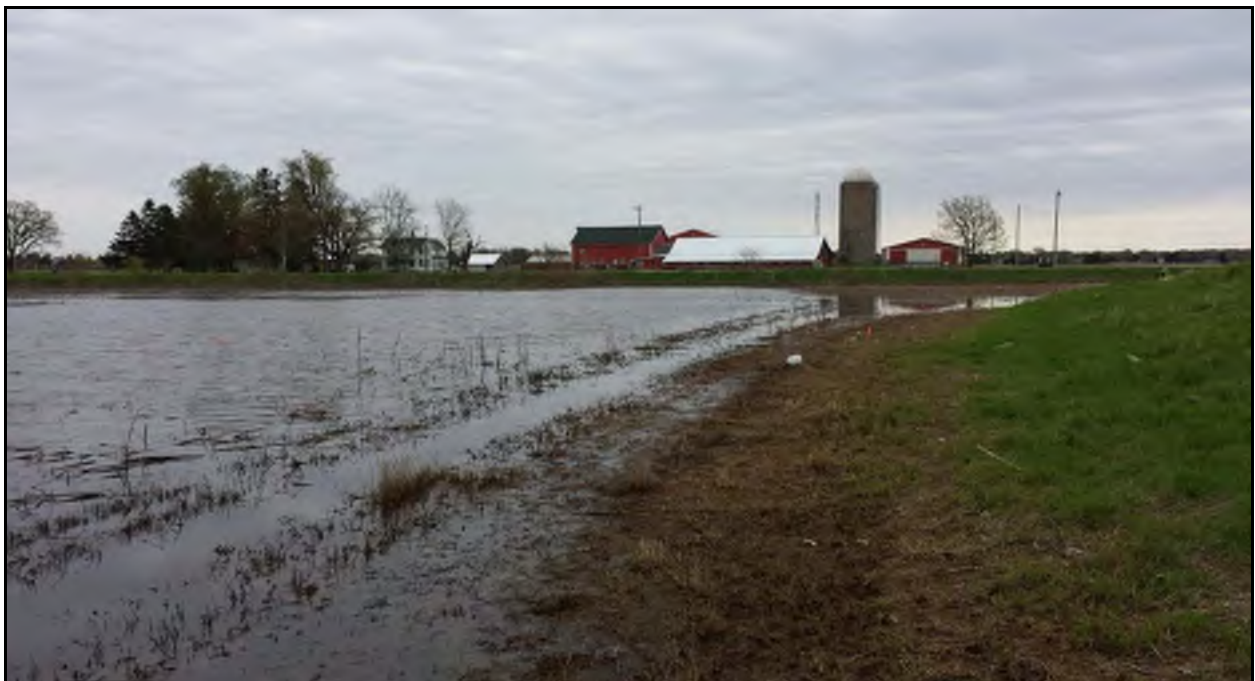
**Photo 2. Wetland 1, emergent/wet meadow, viewing east past Plot 4 (left) and Plot 3 (right).**

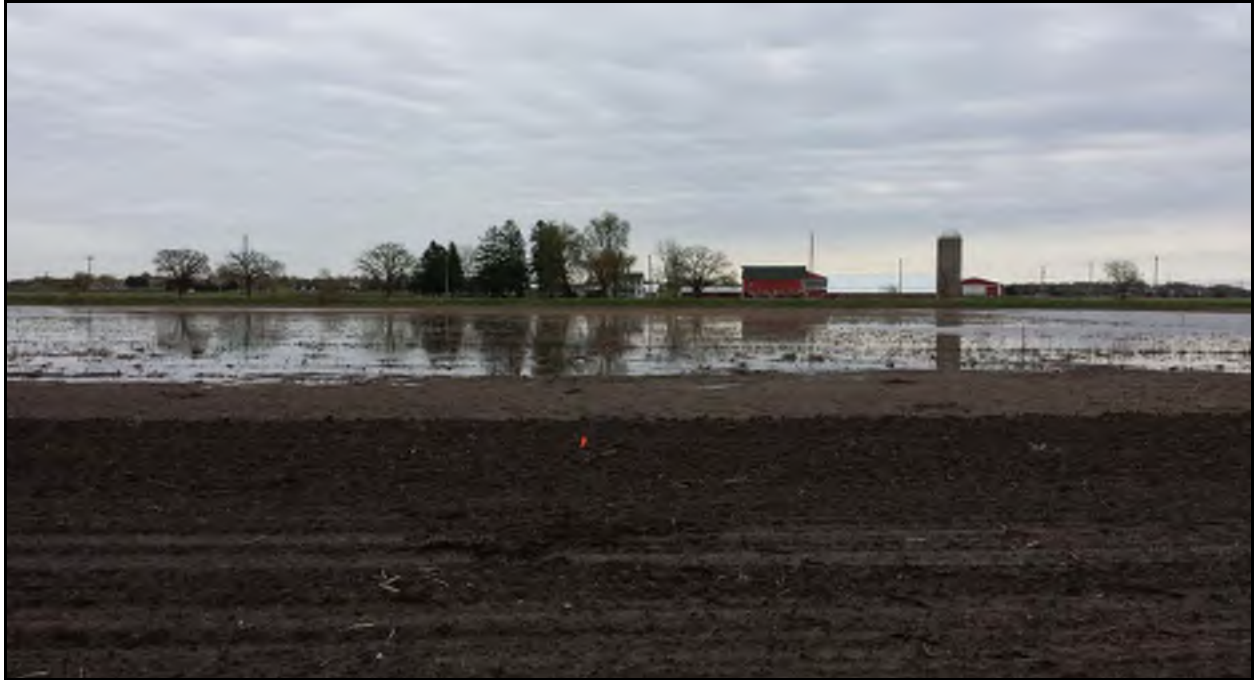
**Photo 3. Wetland 1, emergent/wet meadow, viewing east past upland Plot 6 toward wetland Plot 5.**

- Plot 5: Vegetation is considered significantly disturbed due to previous agricultural activities. A problematic vegetation situation also exists at the sample plot due to seasonal hydrology - deep water is preventing early vegetation growth. No vegetation was present within the sample plot; however, the presence of wetland hydrology and hydric soils suggests the presence of hydrophytic vegetation. Standing water was 4.5" deep. Primary wetland hydrology indicators A1, A2, A3, B8 & B13 and secondary indicator D2 were present.

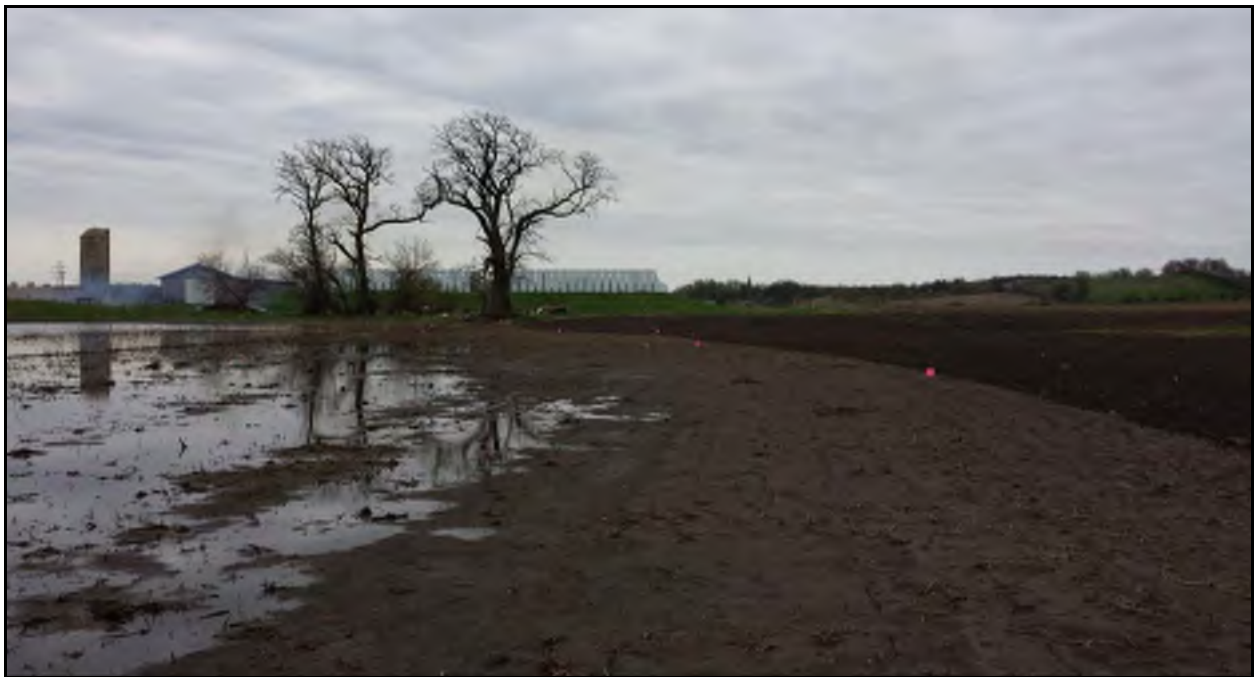
**Photo 4. Wetland 1, emergent/wet meadow, viewing south past wetland Plot 5 (left) and upland Plot 6 (right).**

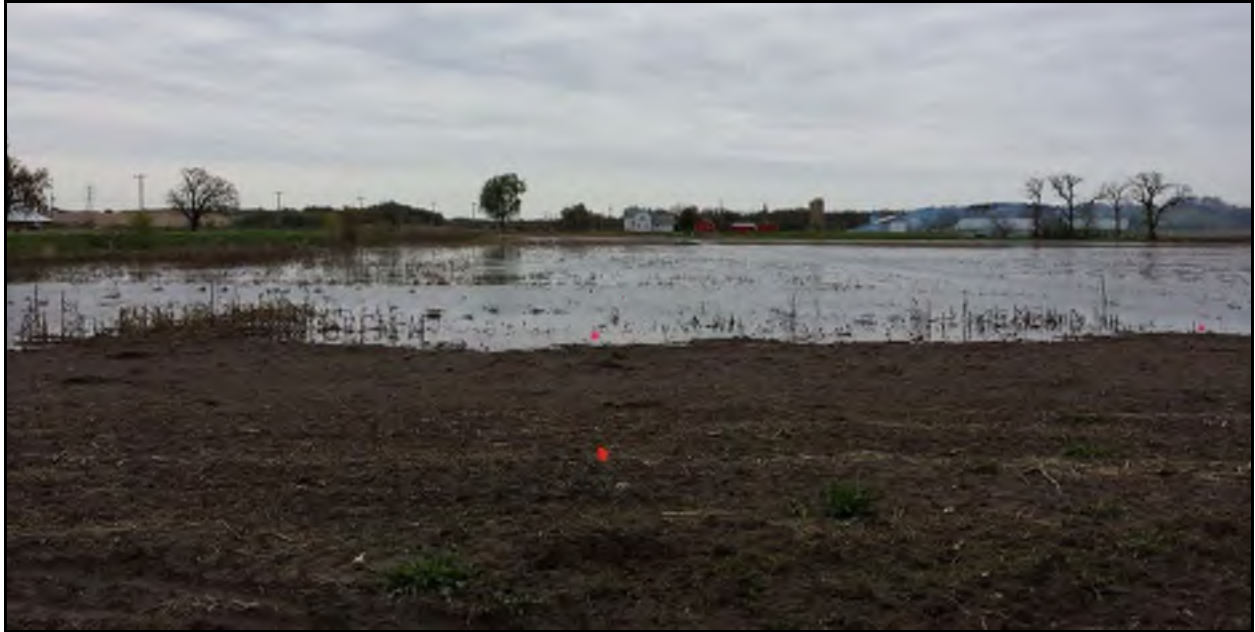
**Photo 5. Wetland 1, emergent/wet meadow, viewing southeast past Plot 7 toward Plot 8.**

Plot 8: Vegetation is considered significantly disturbed due to previous agricultural activities. A problematic vegetation situation also exists at the sample plot due to seasonal hydrology - deep water is preventing early vegetation growth. No vegetation was present within the sample plot; however, the presence of wetland hydrology and hydric soils suggests the presence of hydrophytic vegetation. Standing water was 5" deep. Primary wetland

hydrology indicators A1, A2, A3, B8 & B13 and secondary indicator D2 were present. Breeding frogs were heard within the sample plot providing evidence of B13 (Aquatic Fauna). Reoccurring wetness signatures on the FSA, Google & NAIP imagery are evident 7 out of 33 photo years, 2 out of 16 normal years, many of which have occurred within the past 10 years. Soil matched the A11 & F3 NRCS Hydric Soil Indicators.

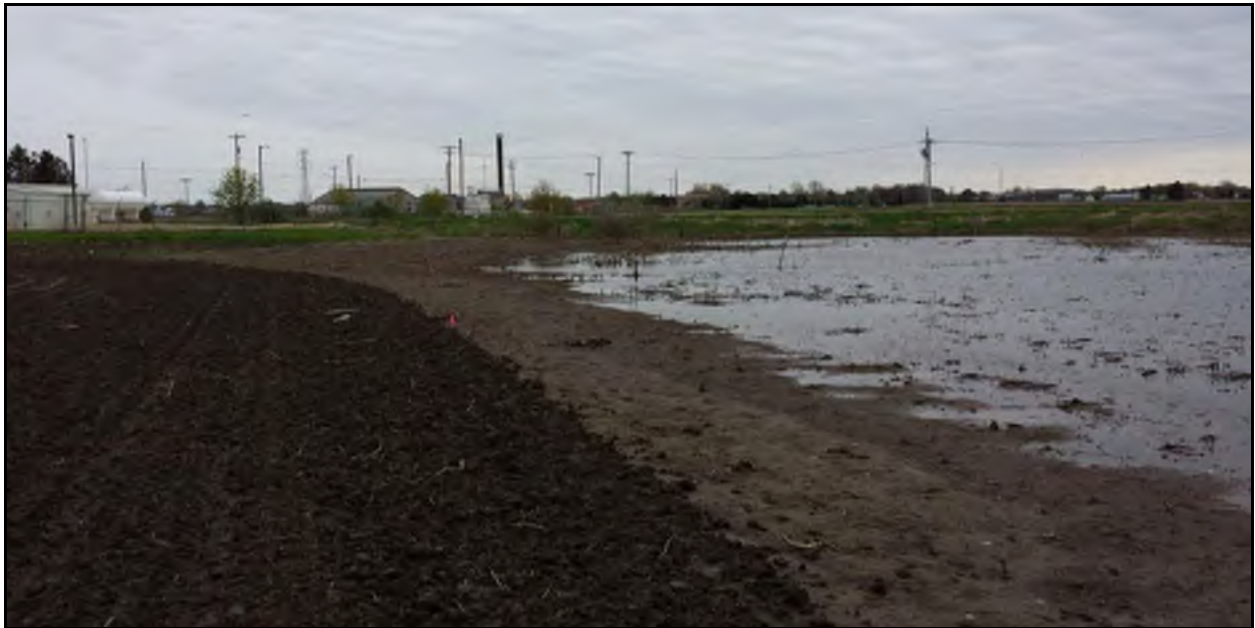
**Photo 6. Wetland 1, emergent/wet meadow, viewing northeast from Plot 7 along wetland boundary.**

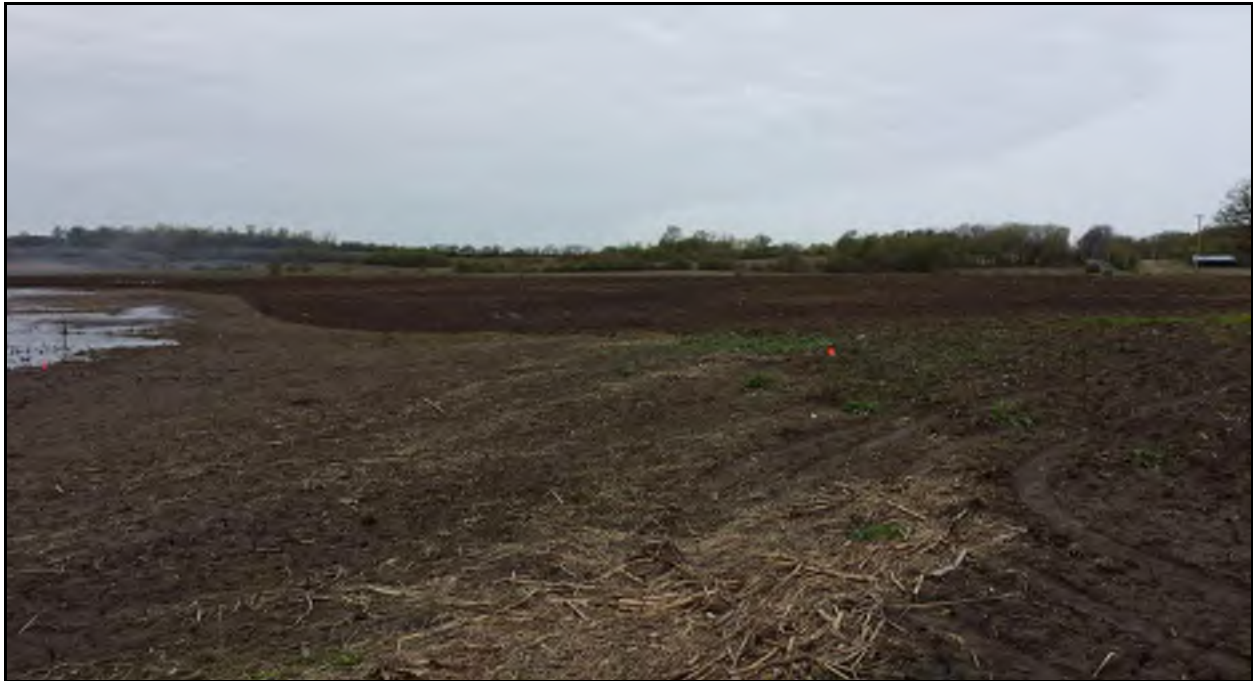
**Photo 7. Wetland 1, emergent/wet meadow, viewing southwest along wetland boundary, Plot 9 can be seen on the right.**

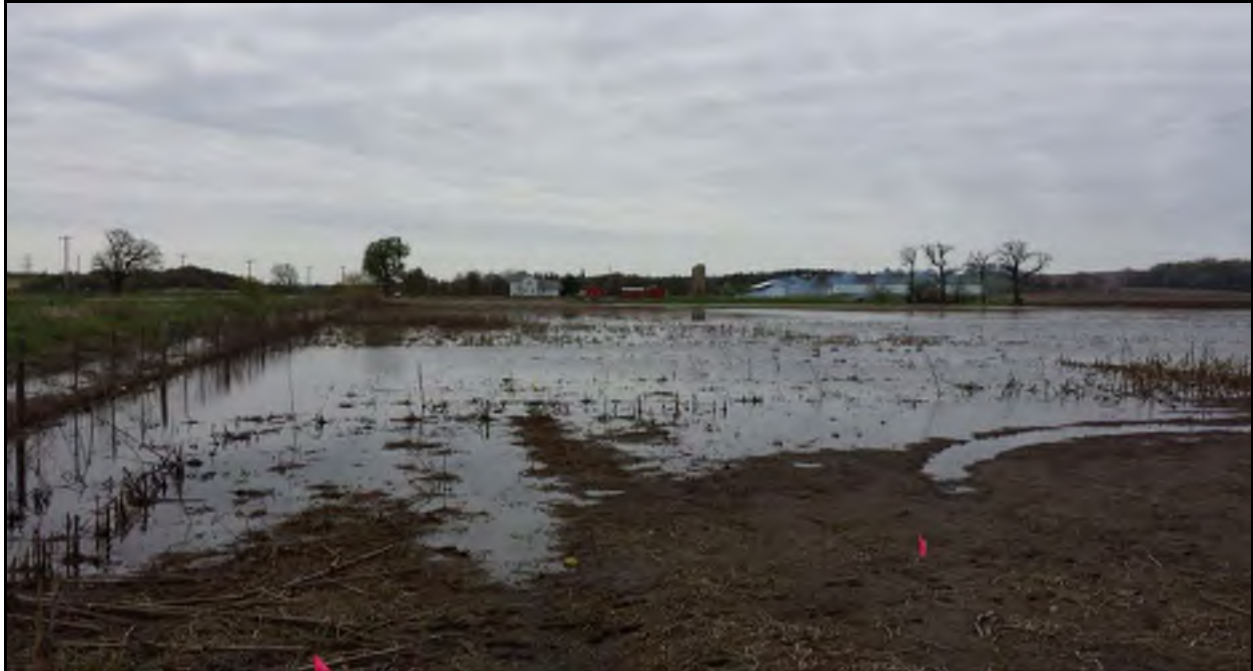
**Photo 8. Wetland 1, emergent/wet meadow, viewing south toward Plot 10.**

Plot 10: Vegetation is considered significantly disturbed due to previous agricultural activities. A problematic vegetation situation also exists at the sample plot due to seasonal hydrology - deep water is preventing early vegetation growth. No vegetation was present within the sample plot; however, the presence of wetland hydrology and hydric soils suggests the presence of hydrophytic vegetation. Standing water was 5" deep. Primary wetland hydrology indicators A1, A2, A3, B8 & B13 and secondary indicator D2 were present. Breeding frogs were heard within the sample plot providing evidence of B13 (Aquatic Fauna). Reoccurring wetness signatures on the FSA, Google & NAIP imagery are evident 7 out of 33 photo years, 2 out of 16 normal years, many of which have occurred within the past 10 years. Soil matched the A11 & F3 NRCS Hydric Soil Indicators.

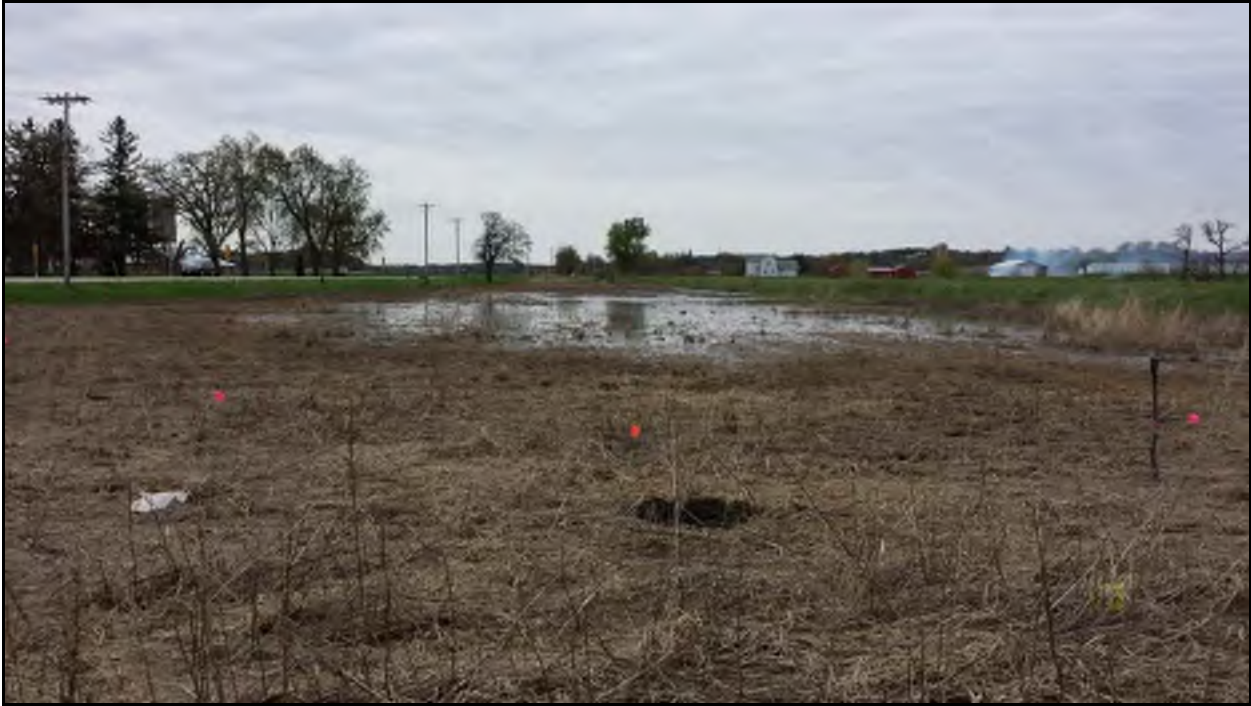
**Photo 9. Wetland 2, emergent/wet meadow, viewing south past Plot 11 toward Plot 12.**

- Plot 12: Vegetation is considered significantly disturbed due to previous agricultural activities. A problematic vegetation situation also exists at the sample plot due to seasonal hydrology - deep water is preventing early vegetation growth. No vegetation was present within the sample plot; however, the presence of wetland hydrology and hydric soils suggests the presence of hydrophytic vegetation. Standing water was 4" deep. Primary wetland hydrology indicators A1, A2, A3 & B8 and secondary indicator D2 were present. Reoccurring wetness signatures on the FSA, Google & NAIP imagery are evident out of 33 photo years, 1 out of 16 normal years, many of which have occurred within the past 10 years. Soil matched the A11 & F3 NRCS Hydric Soil Indicators.

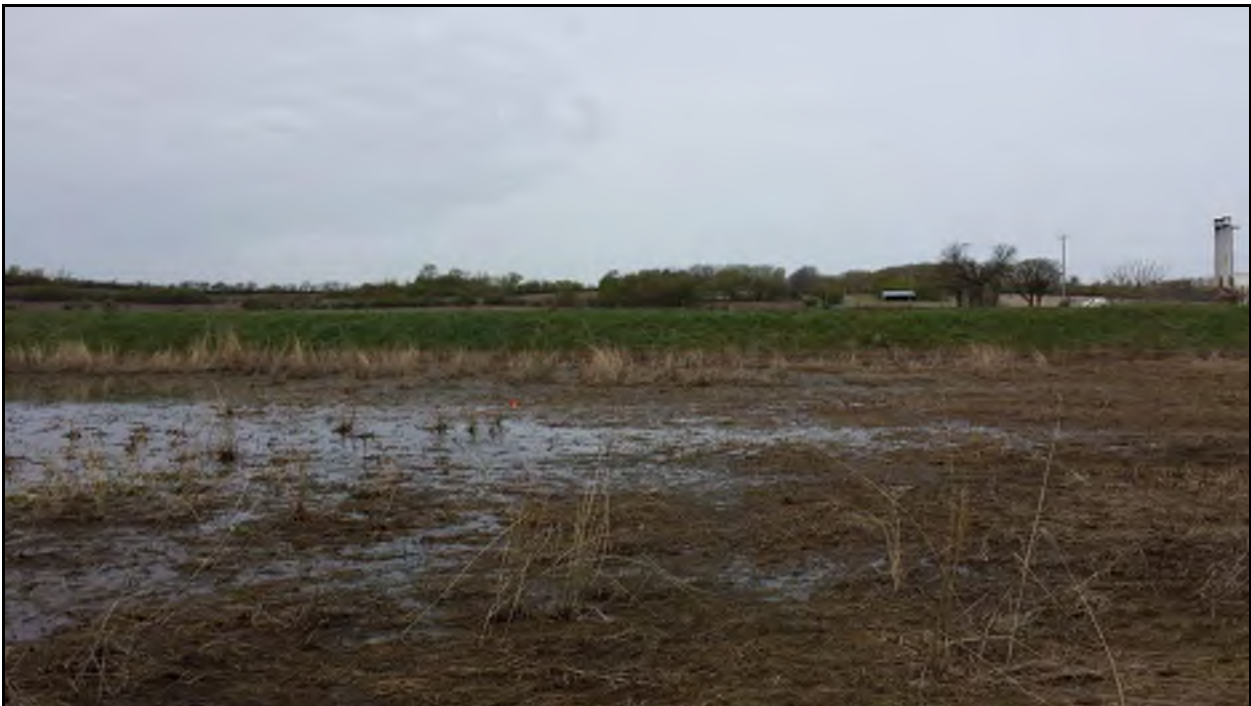
**Photo 10. Wetland 2, emergent/wet meadow, viewing west toward Plot 12.**

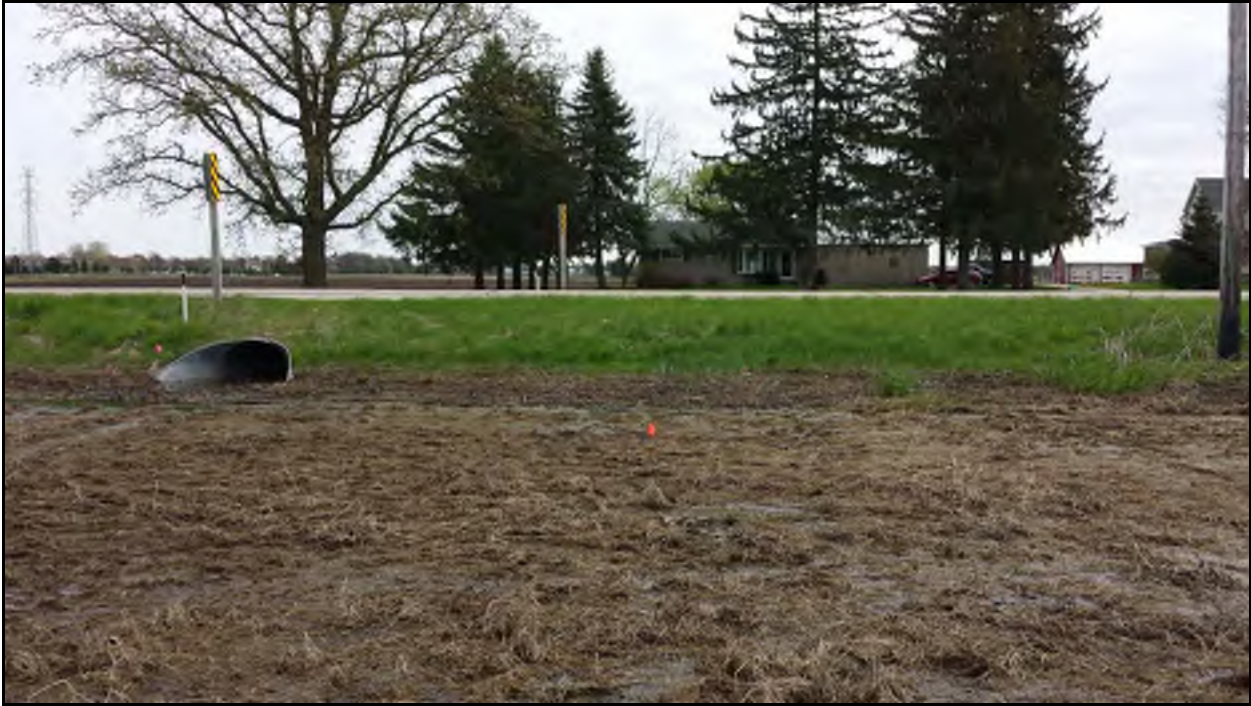
**Photo 11. Wetland 2, emergent/wet meadow, viewing east past Plot 14 toward Plot 13.**

- Plot 14: Vegetation is considered significantly disturbed due to previous agricultural activities. A problematic vegetation situation also exists at the sample plot due to seasonal hydrology - deep water is preventing early vegetation growth. No vegetation was present within the sample plot; however, the presence of wetland hydrology suggests the presence of hydrophytic vegetation. Standing water was 0.5" deep. Primary wetland hydrology indicators A1, A2, A3 & B8 and secondary indicator D2 were present. Reoccurring wetness signatures on the FSA, Google & NAIP imagery are evident out of 33 photo years, 1 out of 16 normal years, many of which have occurred within the past 10 years. Hydric soil indicators were not present so the procedure for determining hydric soils in problematic situations was employed. A problematic soil situation exists at the sample plot due to seasonal hydrology. The presence of wetland hydrology and location within a concave landscape position that appears to pond water for long periods of time suggests a hydric soil is present.

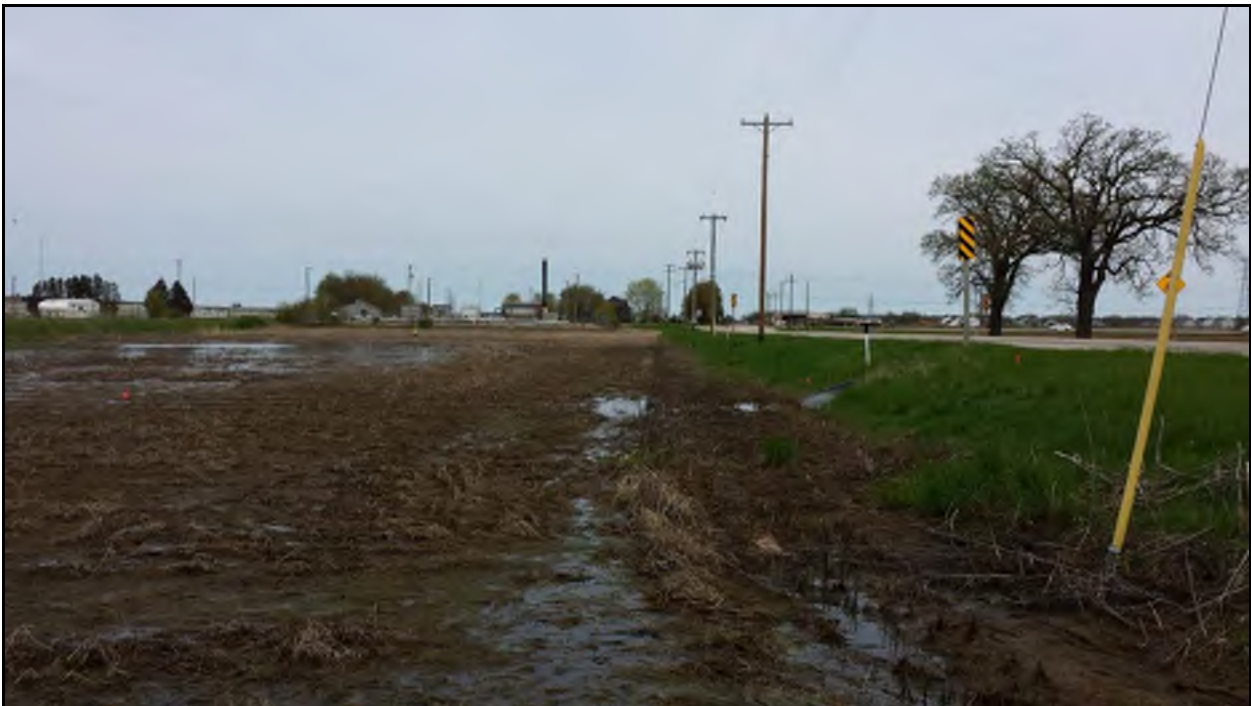
**Photo 12. Wetland 2, emergent/wet meadow, viewing north along the wetland boundary toward Plots 14 (left) and 13 (right).**

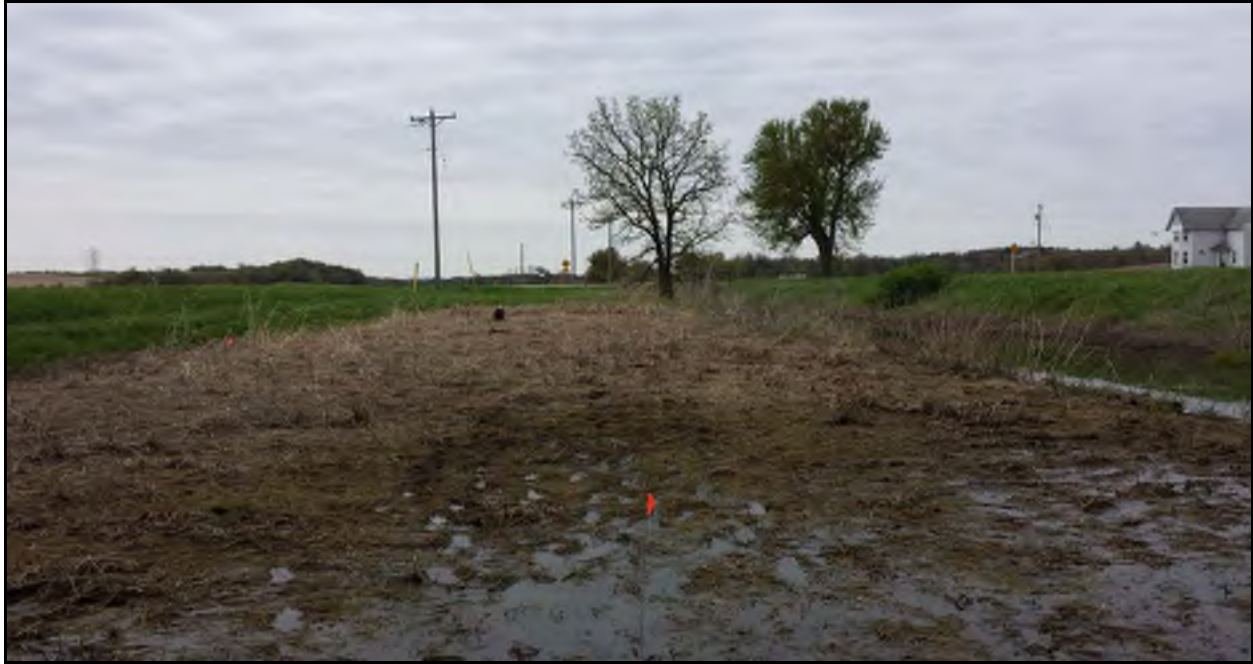
Photo 13. Wetland 2, emergent/wet meadow, viewing south past Plot 15 toward Plot 16.

Plot 15: Dominant vegetation was *Phalaris arundinacea*. The Dominance Test and Prevalence Index are 100.0% and 2.000. Standing water was 3" deep. Primary wetland hydrology indicators A1, A2, A3 & B8 and secondary indicators D2 & D5 were present. Reoccurring wetness signatures on the FSA, Google & NAIP imagery are evident out of 33 photo years, 1 out of 16 normal years, many of which have occurred within the past 10 years. Soil matched the A11 NRCS Hydric Soil Indicator.

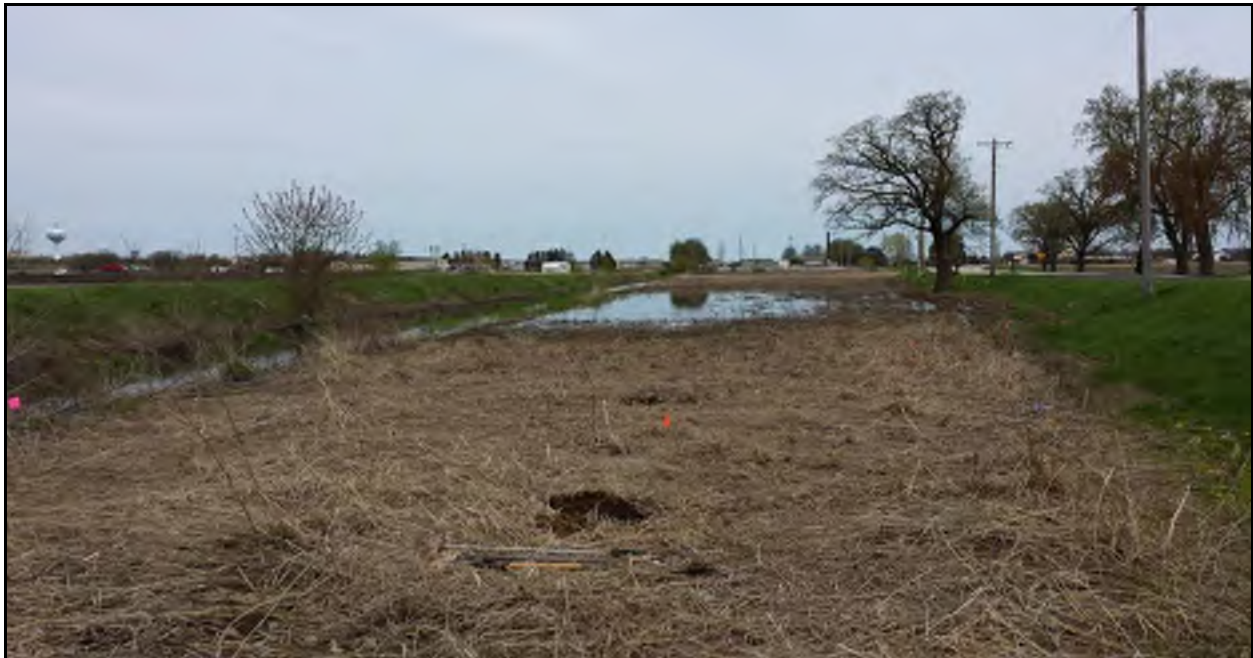
Photo 14. Wetland 2, emergent/wet meadow, viewing north past Plot 16 toward Plot 15.

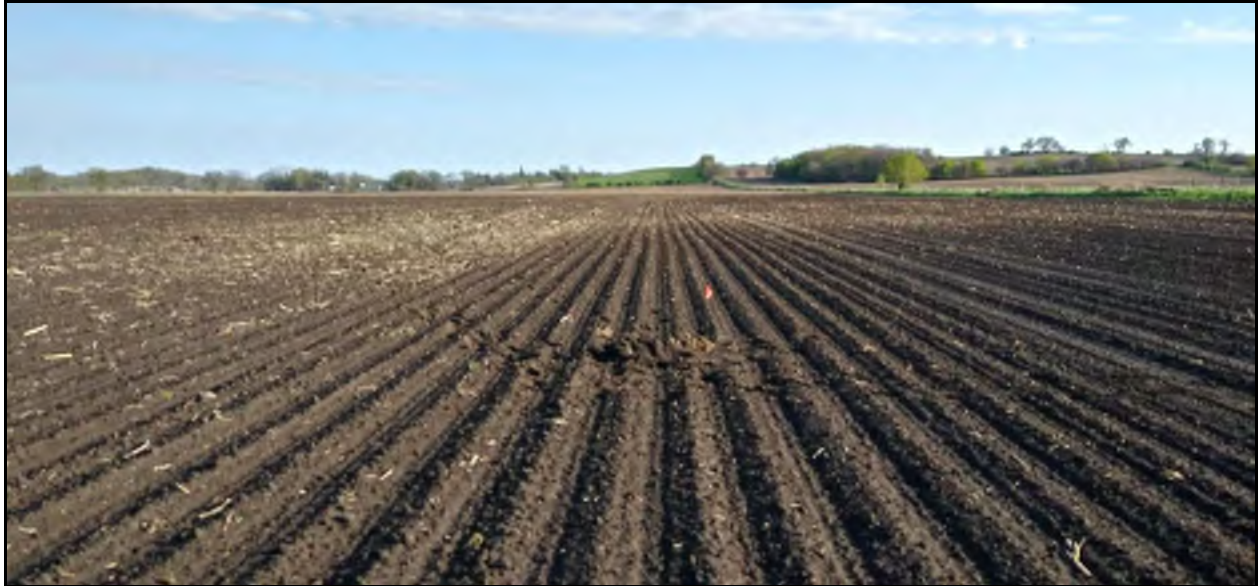
**Photo 15. Upland, agricultural field, viewing south past Plot 1.**

Reoccurring wetness signatures on the FSA, NAIP & Google Earth imagery are evident 0 out of 33 photo years, 0 out of 16 normal years within the western half of the western parcel containing Plots 1 & 2.

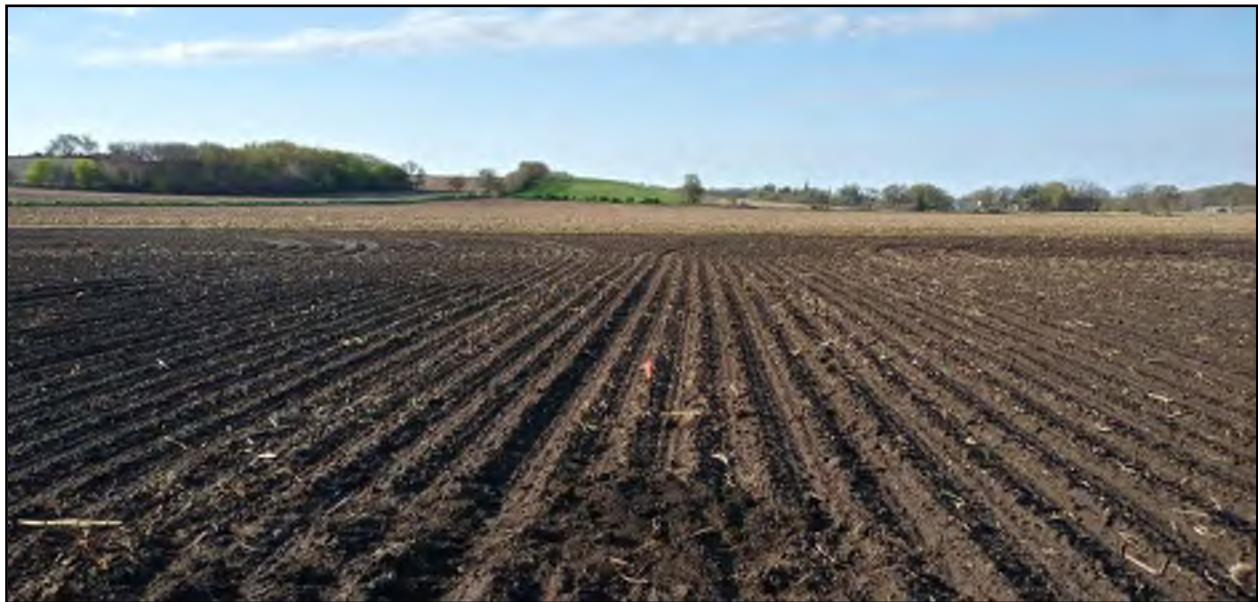
**Photo 16. Upland, agricultural field, viewing north past Plot 2.**

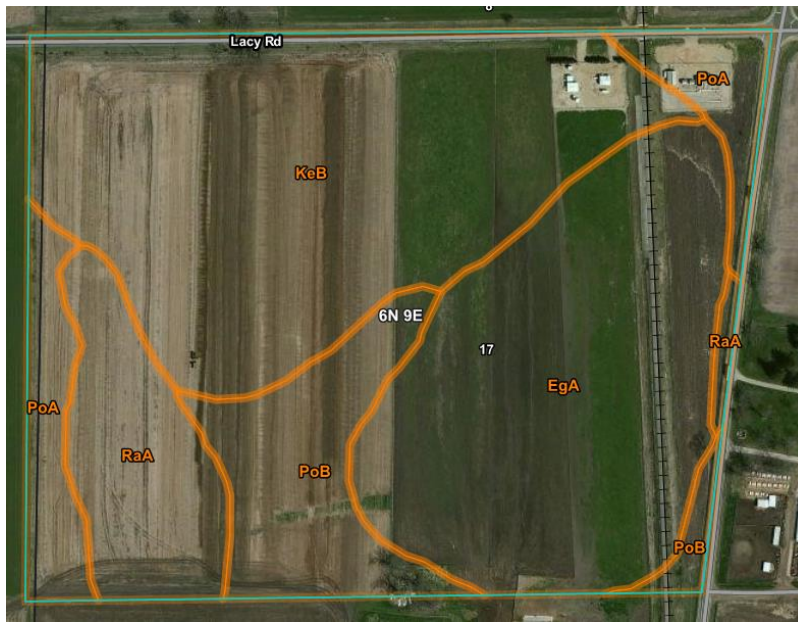
**Figure 3.3.1 Soil Survey Information**

- Plano silty loam (PoA) – Loess over loamy outwash over sand and gravelly outwash soils. Near surface soils generally consist of a surface layer of silt overlying silt and lean clay to a depth of about 4 feet below grade. Below 4 feet the soil profile generally consists of a thin layer of clayey gravel, lean clay, or silty clayey sand and then gravel with silt, gravel with sand, sand with silt, or sand. Approximately 8% of the AOI. Well drained with groundwater often deeper than 6 feet below the ground surface. This soil series typically consists of soils having an AASHTO Classification of "A-4", "A-6", "A-7-6", and "A-7" in the upper 4 to 5 feet and then "A-1" and "A-3", and are in hydrologic soil group B.

Soil mapping of the site vicinity is presented in Figure 3.3.1 below.
