## 2024 Aquatic Invasive Species Early Detection Monitoring and Water Quality Monitoring Report

# Two Sisters Lake

Oneida County, Wisconsin

This report provides aquatic invasive species early detection monitoring and water quality monitoring data conducted on Two Sisters Lake, August 6, 2024, by the Aquatic Invasive Species Program Staff at Oneida County Land and Water Conservation.

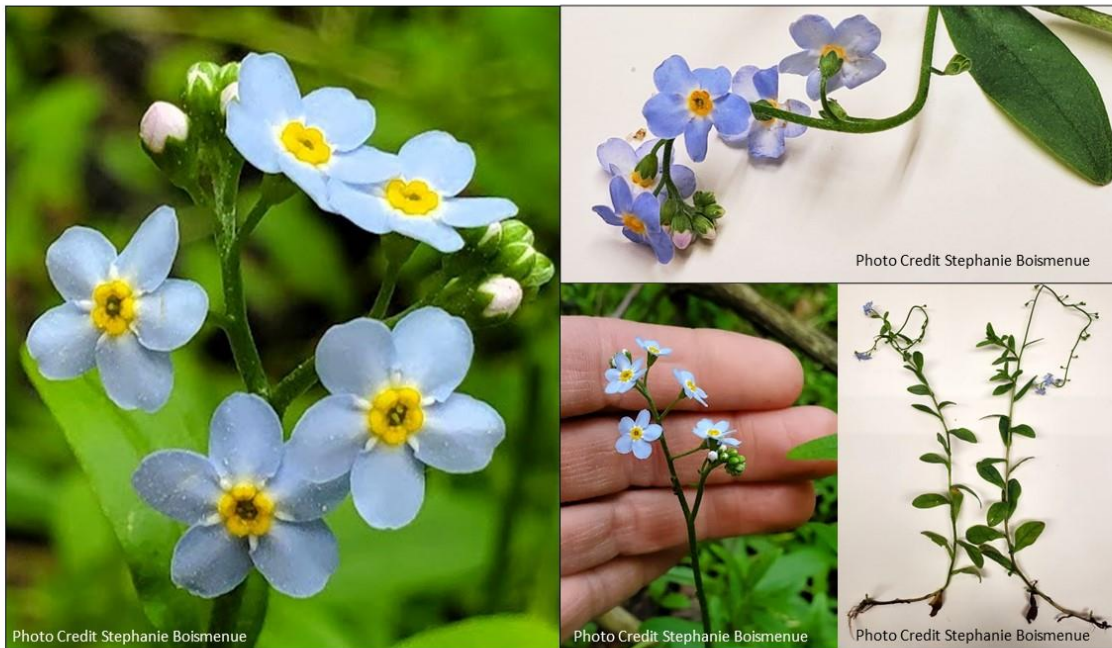
**Description:** Aquatic Forget-me-not is a non-native, herbaceous perennial that escaped water gardens and ponds and spread to shorelines, wetlands, marshes, moist woodlands, and wet meadows. It is a competitive plant that grows rapidly, forms dense monocultures that crowds out native groundcover, reduces soil nutrients, and reduces wildlife habitat.

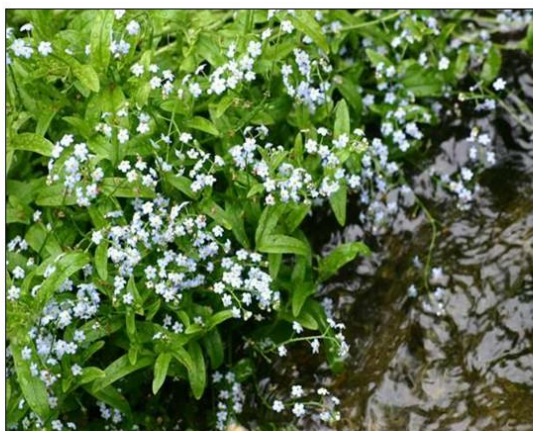
Large cluster of aquatic forget-me-not growing in shallow water.

**Manual:** Hand removal is effective for removing small plants and plant populations. The plants removes easily when the soil is moist. Hand pull or dig the entire plant, including the roots, before the seeds set. **Caution:** The disturbance associated with digging can result in shoreline and sediment erosion

**Disposal:** Dispose of in landfill or by burning. The DNR's and Waste Management programs are asking property owners to separate and bag AIS in clear bags and label the bags "Invasive plants – approved by DNR for landfiling."

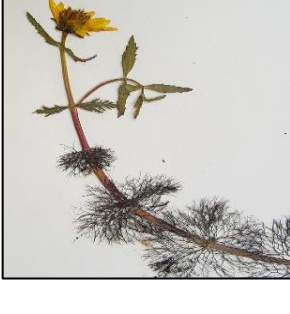
| <p><b>Water Marigold</b> (<i>Bidens beckii</i>)</p> <p><b>Status:</b> Native</p> <p><b>Description:</b> Submerged aquatic plant. Stem usually unbranched, up to 2m tall. Leaves whorled or opposite, heavily divided. Usually two emergent leaves under the flower, simple with heavily serrated/lobed edges. Flowers solitary, yellow, held above the surface.</p> <p><i>Photo Credit: Glen Lee</i></p> | |

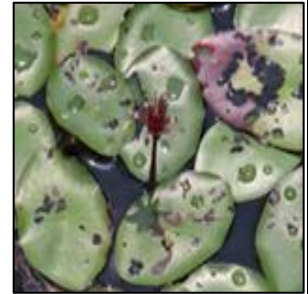
**Watershield** (*Brasenia schreberi*)

**Description:** An aquatic plant with stems up to 2 meters long. This plant has small floating leaves and reddish purple flowers that have 6-8 petals.

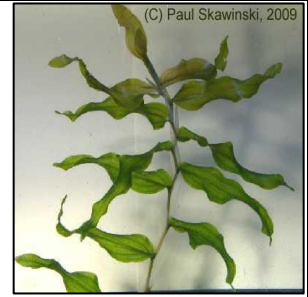
**White-stem Pondweed** (*Potamogeton praelongus*)

**Description:** A submersed plant with a prominent midvein. The tip of each leaf typically splits when pressed between fingers, and the stipules are white and close to the stem.

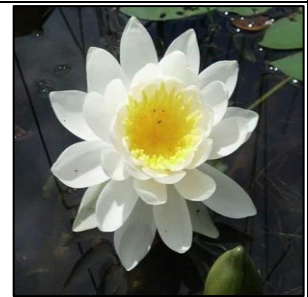
**White Water Lily** (*Nymphaea odorata*)

**Description:** An aquatic plant that has large, round leaves that can grow to be 12 inches in diameter. White water lilies also have large, white flowers with many petals.
