March 22, 2021

**Subject: Vapor Intrusion Investigation Report
905 S. Commercial Street, Neenah, Wisconsin
BRRTS# 02-71-110797**

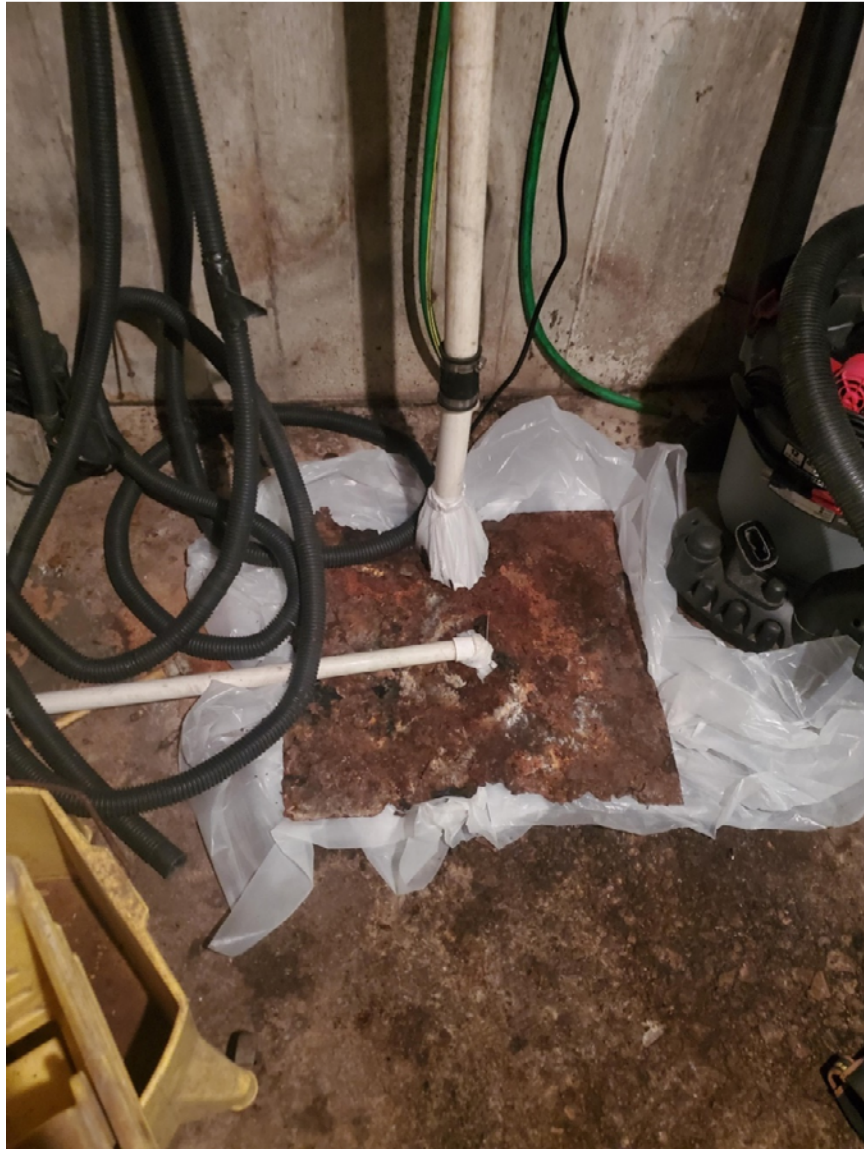
A photograph of the sump prepared for vapor sampling is provided below. The headspace vapor sample (200011-905-SUMP) was collected through disposable polyethylene tubing inserted through a small cut in the plastic. The sample was collected in a 1-liter vacuum canister fitted with a laboratory-supplied regulator that allowed a flow rate of approximately 200 milliliters per minute.

Basement sump with sealed with plastic sheeting in preparation for headspace vapor sampling.
