Subject: Final Case Closure with Continuing Obligations
Uno-Ven
9401 N. 107th Street (Formerly 9521 N. 107th Street), Milwaukee, WI 53224-1107
DNR BRRTS Activity #: 02-41-118373; FID #: 241017700

The subject site operates as a bulk petroleum product storage facility. It has bulk storage tanks, a manifold system, office and warehouse. This industrial property had two releases that were assessed in this remediation project. The first release of 3,700 gallons of unleaded premium gasoline occurred in 1988, in the area west of the trucking loading rack. The second release occurred in 1997 where 550 gallons of unleaded regular gasoline were released from a flange associated with Tank 4. Soil and groundwater investigations were conducted in 1988 and 1997. For remediation, soils around the pipe containing the leak were excavated and disposed off-site and the pipe was repaired. The piping and canopy on-site impeded both the soil and groundwater investigation and further remediation. Natural attenuation groundwater monitoring was implemented for several years and it has been demonstrated that the contaminant plume is stable and/or decreasing. The conditions of closure and continuing obligat

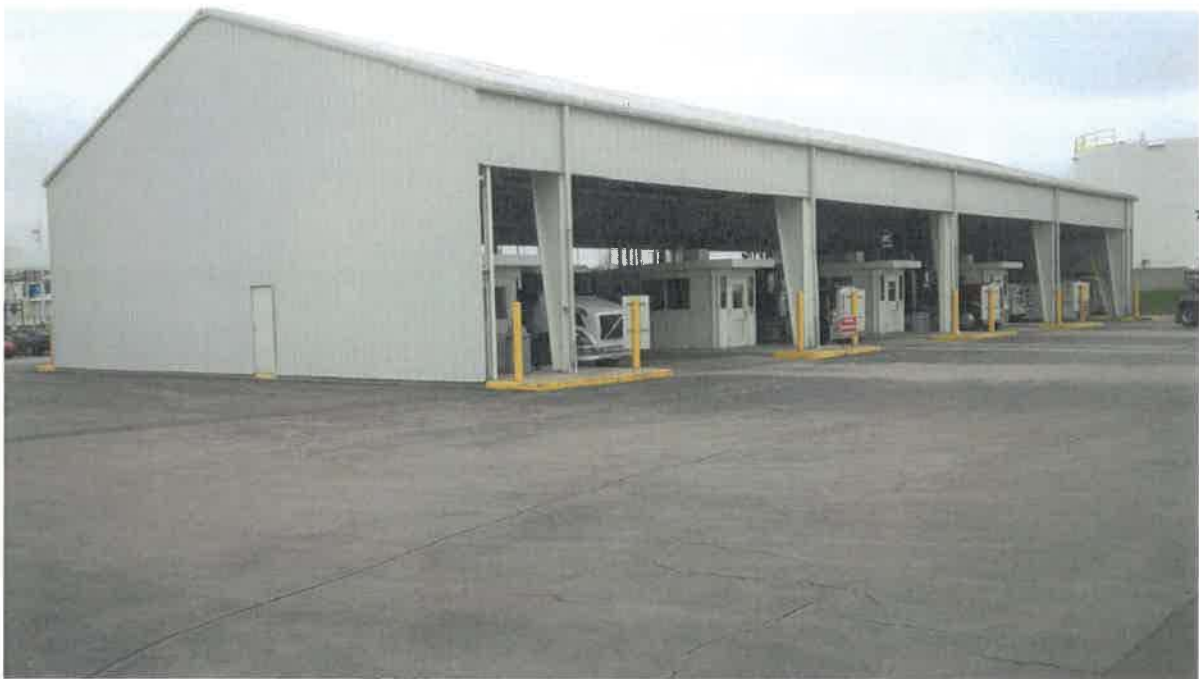
Former PDVMR Milwaukee Terminal (Uno-Ven) – Structural Impediment
Attachment B.5.a

Photograph 1 – Structural Impediment (View Northwest)

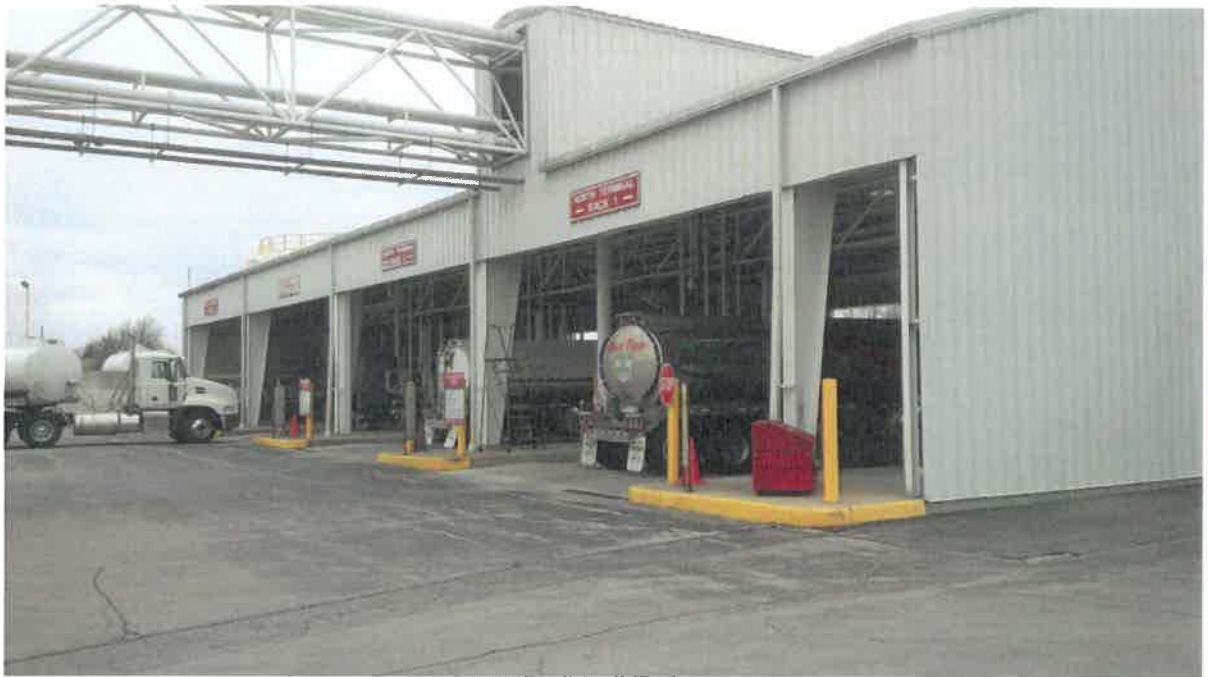
Former PDVMR Milwaukee Terminal (Uno-Ven) – Structural Impediment
Attachment B.5.b

Photograph 1 – Structural Impediment (View Northeast)

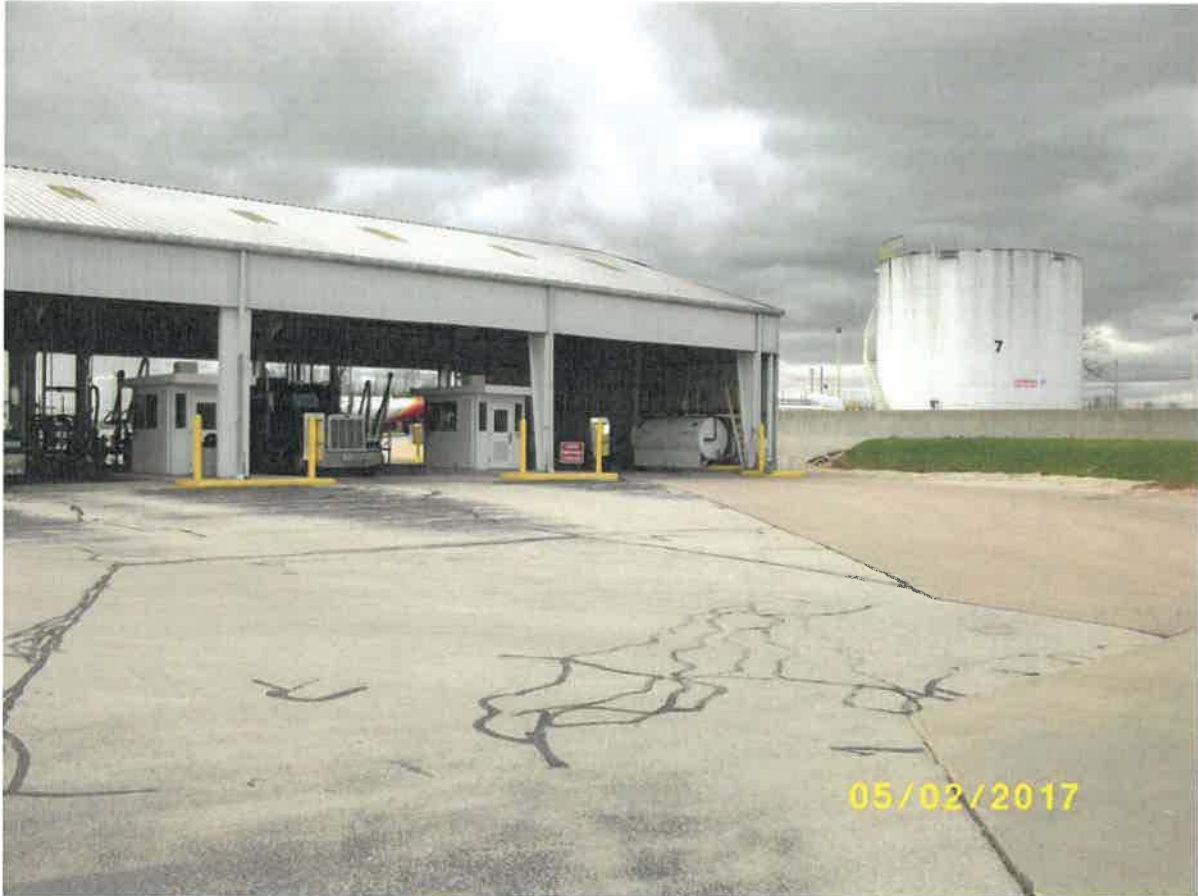
Structural Impediment (View Northwest)

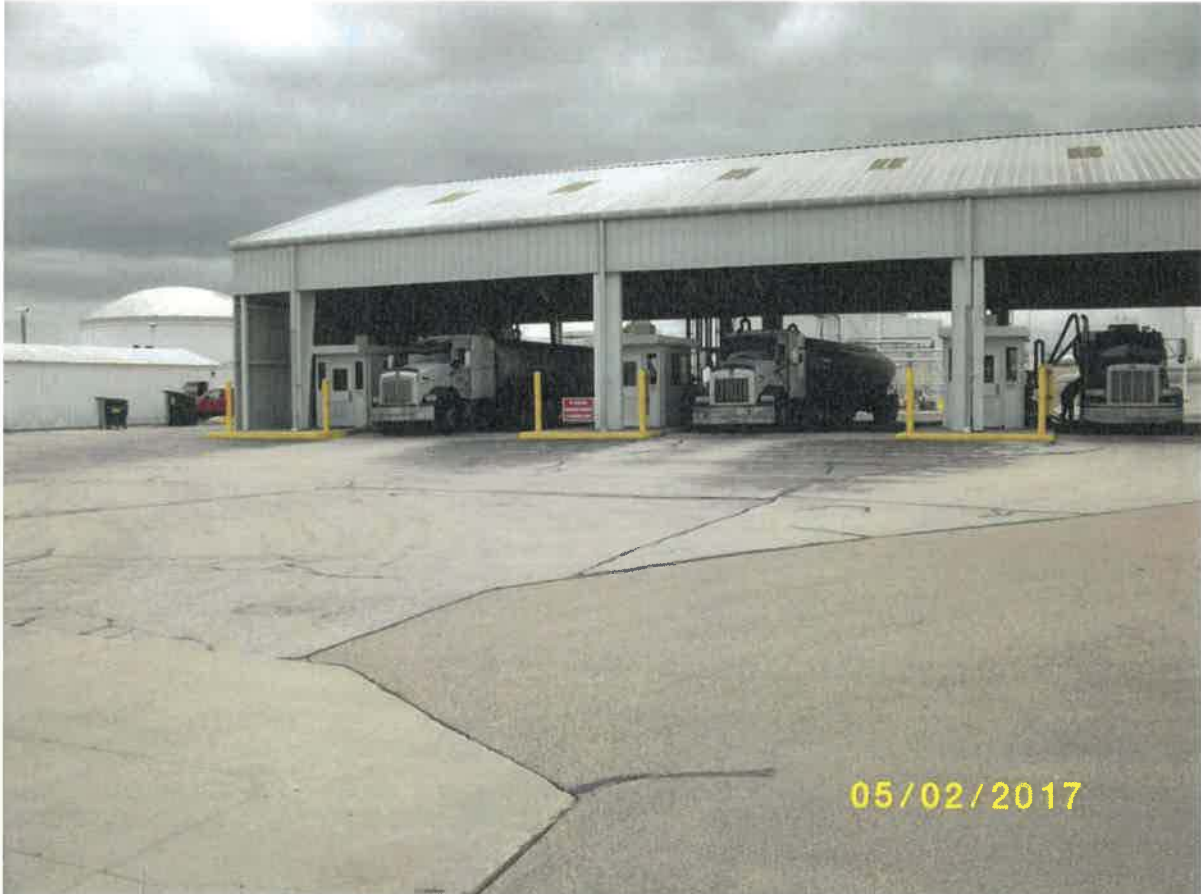
Structural Impediment (View Southwest)

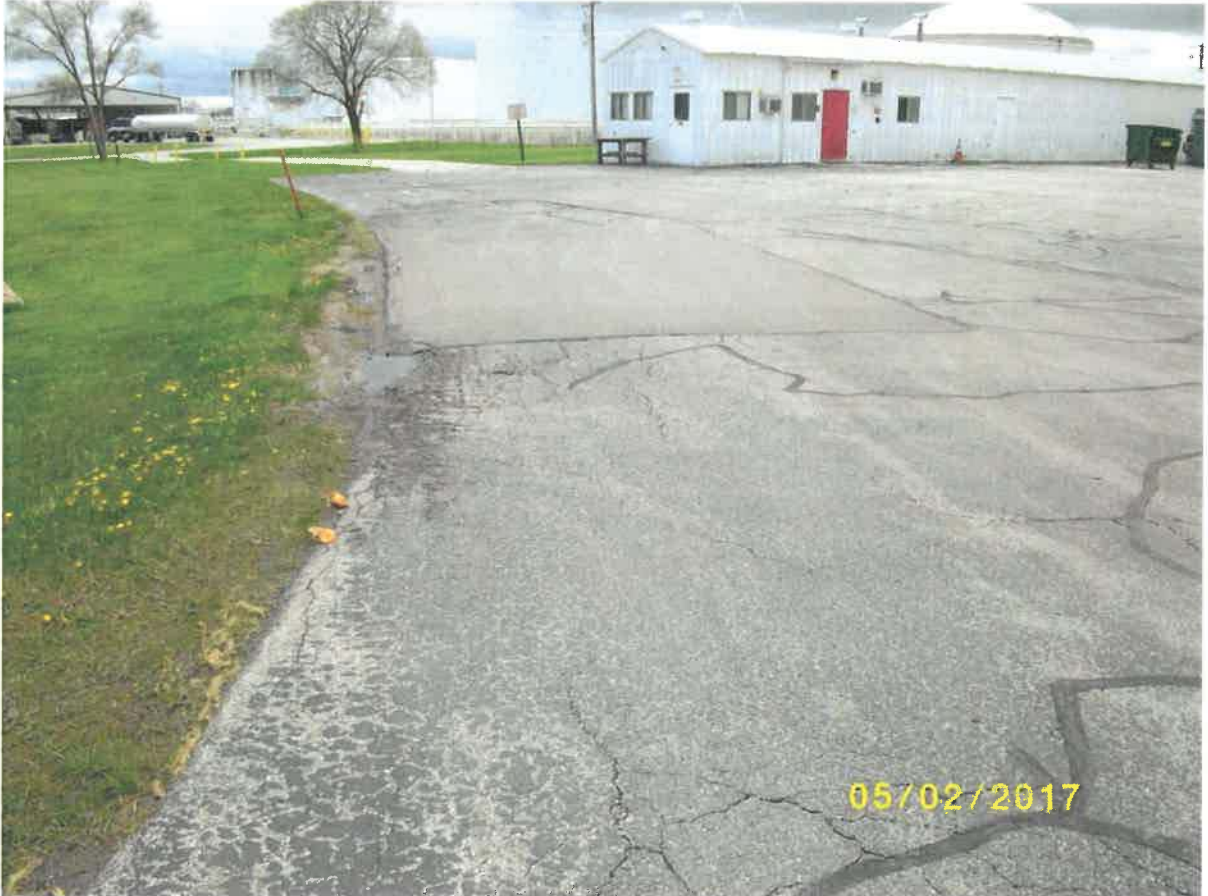
Barrier (View Southwest)

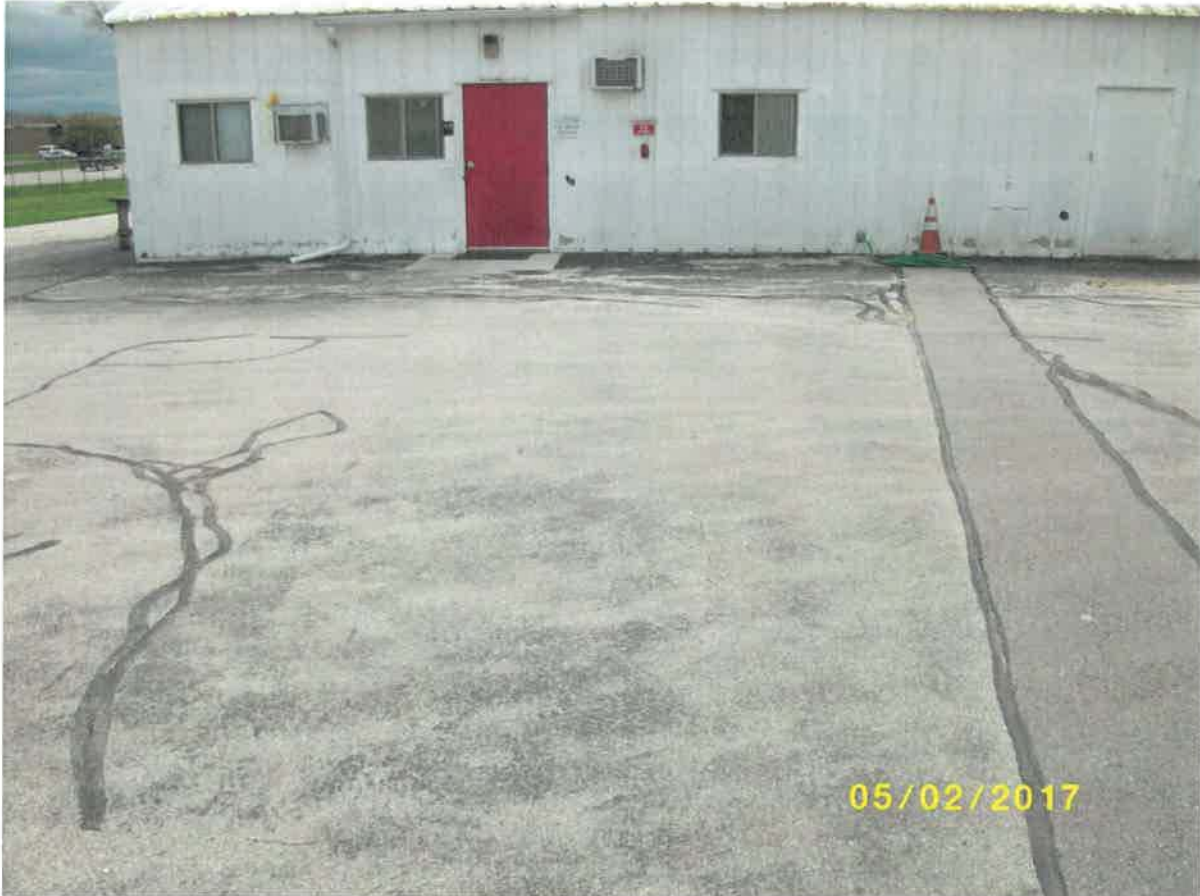
Barrier (View South)

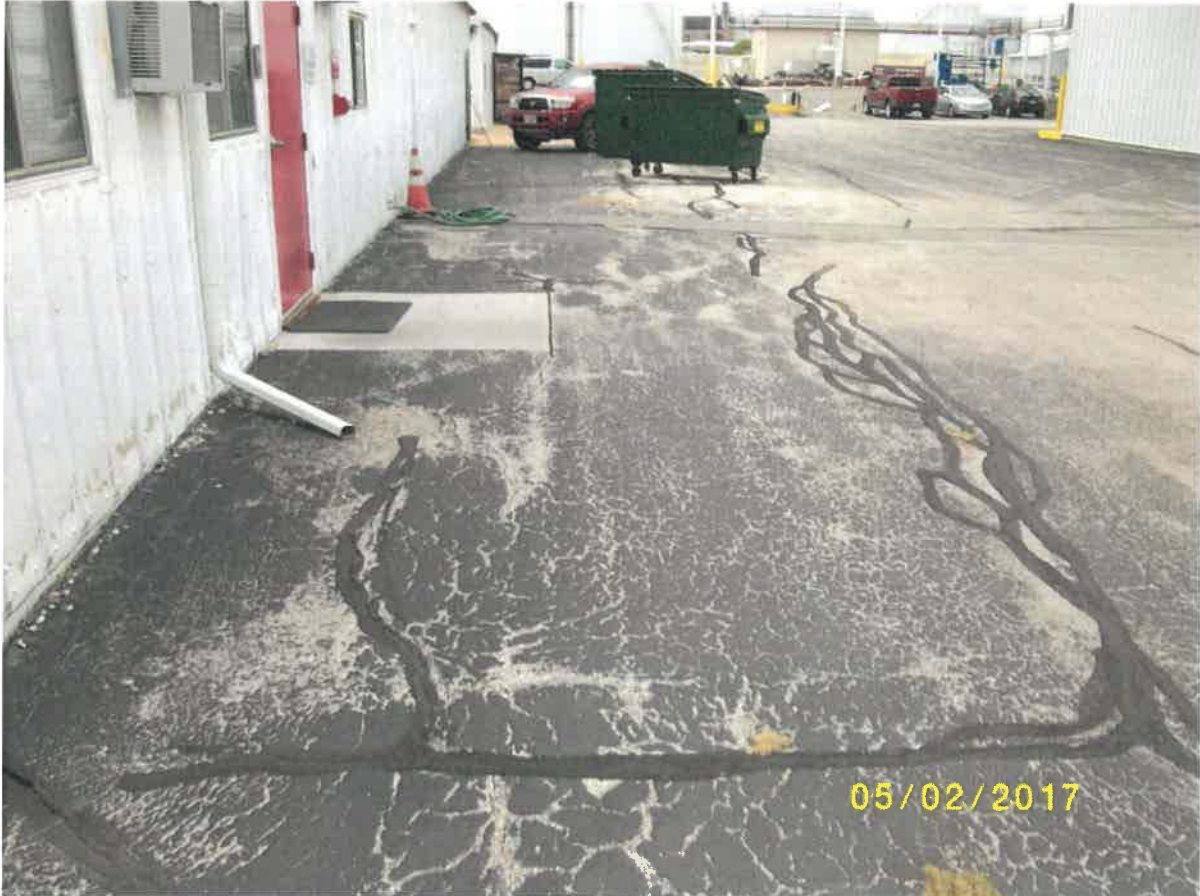
Barrier (View West)
